Structural Inspection Report

**Growth of Adjacent Tree
Bretton Lodge
1, Park Lane
West Bretton
WF4 4JT**

TSI 22135

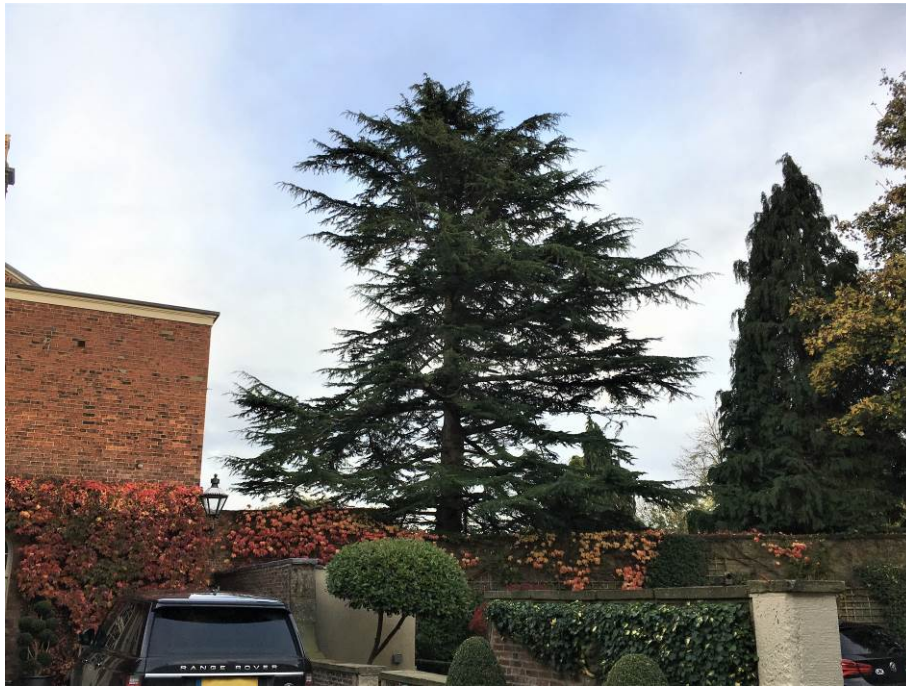
7.1.1 A large conifer, which is the subject of this report, is located approx. 6m from the south-west corner of the main property, and approx. 1.5m to the east side of a tall masonry estate wall that divides the main garden area from an adjacent vehicle parking area. (Photo A1.1).

Photo A1.1 : View of the semi-mature Atlas Cedar located to the south-west of the main residential property at Bretton Lodge. NB branch imbalance due to storm damage.

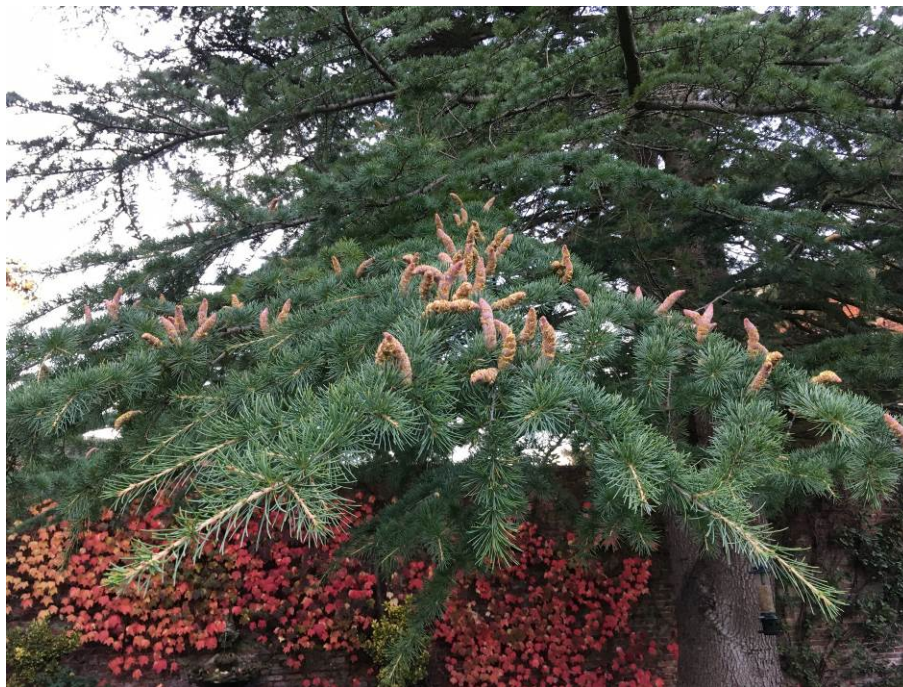
- 7.1.2 The tree is believed to be a male Atlas Cedar (*Cedrus Atlantica*), which when fully mature can reach heights of around 20m. The tree has been identified from the distinctive appearance of its bark, the clustered growth pattern of the foliage, and its flowers, which give off a fine yellow pollen. (Photo A1.2).

Photo A1.2 : Distinctive male flowers and clustered growth of needle-like foliage of the *Cedrus Atlantica*.

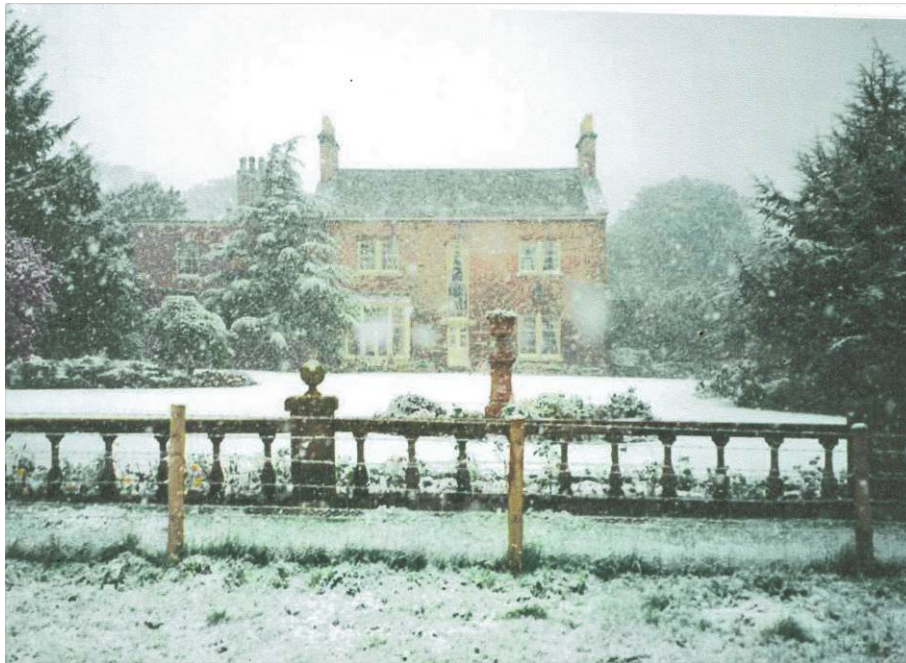
- 7.1.3 A photo, dated as having been taken in Easter 1998, shows the tree as being approx. 8m high at the time. The development of twin trunks is already visible in the photo, and this is a feature of the tree as it currently stands. (Photo A1.3).

Photo A1.3 : Photo of Bretton Lodge taken in Easter 1998, showing the Atlas Cedar to the left hand side of the property. The estimated height of the tree at the time was 8m.

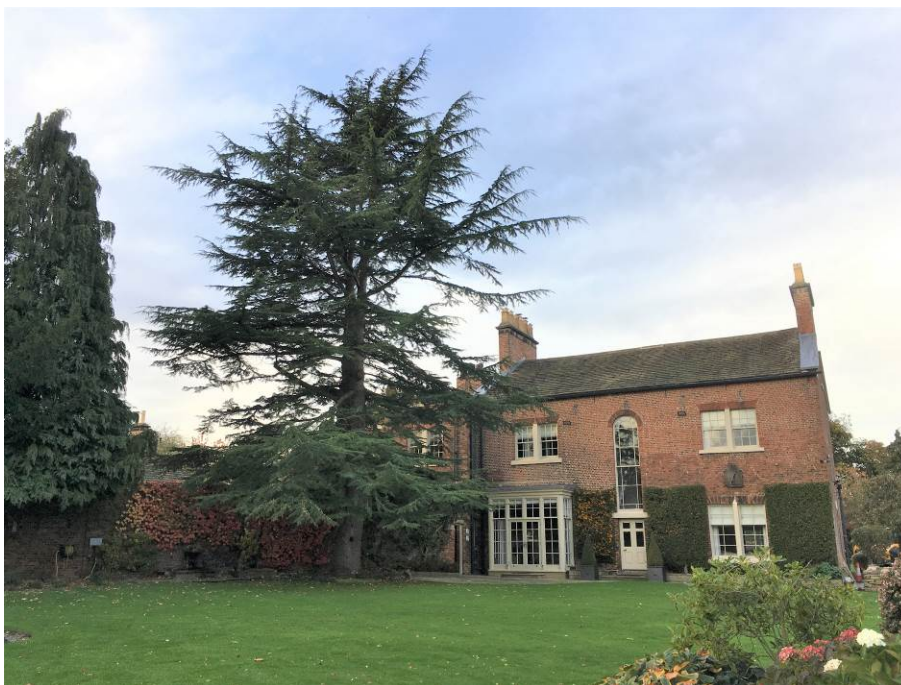
- 7.1.4 The tree is currently estimated to have a height of approx. 15m, and a spread of approx. 12m, and would therefore appear to have roughly doubled in size over the past 25 years. (Photo A1.4).

Photo A1.4 : Current-day view of Bretton Lodge, showing the Atlas Cedar, now estimated to be approx. 15m tall.

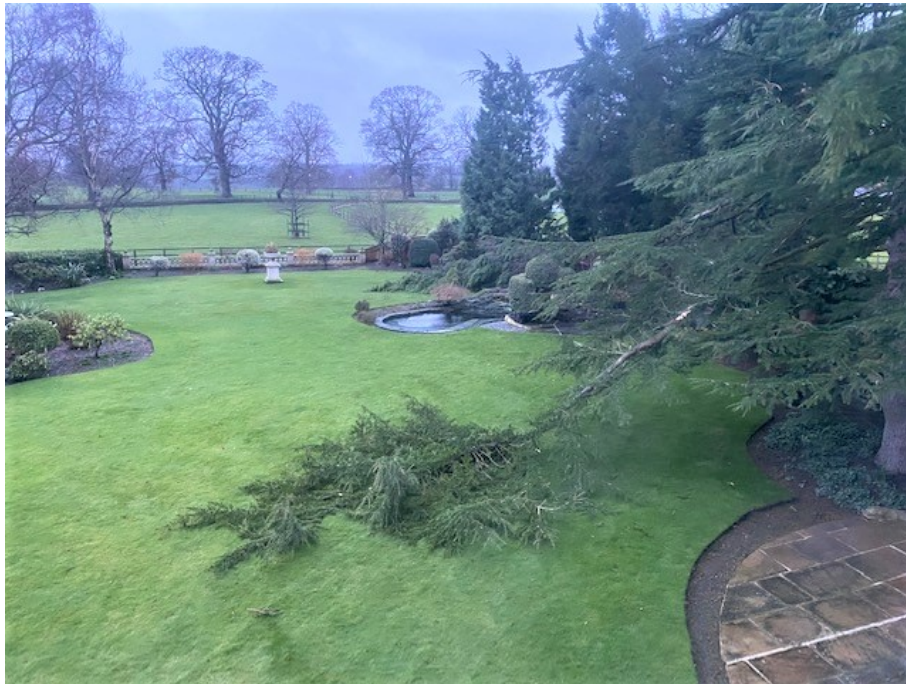
- 7.1.5 Several branches are known to have split as a result of storms Dudley and Eunice, which caused widespread damage across the UK during the week from 13th to 19th February 2022, and during which wind speeds of around 80mph, or 22 m/s, were recorded in the area. The broken stumps of the branches have since been trimmed back, in order to minimise the risk of the onset of fungal decay. (Photo A1.5).

Photo A1.5 : Photo taken on 20th February 2022, showing branch loss due to storms Dudley and Eunice.

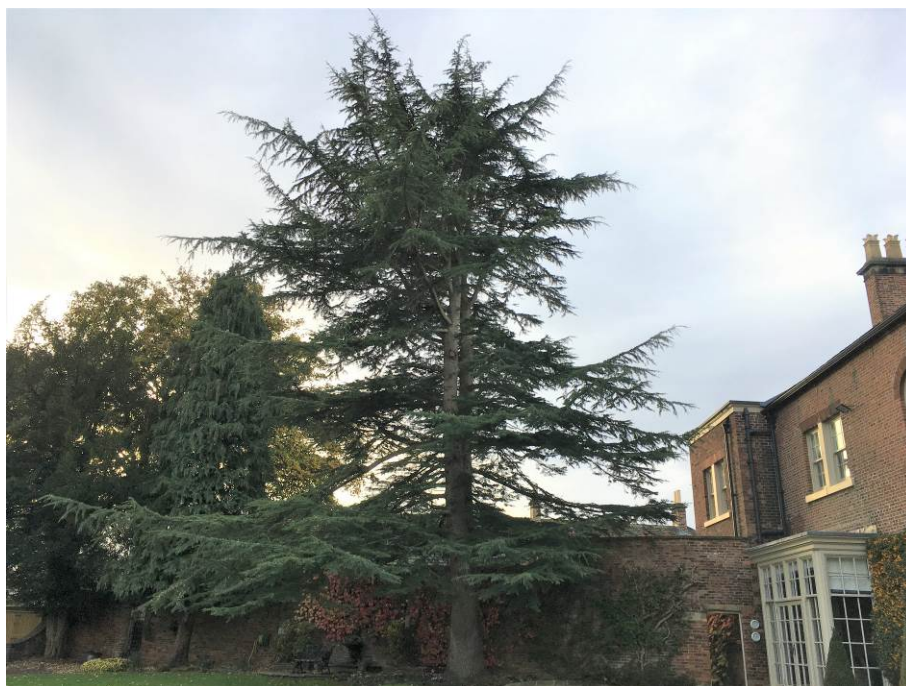
- 7.1.6 The loss of the branches has resulted in the tree becoming somewhat unbalanced in appearance. (Photo A1.6).
- 7.1.7 The tree was noted to have shifted slightly during the storms, with the result that it now has a slight lean towards the property to the north-east. (Photo A1.7).

8.1.1 The tree has become partially imbalanced due to asymmetrical storm loss of branches. Apart from the vertical load imbalance that will have resulted, there will also be an imbalance in the lateral load being carried by the tree in windy conditions. This will result in torsional effects being applied to the trunks, with the possibility of further damage, and hence further instability, being brought about as a result.

Photo A1.6 : The Atlas Cedar, viewed from the east.
NB imbalance of branches due to storm damage.

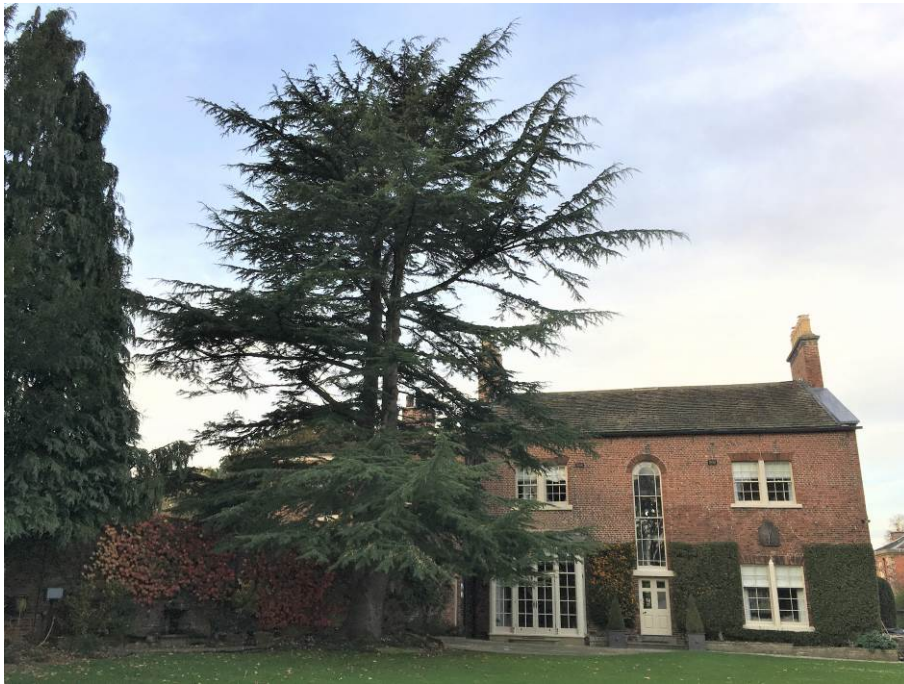
8.1.5 The lateral displacement of the main tree growth towards the north-east will also be exerting an eccentric effect on the anchorage afforded by the remaining root growth, which will have the effect of further increasing the risk of overturning in the future.

Photo A1.7 : A slight eastward lean of the twin trunks is apparent. This appears to be due to a slight rotational shift of the root plate, due to strong winds from the west.

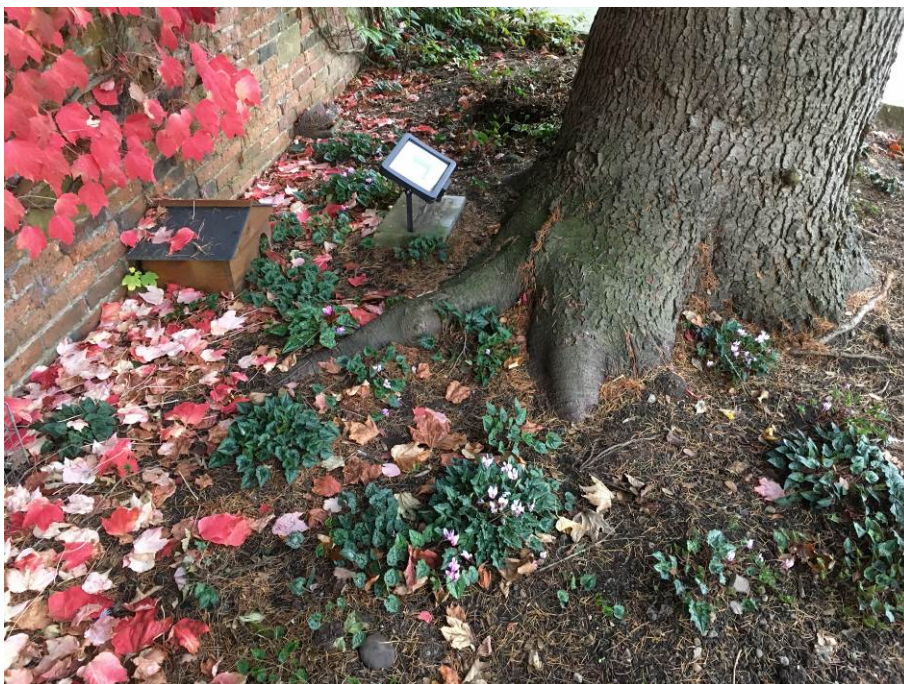
- 7.1.8 The storms also appear to have caused the south-west side of the root plate to have lifted slightly. (Photo A1.8).
- 7.2 The estate wall
- 7.2.1 The estate wall adjacent to the tree is built of mixed coursed sandstone (west face, towards the vehicle parking area) and handmade clay brickwork (east face, towards the tree and main garden) and is capped with sandstone coping slabs. (Photo A1.9).

8.1.2 The unusually strong overturning effect caused by the abnormally high winds in February 2022 appears to have had the effect of lifting the south-west side of the root plate beneath the tree. While this is likely to have resulted in damage to some of the root growth in this area, visual evidence of this is unlikely to become apparent until the commencement of the tree's next growing cycle in the early months of 2023.

8.1.3 It would appear that the larger roots growing to the south-west of the tree have exerted an uplift on the foundations of the adjacent estate wall, resulting in a slight lifting in the bed joint coursing, as well as creating the south-westerly distortion that is visible in the wall itself.

8.1.4 The loss of tree root growth from one side of the root plate has the effect of reducing the tree's ability to withstand winds coming that particular direction. In this case, the damage appears to be to the south-west, which is the normal direction for prevailing winds in this area. Consequently, the risk of further wind damage being caused is considered to be high.

Photo A1.8 : Slight lifting of major roots to the south and west of the tree, with slight resultant lift in the bed joint coursing of the adjacent estate wall.

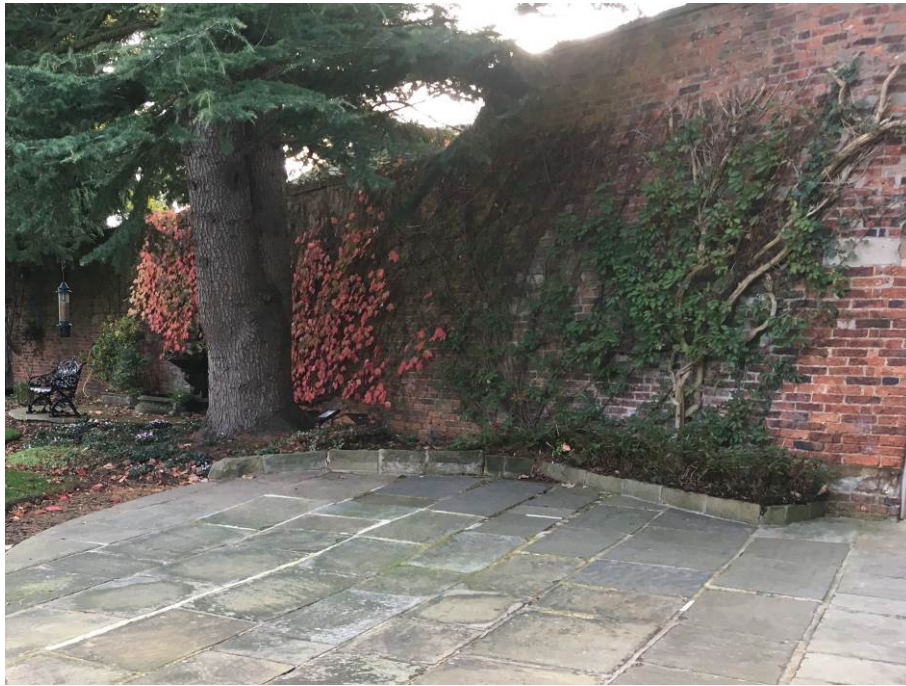
Photo A1.9 : The estate wall runs to the western side of the tree, and is of clay brickwork to its eastern face. NB also sandstone flagged patio area to the north of the tree.

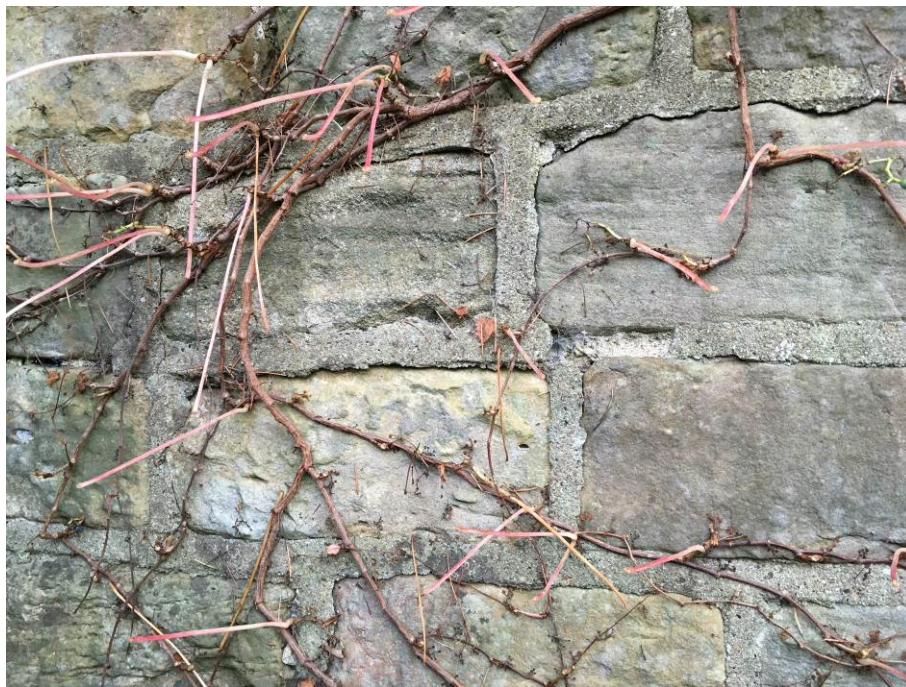
- 7.2.2 The wall appears to have been built using an ash / lime mortar, which allows moderate distortions to be tolerated, without causing cracking of individual masonry units. (Photo A1.10).

Photo A1.10 : Cracking and localised loss of pointing to the western coursed sandstone face of the wall. NB fracturing of individual masonry units does not appear to have occurred.

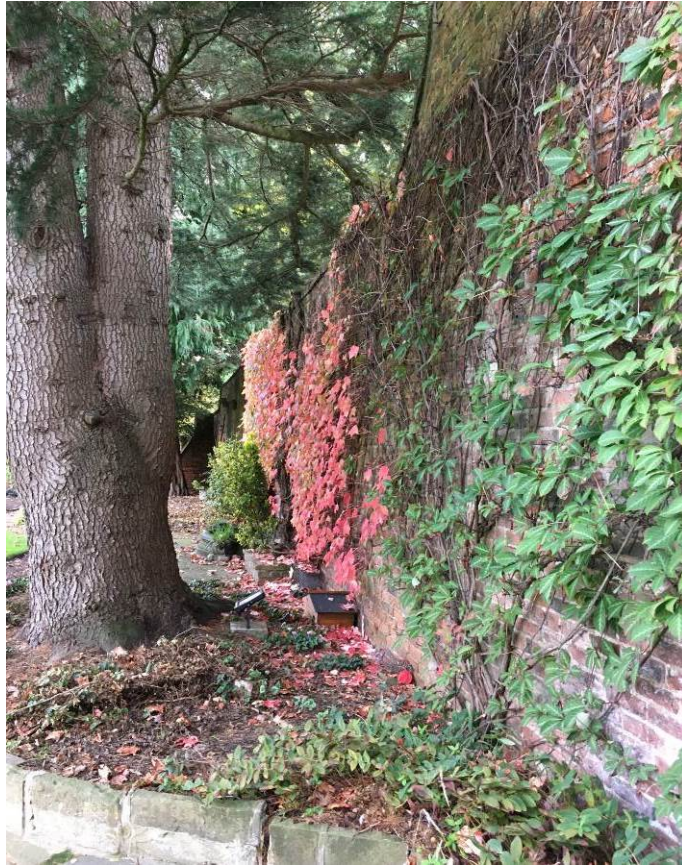
- 7.2.3 The wall varies in height between approx. 3.5m and 4.5m, and was measured as being approx. 450mm thick.
- 7.2.4 The wall in the vicinity of the tree appears to have a slight lean to the west, estimated visually to be approx. 120mm over its height. (Photo A1.11).

8.2.1 The lean that has been induced in the estate wall is approaching the point where the vertical line of thrust through the wall's centre of mass will lie outside of the middle third of the wall's width. If this point is reached, tension forces will start to be induced in the 'outer' (east) face of the wall, which the masonry will not be able to resist. Cracking will then start to develop, and if the degree of lean is not halted by some means, the possibility of collapse will become increasingly likely.

Photo A1.11 : There is a slight westward lean to the head of the wall opposite to the tree, estimated visually to be approx. 150mm.

8.2.2 Possible solutions to this problem include the provision of buttresses or the introduction of structural framing to the 'inner' (west) side of the wall, in order to resist overturning; remedial works to the foundations of the wall to prevent further tilting; or the complete demolition of the wall, followed by its reconstruction with new, upon a suitable foundation – all of which would entail considerable expense.

- 8.2.3 A further option would be to consider the removal of the existing tree, followed by its replacement with a new specimen tree, planted in a more suitable location.

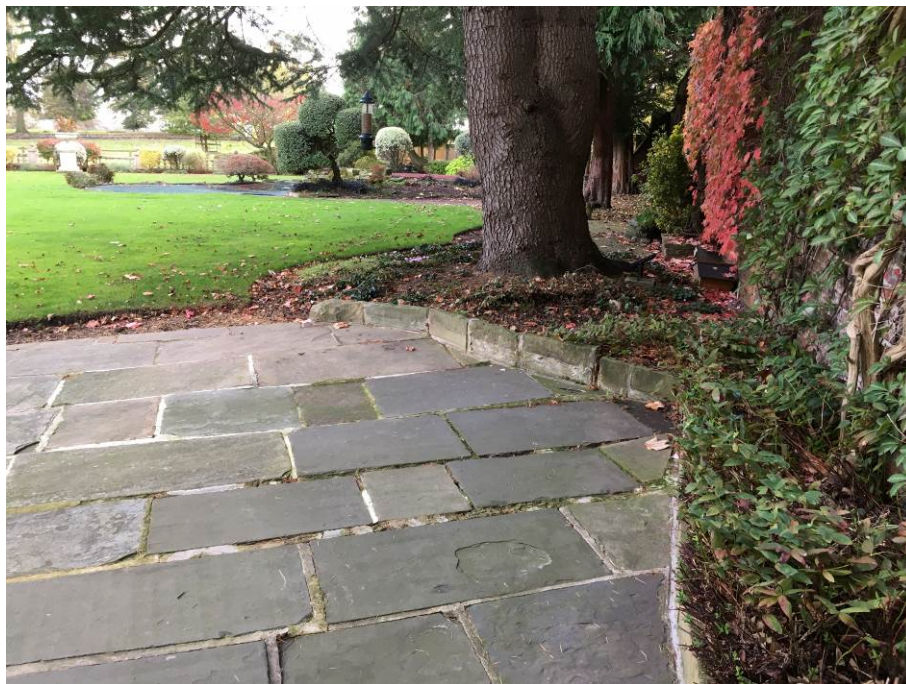
- 7.3 Stone flagged patio area
- 7.3.1 The sandstone paving to the patio area to the north side of the tree was noted to have lifted slightly during the storms in February, resulting in the loosening of the mortar pointing between the flags. (Photo A1.12).

Photo A1.12 : The sandstone paving to the patio has lifted slightly, resulting in the loosening of pointing.
