## Tree Condition Survey

St Swithun's Church, Littleham, EX39 EX39 5HR.

Instructed by:	Andrew Tregoning Church Warden St Swithun's Church Littleham EX39 5HR
Compiled by;	Bruce Macfarlane, MArbor A, P Dip Arb (RFS)
Date:	24 <sup>th</sup> November 2022
Report ref:	CTC241122HS

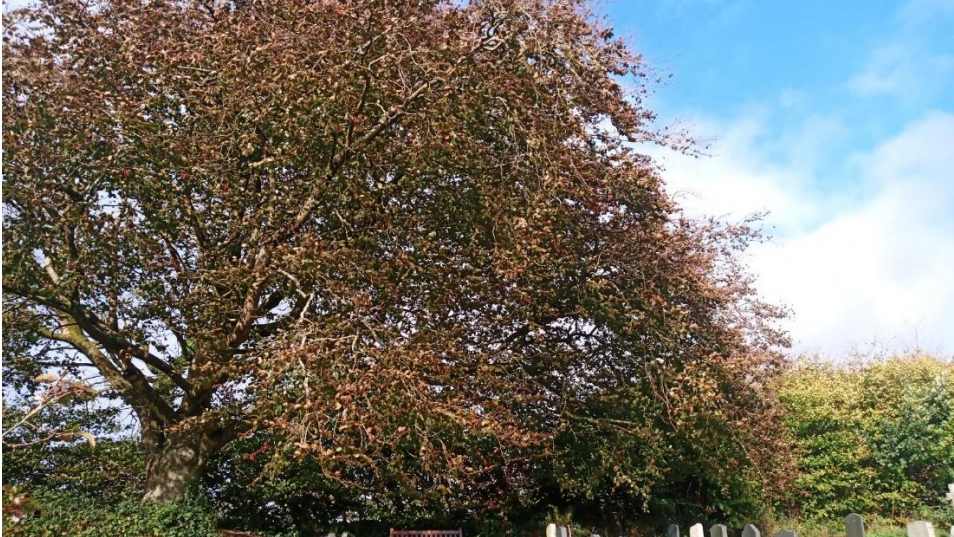
4.1 This is a mature beech growing in the northwest corner of the church grave yard, there are gravestones under the tree and there is also a bench under the trees canopy. The tree has an even canopy, but has one heavily weighted long branch on the east side when viewed from the main path to the church.

Photo 1: T3, Beech viewed from the main path to the church.

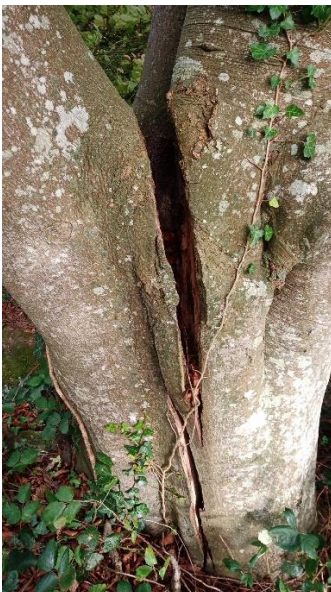
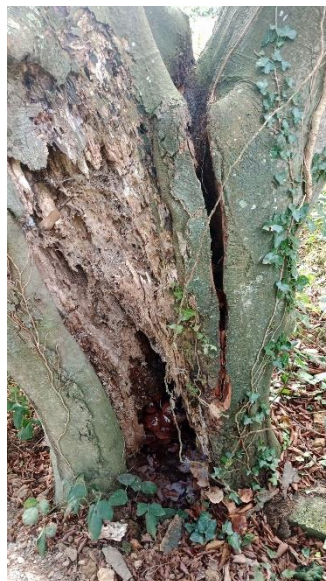
4.3 On the western side of the main trunk one quarter of the tree's trunk has split from the top of the main stem to below ground level. When examining the split, the smaller section of the tree can be seen moving in the wind. Only a small section of the main canopy is connected to the split section of trunk and it is weighted away from the church yard so there is minimal risk to visitors to the church.

Photo 2 & 3: Split trunk seen from both sides of the tree

5.3 The amount of pruning required to retain this tree in a safer condition would be of further detriment to the health of the tree and I recommend this tree is removed at the earliest opportunity. Due to the position of the tree it will require professional dismantling to ensure no damage occurs to the surrounding grave stones.

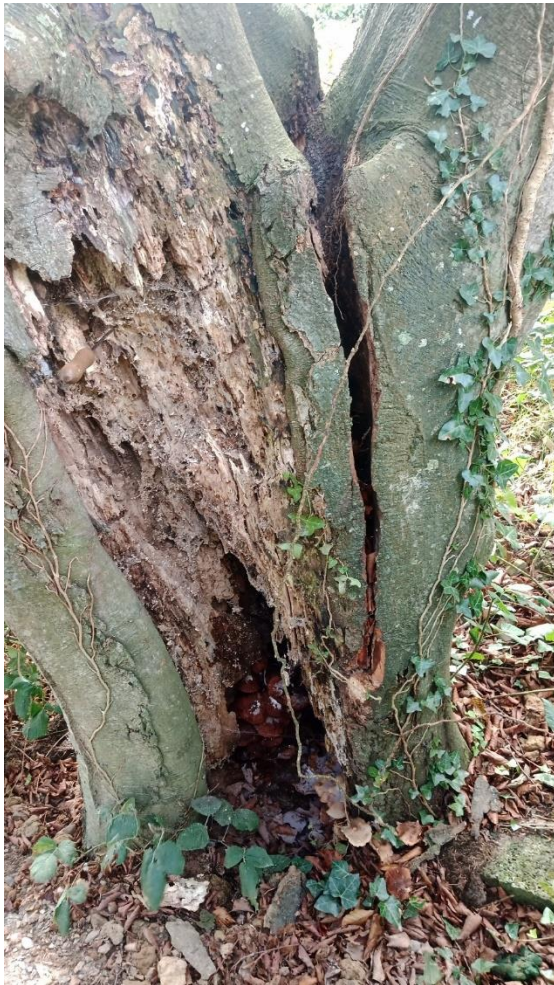
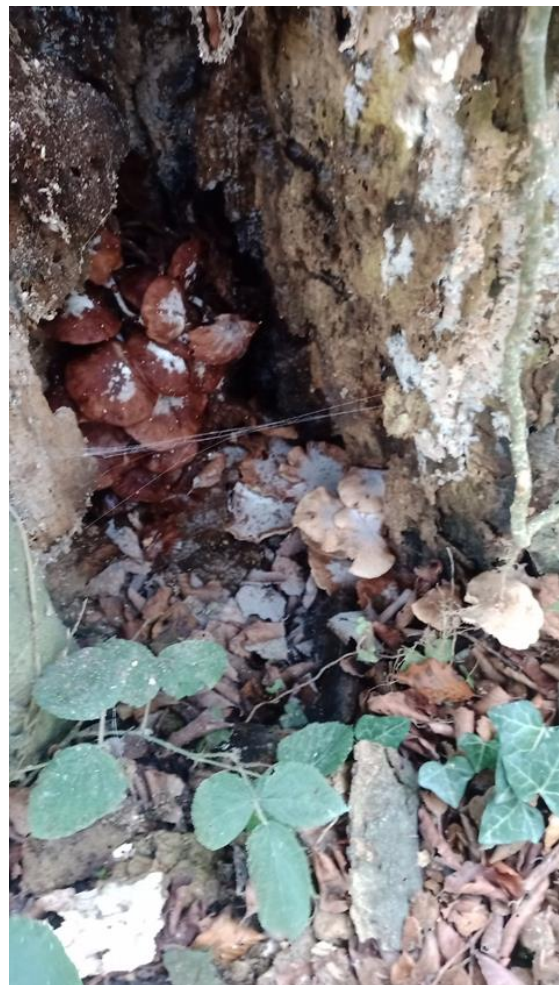
4.4 Also on the north side of the main trunk adjacent to the split is a large area of advanced wood decay. The extensive decay stretches from below ground level up to the main stem union at approximately 1m high, but decay can be seen to have reached into the main branch framework at least 3m high. The decay seems to have started in an old wound in the main trunk and over many years has spread deep into the heartwood of the tree. There is no solid root plate below the main trunk and the decay is likely to have spread into the main root buttresses. There were some fungal fruiting bodies within the trunk cavity belonging to the root decay fungus known as, Honey fungus (*Armillaria* spp.). This is a root and stem decay fungus meaning decay in the main roots is even more likely. Other signs that this is the main decay fungus are white mycelium under the bark, stem bleeding and sheets of black rhizomorphs in the older decayed wood.

Photo 4 & 5: Showing extensive decay and Honey fungus fruiting bodies within the cavity

5.1 Although from a distance this tree appears to be in good condition the extensive decay and split main trunk means this tree is in an unstable condition and failure of part or all of the tree is highly likely, especially in high autumn winds.
