MB Trees (East Anglia) Ltd.

Tree Health & Condition Tree Survey at The Chestnuts, Long Green, Wortham, Diss IP22 1RD

Date of inspection: 24th October 2022

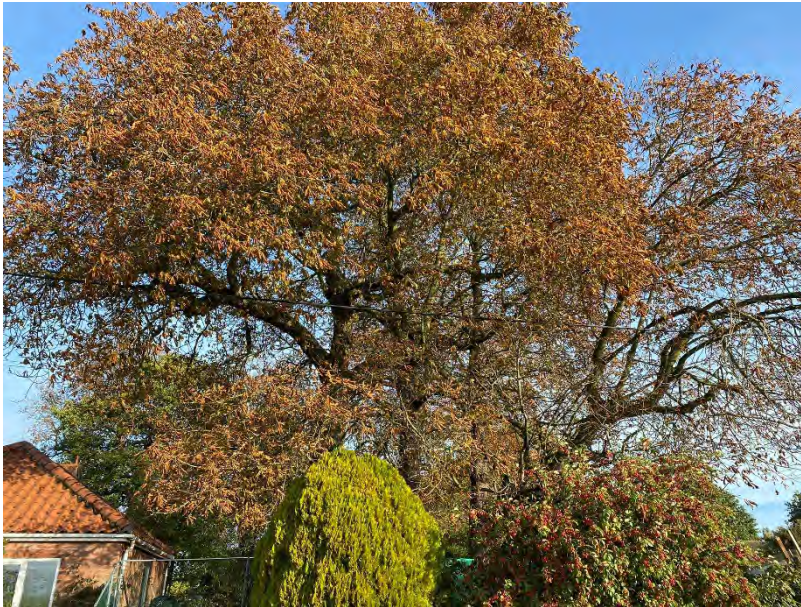
Species of tree: T1 – Horse Chestnut / *Aesculus hippocastanum*

On the northwest top section of the canopy there are some heavily congested branches with canker, causing swelling to selective branches.

At the top of the main stem and where branch structure starts for the upper most section of the canopy there are several old storm damaged wounds creating cavity areas.

The low southwest limb that grows towards and over the low voltage has several large old pruning wounds from heavy pruning next to electrical cable.

The low south limb has a visual cavity on the upper side of the main limb. This also has old pruning wounds near the electrical cable and has strong extension growth from the old pruning area that is now becoming overextended on the cavity created by heavy pruning.

Overall health in good condition and physiological condition fair.

Reduce the height of the tree by 3m and removing heavy cankered branches

Low southwest limb to be reduced by 4m

Low south limb, reduce extension growth by 3-4m

Remaining canopy to be reduced to balance the crown after initial reduction works and reduce any other necessary branches away from the powerline by approx. 1m where possible and leave main crown structure if within 1m

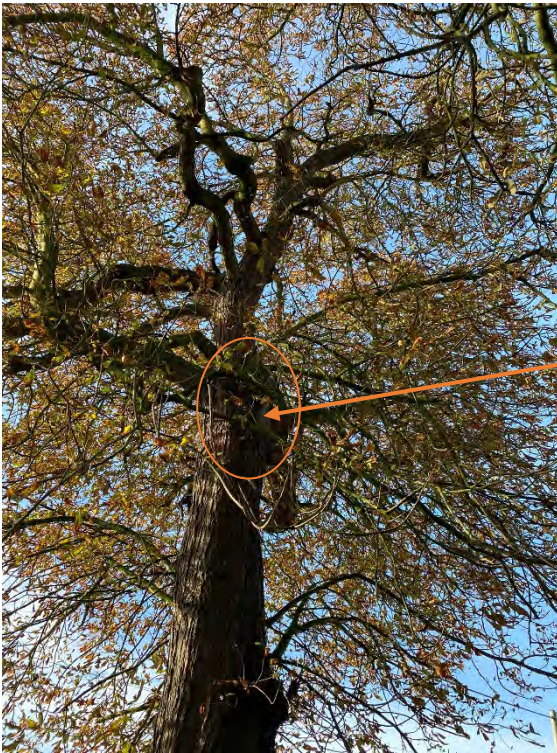
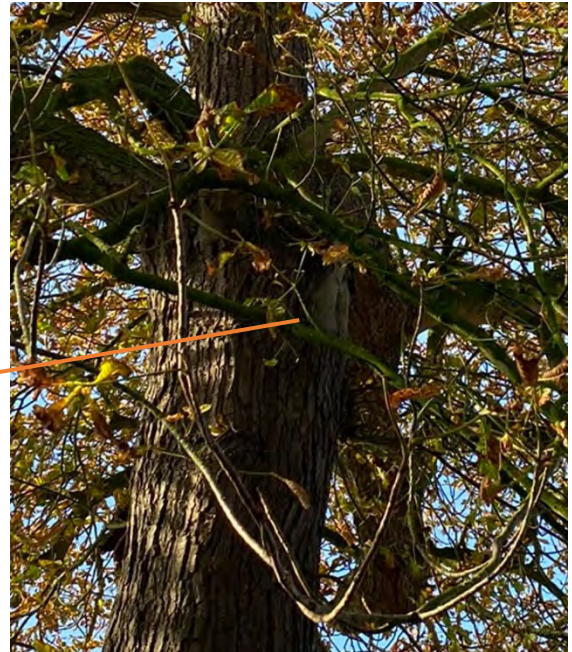
There is a sizeable cavity from old wound on the main stem at approx. 6m from ground level facing north. As can be noted in the picture on following page.

Picture of T1 showing cavity on north side of main stem

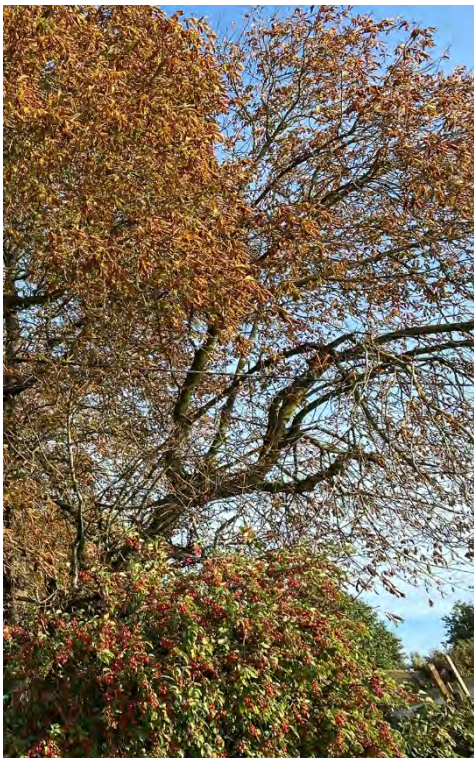
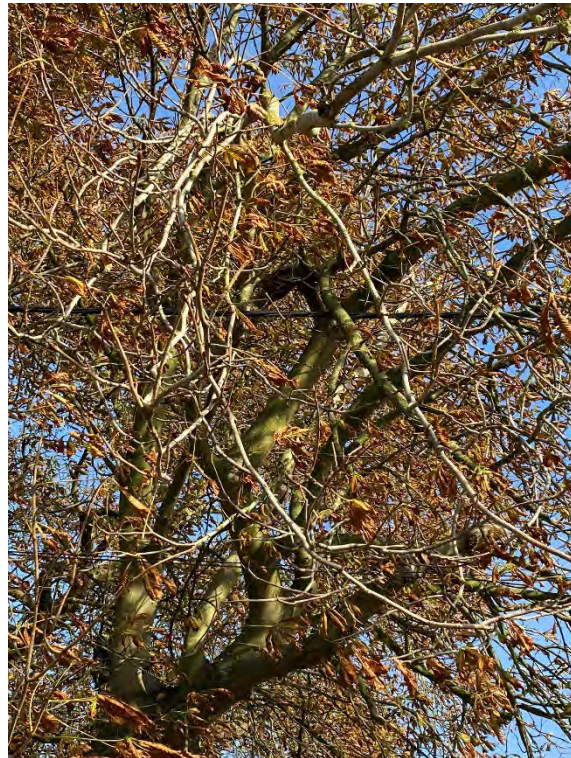
Species of tree: T2 – Horse Chestnut / *Aesculus hippocastanum*

The buds and overall health appear in good condition. The physiological condition however is poor due to previous heavy pruning that once would have been old pollard points. The Canopy extends eastwards towards the neighbouring property and powerlines. There is also A split damaged, branch on the south side almost touching the power cable as can be seen in the photo on P5.

Reduce the canopy by 4m

Remove split damaged branch

Reduce remaining canopy away from powerline by approx. 1m where possible and leave main crown structure if within 1m

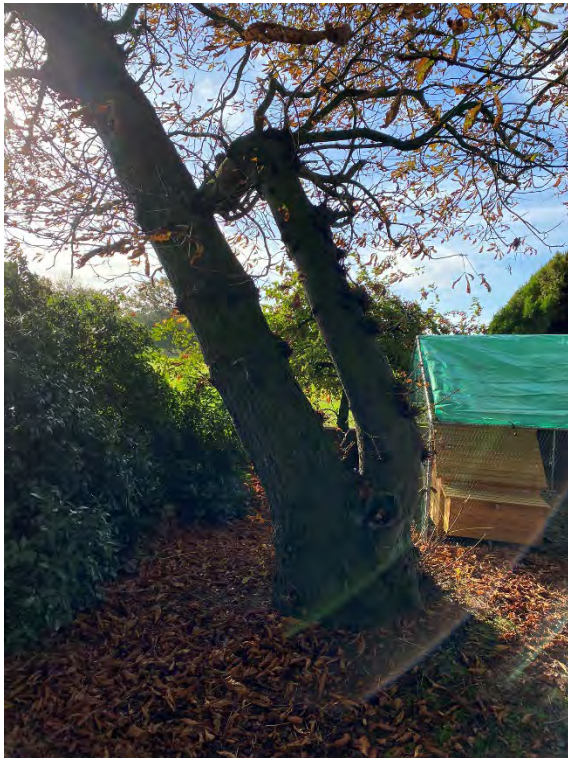
There is a cavity at the base below where the tree divides into two main stems on north side. The probe was inserted into the cavity by approx. 27cm. There is also a smaller cavity on the south side at the base of the tree. The probe was inserted into this cavity by approx. 70cm before hitting solid matter.

Cavity on north side

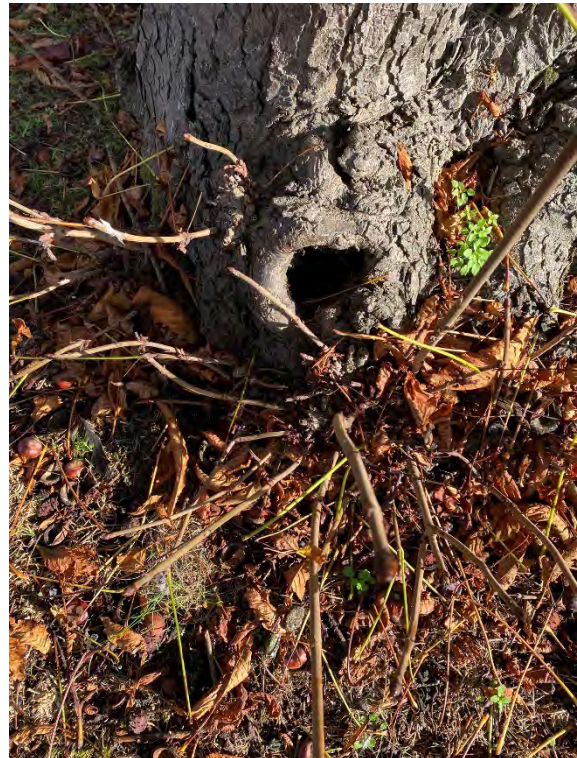
Cavity on south side

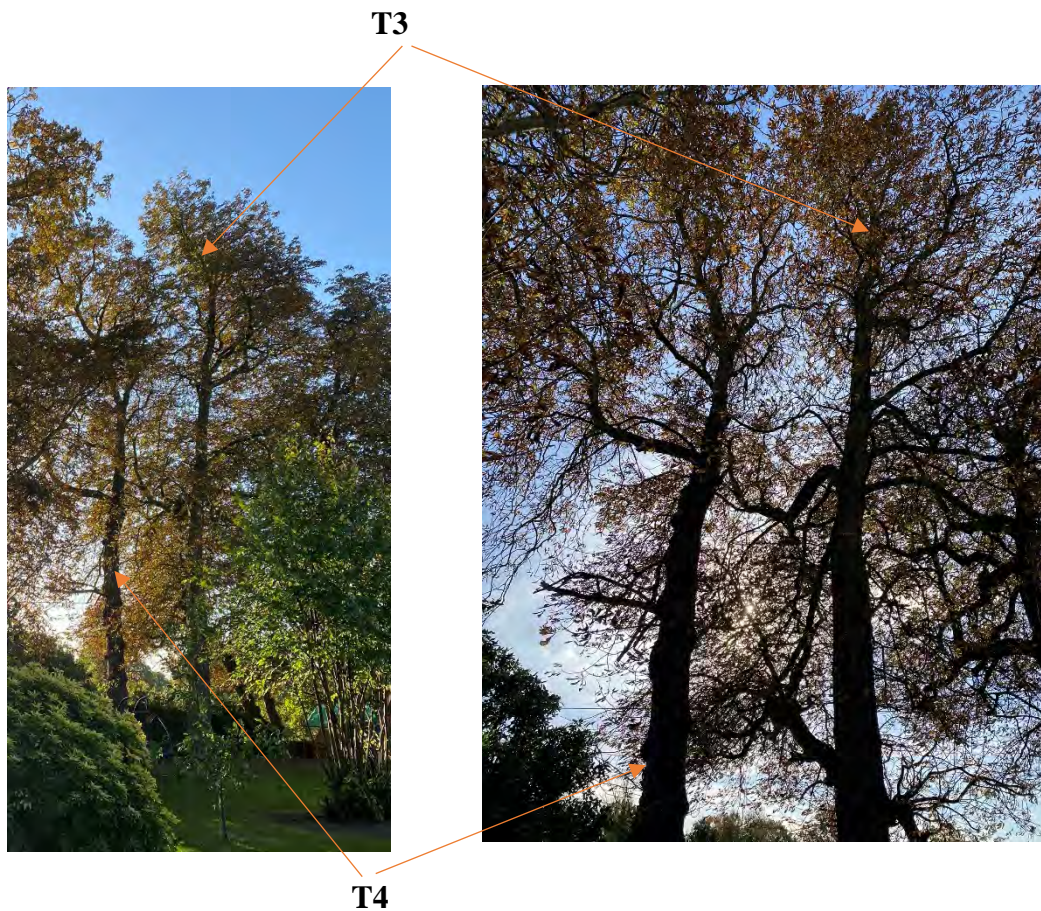
Species of tree: T3 – Horse Chestnut / *Aesculus hippocastanum*

The tree shares a codominant canopy with the neighbouring Horse Chestnut (T4). The crown is in reasonable condition with only one broken branch stub at mid canopy on southeast side. There is also a low extended limb on the southeast that grows towards the neighbour's garden. There are some small amounts of wound wood on the main stem approx. 2m rising from ground level that visually continues up the stem with some small amounts of flaking bark. Hammer test in this area sounded flaking bark areas and sound wood. Overall health and physiological condition are in good vigour and condition.

Due to co dominant canopy and recommendations for T4, reduce the canopy of the tree by approx. 3-4m

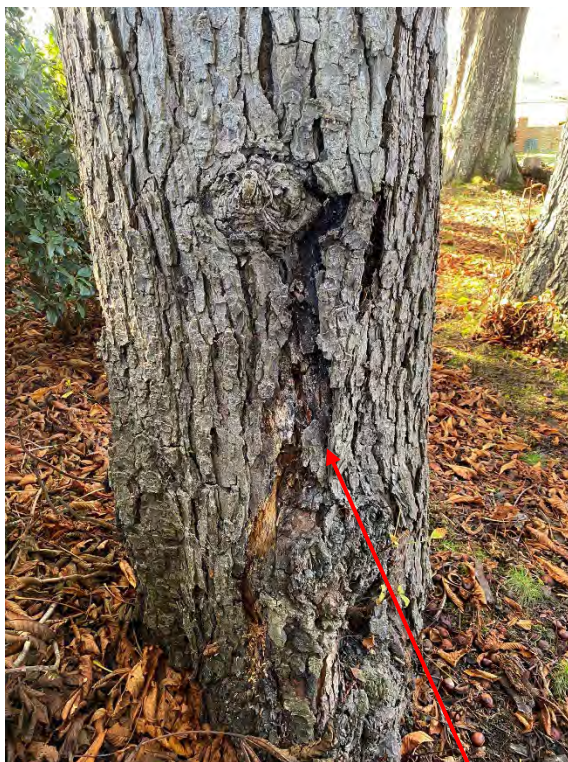
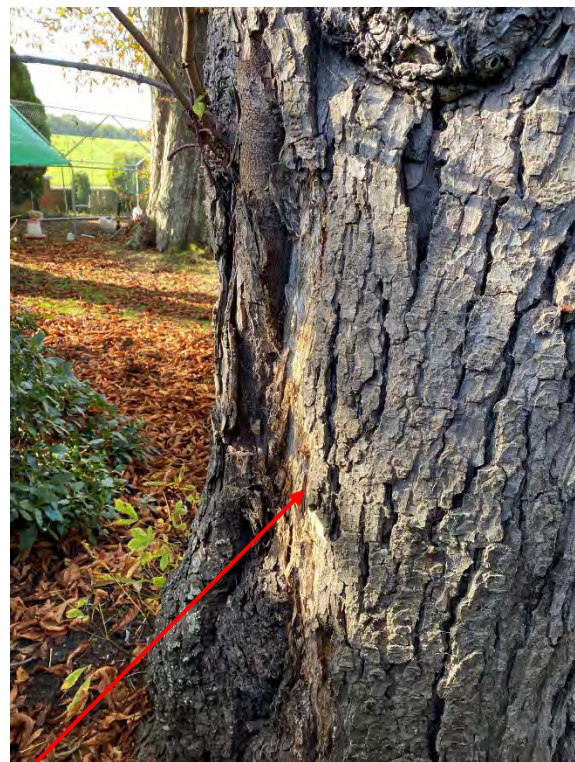
At the base of the tree there is a large wound on the east side that extends upwards with decay to at least 2.5m from ground. There is good wound wood on the southside of the decayed area, with only minor wound wood on the north side. Further investigation of the area and base indicated basal cavities where the probe was inserted at a 45degree angle up to 42cm and downward up to 1m. On the north side the probe was inserted downward up to 72cm. In between the cavities there is still buttress intact buttress root that appears to have put on reactive growth to compensate for the decaying base. Equally the buttress roots on both west and south have put on reactive growth to self-optimize the tree at the base in its current condition. This can be seen more clearly in the pictures below:

Decaying area

Reduce the canopy by 3-4m

A PiCUS test could also be undertaken to show the extent of the decay at the base of the tree for future evaluation and assessment

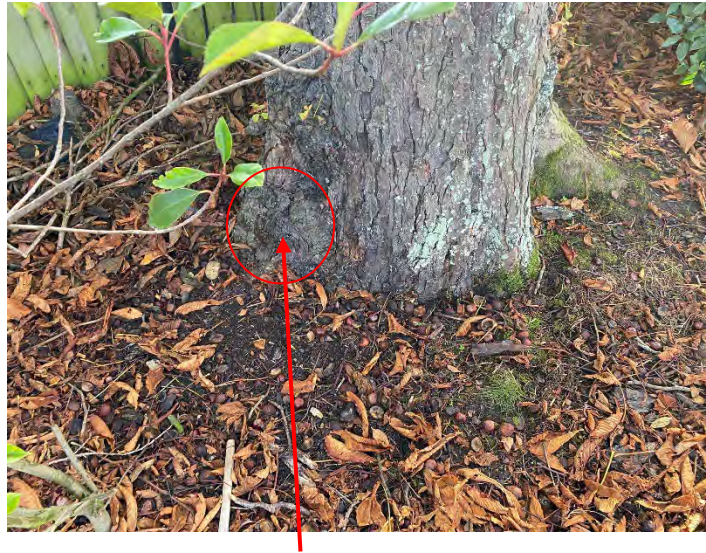
Intact buttress root in middle of decay zone

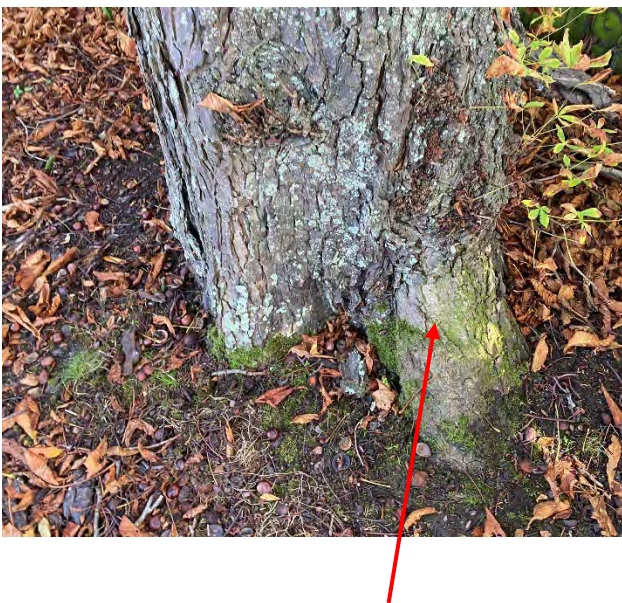
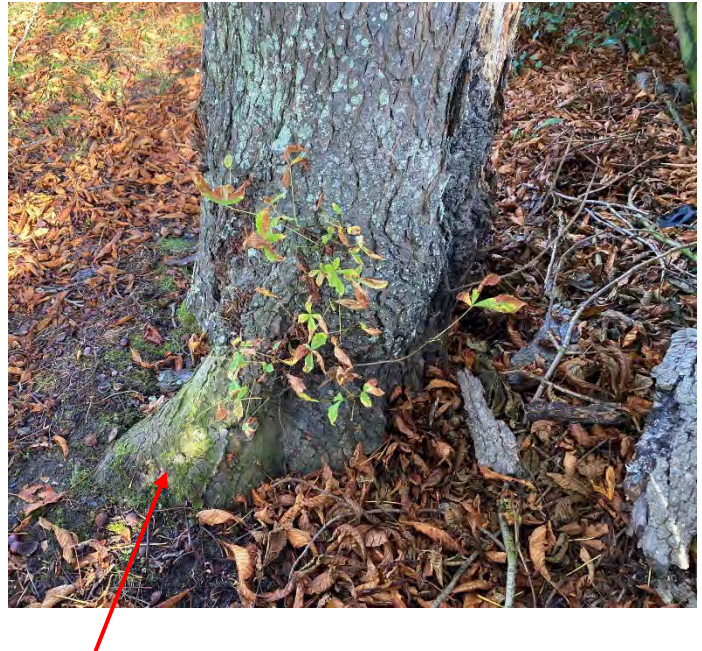
Buttress root putting on reactive growth to compensate decaying area

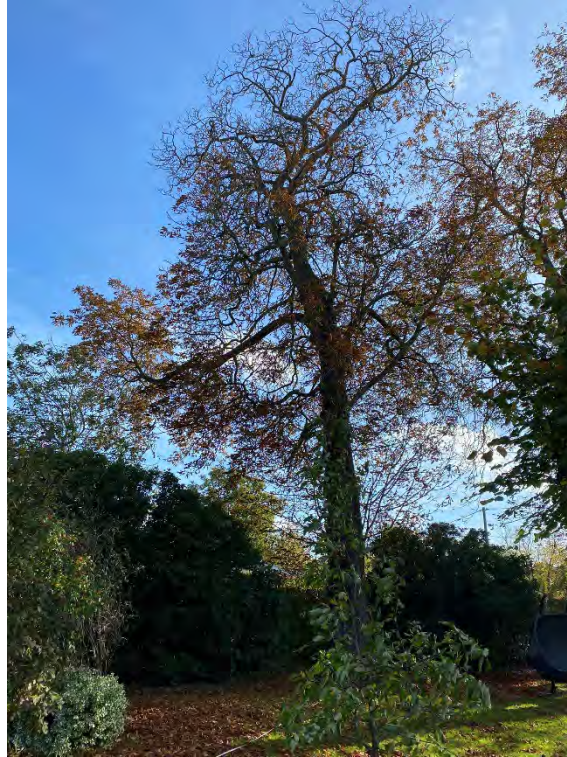
Species of tree: T5 – Horse Chestnut / *Aesculus hippocastanum*

There is an old storm damaged wound on the upper west side of canopy and the majority of the crown has a grown towards the neighbouring garden to the east with low over extended limb on northeast. There is an old scar likely from a lightning strike in the top section of the main stem that runs all the way down the stem to the ground on the south to east side. Scar has good wound wood around the main length overall.

There are some large dead stubs in the low area of the canopy on the east from poor pruning of overhanging branches to the neighbouring property.

At the lower section of the main stem there is some 'Bleeding Canker of Horse Chestnut', identified on the southern side. On the northwest buttress there are some old wounds visible, and a basal cavity was identified between the buttress roots on the north side at ground level with probe inserted up to approx. 55cm.

Reduce overall canopy by 3-4m

Remove dead stubs back to suitable replacement growth if available or main stem if not

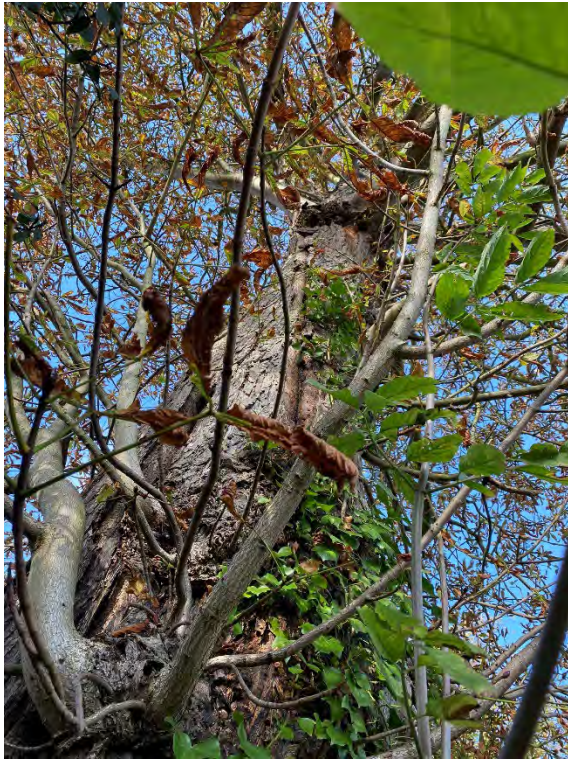
Picture showing potential lightning strike

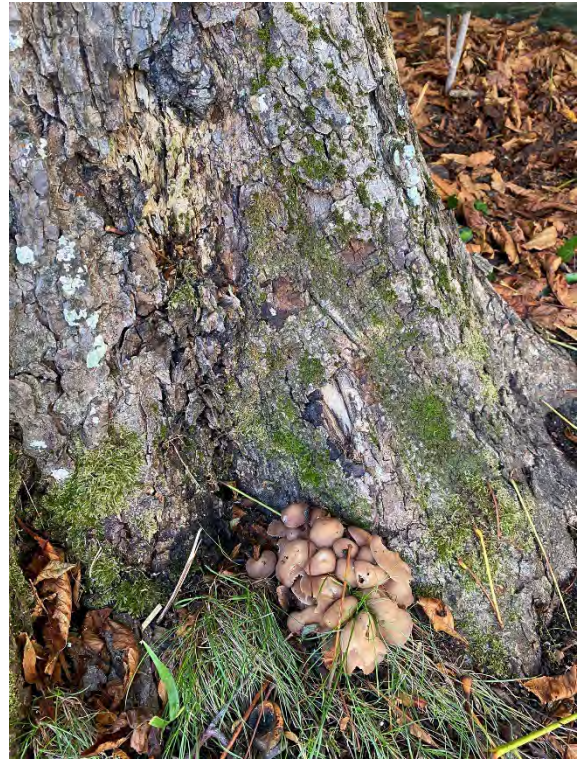
It is noted that at the base on the south to east side where old potential lightning strike finishes there is a decaying area and some mushrooms where found. The exact species is not known by the tree surveyor although likely to be a deadwood saprophyte that is feeding of the dead wood.

Decaying area with unidentified mushrooms

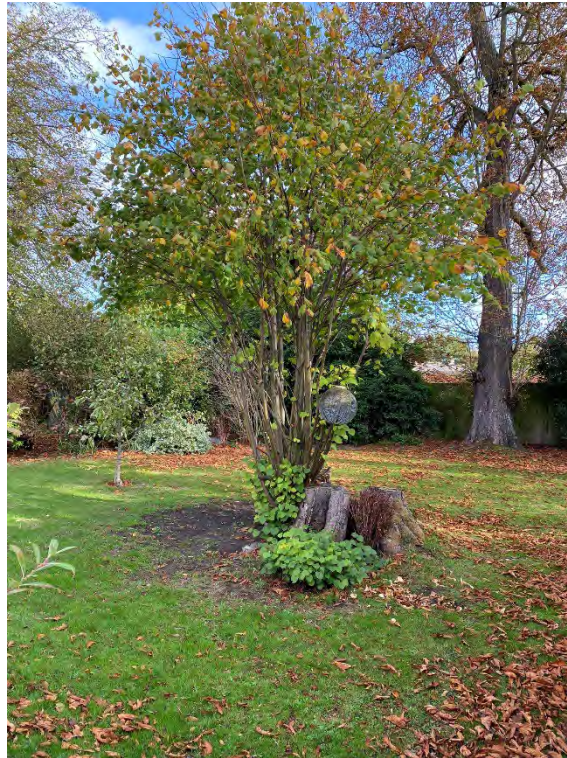
Species of tree: T6 - European or Common Lime / *Tilia x europaea*
Height: 6m
DBH: N/A
Age classification: Over Mature

New young growth has been produced in the section of the old stump that indicates there is still sufficient root structure to support the tree to continue to grow in this area. The health of the new growth is good vigour and condition.

None at present although consideration for future management of coppicing the new growth to the old coppice/stump area on a suitable pruning regime is advised so the new growth does not get too tall on the old decaying main stump causing leverage and potential failure.

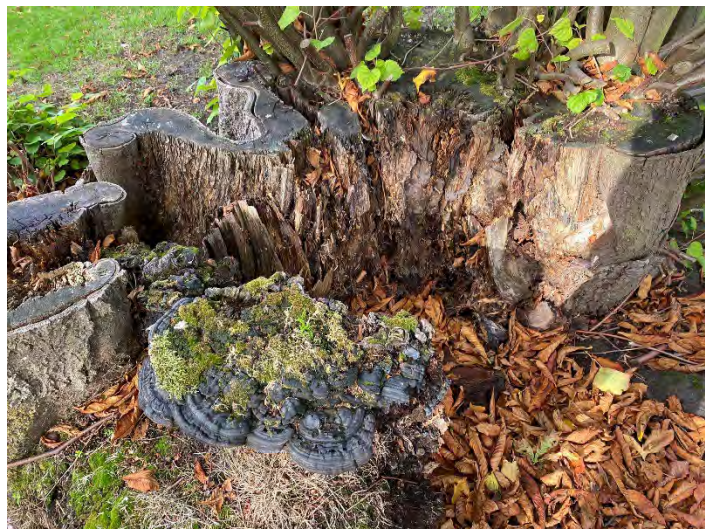
The older main tree has been removed in the past likely due to the heart wood decay pathogen known as Ganoderma. There is still old bracket fungus from the Ganoderma present on the old, decayed stump. As can be seen below:

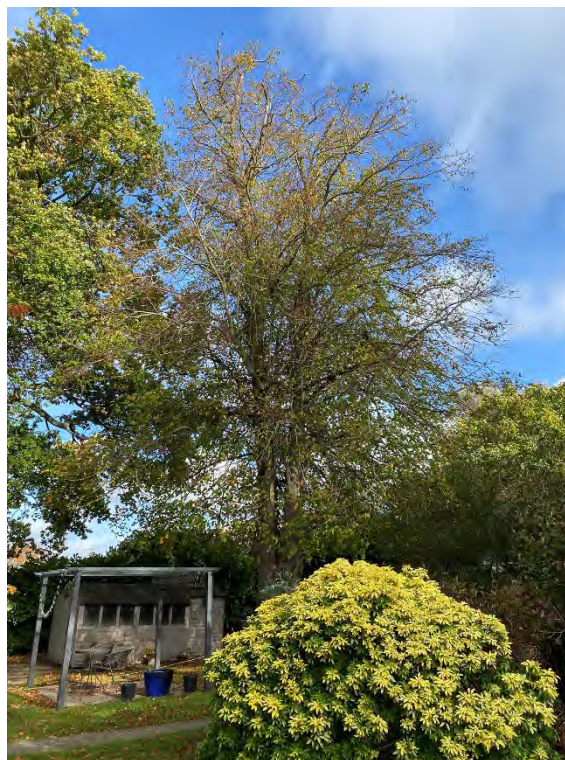
Species of tree: T7 - European or Common Lime / *Tilia x europaea*

Within the canopy there is minor dead wood present including areas in the upper most section near the top of the crown. The overall canopy is also congested with growth, which is a characteristic of this species and likely for the abundance of dead wood from branches naturally and selectively shutting off to produce new growth. There is also a small dead hung up branch on the east area at mid canopy height.

Reduce the height by 2-3m back to suitable growth.

Reduce side lateral growth by 2m

Remove dead wood and hung-up branch from canopy

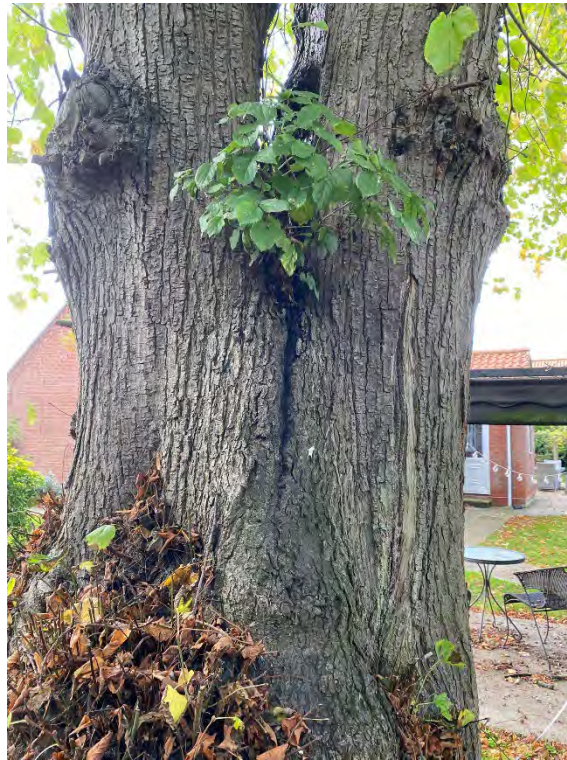
On the lower main stem at approx. 2m the stem divides into two stems and has a tight V shaped union which is not as strong as a Y shaped union. There is also some 'included bark' on the north to northeast side (included bark is where the union of a fork does not properly form internally in the wood structure and as the stem grows can produce swelling where the outer section of the tree is pushed outward. As can be seen in the picture below). The potential weak area at the fork is not considered to be problematic at this time.

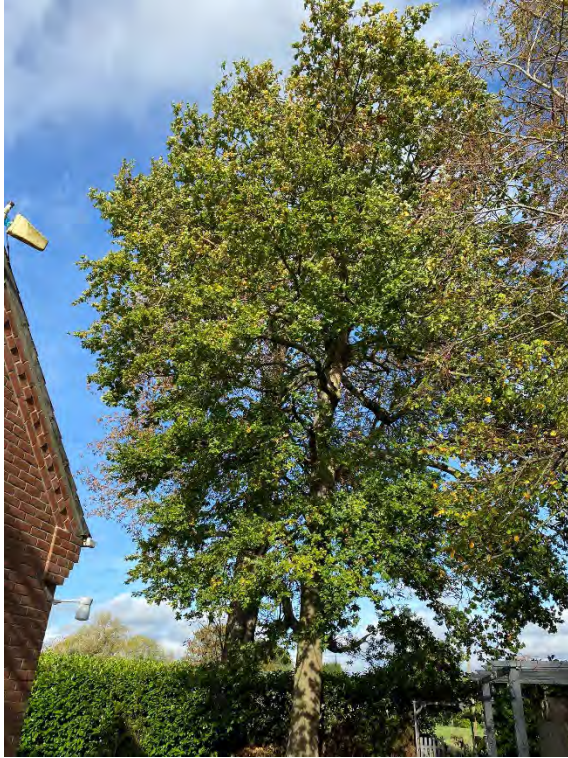
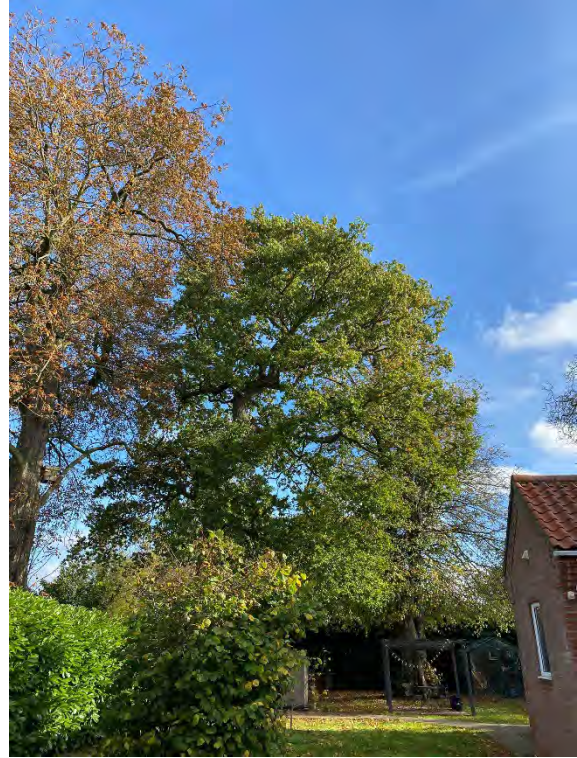
Species of tree: T8 - Oak / *Quercus robur*

The canopy growth is mostly east, south, and west due to the larger neighbouring Horse Chestnut tree that is competing with the oak on the west side. There is a large old pruning wound at the top of the main stem that has created a congested branch structure at this point and producing extended lateral growth to the south.

Reduce the overall canopy by 2-3m to maintain size and shape next to the house and minimise leverage on old decaying pruning wound at top of main stem

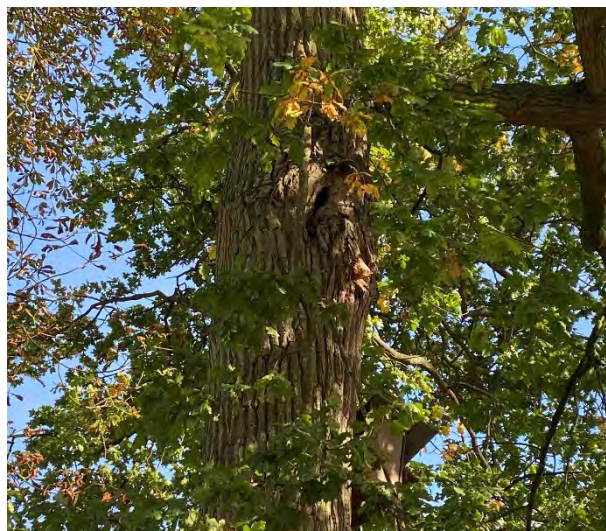
There is a cavity on the main stem at approx. 5m on west to southwest side. Likely from a removed or failed branch, however responsive wound growth is good around the cavity entrance. As can be seen in the picture below:

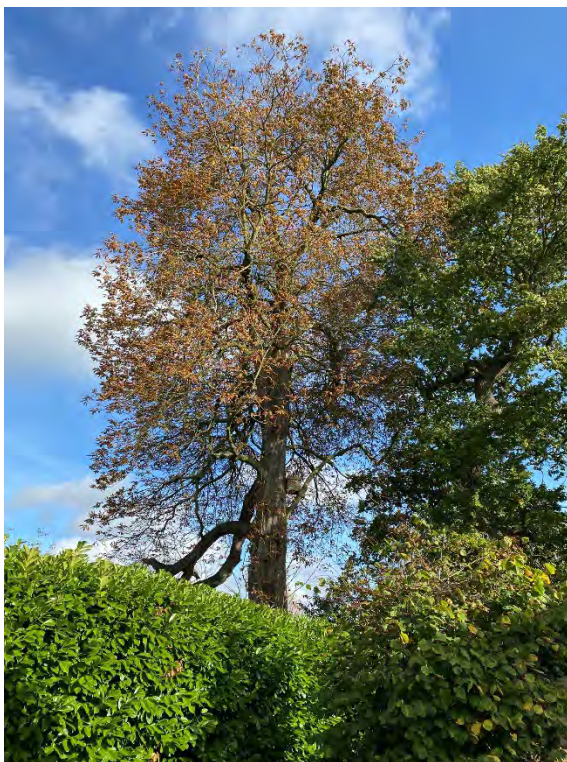
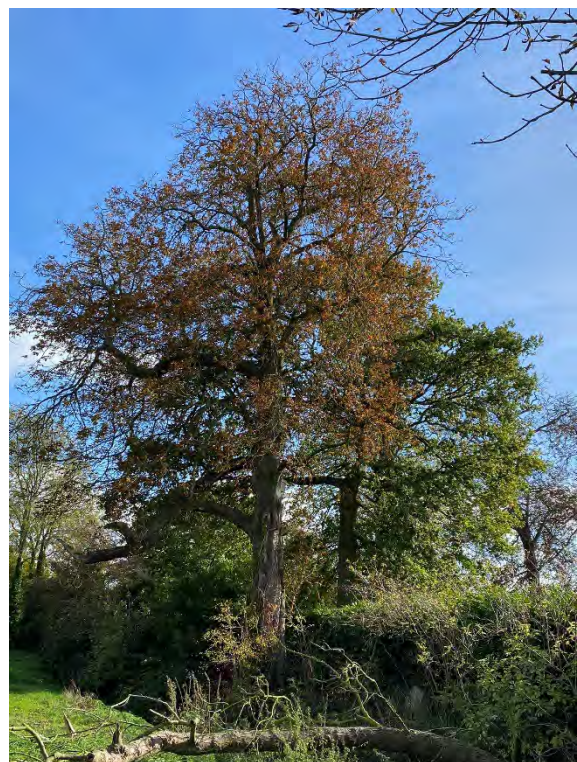
Species of tree: T9 – Horse Chestnut / *Aesculus hippocastanum*

A large old boundary tree in the later stages of its life cycle. The wayward lean of the overall canopy and stem is towards the open field to north side with low target area.

The mid canopy has a several large over extended limbs with visual compensatory growth to aid in strength and support along the length. There has been some heavy pruning on the lowest limbs to north to east side and some natural damage at this area, likely due to heavy summer branches or string winds.

None at present although severance of Ivy at the base would benefit future inspections

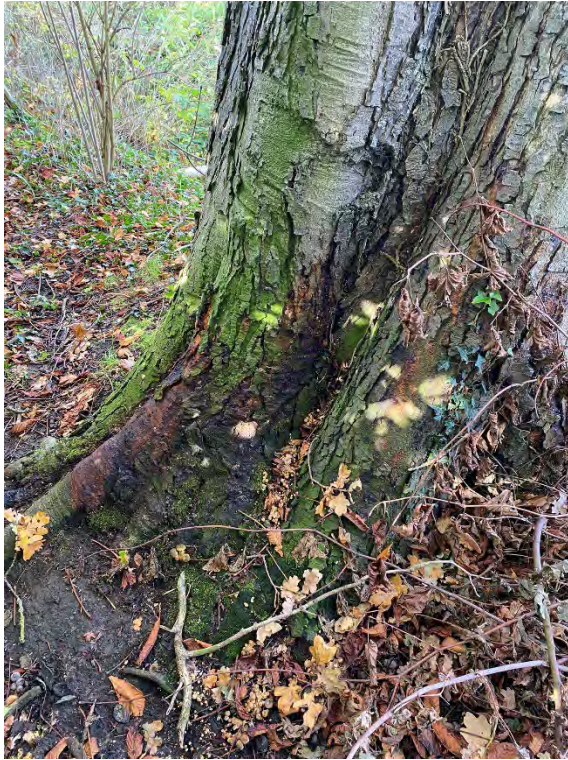
There is evidence of ‘Bleeding Canker of Horse Chestnut’ at the base on the south side although minor at present. The north side base and stem is hindered for inspection due to Ivy. Overall health in reasonable condition and physiological condition fair for age and size.

'Bleeding Canker of Horse Chestnut' at the base on the south side

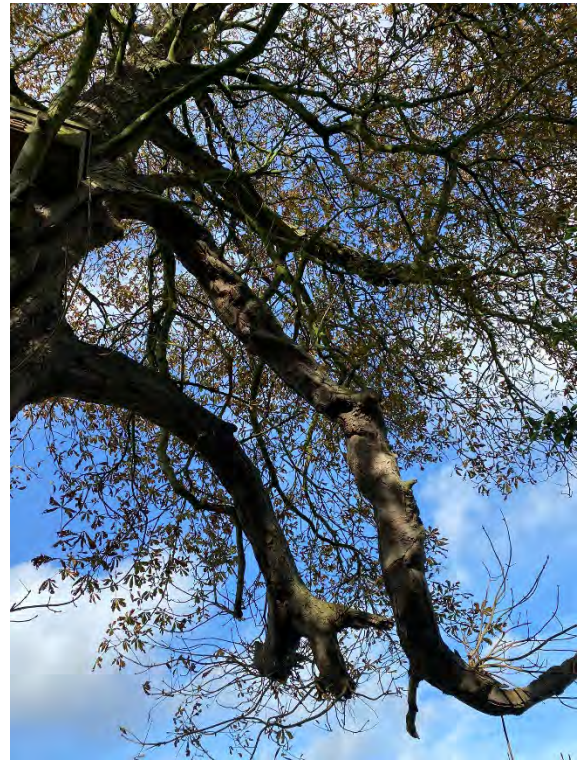
Low over extended limbs with poor pruning wounds or natural failure points

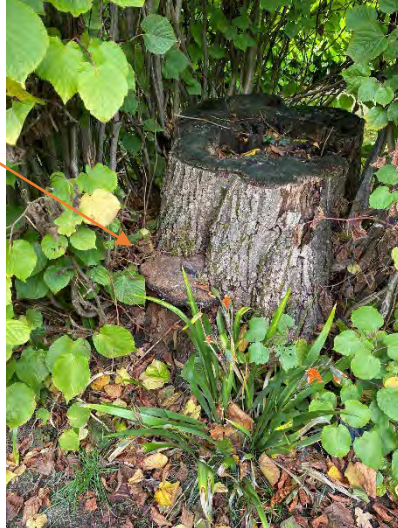
Similar to T6, where the older main tree has been removed in the past likely due to the heart wood decay pathogen known as Ganoderma. There is still old bracket fungus from the Ganoderma present on the old, decayed stump. As can be seen below:

None at present although consideration for future management of coppicing the new growth to the old coppice/stump area on a suitable pruning regime is advised so the new growth does not get too tall on the old decaying main stump causing leverage and potential failure.

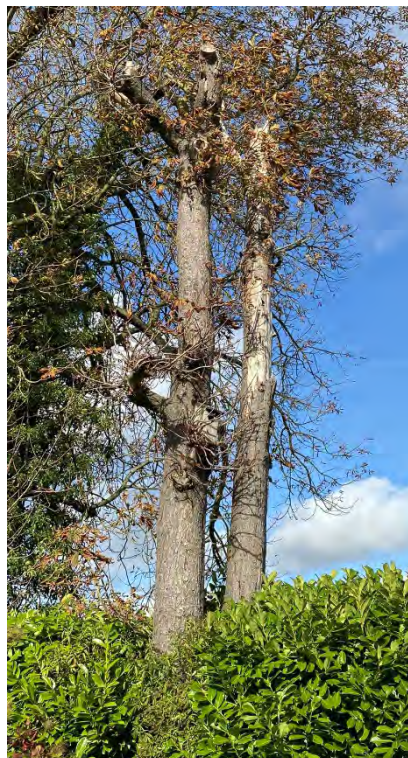
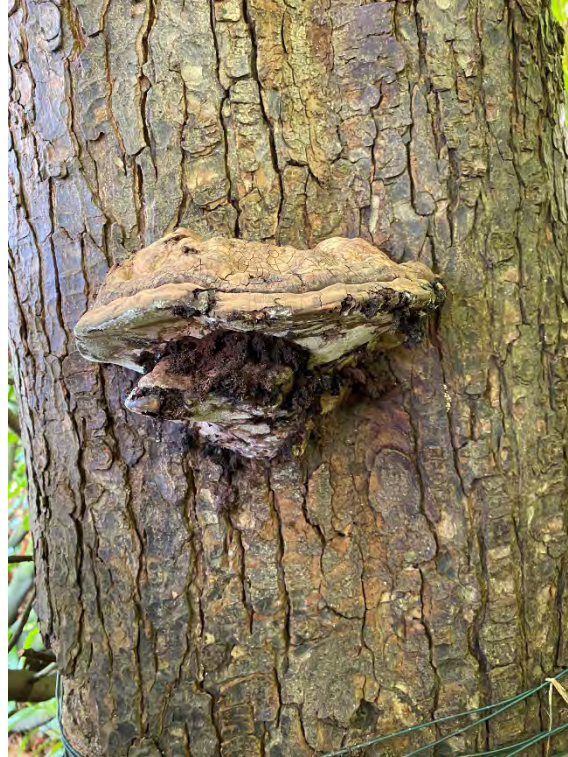
Species of tree: T11 – Horse Chestnut / *Aesculus hippocastanum*

Tree is in poor health and condition. There are two stems, and the northern stem has now completely died. The remaining stem has very little growth and Ganoderma species present near the base.

Fell the tree to ground level due to poor health, poor condition, and dead stem

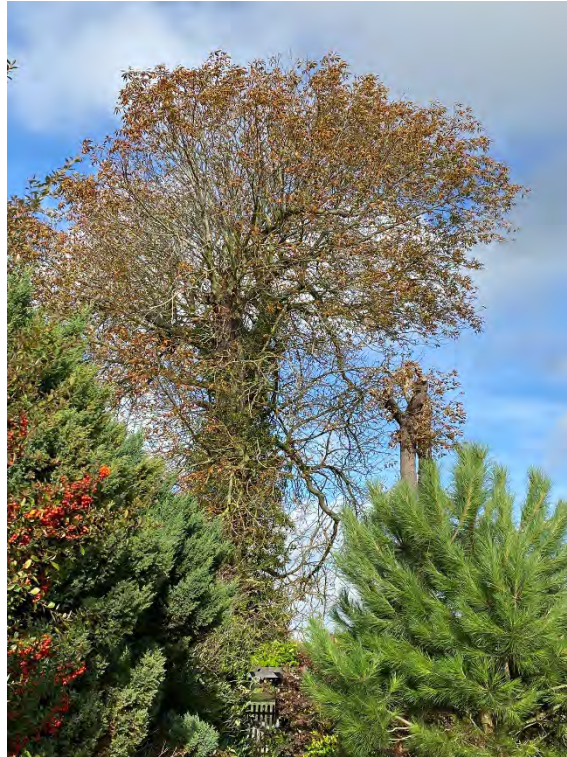
Species of tree: T12 – Horse Chestnut / *Aesculus hippocastanum*

The canopy has been heavily reduced in previous years and does have good extension growth of up to 6m estimated, on top of the old large decaying wounds. It appears due to the younger smaller growth, that the southern area has been reduced more recently and likely due to growing over neighbouring property.

There are several cavities throughout the main stem and branch structure from old natural wounds or poor pruning and large limb removal.

An old wound and cavity are visible approx. 2m from ground level although extent of cavity is not known due to height constraints.

The tree is sited on top of a deep ditch and the tree has put good compensatory buttress root system for anchorage. The lower section of the main stem up to approx. 2m from ground level is hindered for inspection due to Ivy cover.

Reduce the canopy of the tree back to previous pruning points and assess condition of major wood at pruning points. If decay deemed extensive at these points, then reduce further to healthy sound wood.

Remove Ivy from lower main stem and inspect cavities throughout the crown and main stem

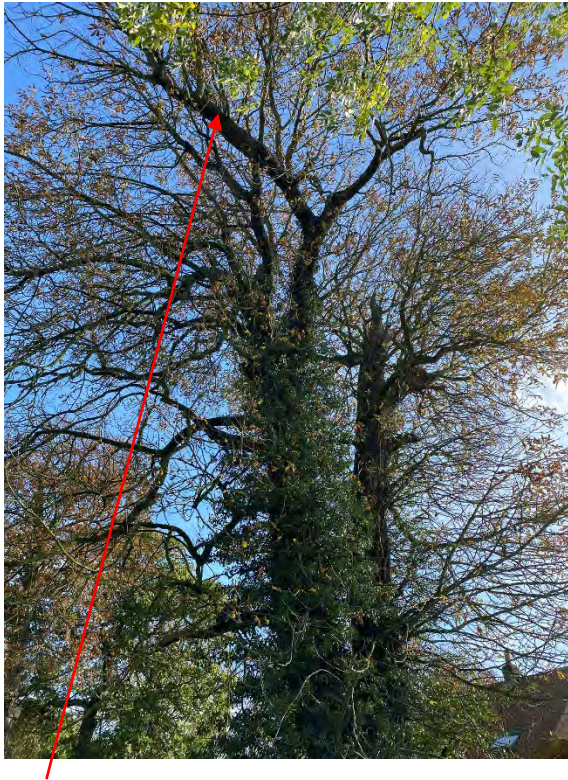
At the top of the canopy on the west side there are two over extended side lateral branches that have had reduction works in the past but not side lateral reduction works.

Western over extended limbs for further reduction works

Overextended limbs on upper west canopy to be reduced further by approx. 4-5m to suitable pruning points

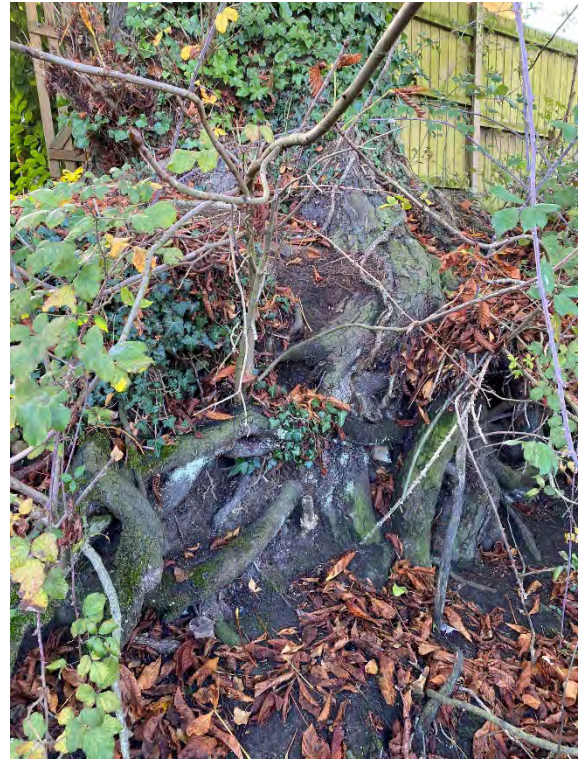
Good buttress root formation for anchorage of top of bank
