0309_Winsor House

Roof condition for proposed re-sheeting

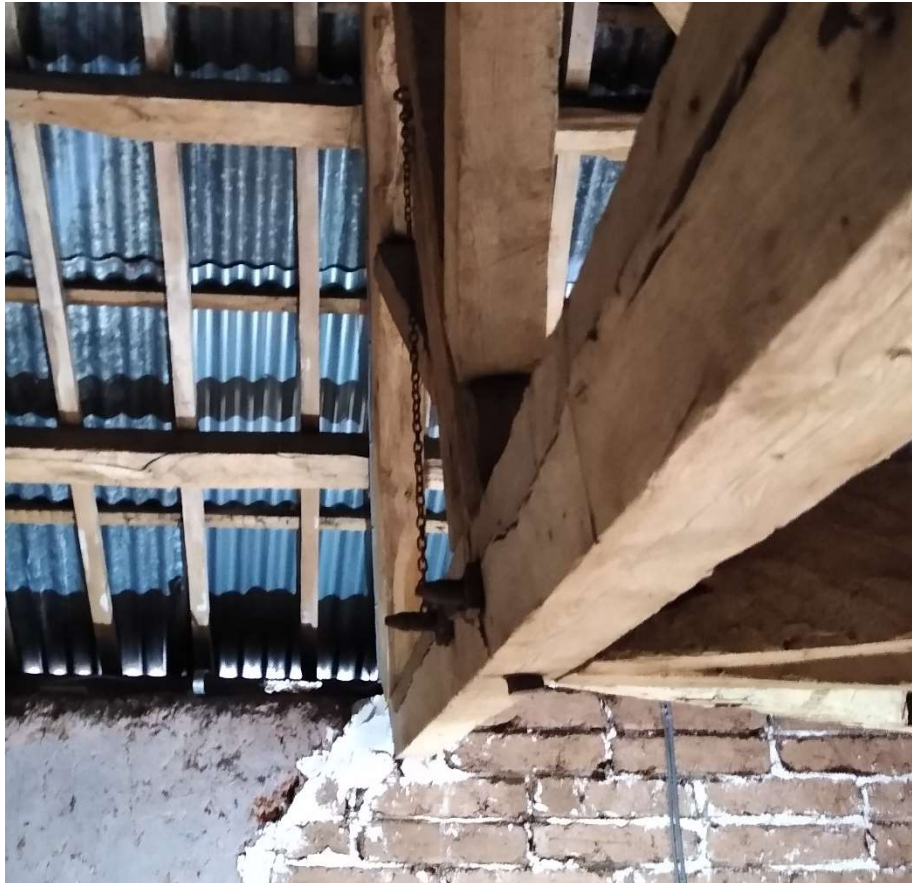
2.1.1. *Hipped end truss at north end*

Image 2 - West bearing north truss

The hipped end truss has rotated towards the north. This is likely to relate to the previous collapse of the north end wall around 2007. It is possible that no bearing plate was placed under the truss west bearing and this may have led to deformation of the cob around the bearing. The presence of a bearing plate should be checked for, and a longer padstone may be required to span over some localised cracks.

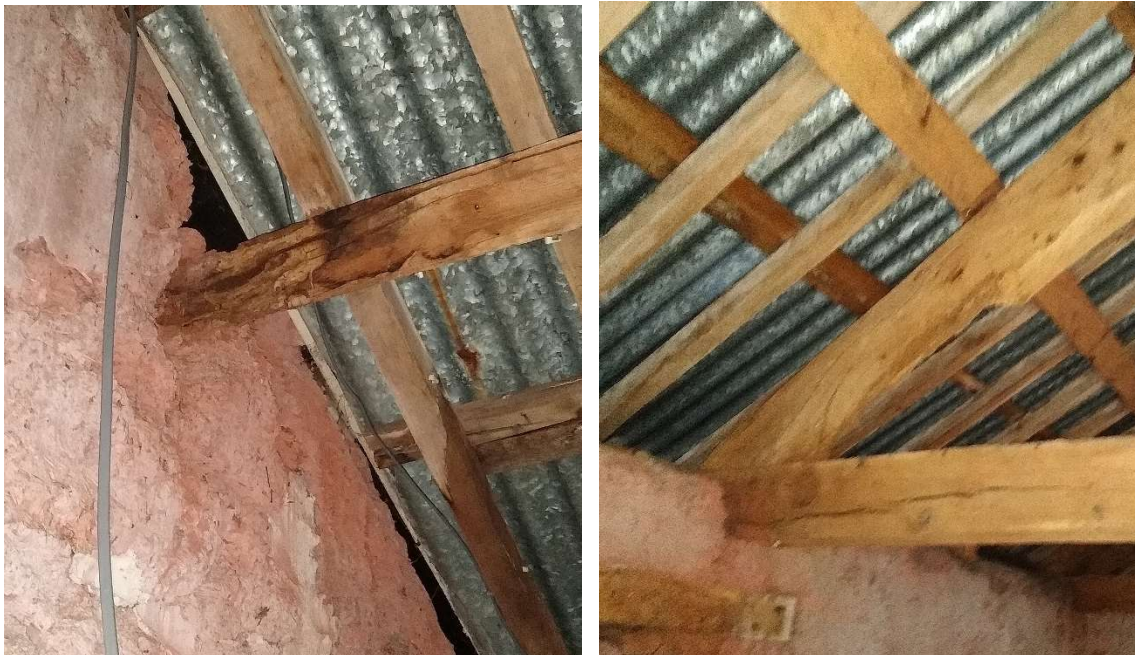
2.1.2. Gable end truss at the south end

Image 3 - South end truss and west purlin

There has been water ingress through the corrugated sheeting where the roof steps up between the barn and living accommodation. The water ingress has caused decay to one of the purlin ends, and there are signs of insect damage on the west primary truss rafter. The decay to the truss appears historic. It is likely that the purlin end will require a spliced end repair in like for like timber, or replacement

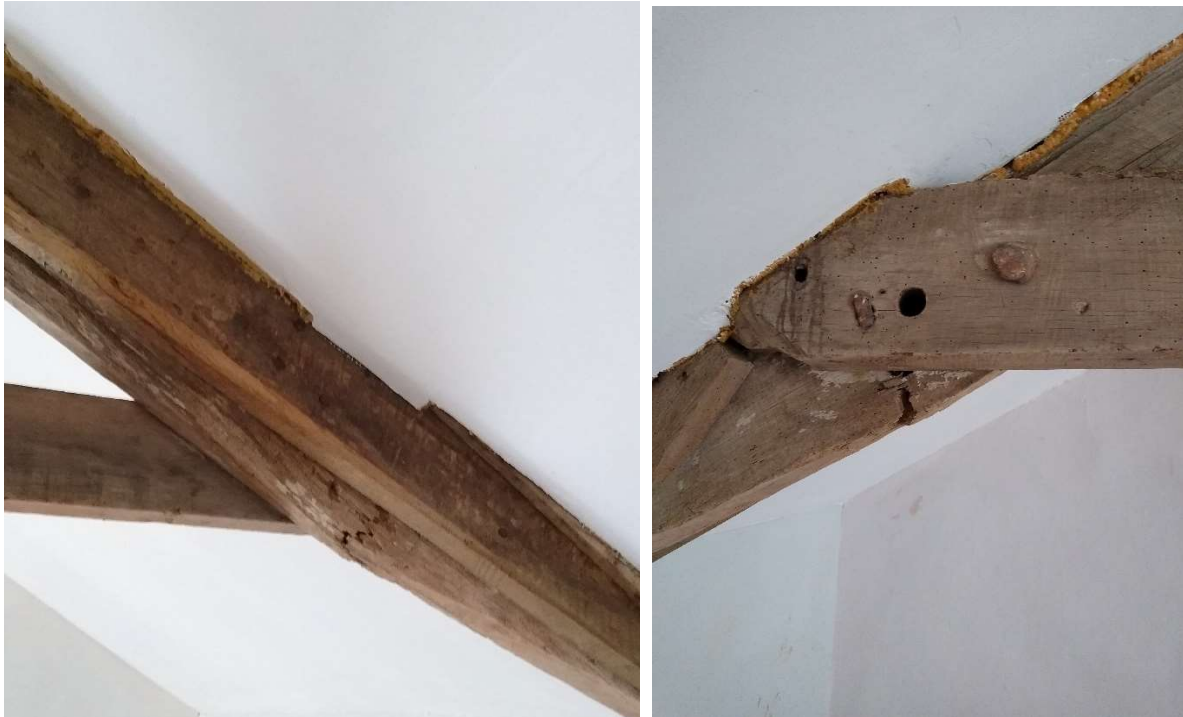
2.2.1. North end truss

Image 4 - North end truss

The east end primary rafter has previously failed at a peg connection. It is likely the connection was with a previous tie location. There is woodworm around the location of the failure. The failure has been spliced across with a section of oak nailed into the primary rafter. It is likely the repair is a number of decades old. A number of the nails have missed the original timber and there is surface corrosion. It is unlikely the repair would meet modern standards but does appear to be working. It would be possible to add new fixings alongside the existing to enhance the robustness of the connection. Alternatively repairs could be undertaken from above once the corrugated metal sheet is removed.
