JPC Environmental Services
(A Division of J P Chick & Partners Limited)

07 November 2022
IE20/040/CSJ/RMC

SITE WALKOVER AND RE-ASSESSMENT OF SITE CONDITIONS TO INFORM CONDITION 9 - REMEDIATION STRATEGY (DC/22/1266/FUL) FLAX FARM, STANSFIELD ROAD, POSLINGFORD, SUDBURY, CO10 8RD

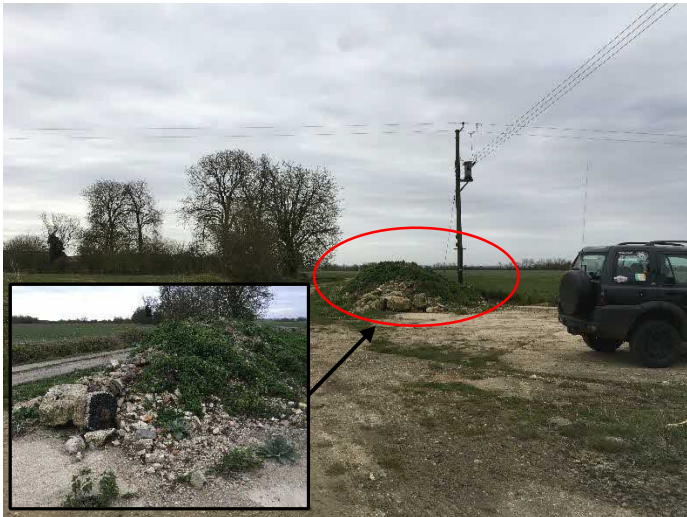
- 2.2 The site was accessed from Stansfield Road to the north, via a concrete entrance, which was still intact with no signs of alteration since the 2020 investigations. The entire north and east boundary was demarcated by heras fencing, to keep the site secure. Stockpiled building and waste materials, identified in 2020 on the eastern boundary were no longer present. We understand from Mr Burnett that as part of the conditions for purchasing the site, it was agreed with the vendor that the stockpile would be removed prior to purchase. Photographs included in the appendices show that this stockpile is no longer present.

Figure 1: May 2020 - View looking south from site entrance, shows heap of waste materials.

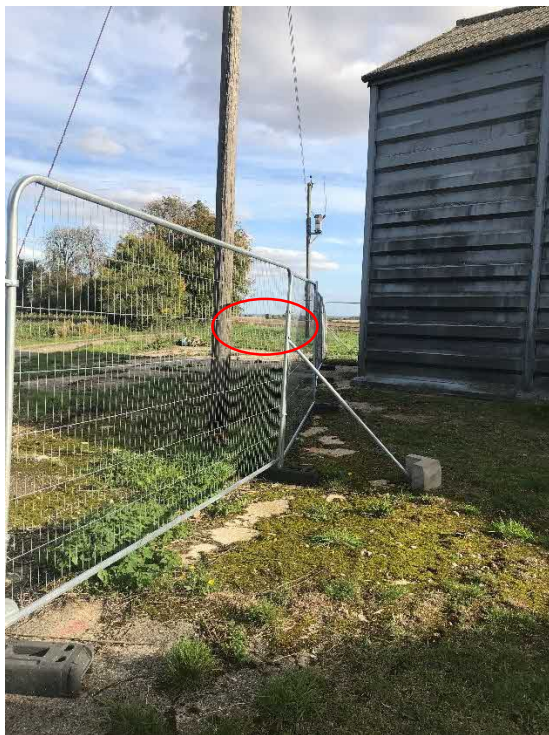
Figure 2: October 2022 - View looking south from site entrance shows that the stockpile is no longer present.

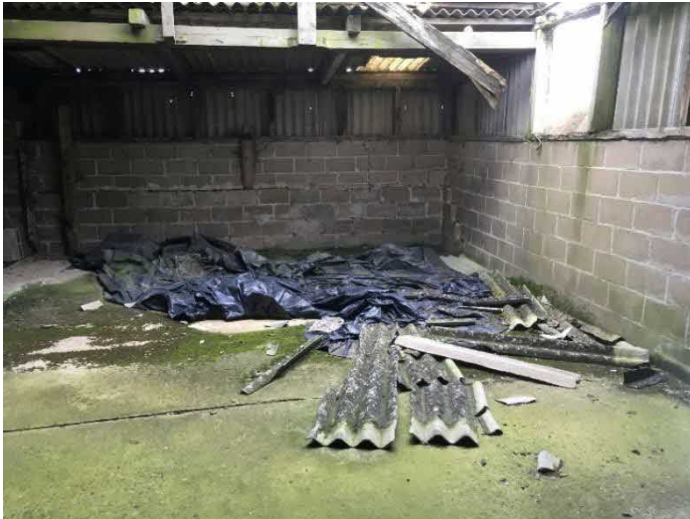
- 2.5 Internally the majority of the barn was well maintained, with no significant changes since 2020. The only exception to this is the north-west corner of the barn, where asbestos roofing had degraded and fallen in during 2020. This has since been repaired to prevent further degradation and dispersion of asbestos sheet throughout the barn.

Figure 3: May 2020 - Internal view in north-west corner of the barn, where asbestos roofing had degraded and fallen in.

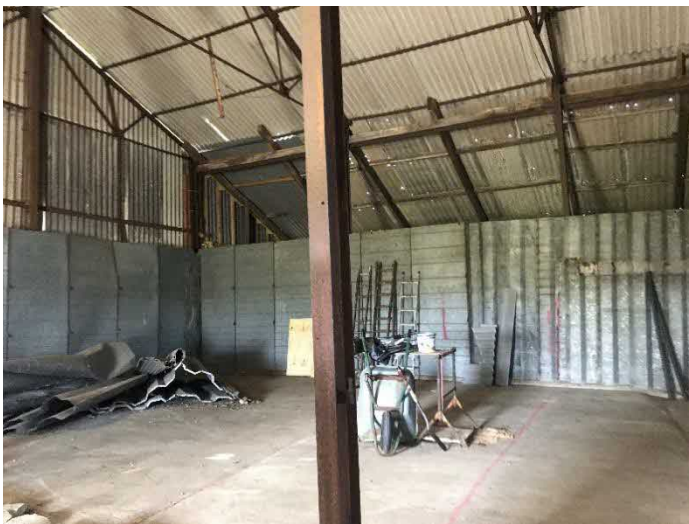
Figure 4: October 2022 -Internal view of north-west corner, where broken asbestos roof has now been replaced.

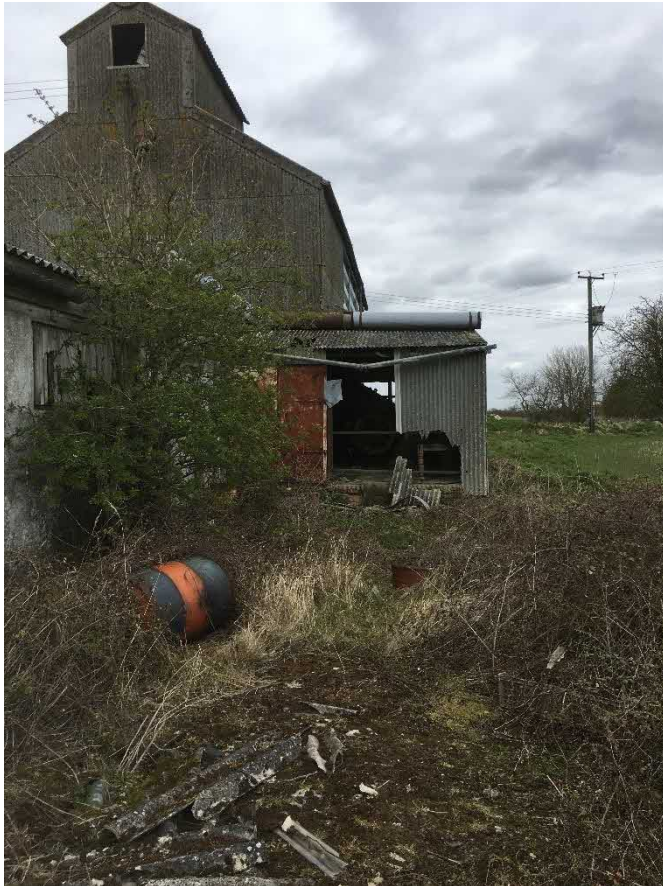
- 2.3 To the south of the barn the overgrown vegetation, metal drum and broken asbestos sheet identified on the ground in 2020 had been cleared. Mr Burnett informed us that the area was cleared very carefully, with the metal drum and various pieces of asbestos sheeting being stored neatly in the corner of the barn. Any further pieces of broken cladding have also been carefully placed in the pile, awaiting disposal during the planned remediation works. The photographs enclosed in the appendices shows the

Figure 5: 2020 - View looking east across the back of the barn. Overgrown with vegetation and broken asbestos sheeting, and metal drum.

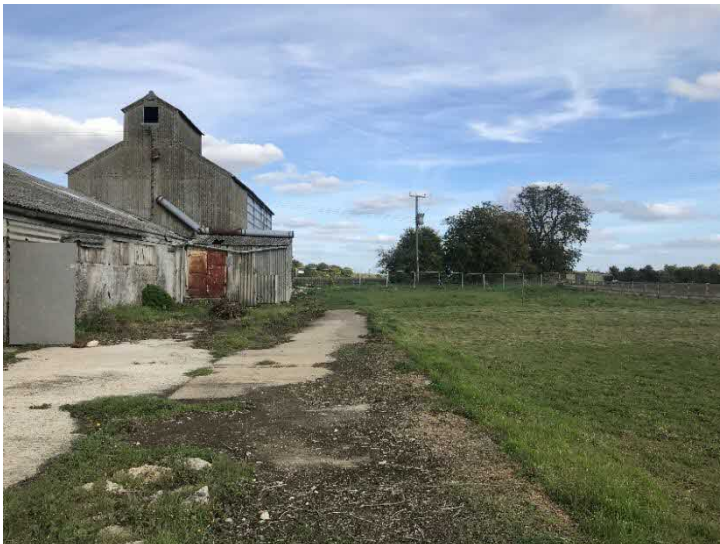
Figure 6: October 2022 - View looking east across the back of the barn. Vegetation has been cut back and drum and broken asbestos sheeting cleared.

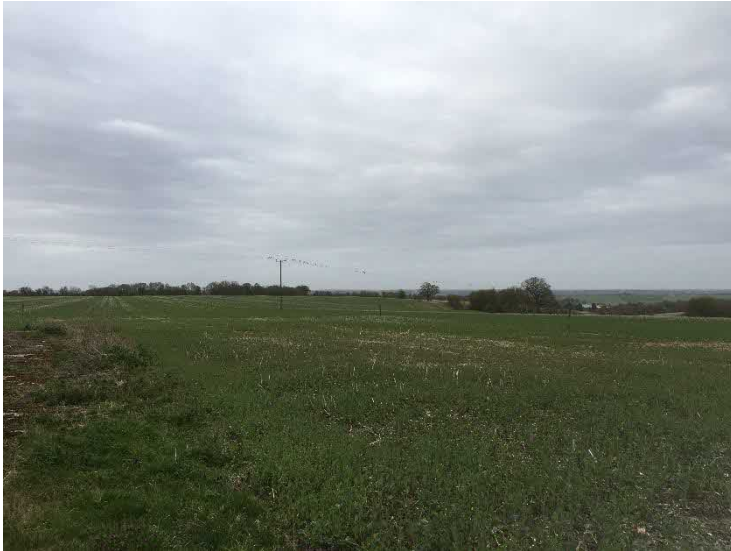
Figure 7: 2020-View from north west corner looking south across the rear of the site, showing part of farmer's field.

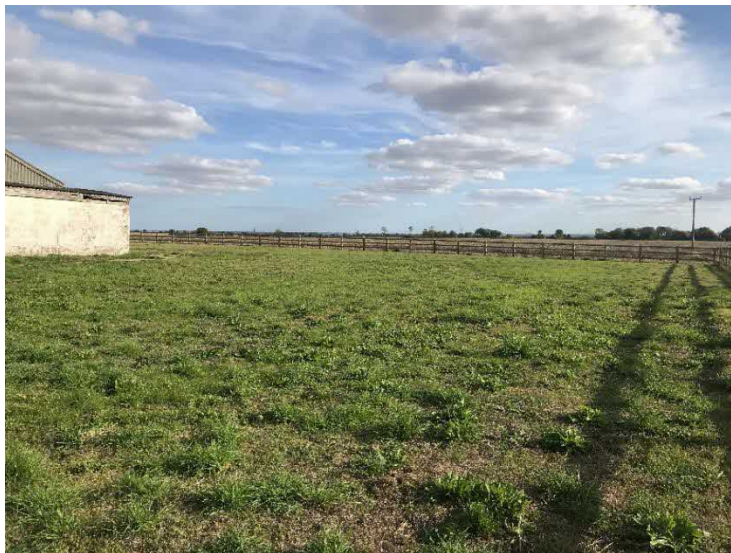
- 2.4 The west and south boundary is now marked by a post and rail wooden fence demarcating the extent of the purchased site. This corresponds to the blue line shown in figure 1. This is now laid to meadow, and will remain meadow as part of the conditions of the new development. The red boundary shown in figure 1 between the agricultural barn area and meadow, was investigated with a series of trial pits in 2020. These showed that no contamination extended into the farmer's field. Therefore the meadow present between the red and blue lines (figure 1) will not be subject to remediation.

Figure 8: October 2022 – View from north-west corner looking south across the rear of the site. Part of the farmers field now lies within the site boundary, and is demarcated by the fence line.

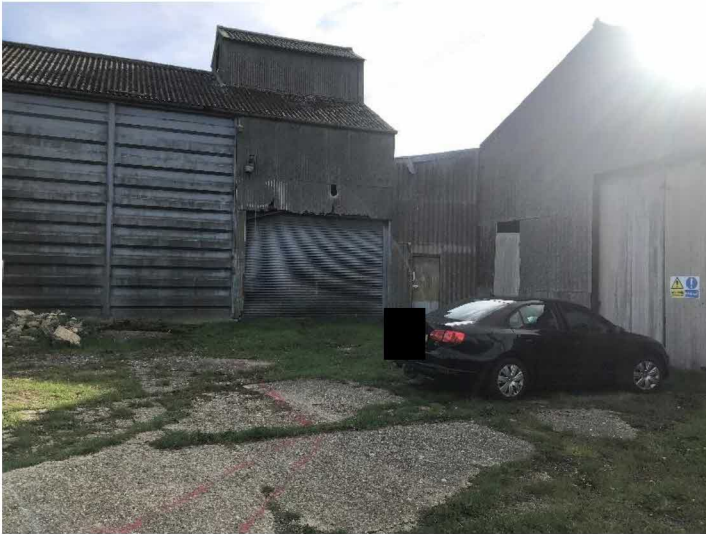
Figure 9: October 2022 -View looking south across the front entrance of the barn, and areas of concrete hard standing.

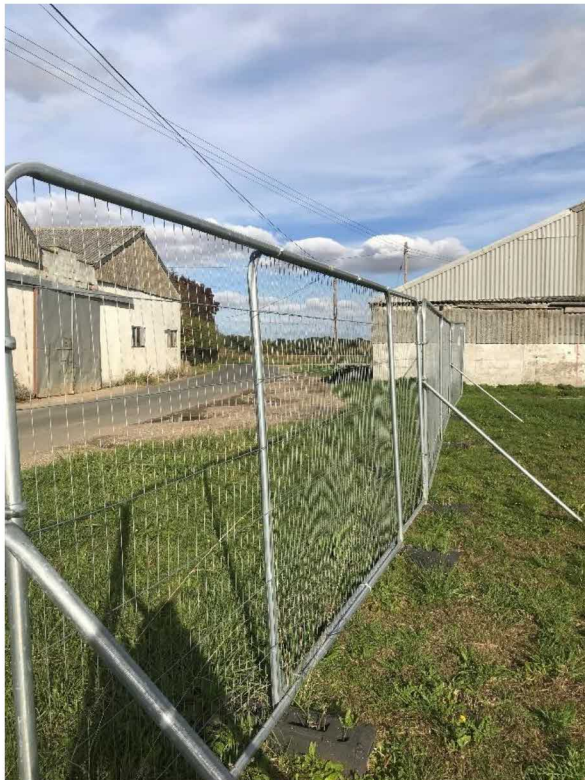
Figure 10: October 2022- View looking east across the front boundary of the site. Now bound with heras fencing.

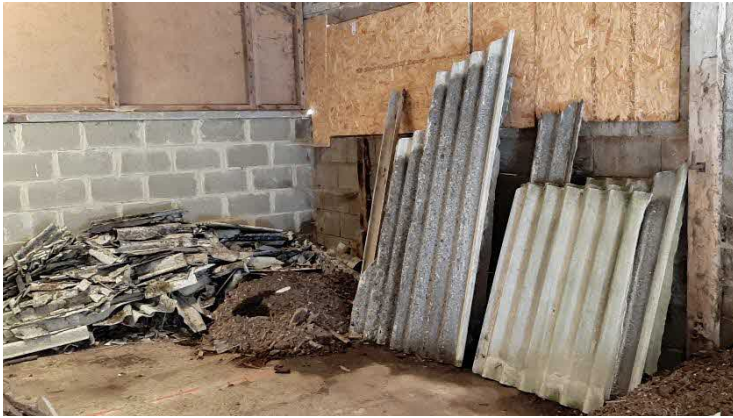
location within the barn of the stored cladding. The careful movement and placement of the cladding within the barn has prevented further external weathering of the materials and degradation.

Figure 11: October 2022- Internal view of barn showing the stored broken asbestos sheeting.

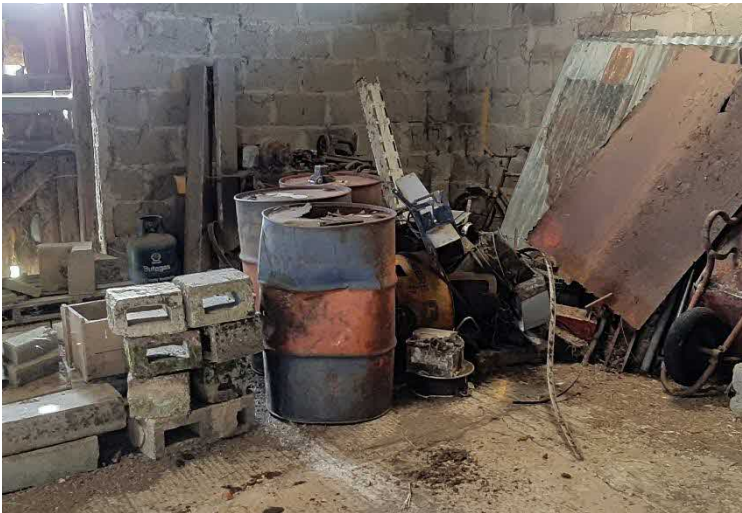
Figure 12: October 2022- Internal view of barn showing the empty metal drums, previously found externally to the barn in May 2020.
