# Asbestos Survey Report

(Refurbishment/Demolition)

**Flax Farm Barn**

**Stansfield Road, Poslingford**

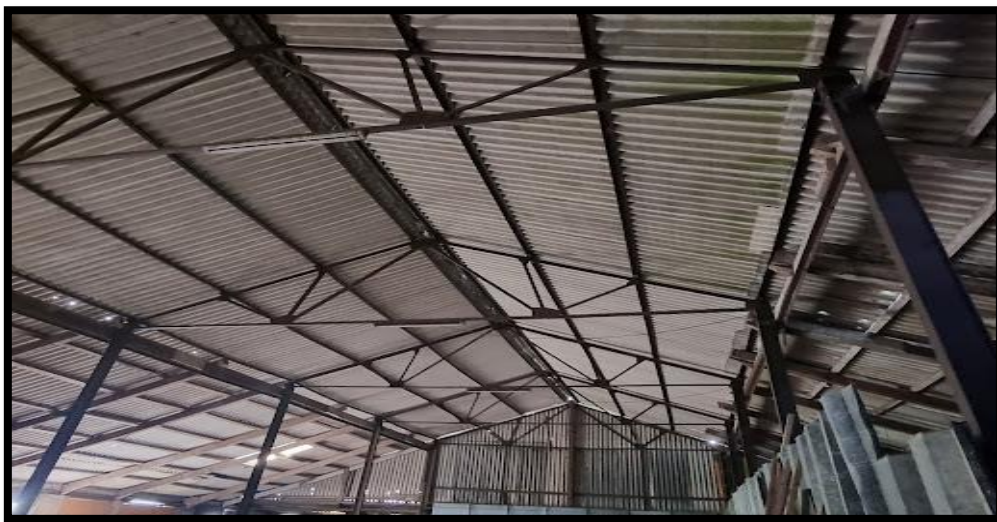
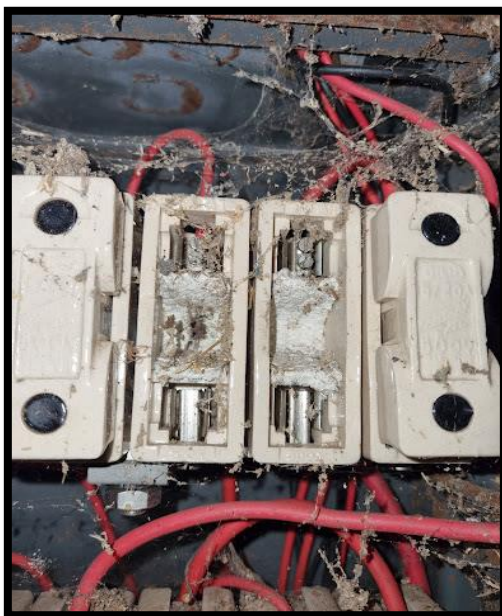
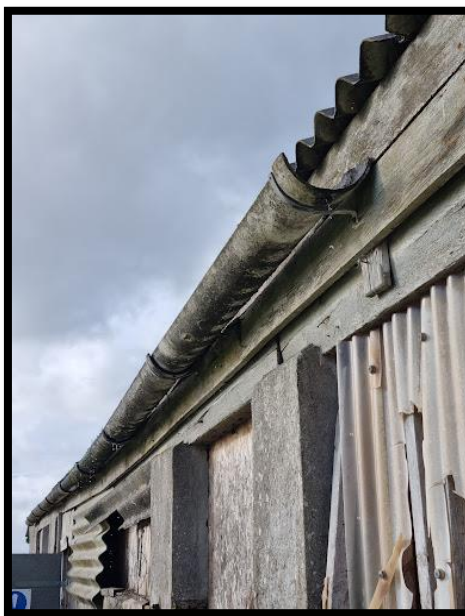
Asbestos has been used extensively to the storage / barns mainly in the form of asbestos roofing and cladding.

Other instances of asbestos were within fuse boxes and in the form of rainwater guttering and downpipes, as pictures depict below.

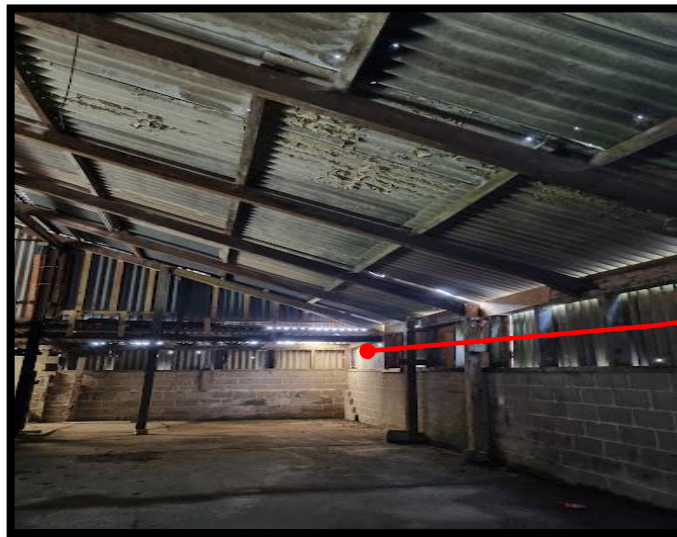
Level	Roof
Room/Area	Exterior Sheeting
Description	Side / End Cladding
Amount	<200m2
Sample/Ref No	01
Laboratory Ref	11073-1

Material assessment		Score
Product Type	Cement Product	1
Condition	Some Damage	1
Surface Treatment	None	1
Asbestos Type	Chrysotile	1
Accessibility	Easy	0
Algorithm Score		4

RECOMMENDATION	Remove prior to demolition
ADVICE	ACM removal and disposal should be carried out by a competent, qualified person as per HSE regulations.

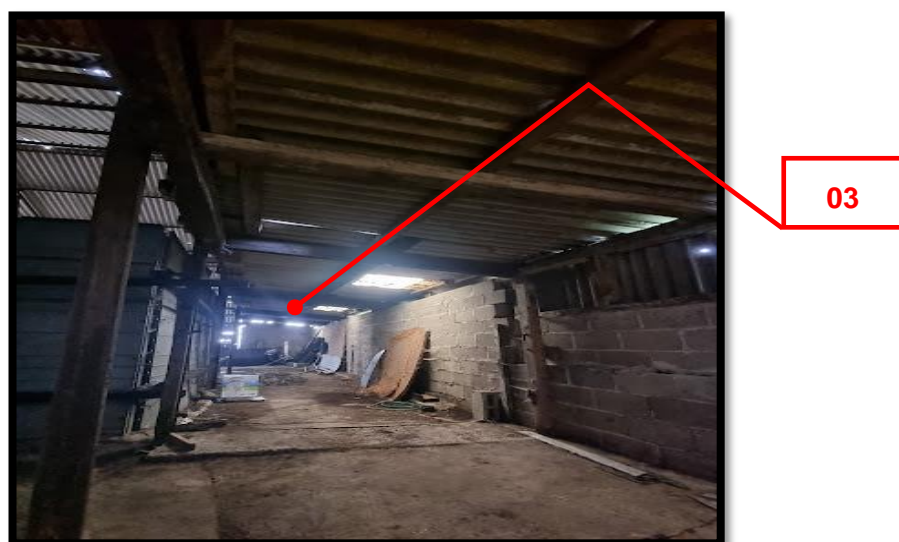
Level	Roof
Room/Area	Roofing
Description	Barn 1 Lean-to
Amount	<70m2
Sample/Ref No	03
Laboratory Ref	11073-3

Material assessment		Score
Product Type	Cement Product	1
Condition	Some Damage	1
Surface Treatment	None	1
Asbestos Type	Chrysotile	1
Accessibility	Easy	0
Algorithm Score		4

RECOMMENDATION	Remove prior to demolition
ADVICE	ACM removal and disposal should be carried out by a competent, qualified person as per HSE regulations.

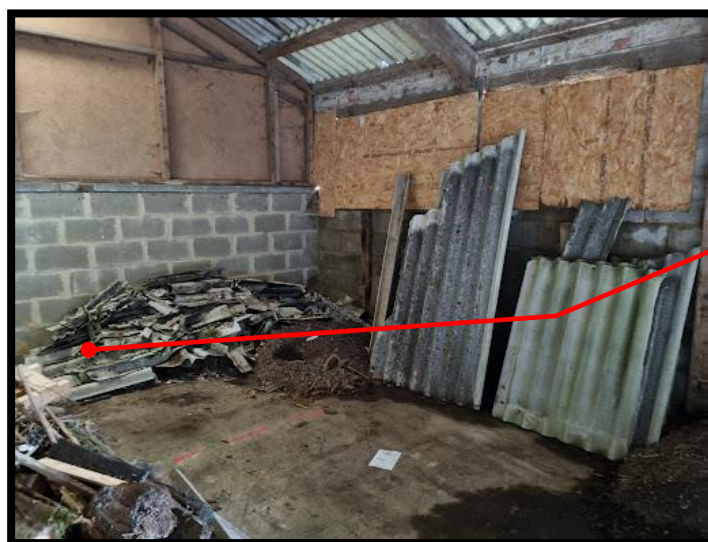
Level	Roof
Room/Area	Roofing Debris
Description	Barn 1
Amount	<0.7t
Sample/Ref No	04
Laboratory Ref	11073-4

Material assessment		Score
Product Type	Cement Product	1
Condition	High Damage	2
Surface Treatment	None	1
Asbestos Type	Chrysotile	1
Accessibility	Easy	0
Algorithm Score		5

RECOMMENDATION	Remove prior to demolition, material is loose and friable
ADVICE	ACM removal and disposal should be carried out by a competent, qualified person as per HSE regulations, under>NNLW.

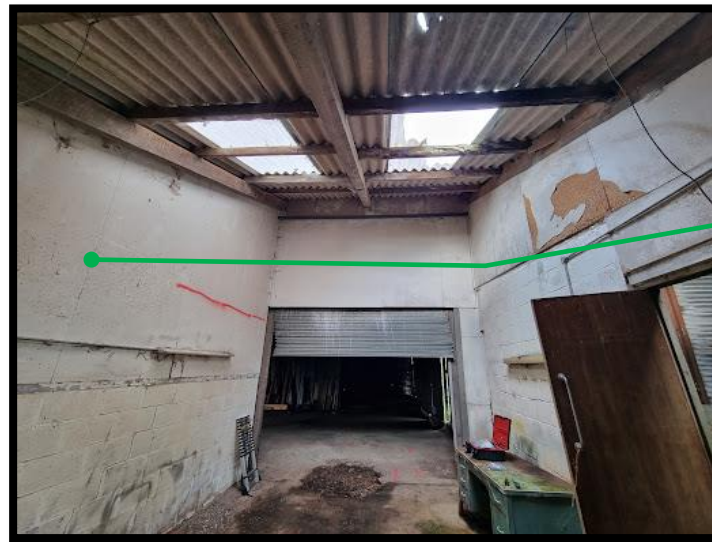
Level	Roof
Room/Area	Store Area
Description	Barn 1 Wall Panels
Amount	<30m2
Sample/Ref No	05
Laboratory Ref	11073-5

Material assessment		Score
Product Type	Board Product	0
Condition	High Damage	0
Surface Treatment	None	0
Asbestos Type	Chrysotile	0
Accessibility	Easy	0
Algorithm Score		0

RECOMMENDATION	Remove prior to refurbishment.
ADVICE	None as material is non asbestos

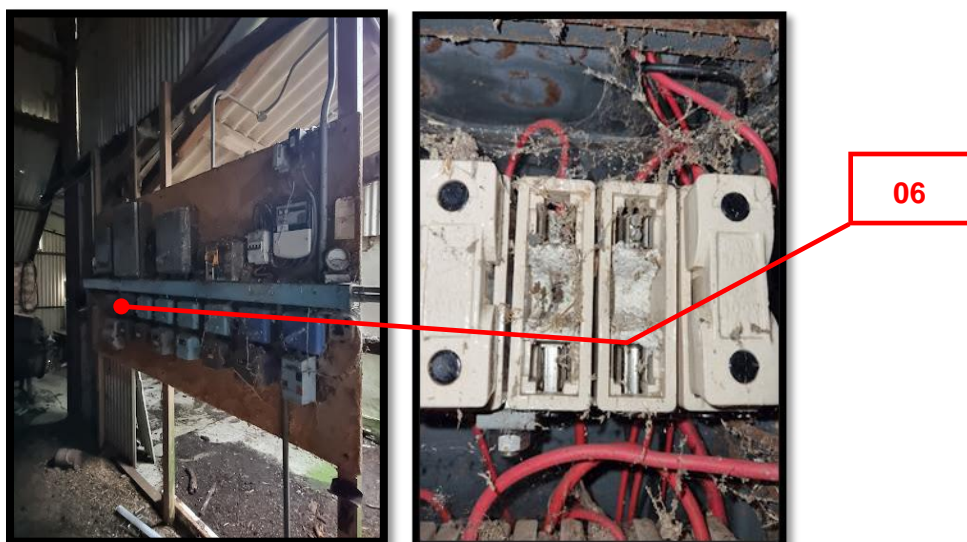
Level	Ground Floor
Room/Area	Grain Store
Description	Flash guards to MEMS
Amount	<Unknown
Sample/Ref No	06
Laboratory Ref	11073-6

Material assessment		Score
Product Type	Textile Product	1
Condition	Good	2
Surface Treatment	None	1
Asbestos Type	Chrysotile	1
Accessibility	Easy	0
Algorithm Score		5

RECOMMENDATION	Remove prior to demolition, material is loose and friable
ADVICE	ACM removal and disposal should be carried out by a competent, qualified person as per HSE regulations.

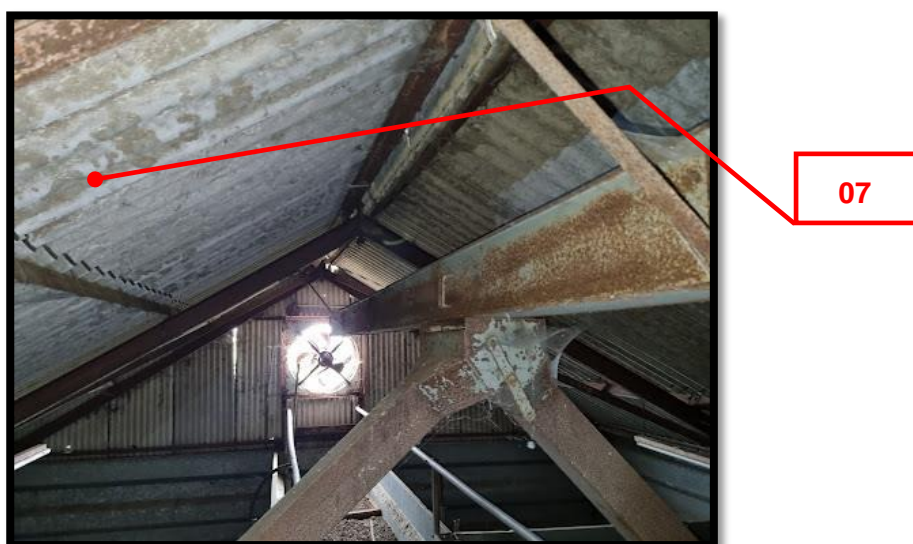
Level	Roof
Room/Area	Grain Store
Description	Grain Store Roofing
Amount	<200m2
Sample/Ref No	07
Laboratory Ref	11073-7

Material assessment		Score
Product Type	Cement Product	1
Condition	Good	1
Surface Treatment	None	1
Asbestos Type	Chrysotile	1
Accessibility	Easy	0
Algorithm Score		5

RECOMMENDATION	Remove prior to demolition, material is loose and friable
ADVICE	ACM removal and disposal should be carried out by a competent, qualified person as per HSE regulations.

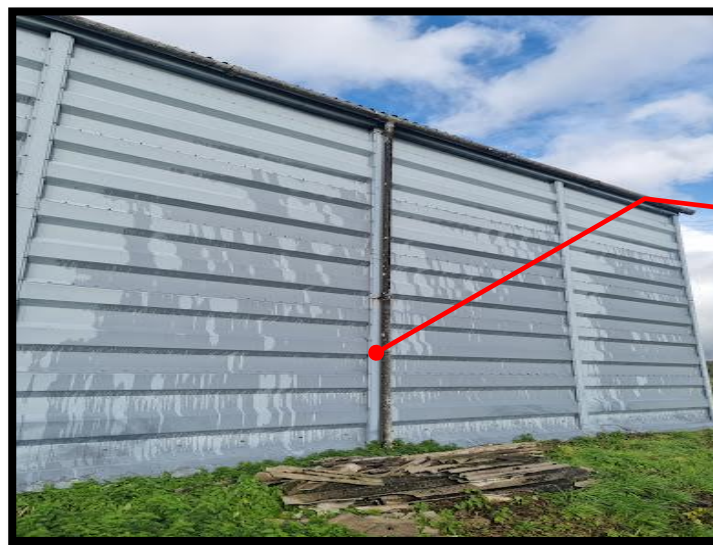
Level	Roof
Room/Area	Grain Store
Description	Grain Store Guttering
Amount	<30Lm
Sample/Ref No	08
Laboratory Ref	11073-8

Material assessment		Score
Product Type	Cement Product	1
Condition	Good	1
Surface Treatment	None	1
Asbestos Type	Chrysotile	1
Accessibility	Easy	0
Algorithm Score		4

RECOMMENDATION	Remove prior to demolition, material is loose and friable
ADVICE	ACM removal and disposal should be carried out by a competent, qualified person as per HSE regulations.

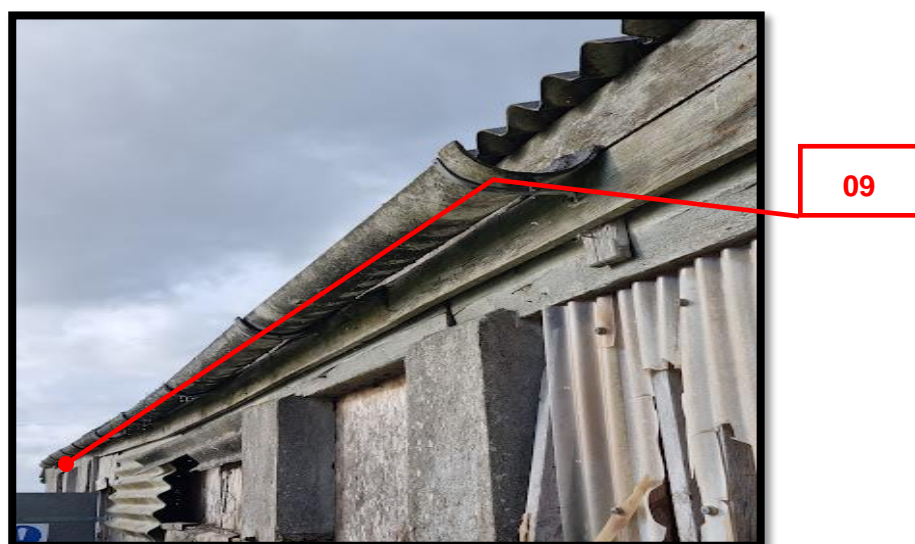
Level	Roof
Room/Area	Barn 1
Description	Guttering rear and side
Amount	<30Lm
Sample/Ref No	09
Laboratory Ref	11073-9

Material assessment		Score
Product Type	Cement Product	1
Condition	Good	1
Surface Treatment	None	1
Asbestos Type	Chrysotile	1
Accessibility	Easy	0
Algorithm Score		4

RECOMMENDATION	Remove prior to demolition, material is loose and friable
ADVICE	ACM removal and disposal should be carried out by a competent, qualified person as per HSE regulations.

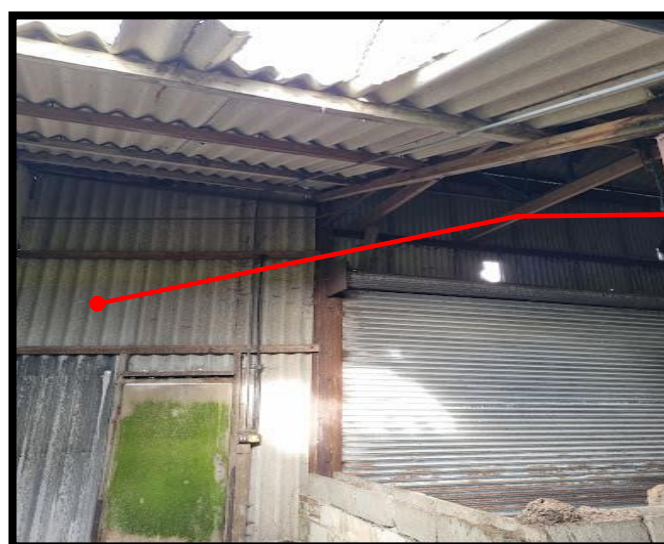
Level	Roof
Room/Area	Grain Store
Description	Cladding
Amount	<100m2
Sample/Ref No	10
Laboratory Ref	11073-10

Material assessment		Score
Product Type	Cement Product	1
Condition	Good	1
Surface Treatment	None	1
Asbestos Type	Chrysotile	1
Accessibility	Easy	0
Algorithm Score		5

RECOMMENDATION	Remove prior to demolition, material is loose and friable
ADVICE	ACM removal and disposal should be carried out by a competent, qualified person as per HSE regulations.
