Arboricultural Services

Arboricultural Health and Safety Survey

CAS/2019/218

Linton Park, Linton, Maidstone, Kent, ME17 4AB

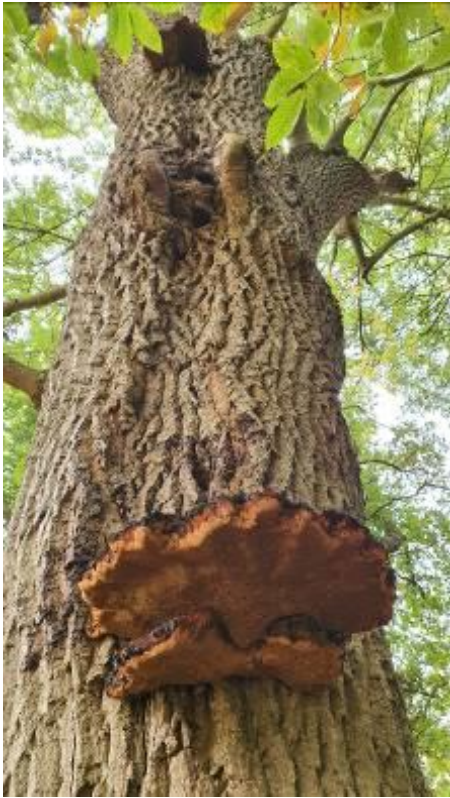
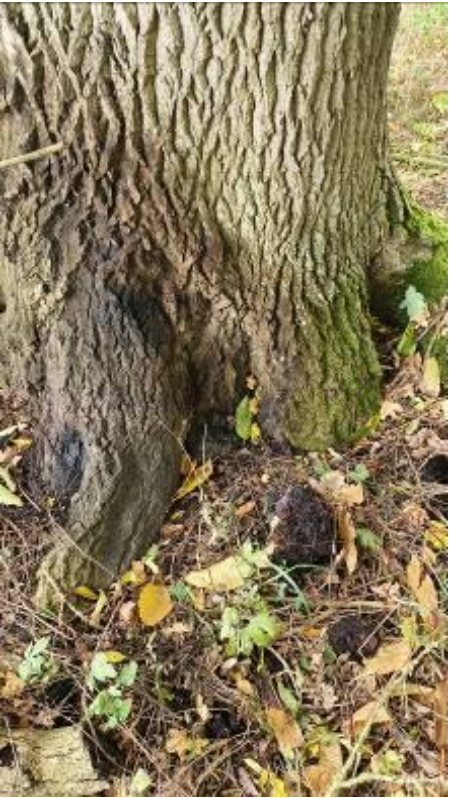
Fungal Brackets Located on T040 Ash

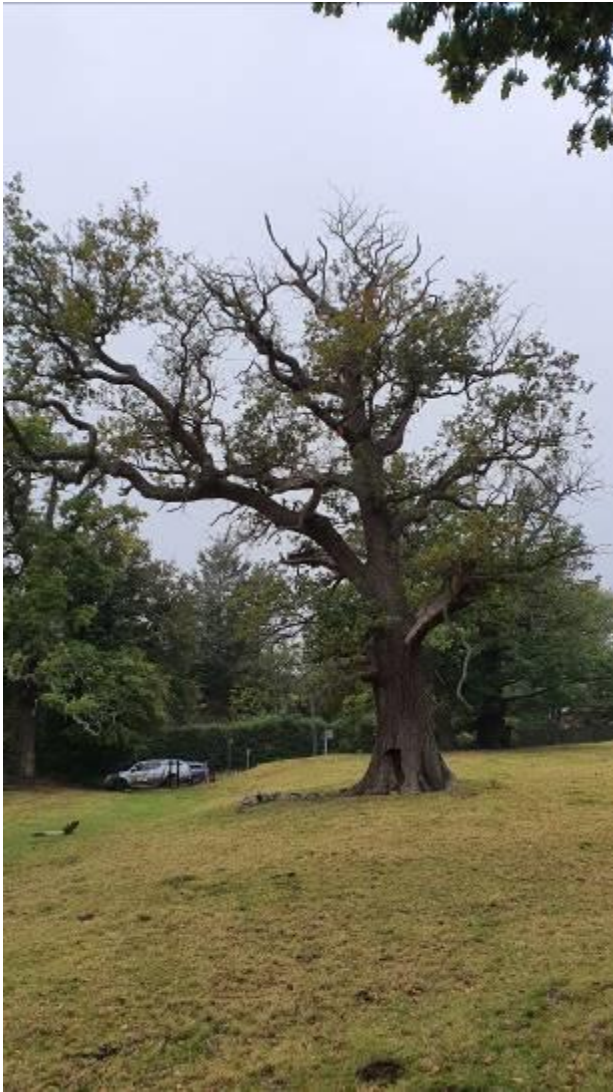
T066 Oak viewed from East

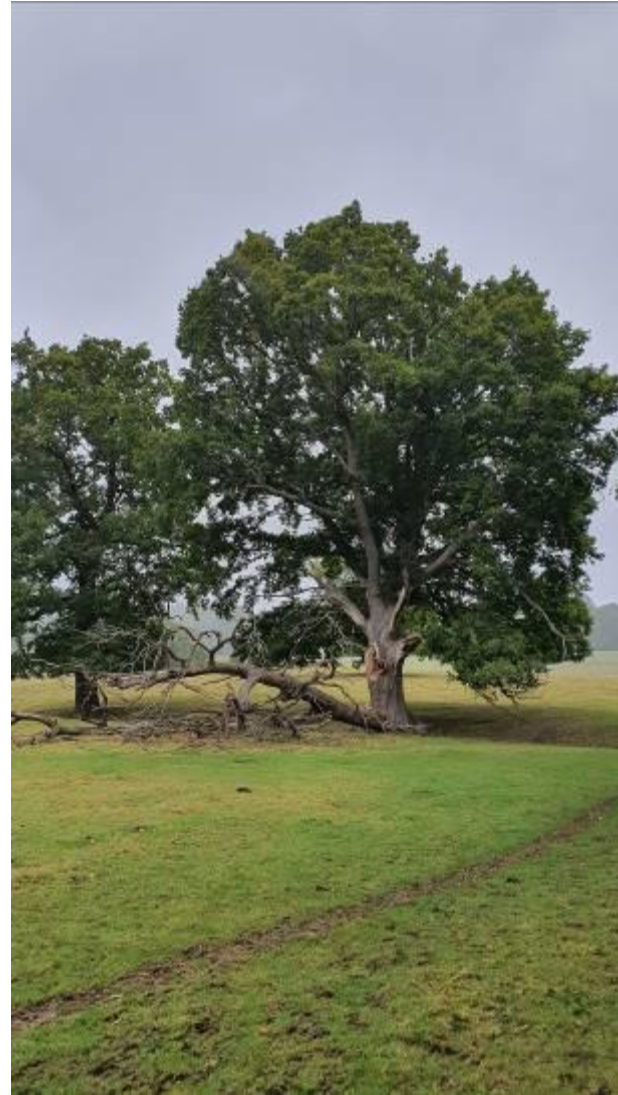
T067	Oak (Quercus sp.)	Target # - footpath	Height (m): 20 Crown Radius (m): 10 DBH (cm): 130 Life Stage: Over Mature Life Exp.: 40+ Years	Tree has shed a major limb revealing brown rot within main stem. Significant cavity noted in buttress area to extent of metal probe (60cm)	Poor	Preferred option - change public desire line by installation of fencing to allow natural deterioration of tree and retain habitat / landscape value. or 50% crown reduction & removal of major deadwood Timescale: 04-Oct-2020 (1 Year)

T067 Oak with large limb failure viewed from South East

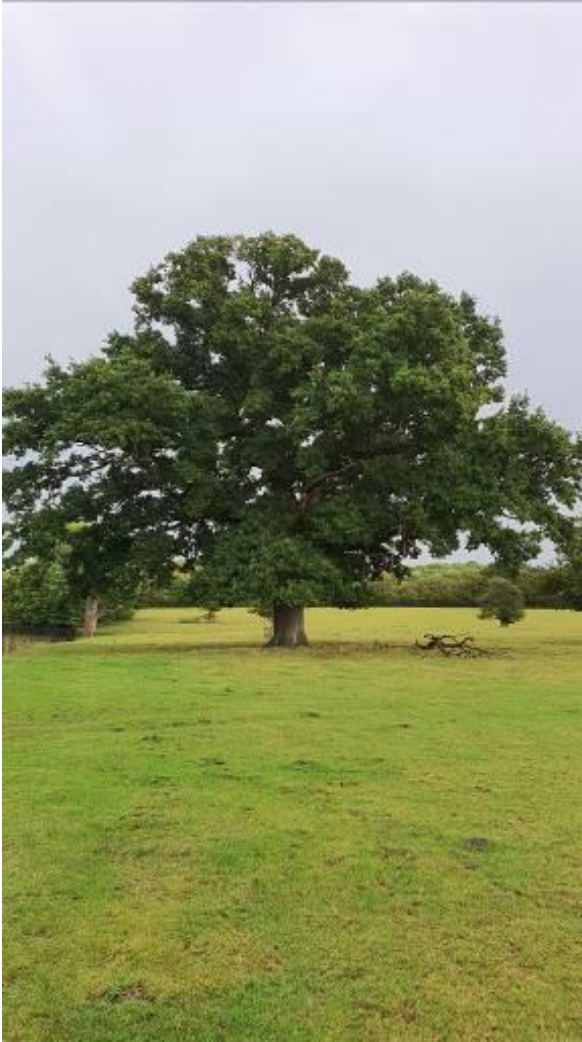
T068 Oak viewed from West

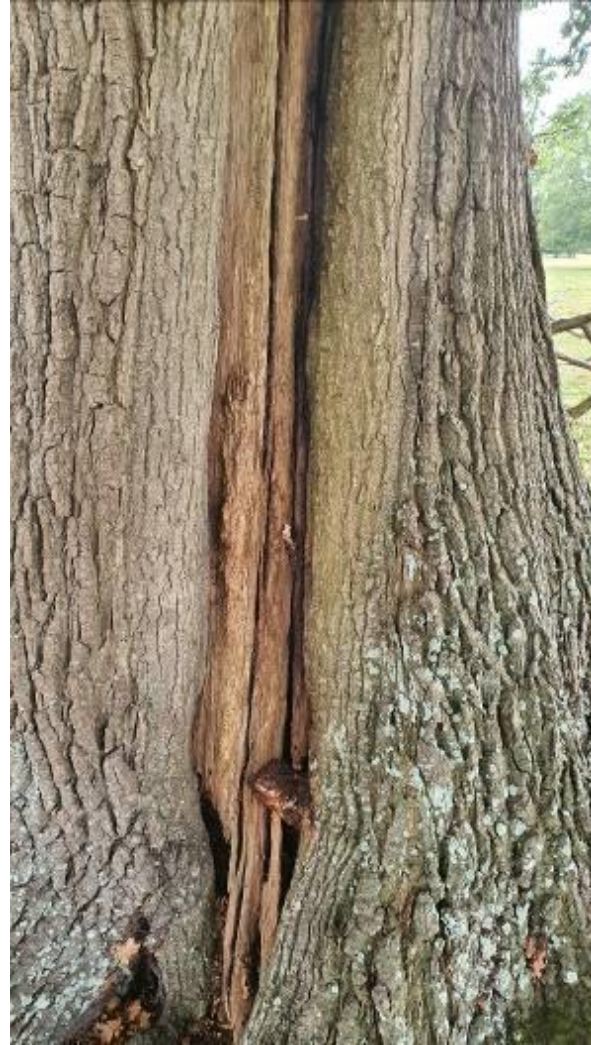
T068 Oak – stem damage and fungal fruiting body.

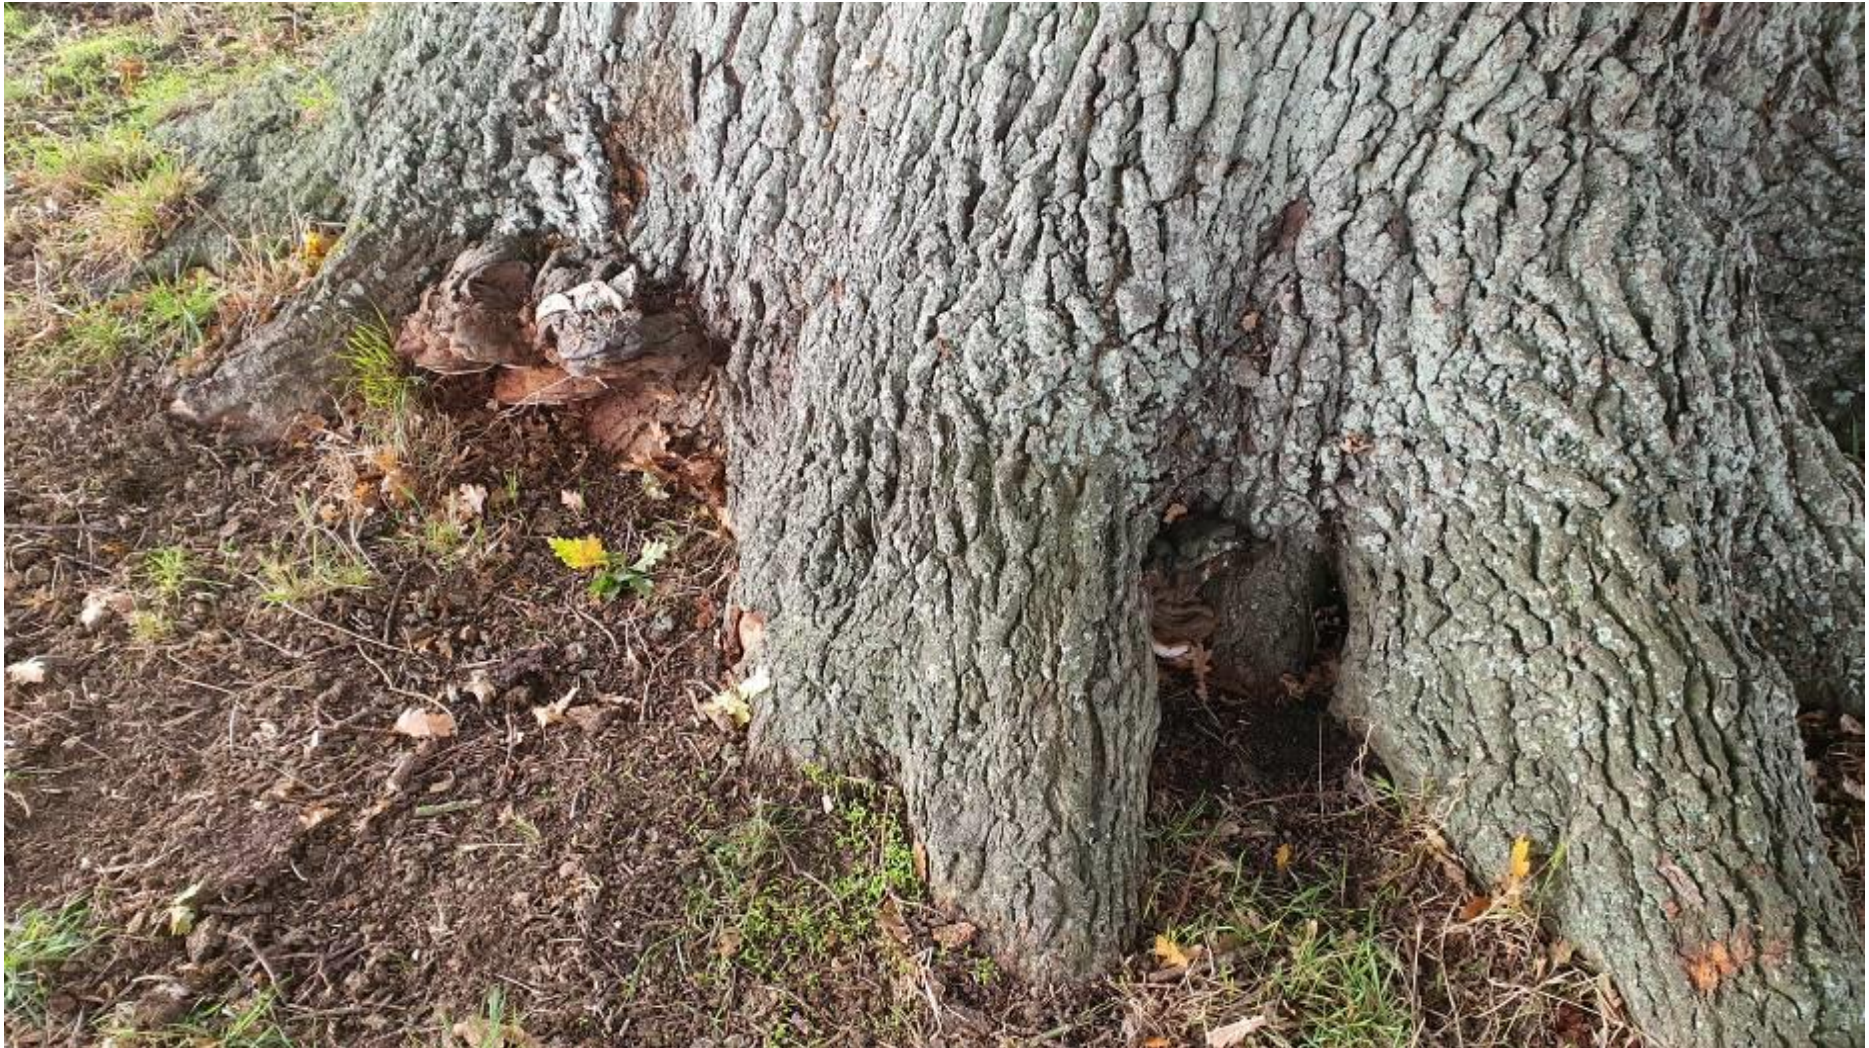
T068 Oak – *Ganoderma* spp fruiting bodies around buttresses

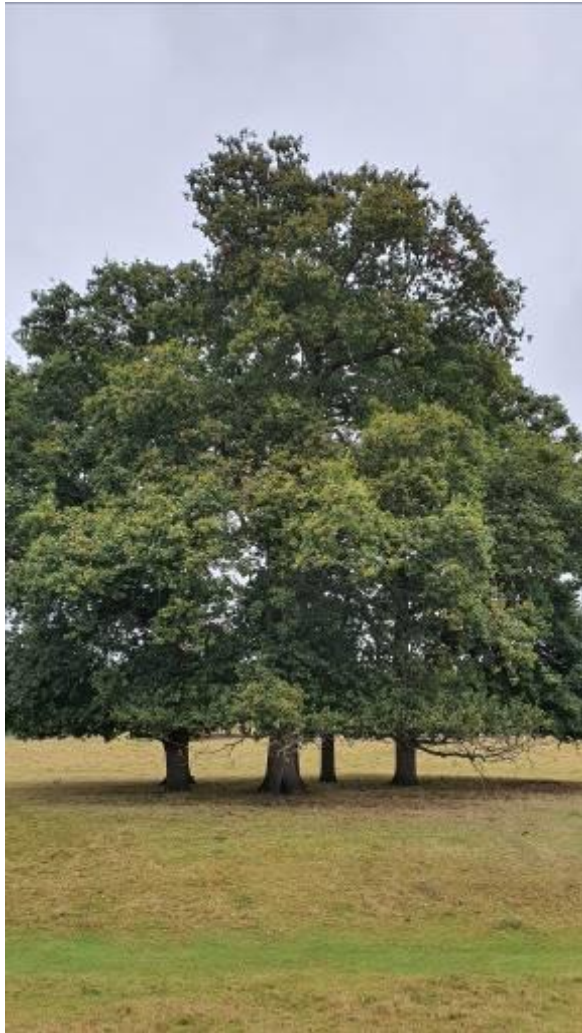
T071 Oak viewed from South

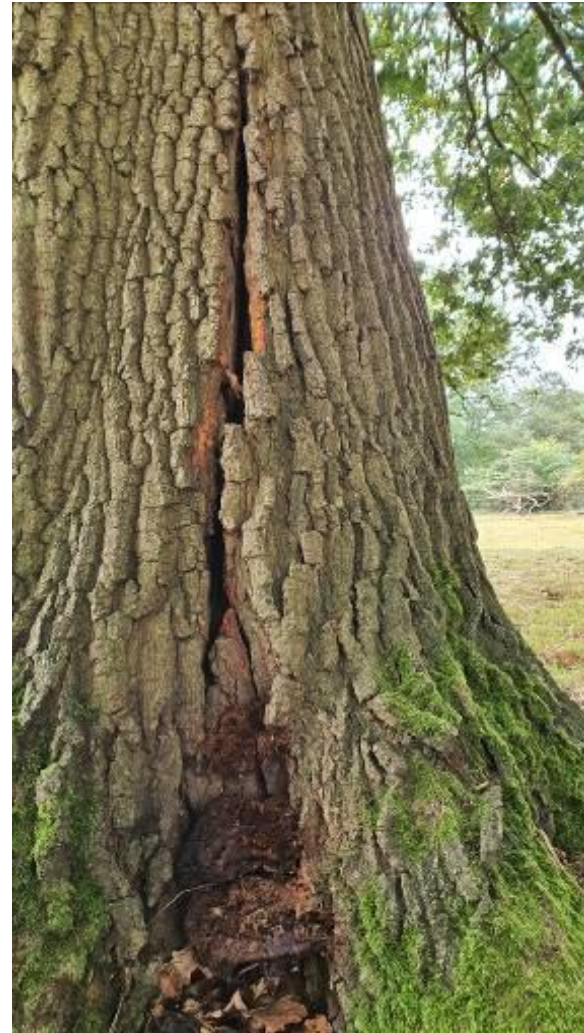
T071 Stem damage viewed from North with fungal bodies

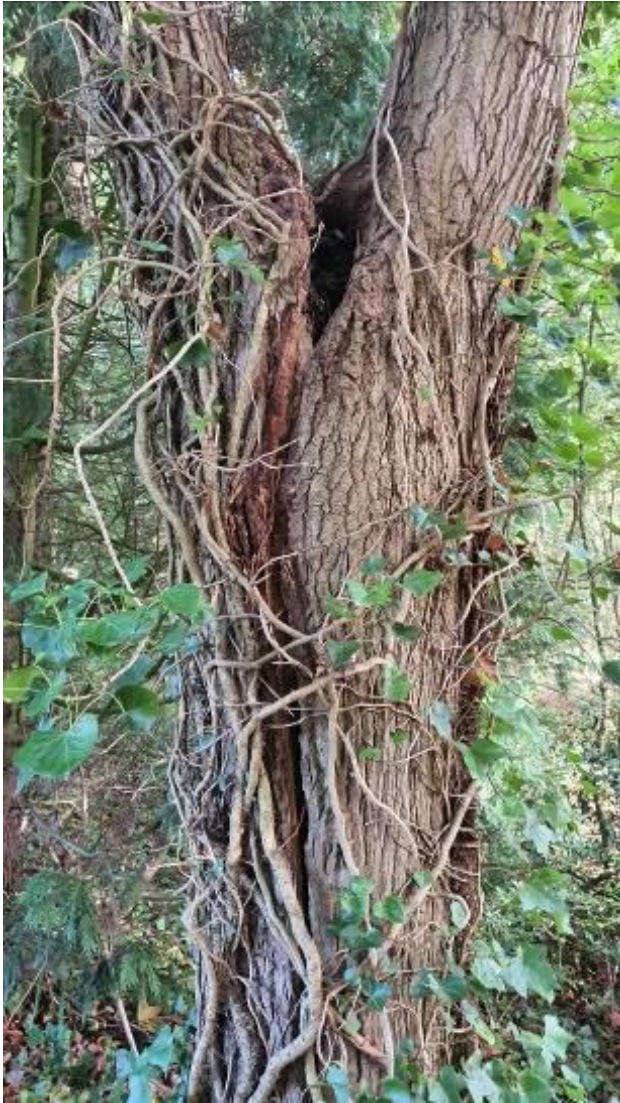
T073 Poplar – main stem split

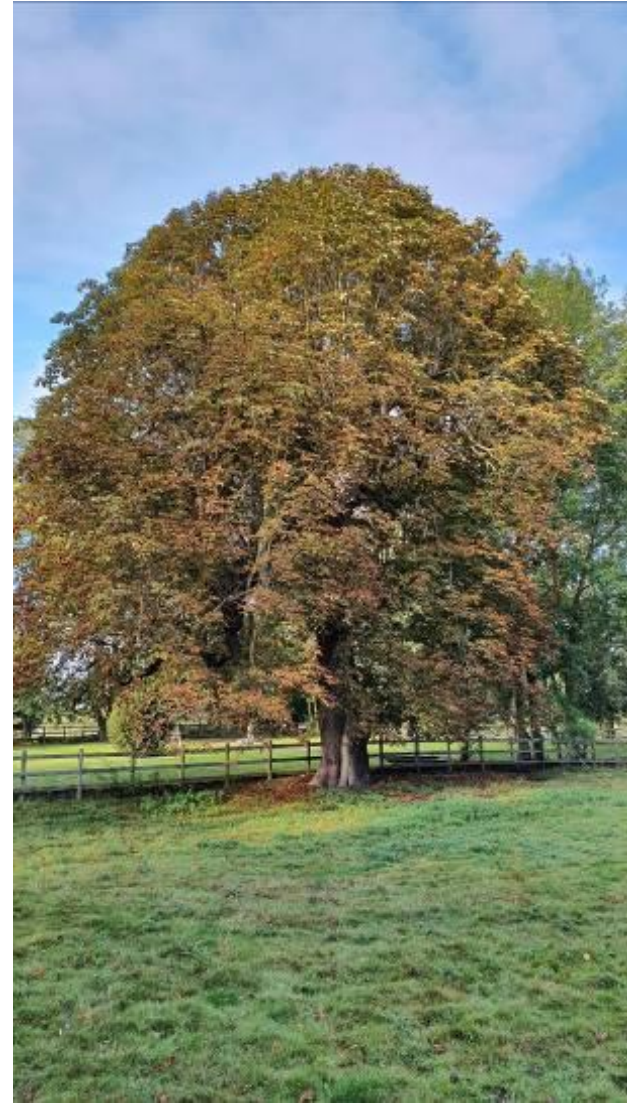
T074 Horse Chestnut

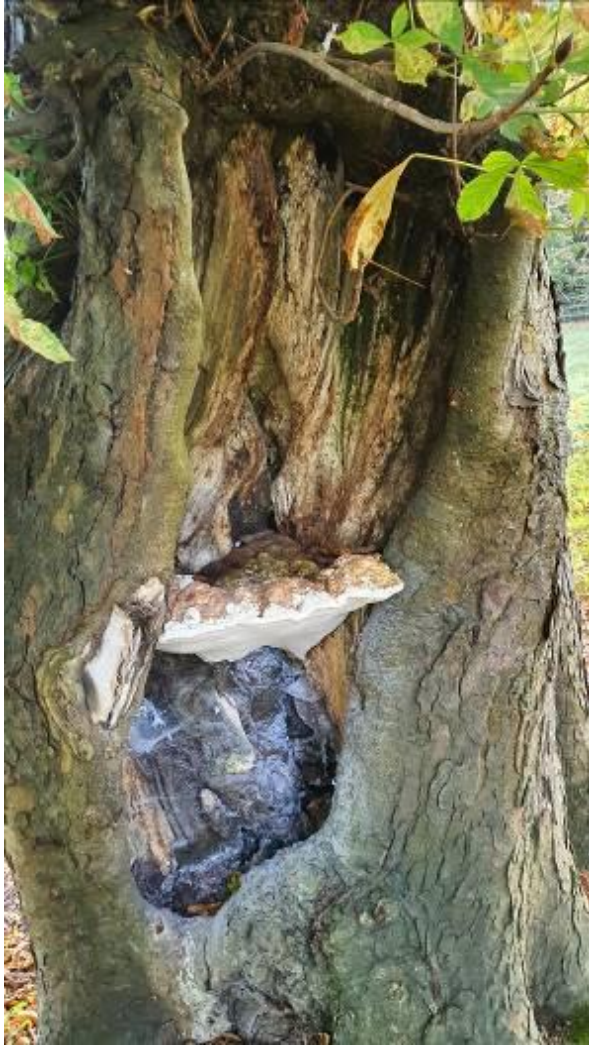
T074 Horse Chestnut – *Ganoderma spp* bracket

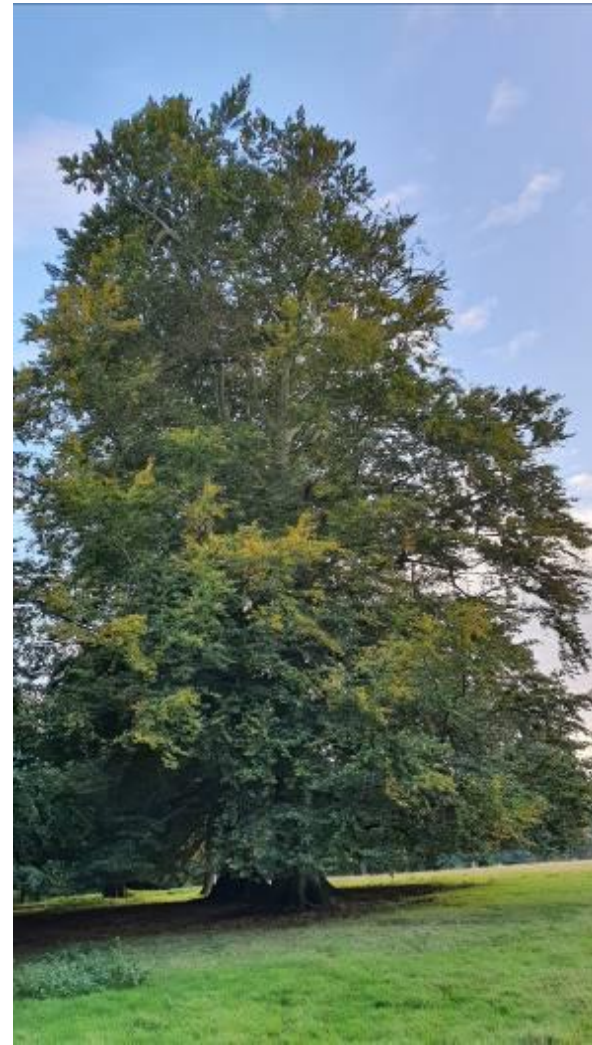
- 2.2.9 Located along the main driveway to Linton Park House is a large mature Beech (T075) which was measured as 35m tall. The tree is located within easy falling distance of the access driveway which has periods of high activity through the day. The tree was noted as having Giant Polypore (*Meripilus Giganteus*) fruiting bodies growing on and around its root plate with at least seven individual clumps located predominantly to the East of the main stem. This decay is synonymous with brittle fracture of the lower main stem particularly on Beech. Therefore it is recommended that this tree be turned into an 8m monolith to reduce wind loading and be allowed to stand for habitat value until such a time as the main stem becomes unstable. If retention of a monolith is undesirable then complete removal is recommended.

T075 Beech – located on driveway

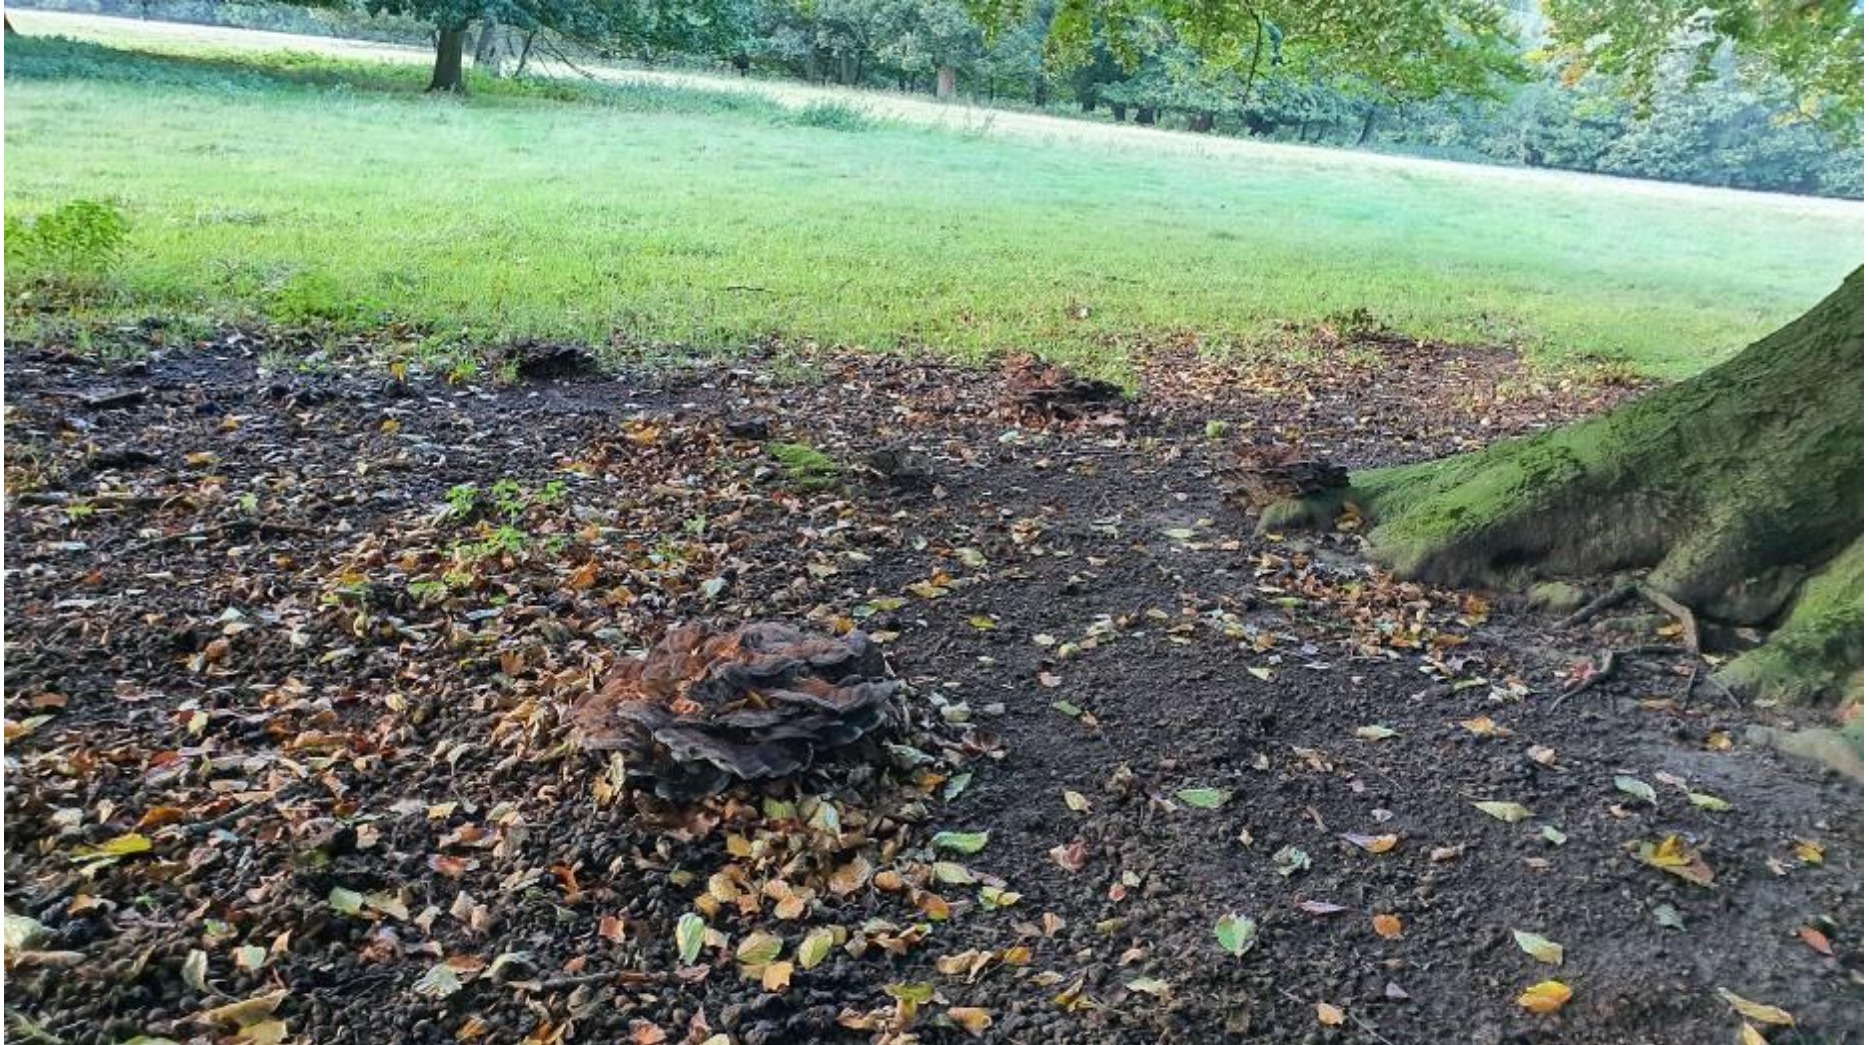
T075 Beech – multiple Giant Polypore (*Meripilus Giganteus*) fruiting bodies
