## **Brief Heritage Statement for Removal of Rotten Thatch To Mill Barn, RG20 4UD**

### **Application 22/03074/LBC**

### **Listed Building / Planning Application**

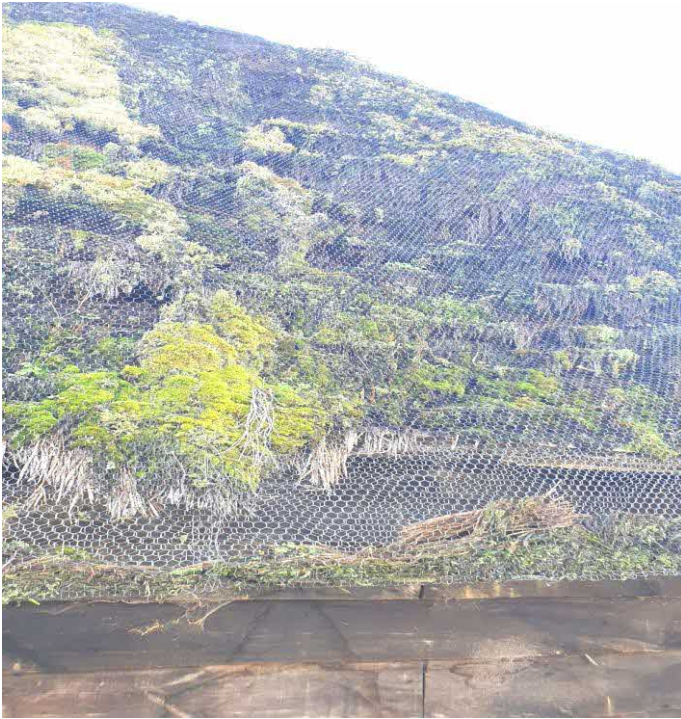
**Front Thatch**

1. The thatch has now rotted away exposing the under roof, battens, steel ledgers and spars.
2. Water is now starting to penetrate the fixing holes. As there is no thatch overhang it is running down the weather boarding and doors in places and soaking in.

**The above rotten thatch issues need addressing.**

1. Remove remainder of thatch, fixings and battens.
2. Repair holes in existing iron sheets.
3. Install gutters and downpipes.
