MILL LANE BARN, MILL LANE, ECCHINSWELL, RG20 4UD

APPLICATION FOR REMOVAL of THATCH To Grade II barn

RECENT PHOTOS ~ November 2022

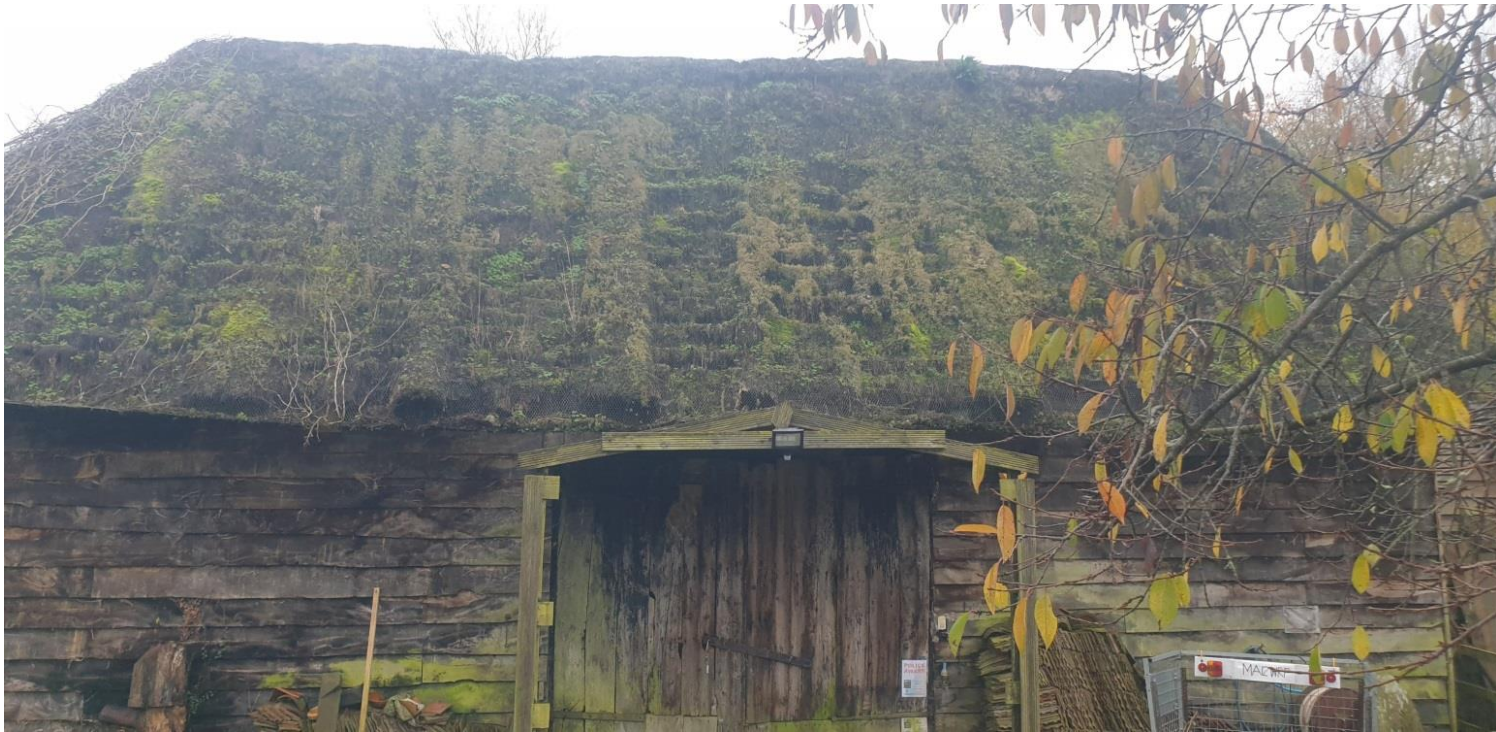
FRONT NORTH VIEW FROM LANE (Burnside to right)

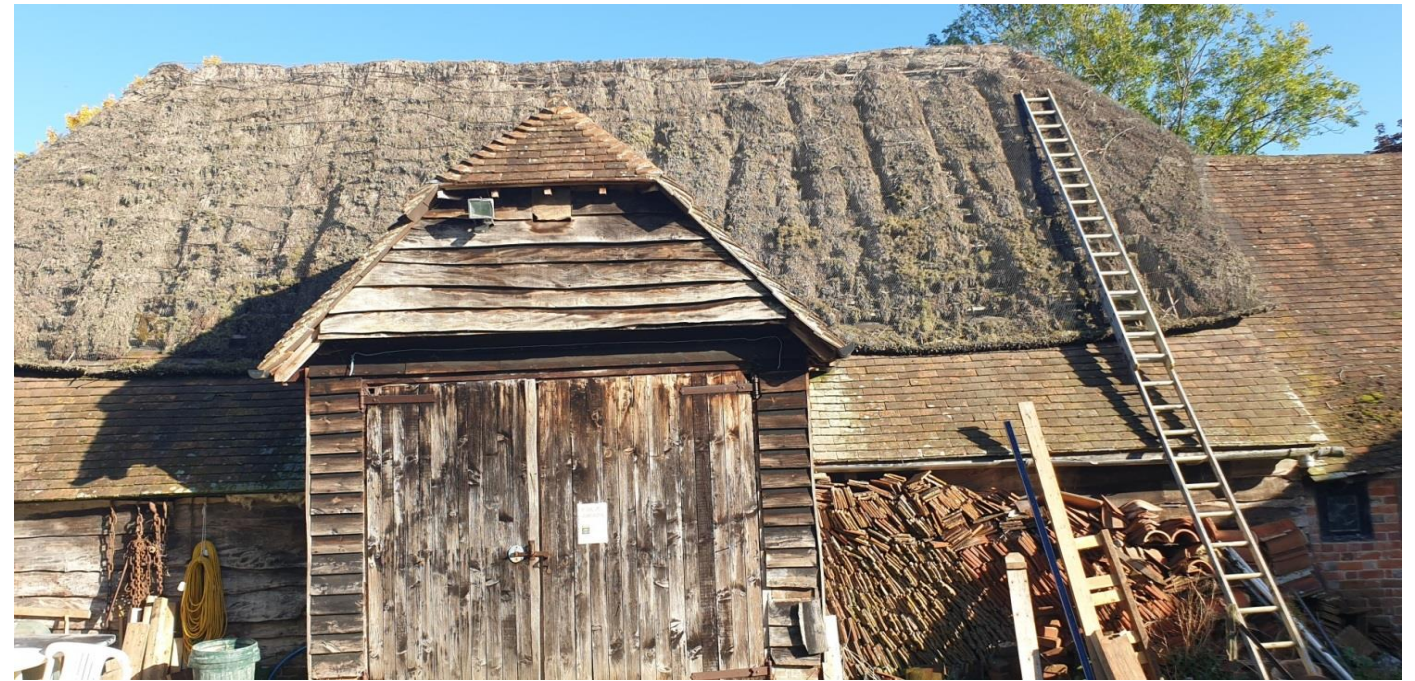
SOUTH ELEVATION ~ REAR VIEW

Thatching was done in 1992 and has now deteriorated back to battens and original corrugated iron roof (see photo of barn in 1990)

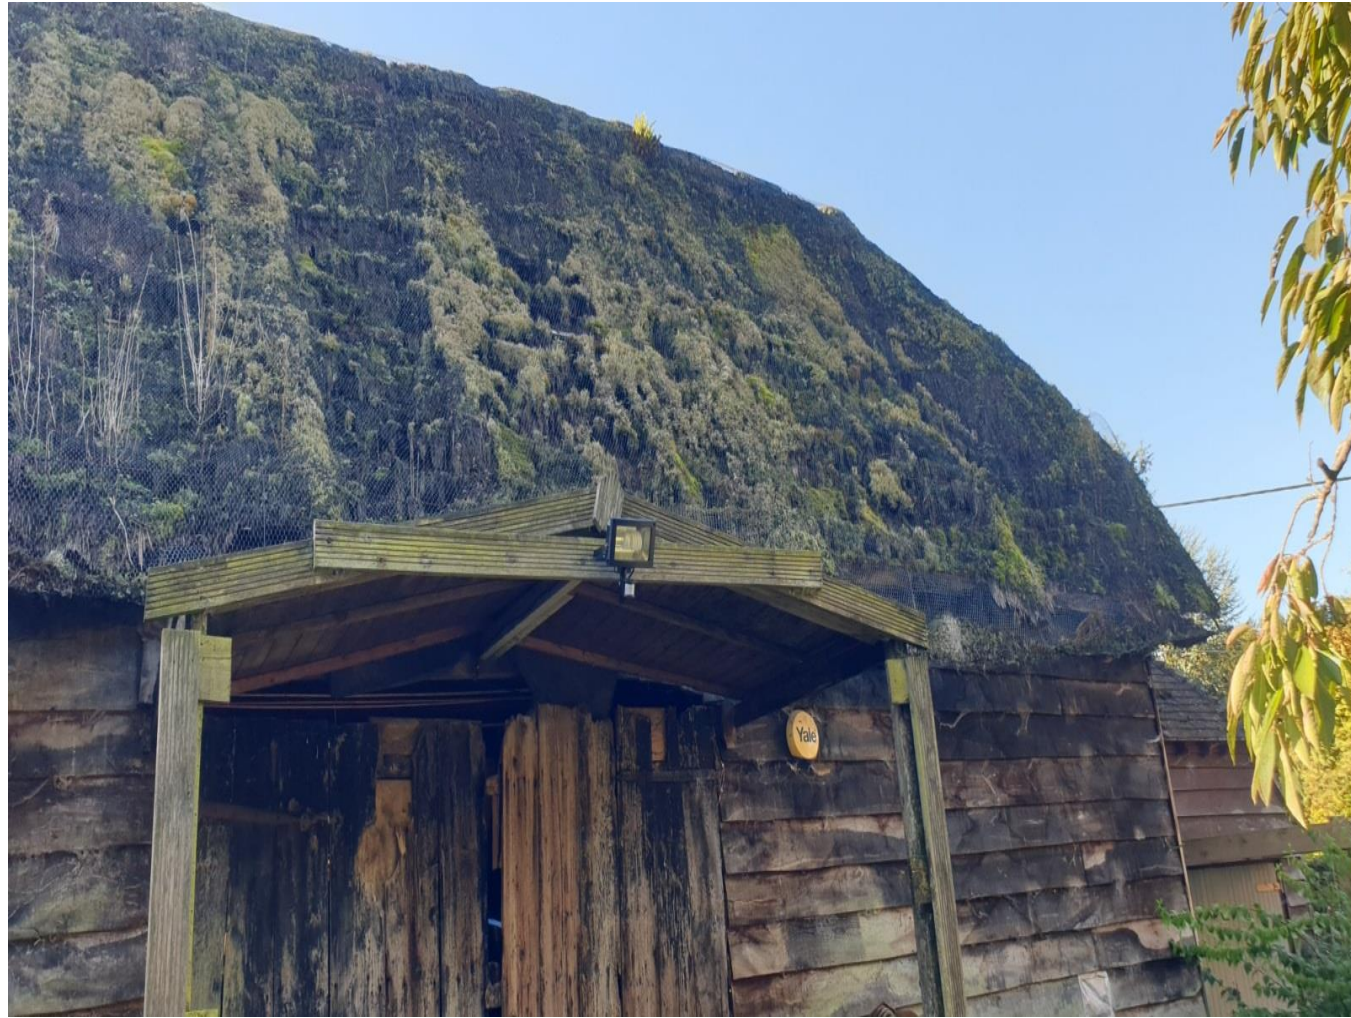
FRONT THATCH

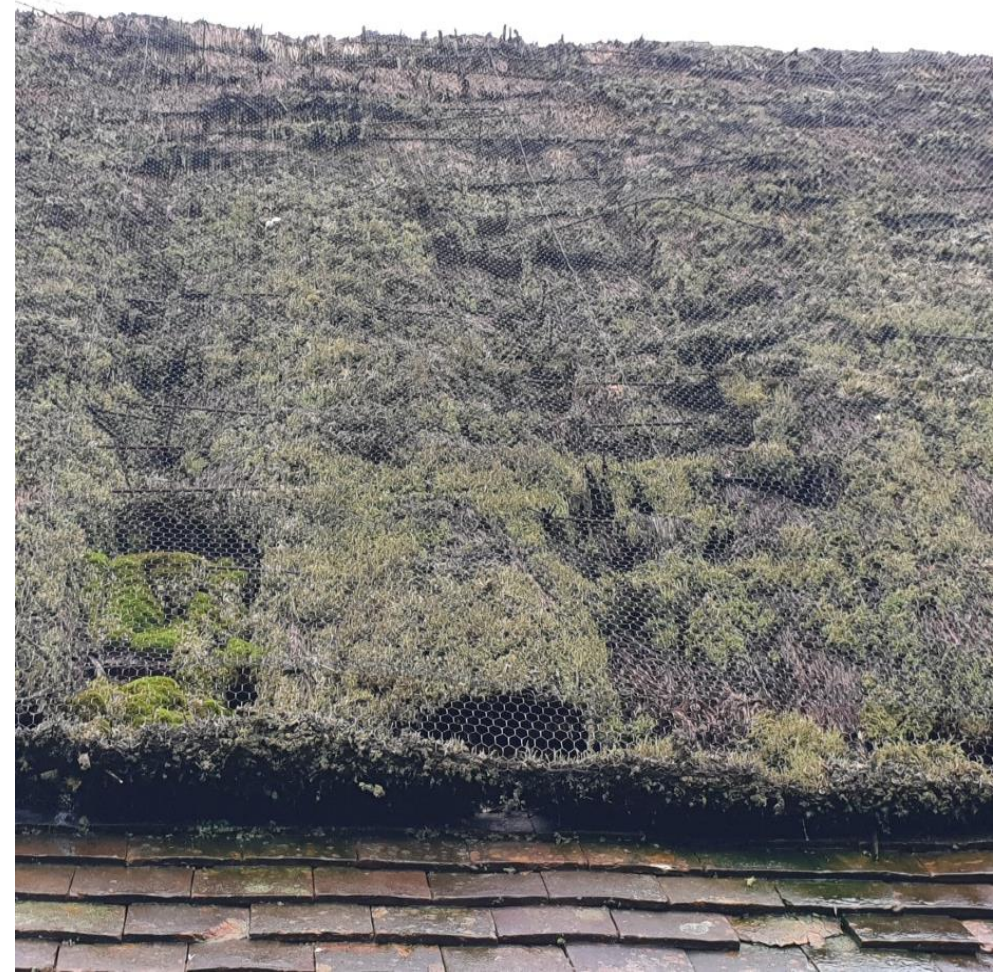
Reason : The thatch has now completely deteriorated back to fixing battens and is slipping off. The roof is starting to leak through the batten fixing holes and access is needed to seal holes.

DETERIORATED THATCH EXPOSING SPARS AND CORRUGATED IRON

Re-instatement of thatch is costly and there is a repairable iron roof below. Burnside Cottage, 10 meters away, had a thatch fire in approx. 2003 posing a serious threat to this all timber barn. Vermin are starting to nest. The thatch will slip off soon and whatever happens to the roof; the thatch needs removing.

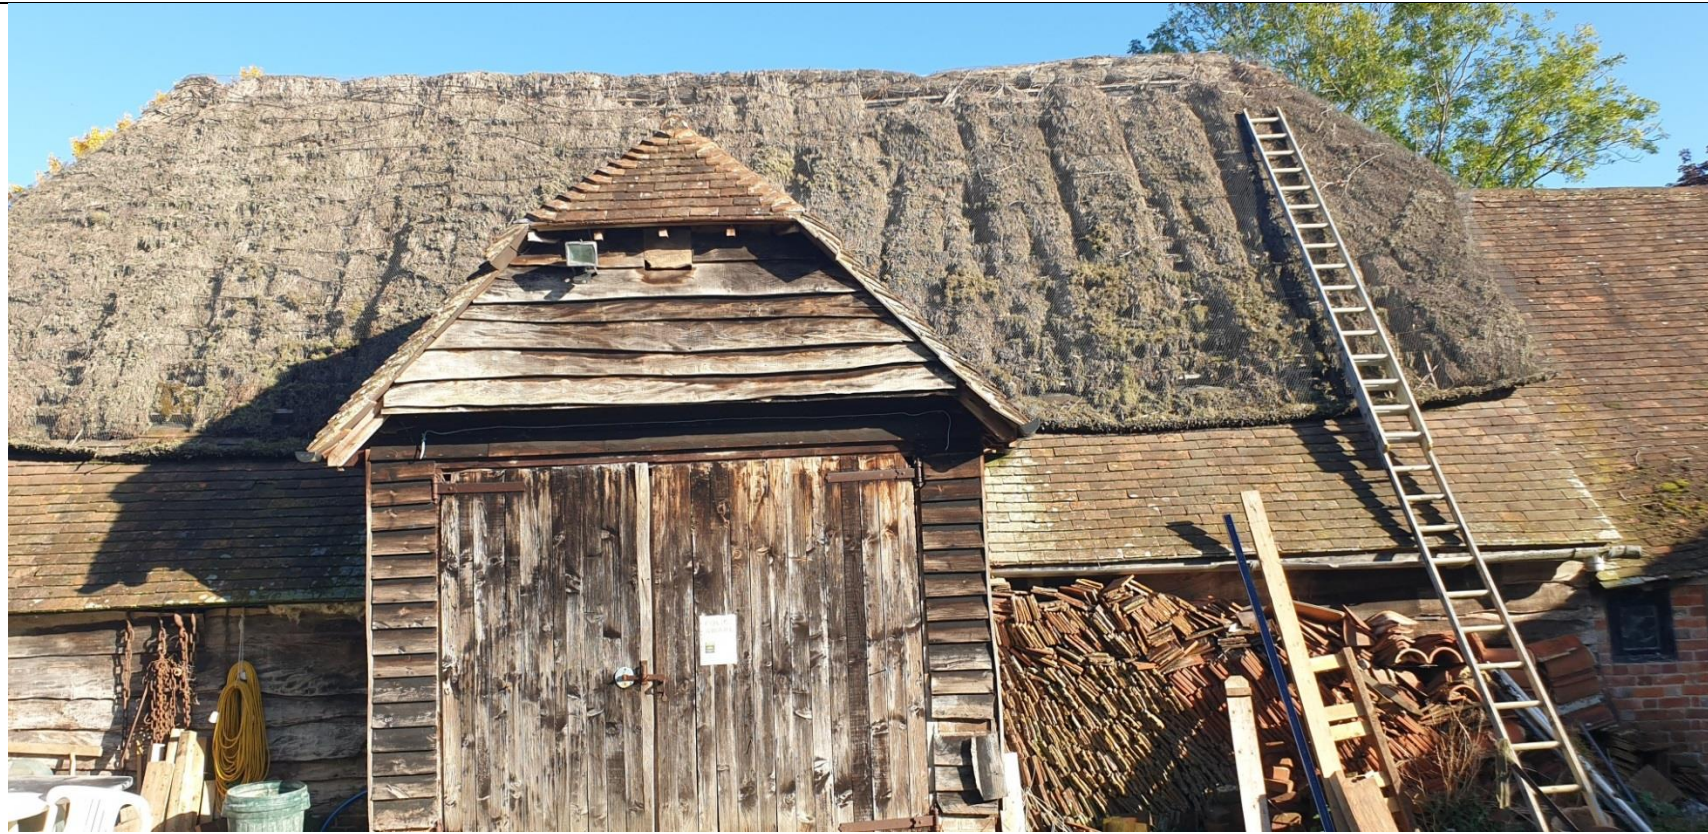
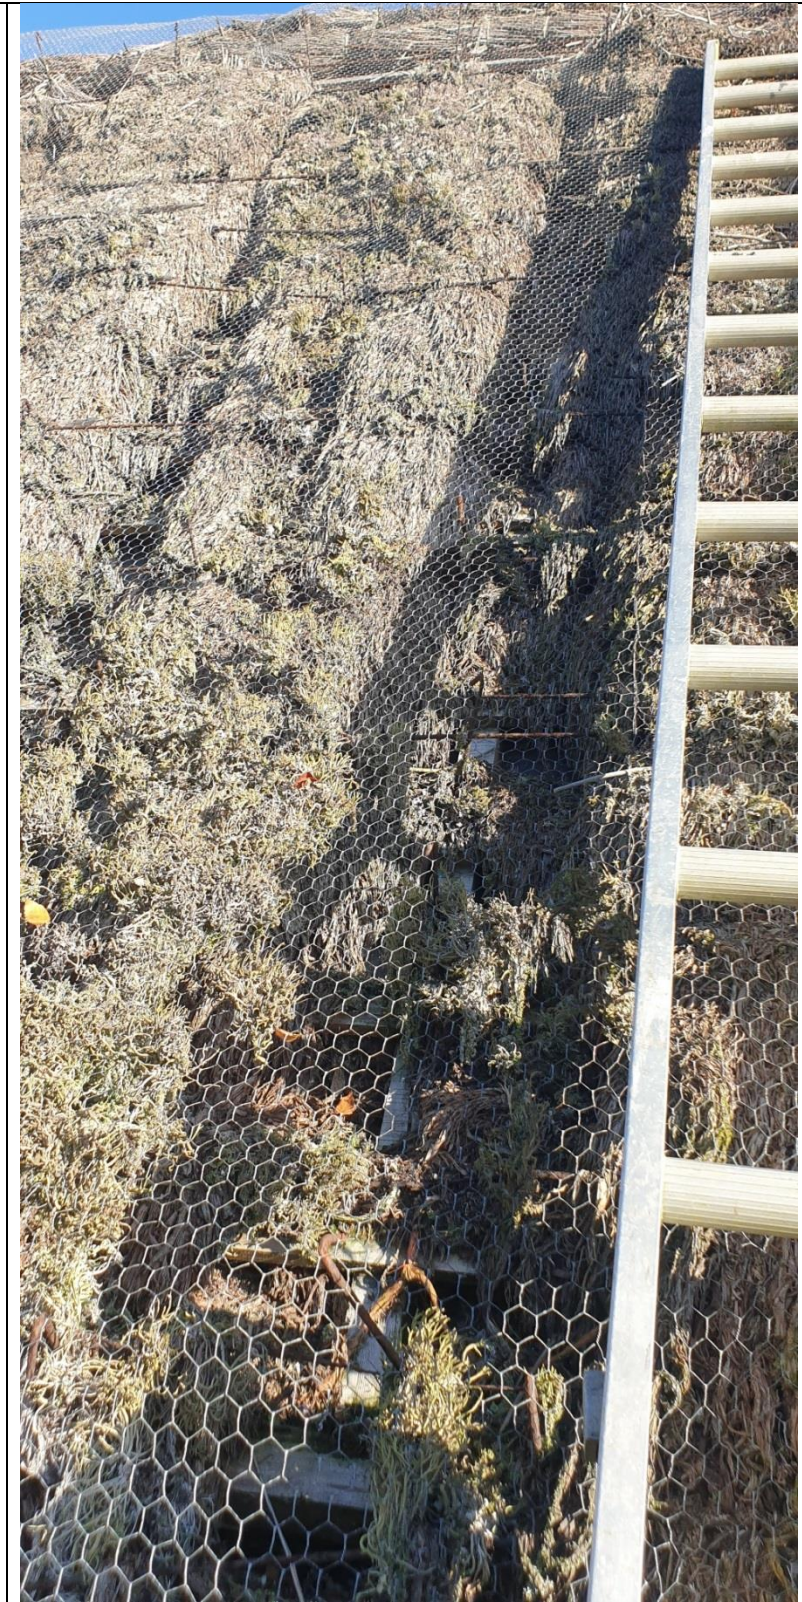
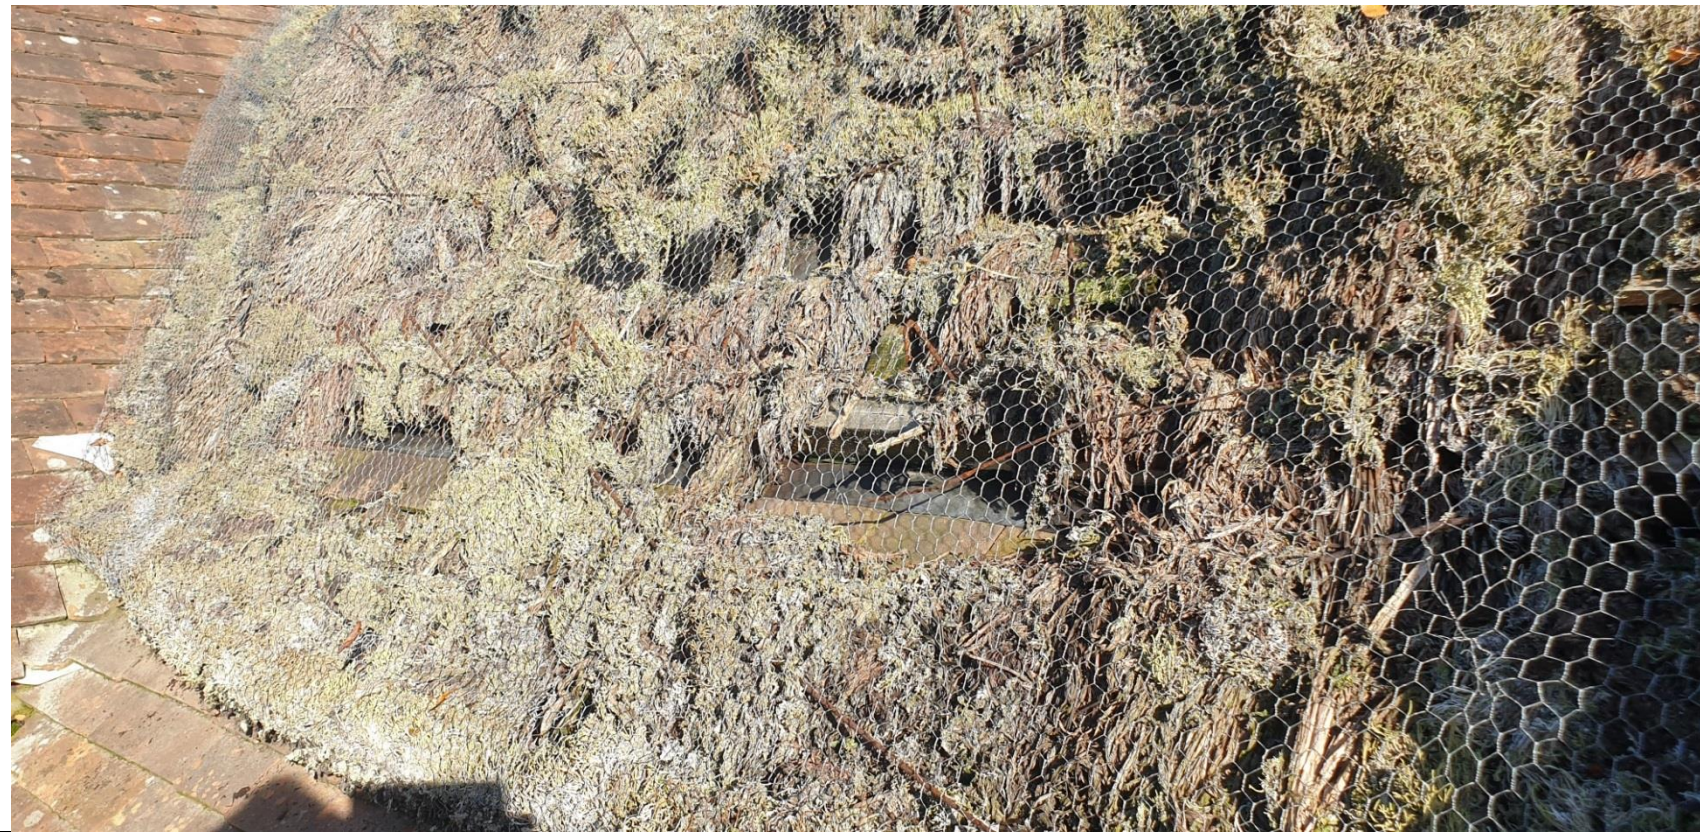
REAR THATCH and DETAIL

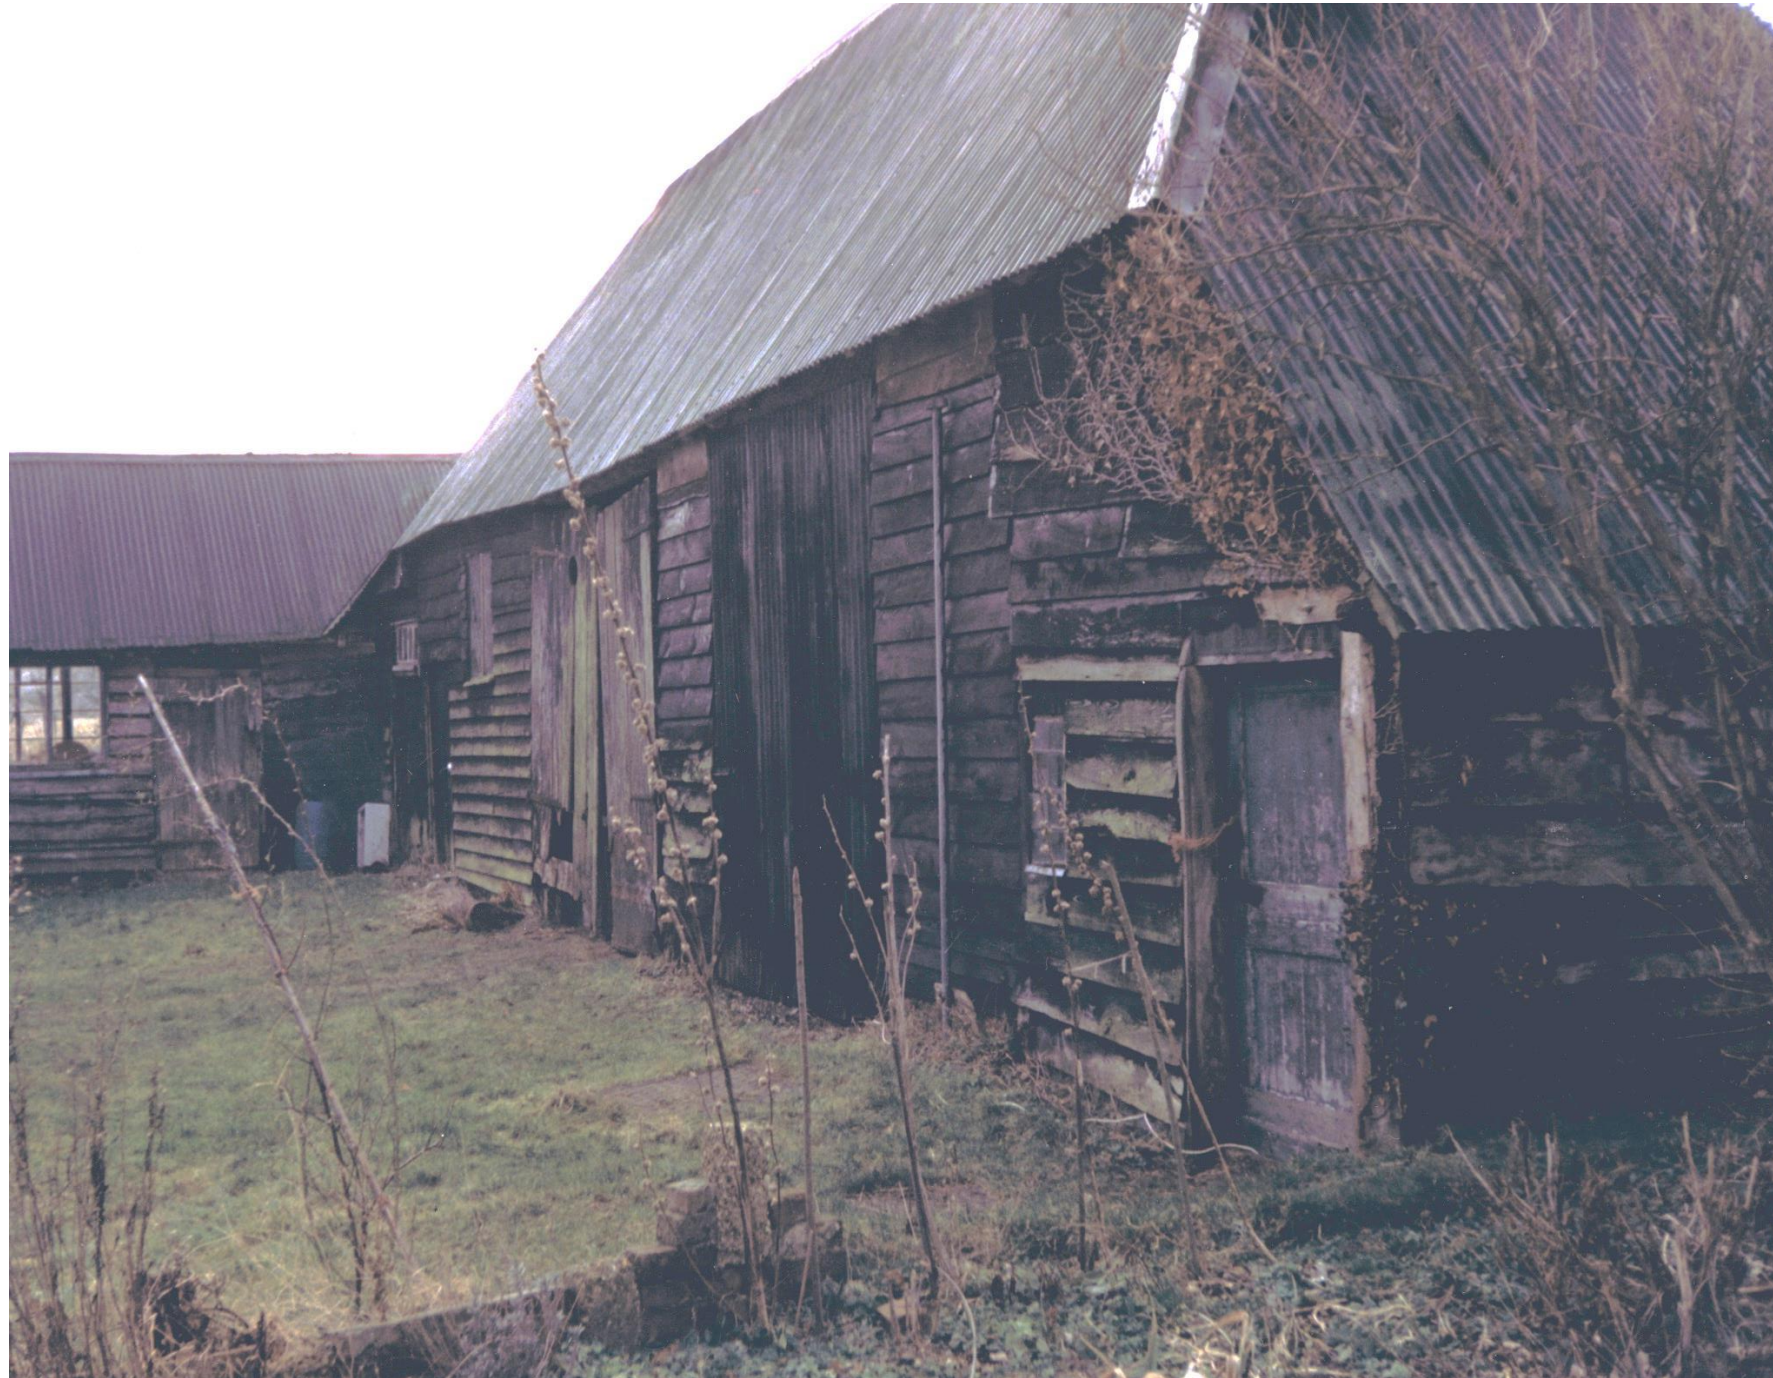
BARN IN 1992 & As it was when Listed

NOTE : This Corrugated Iron Roof is still under thatch and was left for strength, not to disturb original timbers and a partial, short time fire barrier.
