## Tree Survey, Arboricultural Impact Assessment and Arboricultural Method Statement

for a scheme of two detached dwellings on land at Harps House, Wells Road, Draycott, Cheddar, Somerset, BS27 3SF

10 January 2017

Prepared by Ian Monger MSc, BSc (Hons), Tech Cert, MArborA Survey Ref: IMT-SPC-201701

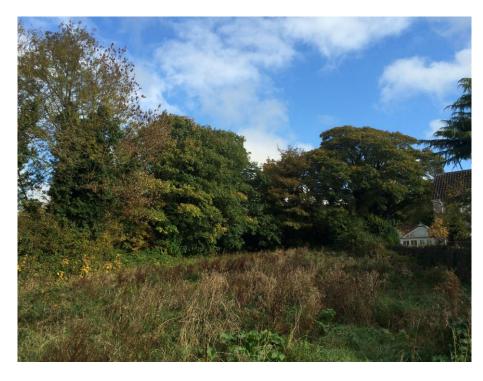
*Figure 1: View from inside the site looking north east towards T1 Sycamore to G2 Common Ash.*

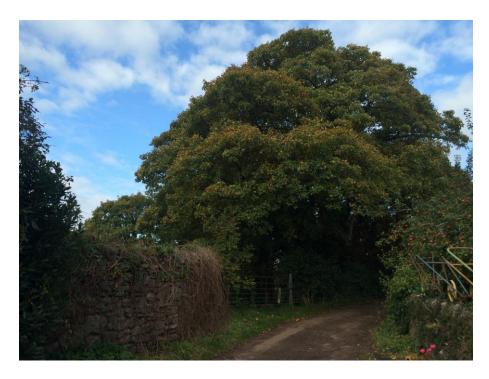
*Figure 2: View from Vicarage Lane looking north towards the rear entrance gate and T1 and T2 Sycamore.*

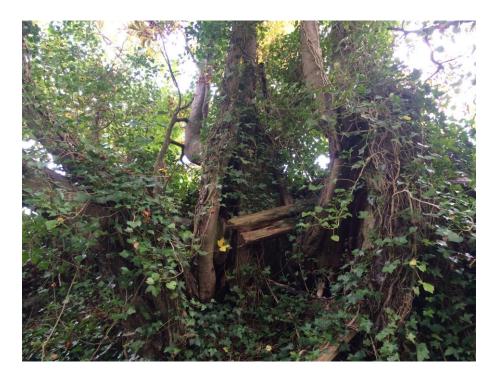
*Figure 3: Detail of the decaying Horse Chestnut T4 recommended for re-pollarding to extend its life.*

- Tree surgery work for purely sound arboricultural reasons has been recommended. This includes re-pollarding the large Horse Chestnut T4, felling a dead Horse Chestnut in Group 1, and removing deadwood from some trees. Other minor pruning work has been recommended.
