STRUCTURAL REPORT
ON
CONVERSION OF
AGRICULTURAL BUILDINGS
AT
ROSECOTE FARM
AISLABY ROAD, EAGLESCLIFFE
STOCKTON ON TEES, TS16 0QR

OCTOBER 2022

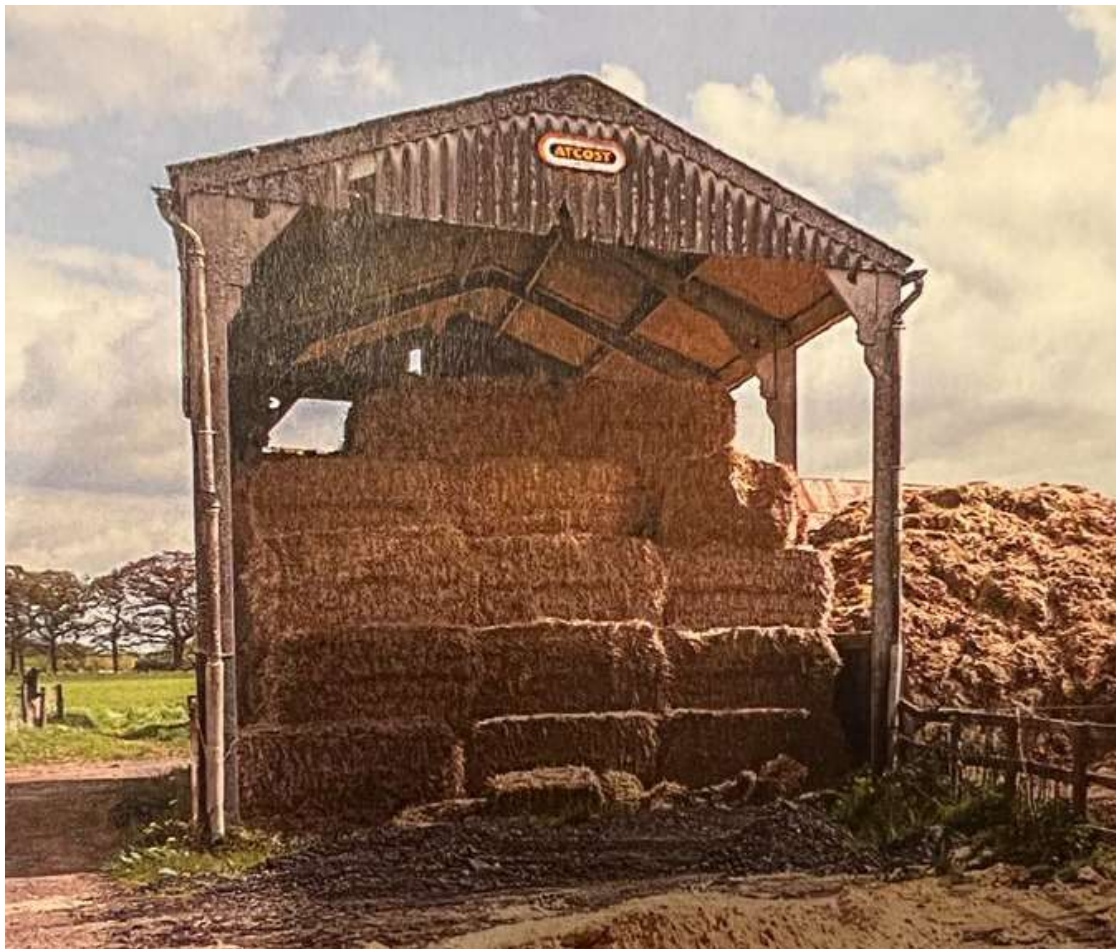
View on Dairy Barn

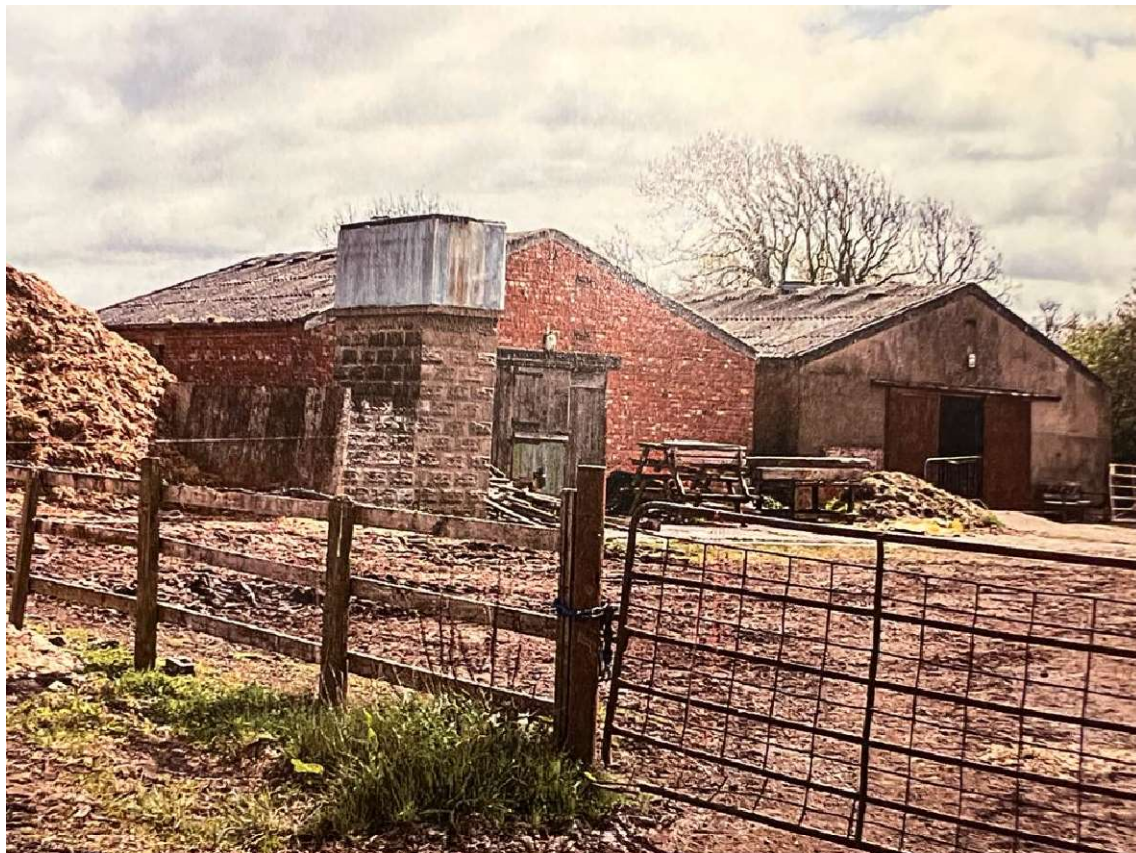
View on Dairy Buildings
