Structural assessment

Pentre Barn

Llangattock Lingoed

T5859– Pentre Barn – Issue 1

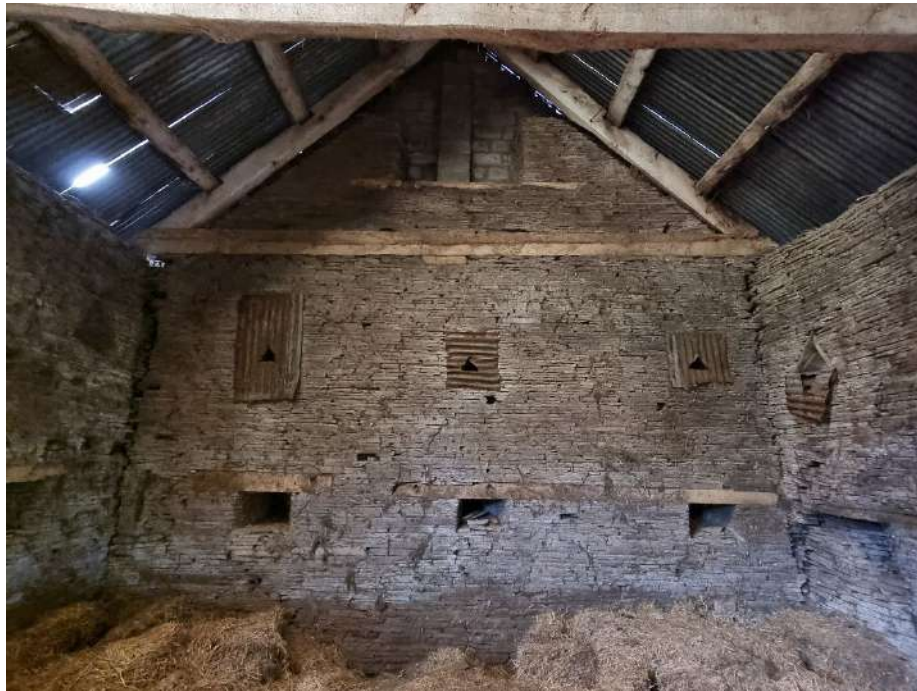
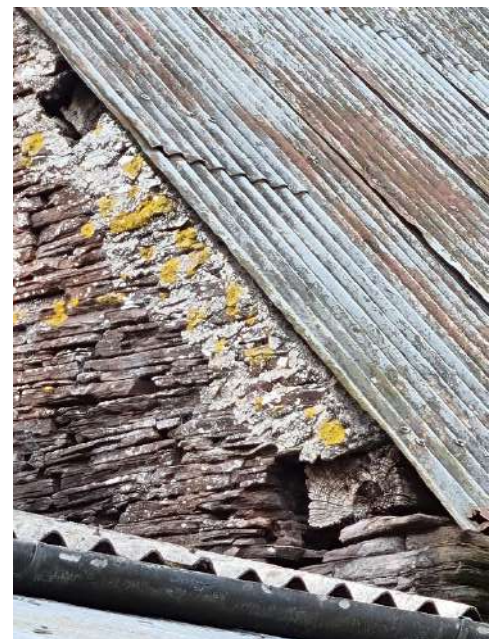
3.2.2 East gable

- The wall incorporates the characteristic triangular upper, and rectangular lower, ventilation openings. In this instance, the upper openings being covered internally with corrugated steel sheeting. The lower openings are tapered on plan and incorporate substantial timber lintels, combined as a bonding timber on the southern half of the wall.
- Junctions with the north and south walls display failure of the dry-stone 'bonding' with significant outward movement of the north wall (see later notes). The gable has also rotated eastwards
- The apex of the east gable has been reconstructed in single-leaf modern blockwork, incorporating a central pier on the line of the ridge. Externally, the purlins have been seen to retreat from the wall face due to outward wall rotation.

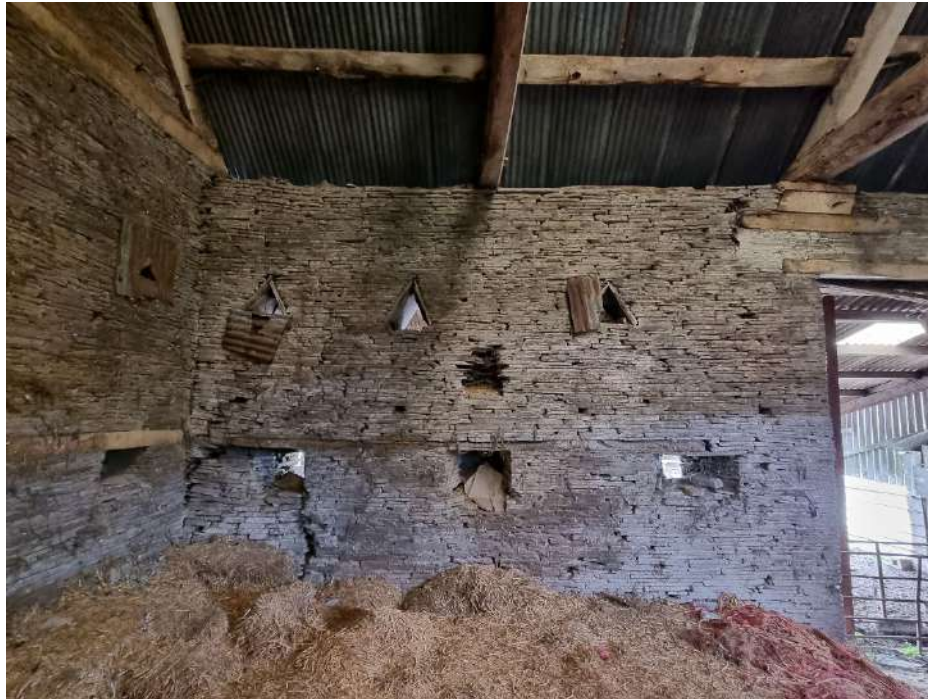
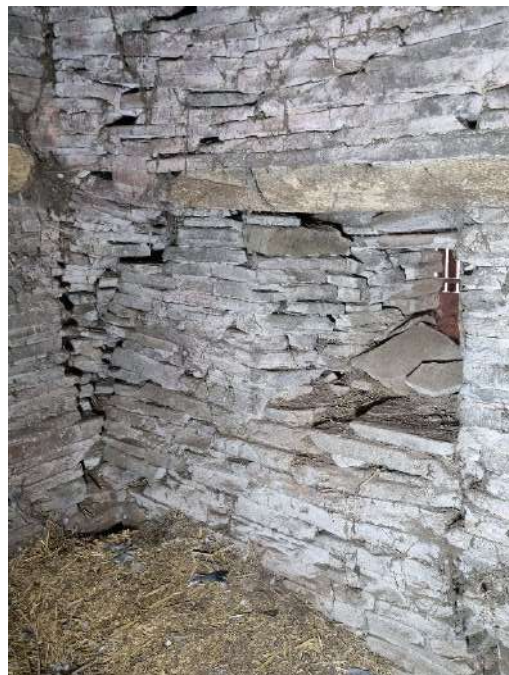
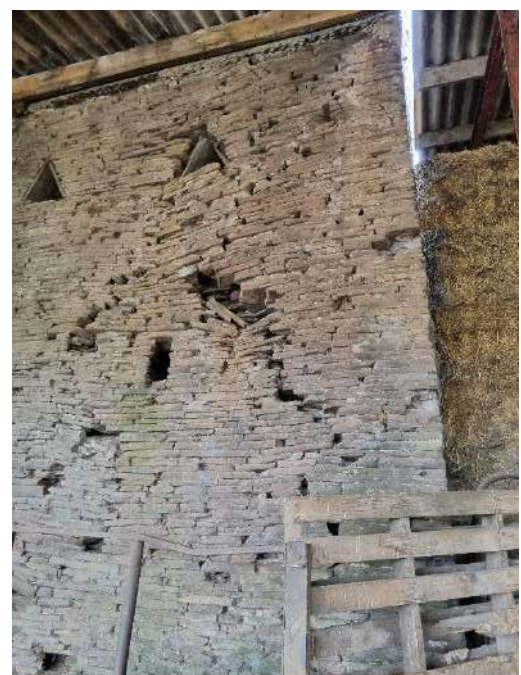
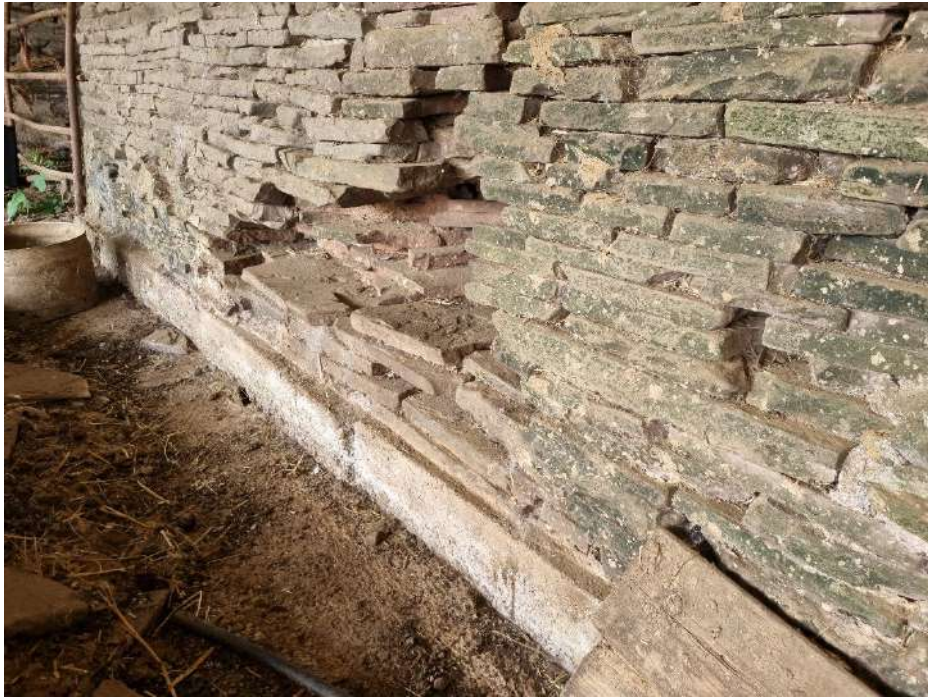
3.2.3 South-east panel

- Significant structural distress is evident in the section of wall, which appears to have resulted from a combination of impact damage and under-mining of founding sub-soil along the external face of the wall, within the modern steel barn.

- In-situ concrete is apparent along the base of the exterior of the wall where levels appear to have been reduced, resulting in loss of support to the foundation of the original wall.
- Wall distortion is so significant that a substantial area of reconstruction will be required.

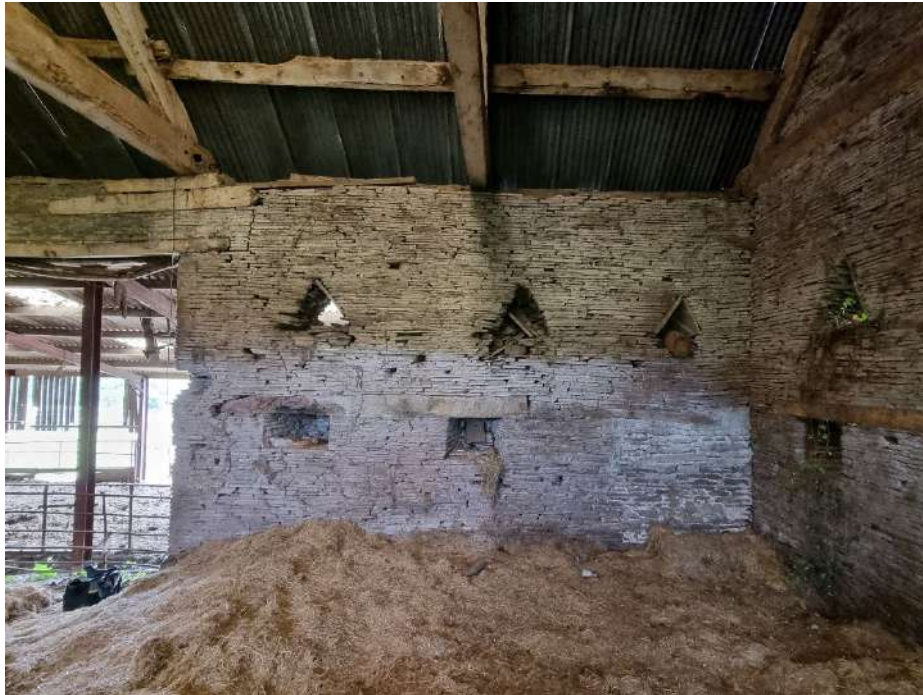
3.2.4 South-west panel

- Significant misalignment of masonry bed joints is evident towards the SW corner, where an area of pointed, possibly rebuilt, stonework can be seen. Foundation related movement appears to have taken place.
- Loss of masonry is apparent around the upper triangular apertures.
- Lintel to the main door opening is deflected and requires is deflected, resulting in a partially reconstructed area of masonry to the eastern bearing, and a vertical crack beyond the western bearing. Replacement or strengthening will be required.

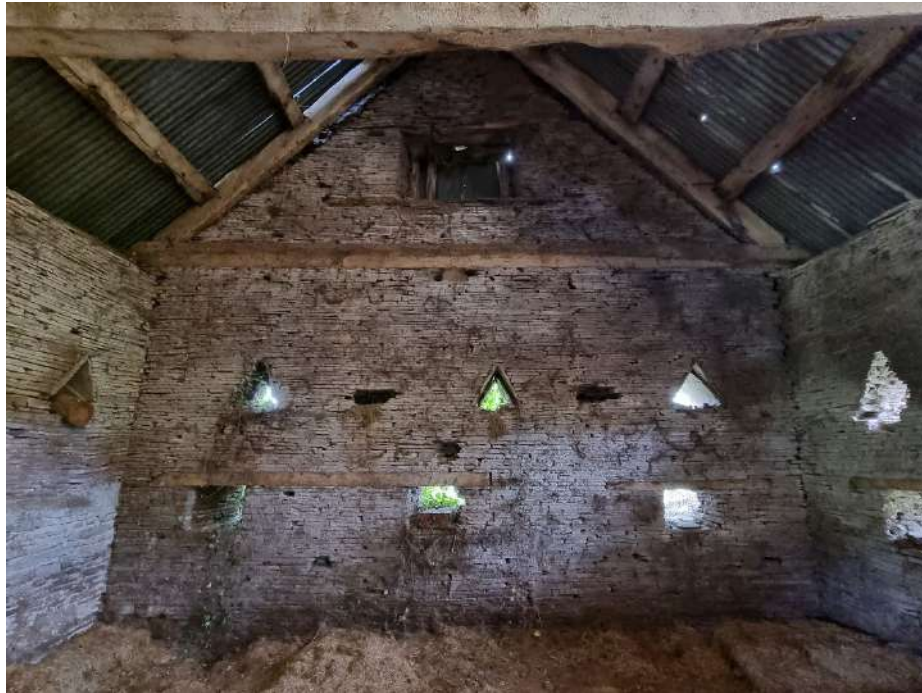
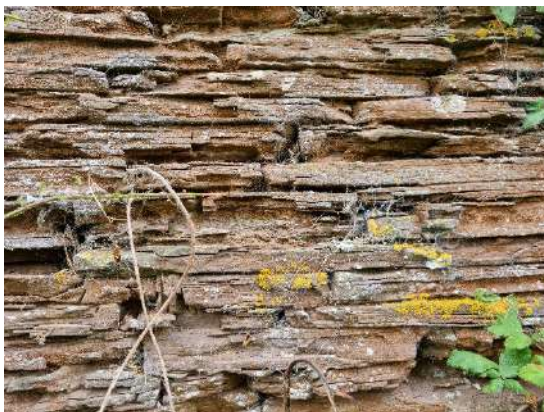
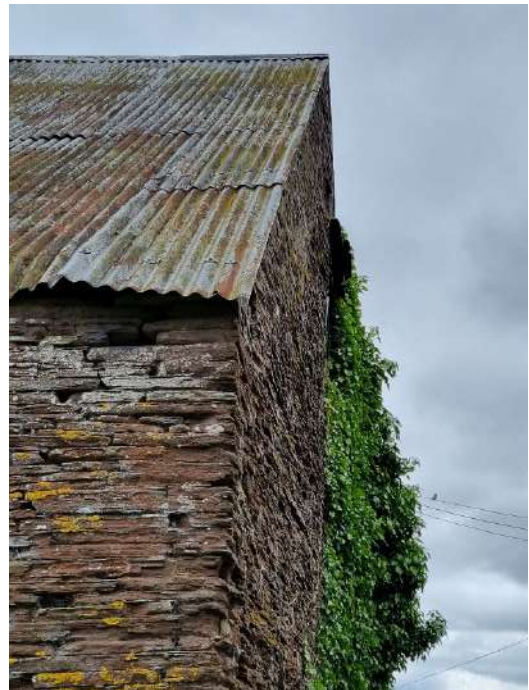
3.2.5 West gable

- The main portion of the gable wall appears relatively perpendicular, but the apex displays an outward lean.
- The exterior face of masonry is in very poor condition as a result of weathering
- Some voiding is present

As a consequence of the above, reconstruction will be necessary in a number of locations. The approximate extent is depicted on appended drawing **T5859-SK02**. In some cases, such as where the facing stonework is badly eroded on the western gable, this could comprise dismantling and reconstruction of partial-thickness rather than the entire wall. The walls are extremely thick (refer to sketch T5859-SK01) which makes this partial replacement viable. This partial-thickness repair also applies to a number of localised problems surrounding ventilation apertures and along verges etc.

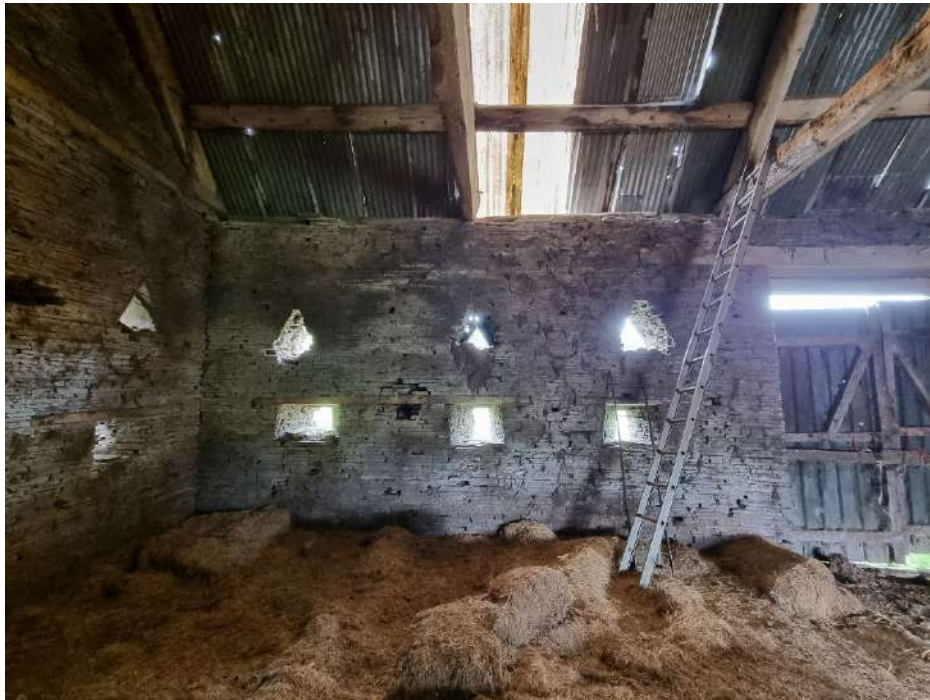
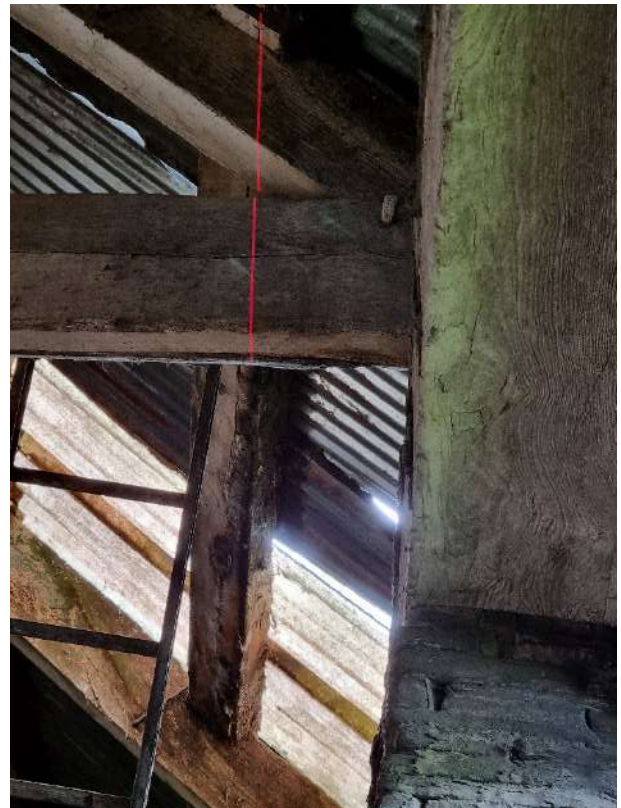
3.2.6 North-west panel

- This wall displays a significant outward lean, which is evident at the high level junction at the NW corner, and worsens towards the east.
- The extent of outward lean was measured at the door reveal, where the base of the vertical laser line shown in the photograph is touching the inner face of the wall. The outward lean is 300mm in a height of 3150mm.

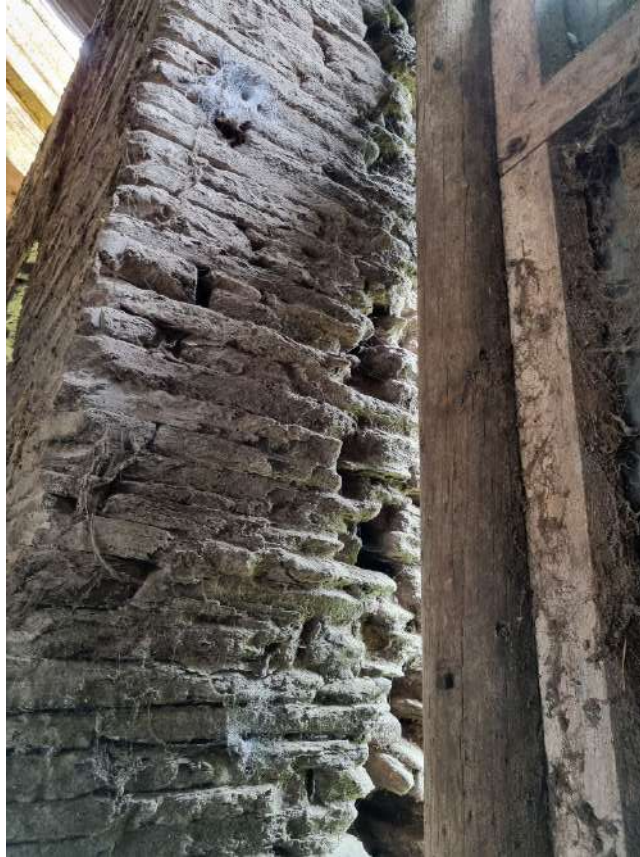
- Delamination (vertical fracturing within the thickness of the wall) is clearly evident at the door reveal and within the ventilation apertures.

- As a consequence of the outward lean, combined with the delamination, a substantial portion of this wall requires reconstruction. The approximate elevational area of reconstruction will be a minimum of 14m².

Where the outward movement is more significant and is combined with delamination, such as along the north wall, reconstruction of the full thickness of the wall will be required.

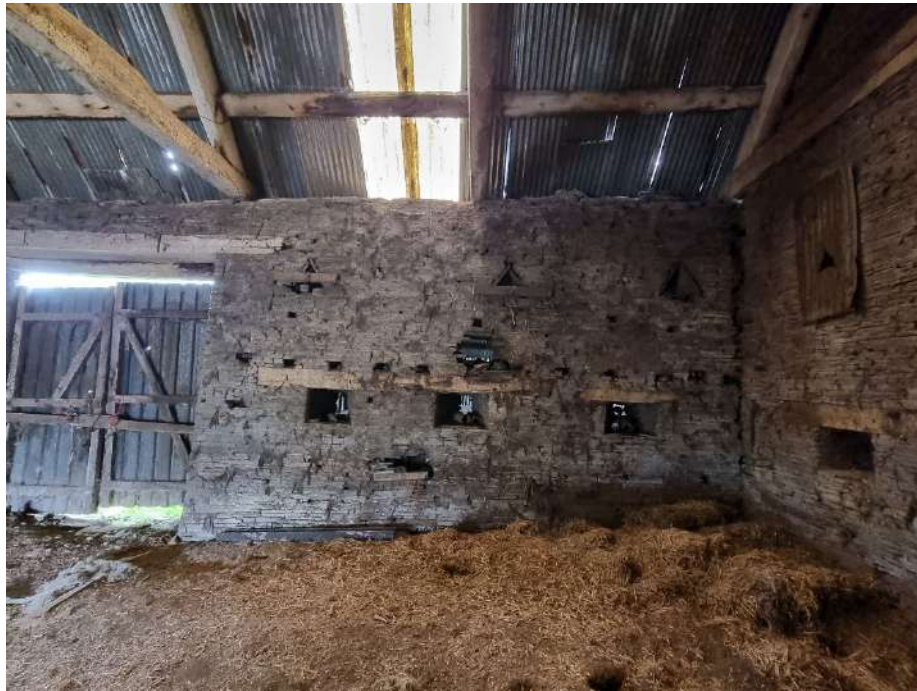
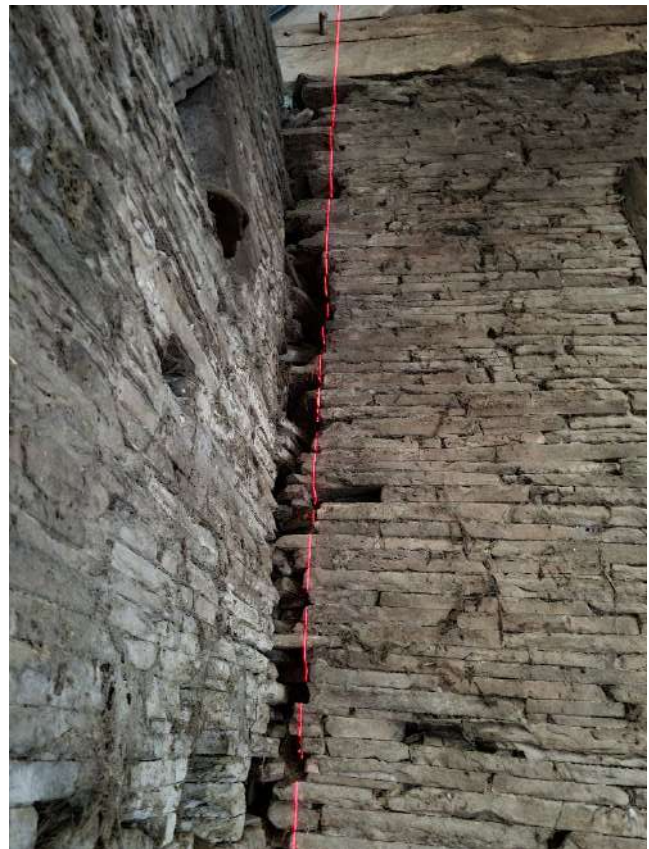
3.2.7 North-east panel

- This wall displays a significant and consistent outward lean, which is evident at the door reveal and the fractured junction at the NE corner.
- The extent of outward lean was measured at the NE corner, where the base of the vertical laser line shown in the photograph is touching the inner face of the wall. The outward lean is 200mm in a height of 3600mm.

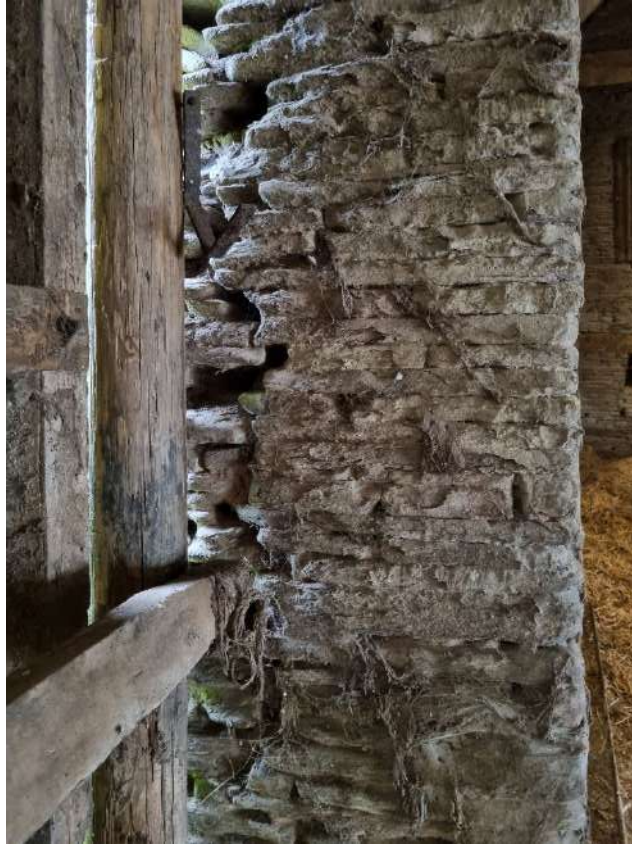
- Delamination (vertical fracturing within the thickness of the wall) is clearly evident at the door reveal and within the ventilation apertures.

- As a consequence of the outward lean, combined with the delamination, a substantial portion of this wall requires reconstruction. The approximate elevational area of reconstruction will be a minimum of 18m².

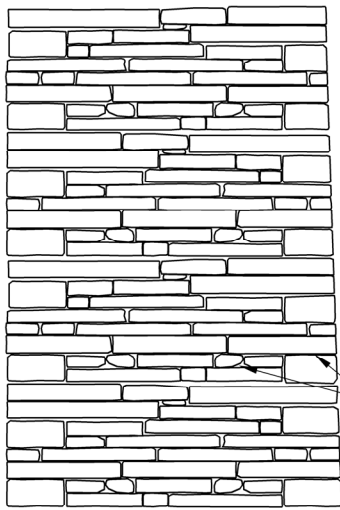
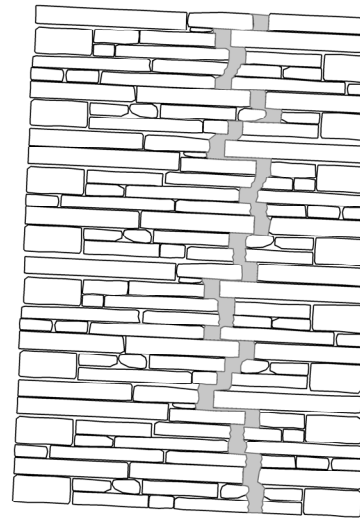
Solid wall - Pentre barn

Difficult to mechanically tie through the wall thickness, with individual stones being only average 40mm thick, and laid largely 'dry' with many voids.

'Dry' or thin mortar beds 3mm-6mm.

This demonstrates the nature of this largely dry-laid wall of solid construction, but adopting thin format stone. This depicts the idealised multiple over-lap bonding through the thickness of the wall.

The structural qualities of the wall are dependent upon the friction between over-lapped stones. The thin nature of the tying stones makes these susceptible to fracture and consequential delamination.
