## **Proposed conversion of barns to two dwellings at Winston Court, Llanvetherine**

### **Structural survey**

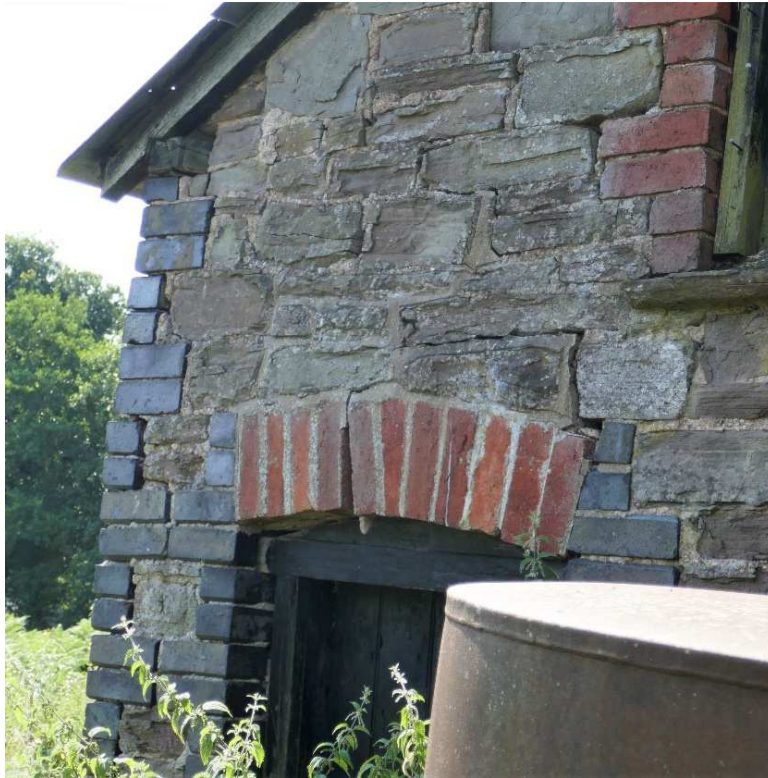
The exception to this is the Fowl House on the eastern end of the range. This has sagging arches to both windows and the door as well as disrupted quoins at both corners. In addition the roof structure cuts across the gable end window of the Cart Shed and sags due to lack of fixity to the wall across the opening.

1. The doorway and quoins of the Fowl House require rebuilding

The repairs include some small areas of rebuild or repointing to the external stonework, rebuilding of brickwork to the Fowl House, stitching some minor cracks and replacing some timber lintels.

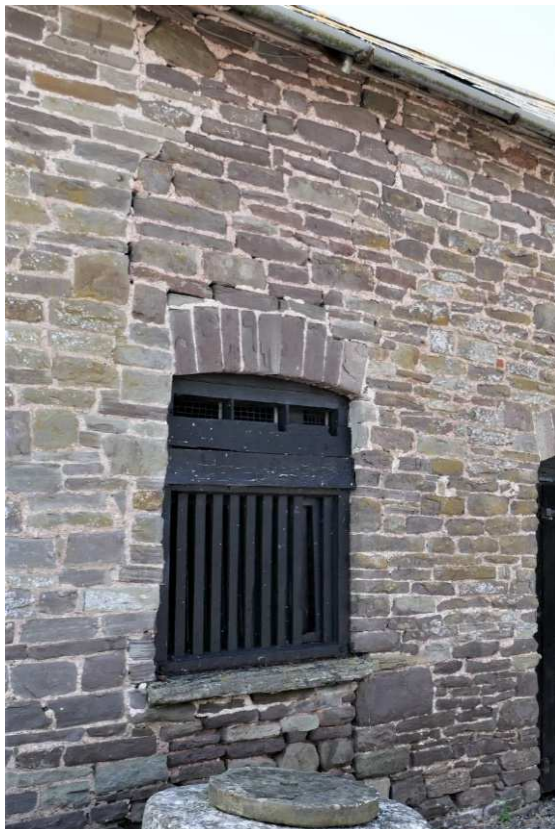
2. The north side of the Cider House requires repointing

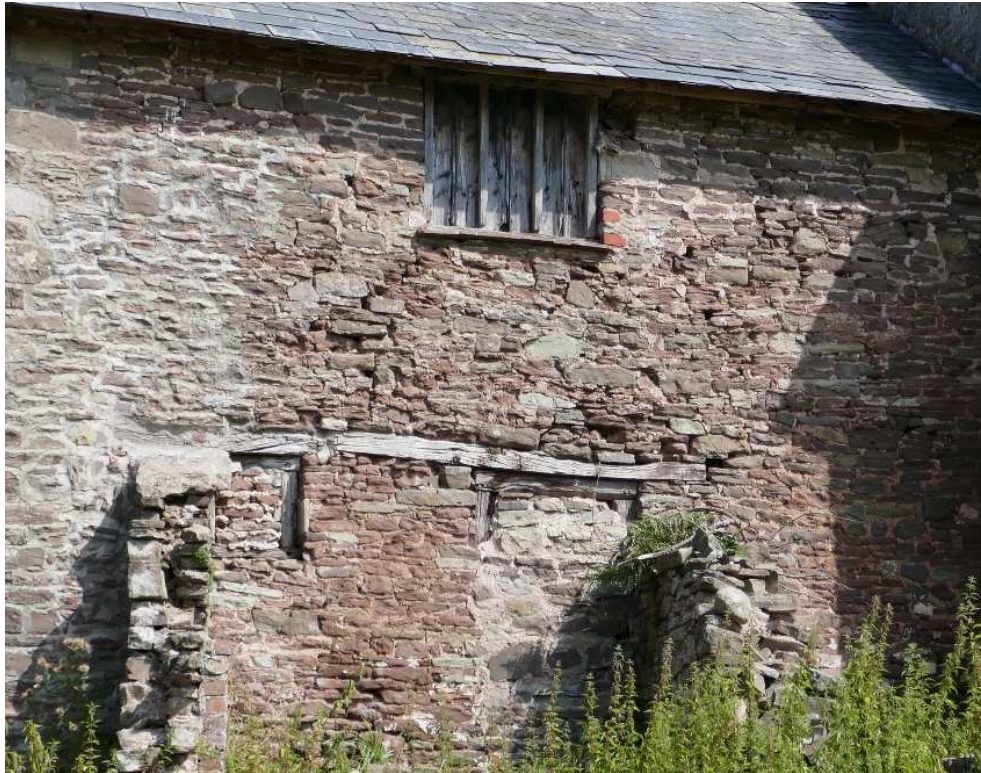
The remains of animal pens abut the south wall of the Cider House. It is understood that these will be retained as landscaping features and as such do not come under the scope of this survey. The south wall of the Cider House requires some rebuilding and the animal pen walls will have to be reduced in height to allow this.

3. The south side of the Cider House requires rebuilding of the outer skin of stonework

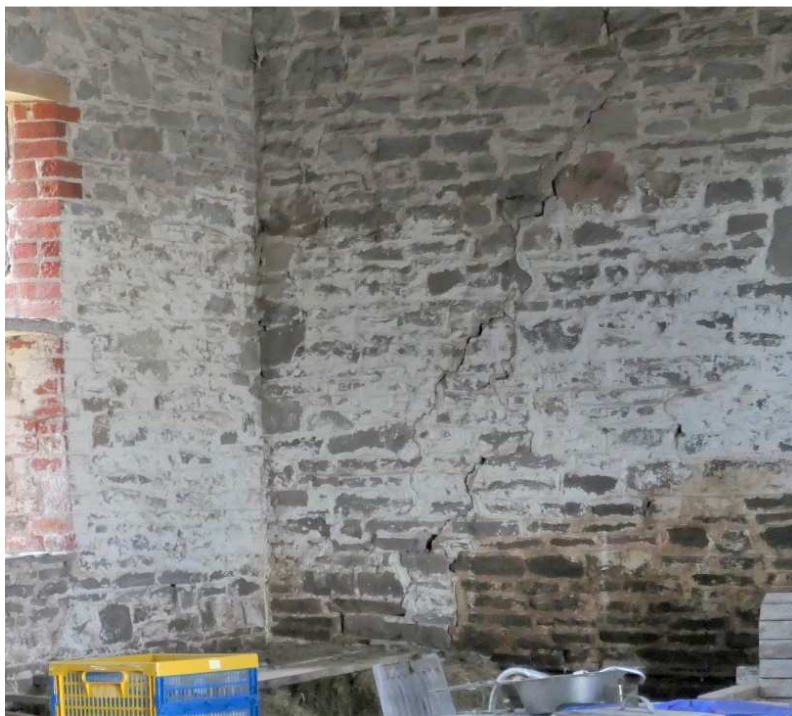
4. The internal cracking in the Threshing Barn

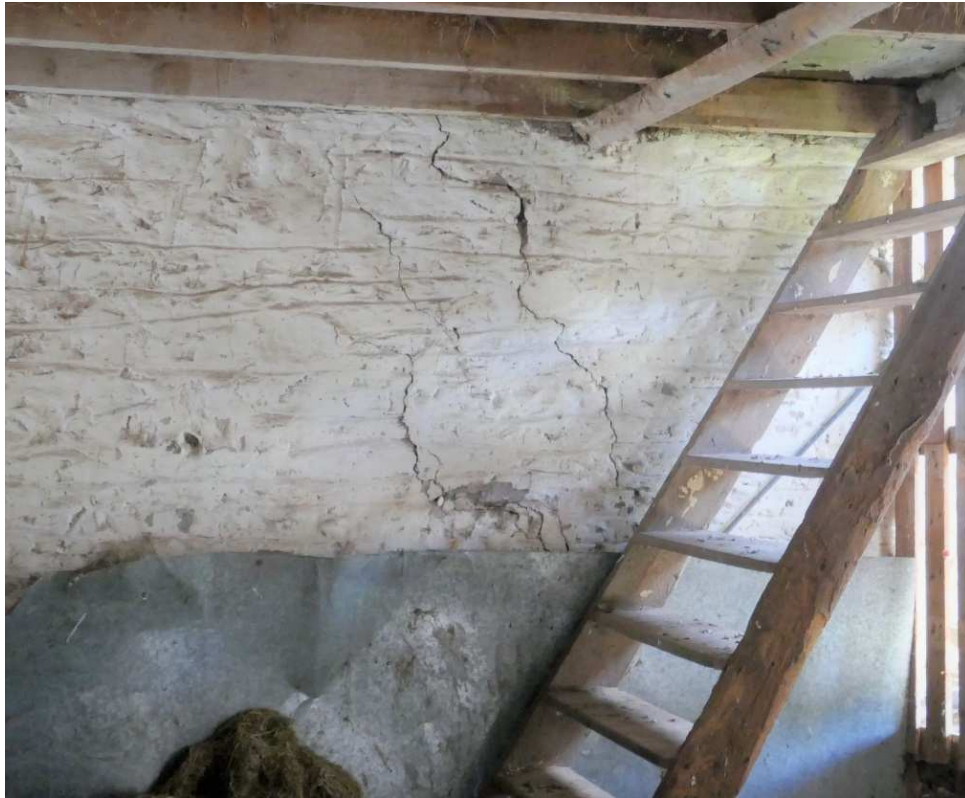
5. The same crack on the Cowhouse side

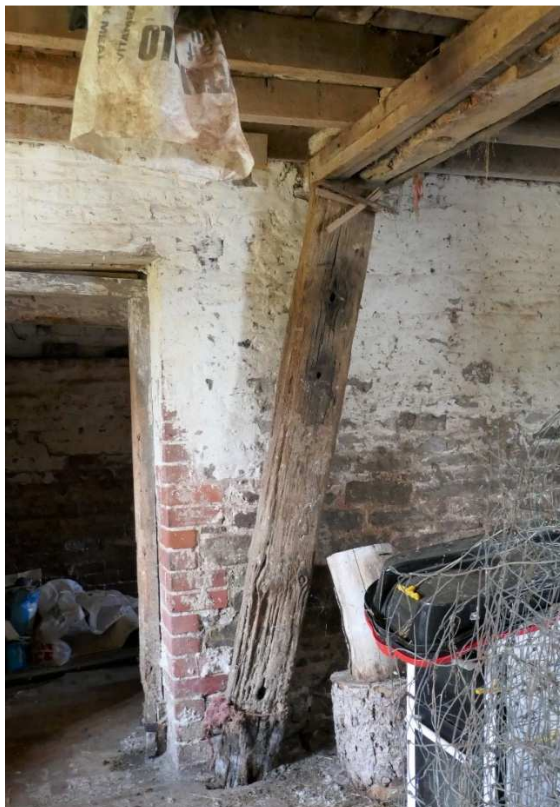
6. Defective timberwork in the Cowhouse

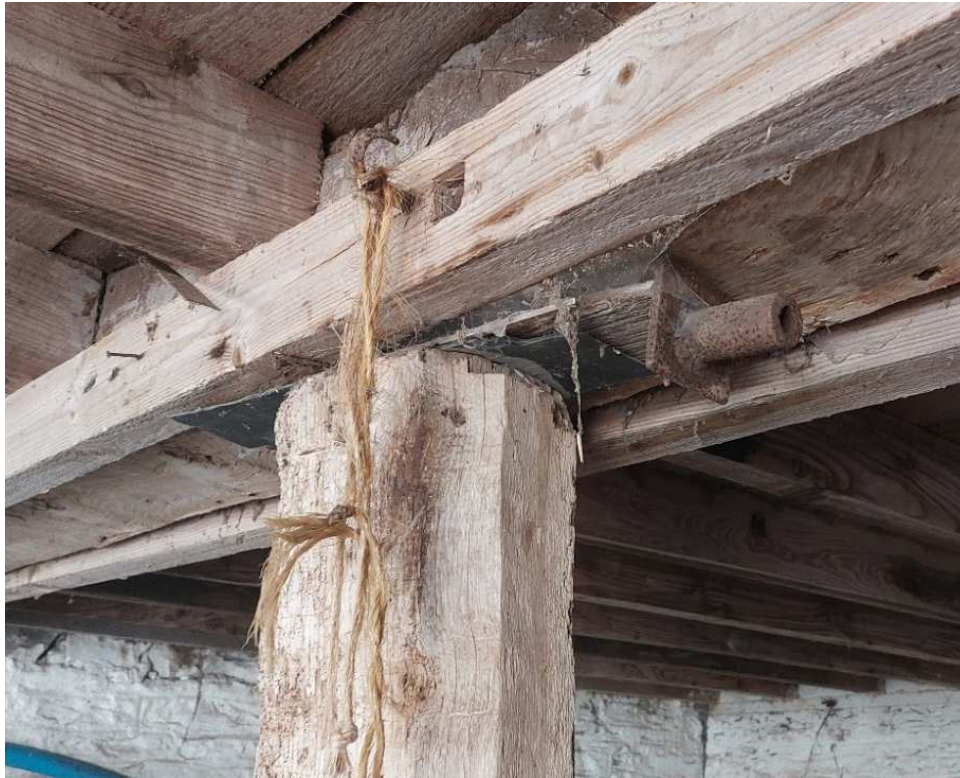
7. The beam across the cart shed with nailed on bearers for the floor joists on each side. Note the steel packer.

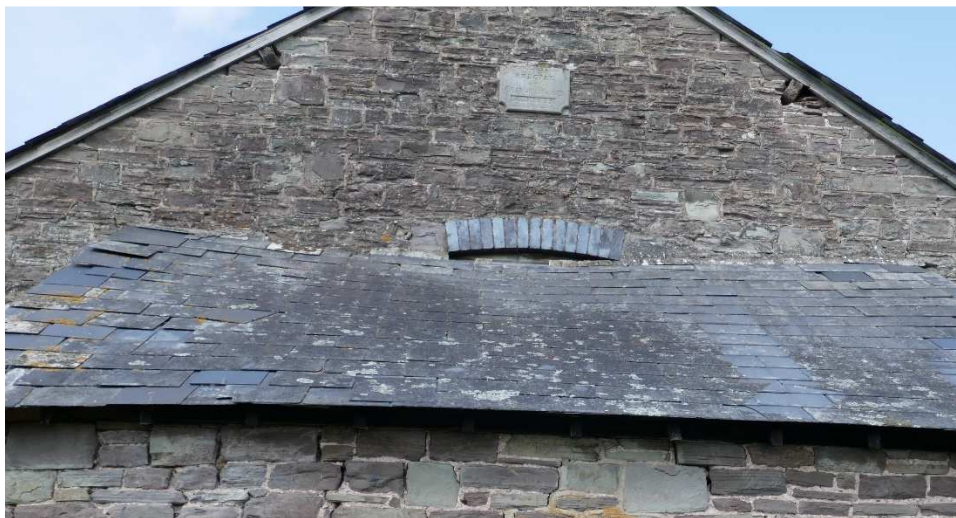
8. The Fowl House roof crossing the hayloft window

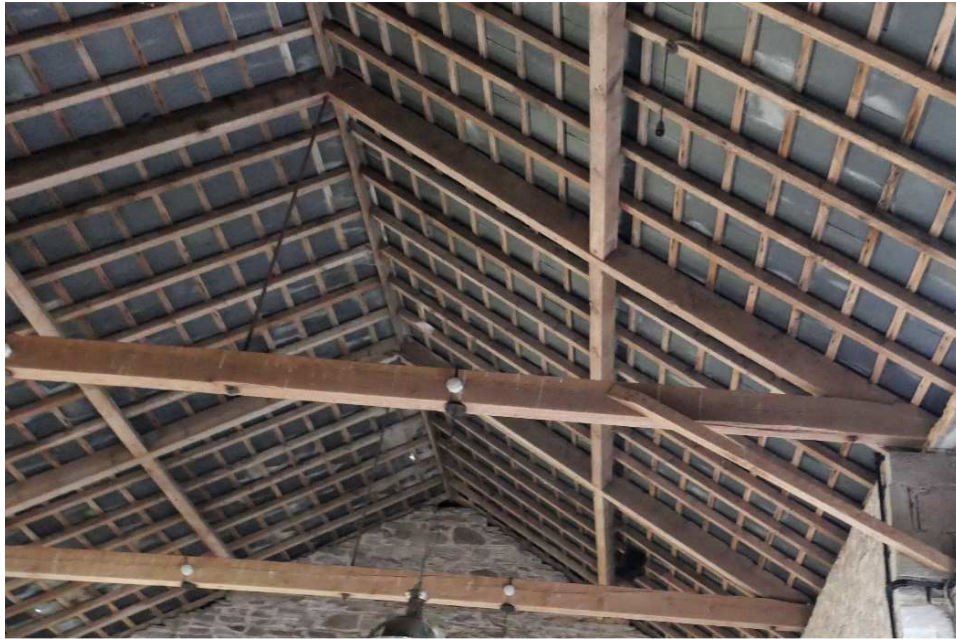
Regarding the other roof structures these are all in good condition but comprise slender timber members. These will need to be strengthened in order to support the additional weight of insulation, ceilings etc.

9. The undersized rafters and trusses in the Threshing Barn

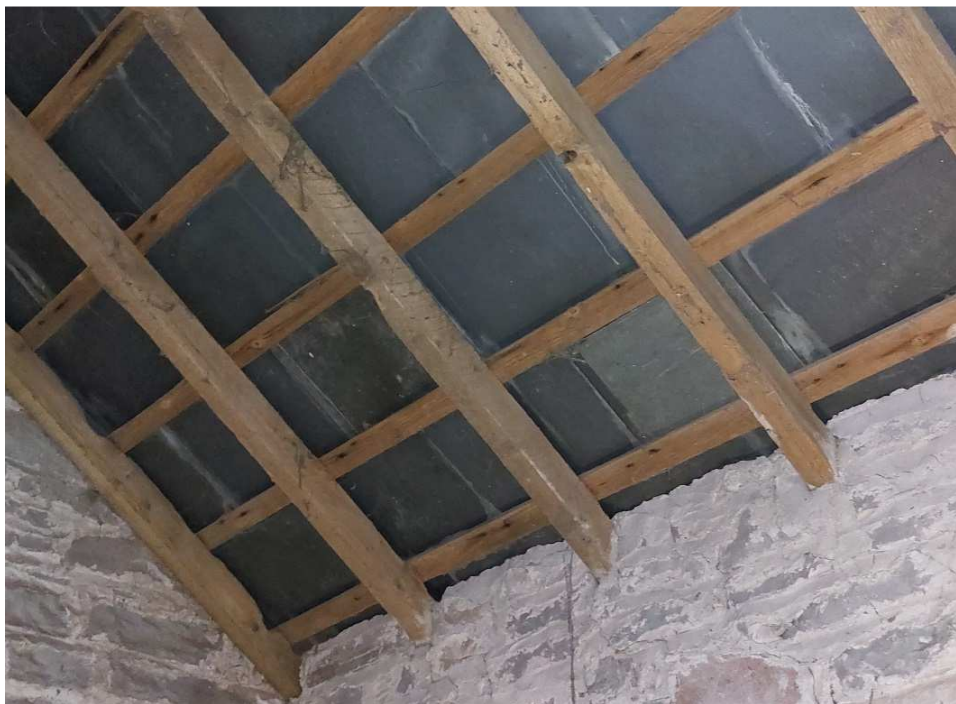
10. There are similar sized rafters in the Cart Shed

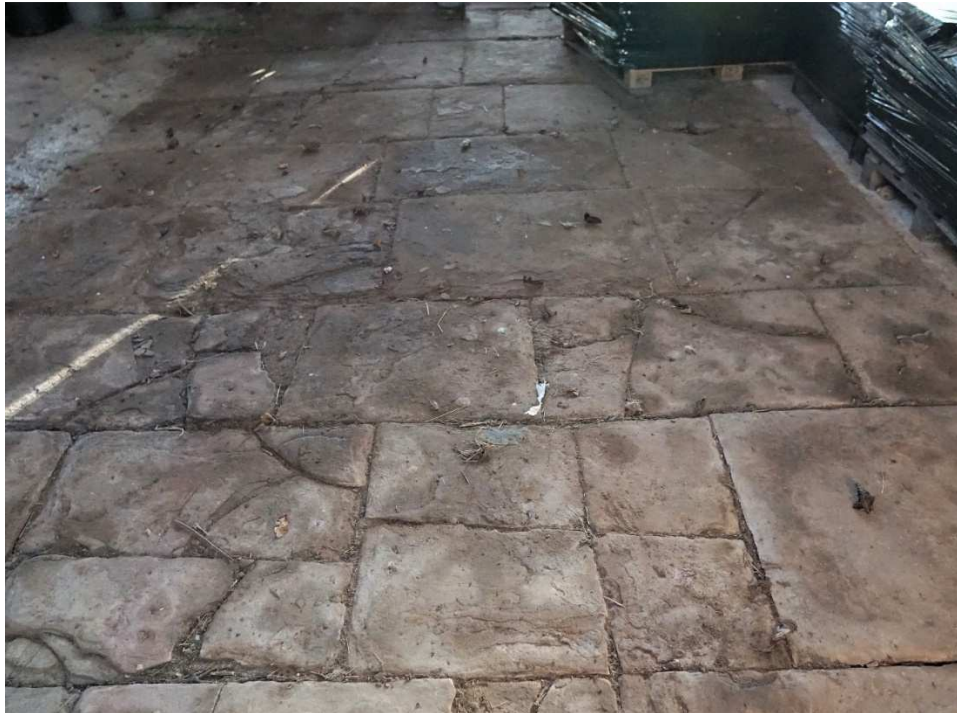
11. The flagstone central cartway in the Threshing Barn

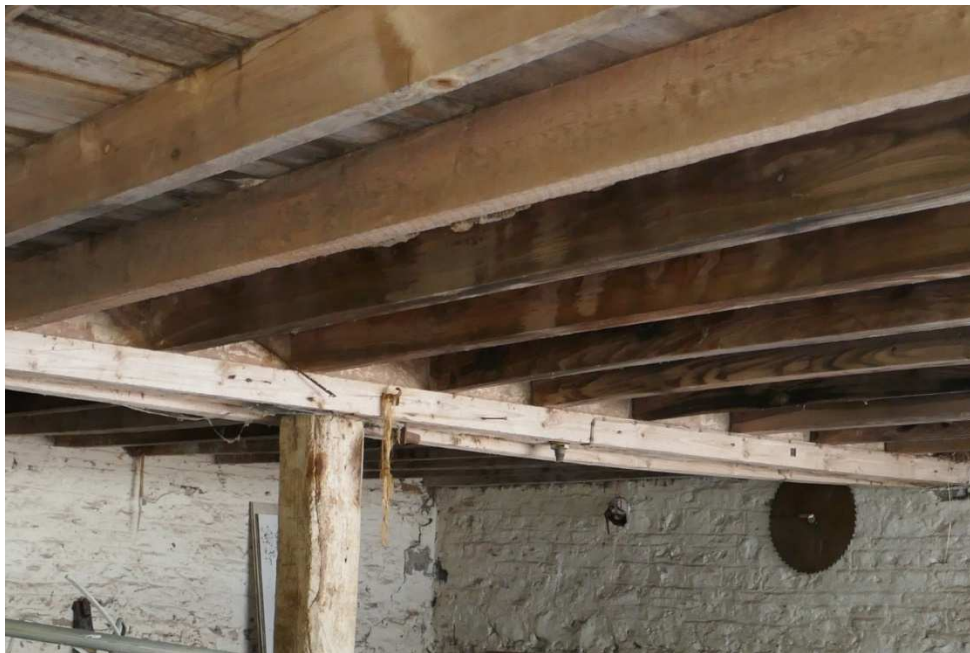
12. The patched structural timbers in the Cart Shed

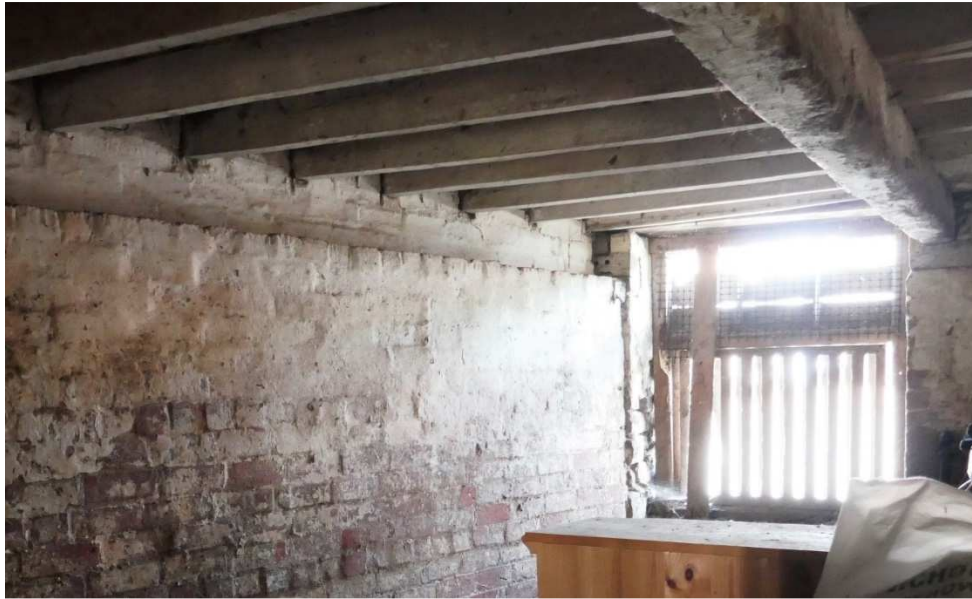
There are intermediate floor structures in the cart shed, cow barn and cider house but none of these are serviceable and all of them will need repairs to structure and the replacement of floorboards.

13. The beams and floor joists in the Cowhouse

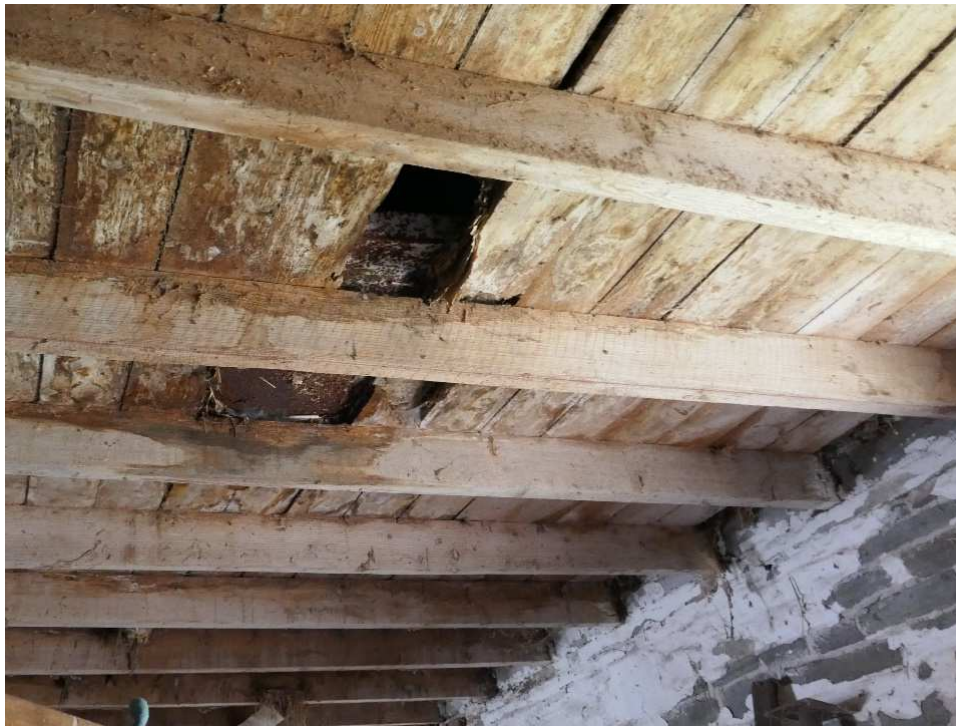
Guttering is provided to the roof on the yard side but not to those facing the field. Downpipes are either missing or damaged leading to some localised damp patches on walls and floors.

14. Damp affecting floorboards and joists in the Cow house

Provision of rainwater gutters and downpipes will be required all around along with a scheme of land drainage to the perimeter of the building.

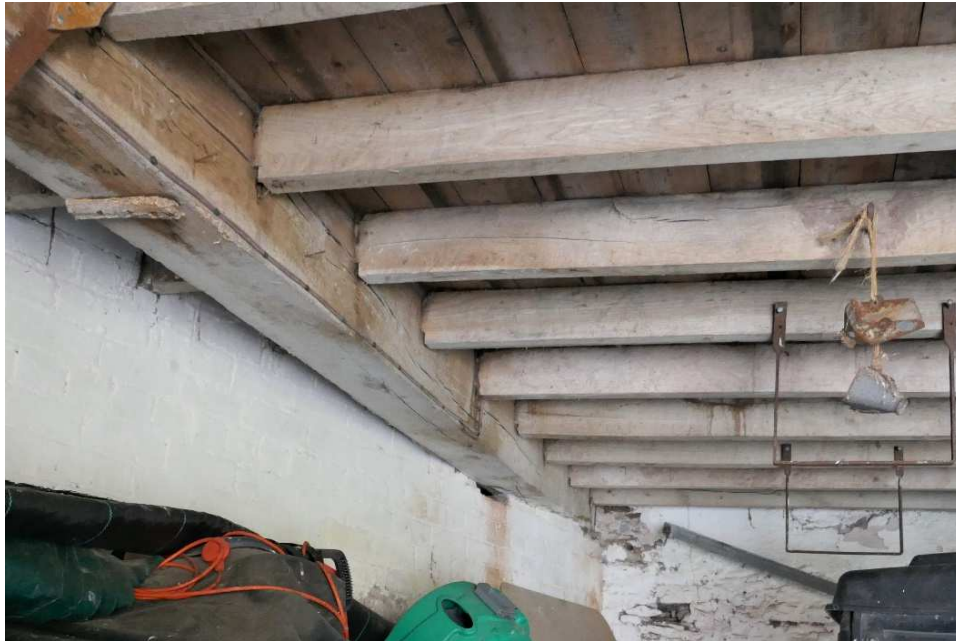
15. The floor joists and beams in the Cider House
