Structural Inspection

**Inspection of Masonry and Timber-Framed Piggery Building for Permitted
Development at**

**Rosamondford Farm,
Perkins Village,
Exeter,
EX5 2JG**

Reference R220821/SI/00

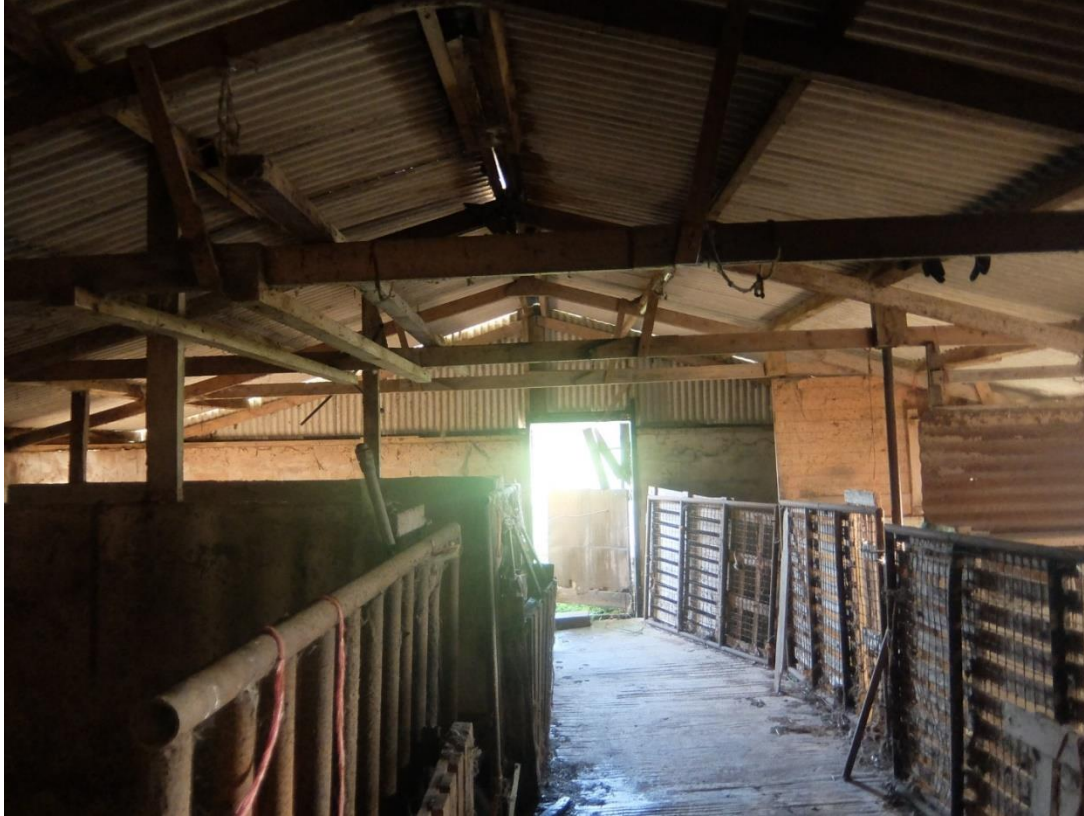
2.2.1 This section of the building consists of blockwork masonry walls up to eaves level. There is timber studwork supporting corrugated fibre cement sheeting above the eaves within the right side gable wall.

2.2.2 The roof structure consists of timber trusses at quite close centres supported on the front and rear walls. The corrugated fibre cement roof sheeting is supported by timber purlins spanning between the trusses.

Internal view within left hand section

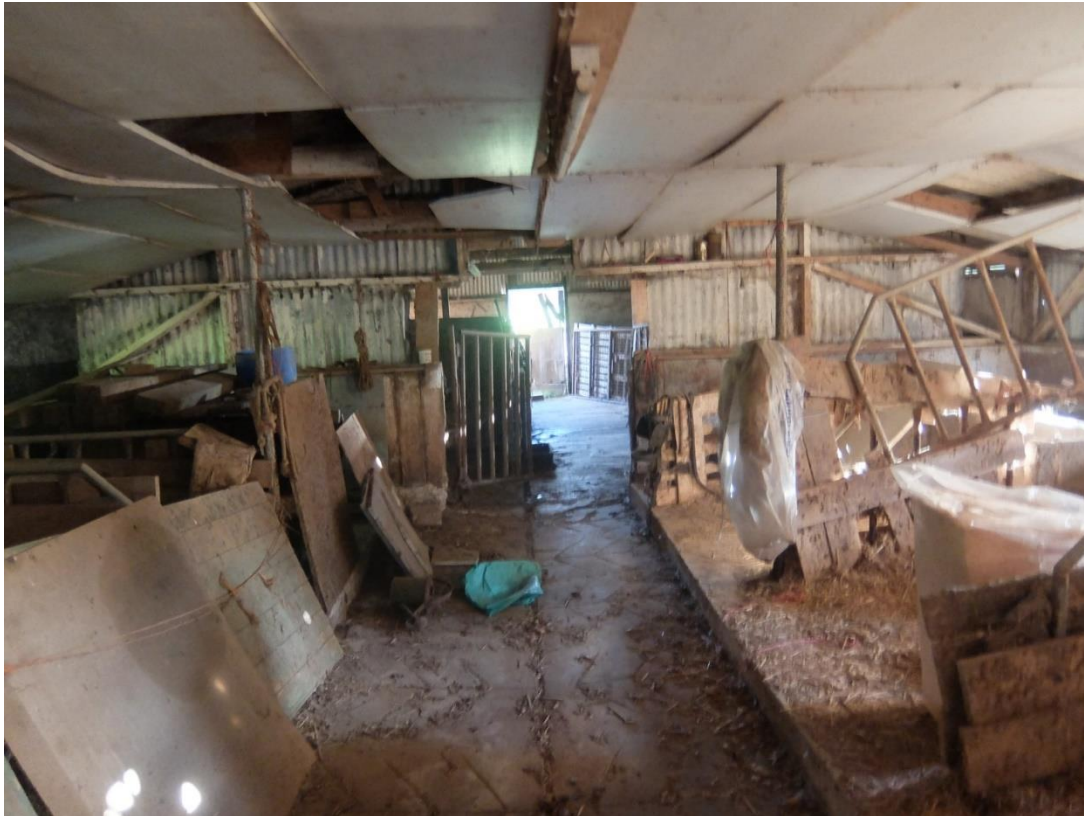
- 2.3.1 This section of the building consists of a low-level blockwork plinth with timber studwork walling above clad externally with corrugated steel sheeting.
- 2.3.2 The roof structure consists of timber trusses at quite close centres supported on the front and rear walls. The corrugated fibre cement roof sheeting is supported by timber purlins spanning between the trusses. The roof structure is partially hidden by insulation fixed to the timber frames.
- 2.3.3 There are timber studwork dividing walls to the attached sections.
- 2.3.4 There is a concrete slab throughout with steps up into the pens.

Internal view within second section from the right hand end

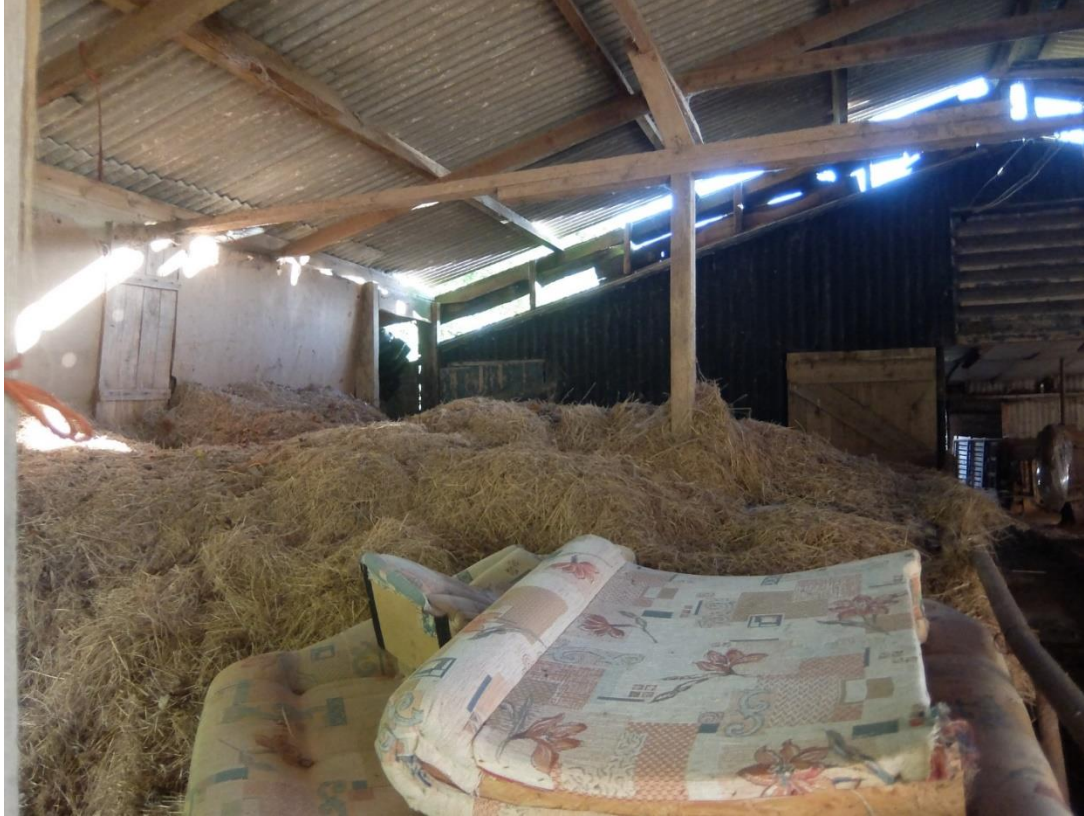
- 2.4.1 Within this section of building the eaves levels are higher than the remainder of the building. The front wall consists of a blockwork plinth with timber studwork clad with horizontal boarding.
- 2.4.2 The rear wall consists of blockwork masonry to just below eaves level with a substantial eaves beam.
- 2.4.3 There are access openings opposite each other within the front and rear walls.
- 2.4.4 There is a blockwork masonry internal storage area within this section.
- 2.4.5 The dividing wall to the section to the left side section consists of blockwork masonry up to eaves level with timber studwork above.
- 2.4.6 The roof structure consists of timber trusses supported by internal timber posts and blockwork wall plus on the front and rear walls. There are timber purlins supported by the trusses and left side dividing wall. The roof is covered with corrugated fibre cement sheeting.

Internal view with central section

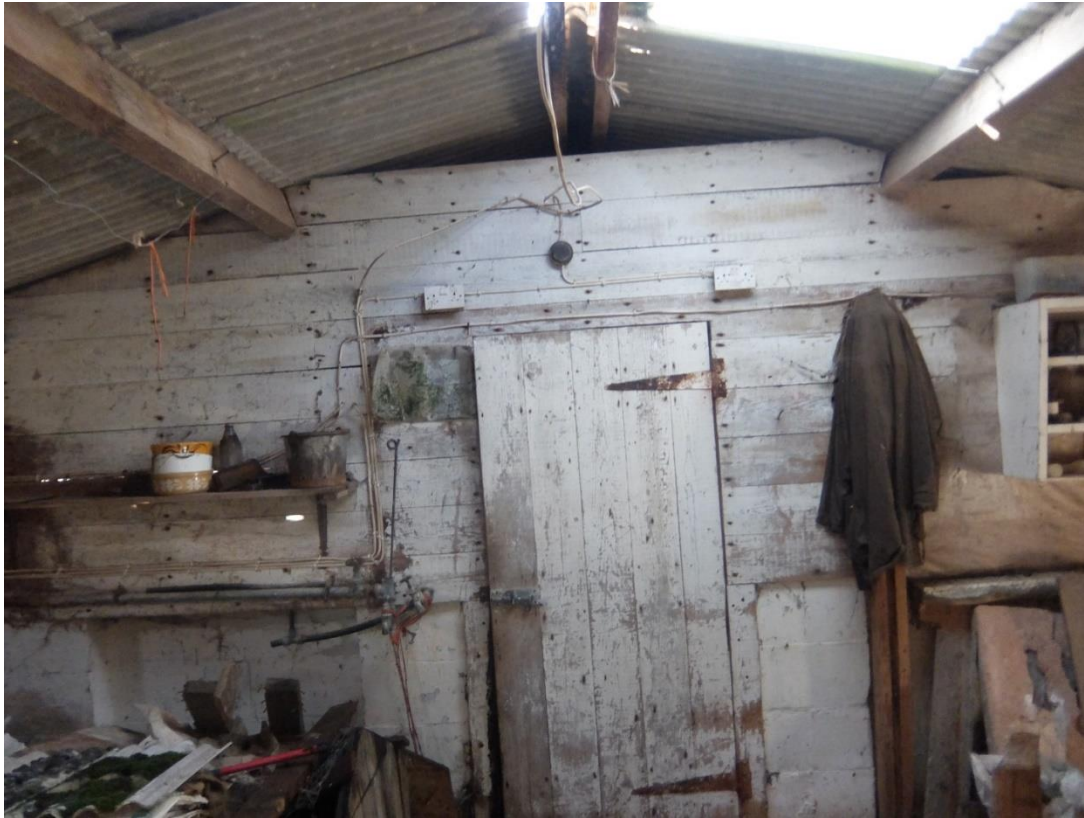
- 2.5.1 This is a narrow portion of the building used for storage.
- 2.5.2 The front and rear walls consist of blockwork masonry walls up to eaves level with intermittent externally projecting blockwork masonry piers.
- 2.5.3 The dividing wall to the left side section consists of blockwork masonry with timber studwork above.
- 2.5.4 The roof structure consists of timber purlins supported by the dividing walls. The roof is covered with corrugated fibre cement sheeting.

Internal view within fourth section from the right hand end

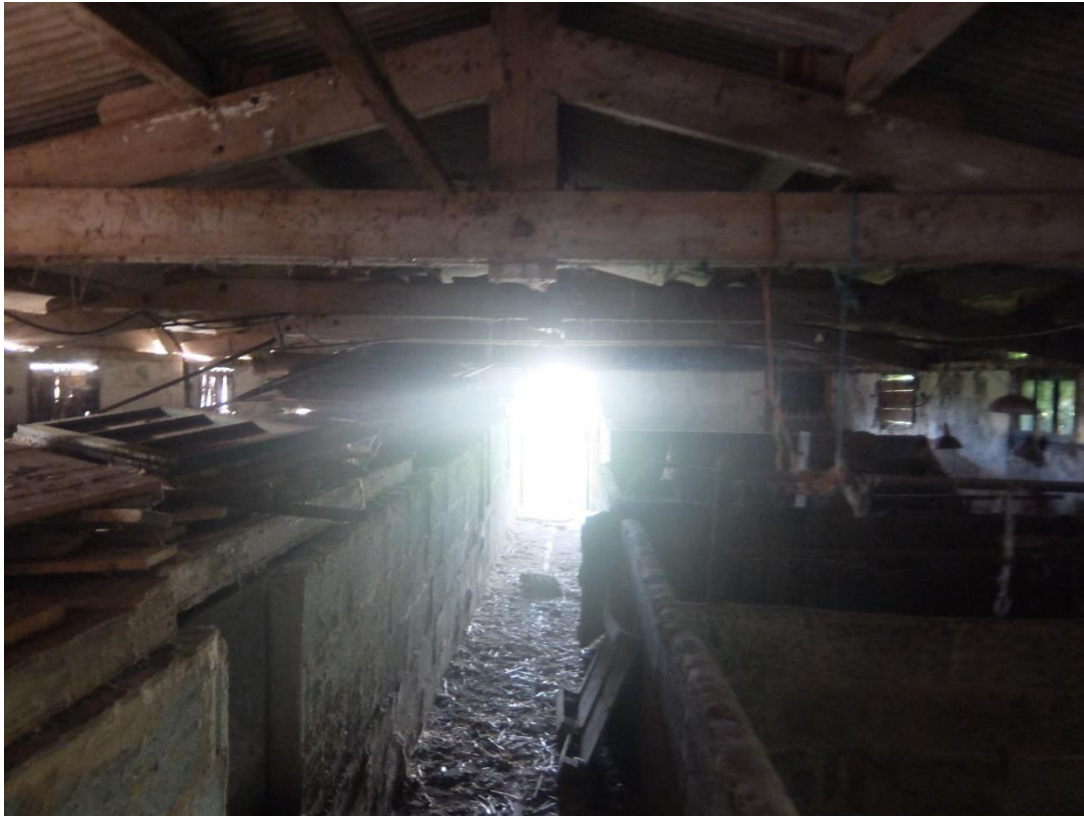
- 2.6.1 The front, rear and left side gable perimeter walls consist of blockwork masonry up to eaves level with intermittent externally projecting masonry piers. There is timber studwork above the left side gable wall clad with corrugated steel sheeting.
- 2.6.2 The roof structure consists of substantial timber trusses with steel scissor tie rods between raised collar timber ties. There are timber purlins supported by the trusses and gable wall covered with corrugated fibre cement sheeting.
- 2.6.3 There is a concrete slab throughout with steps up into the pens. The pens have low level blockwork masonry to all sides.

Internal view within left hand end section

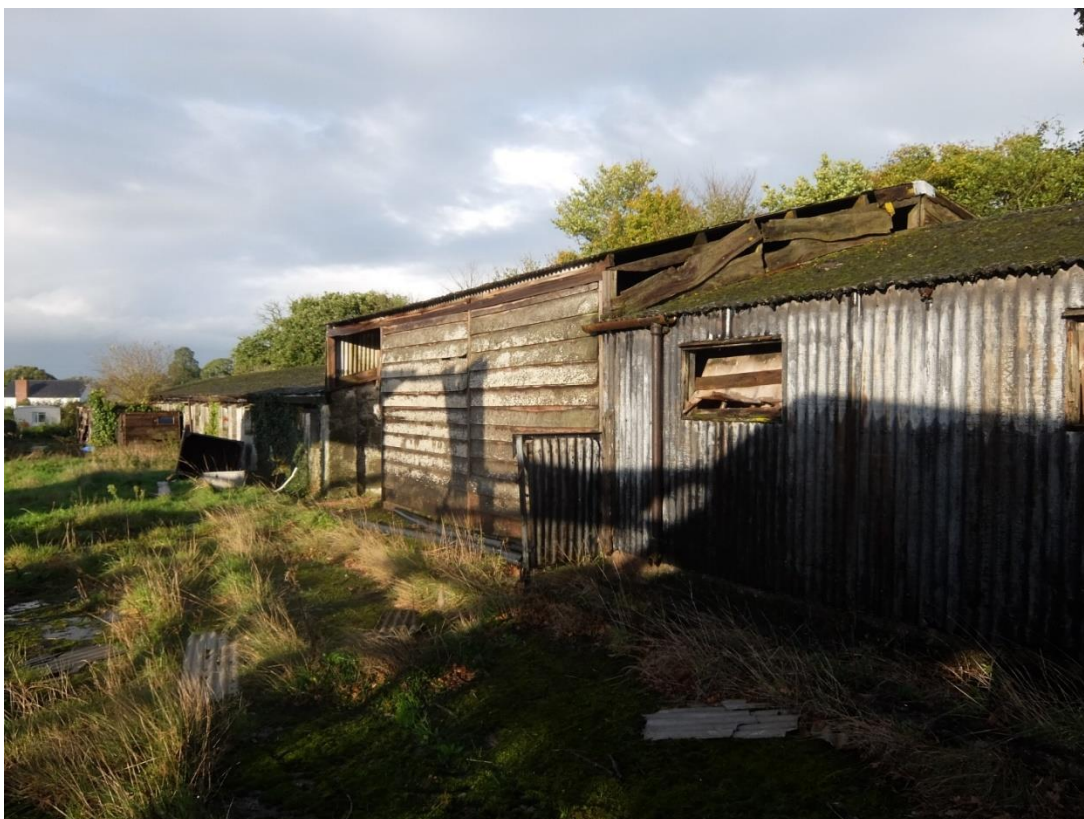
Part of front wall

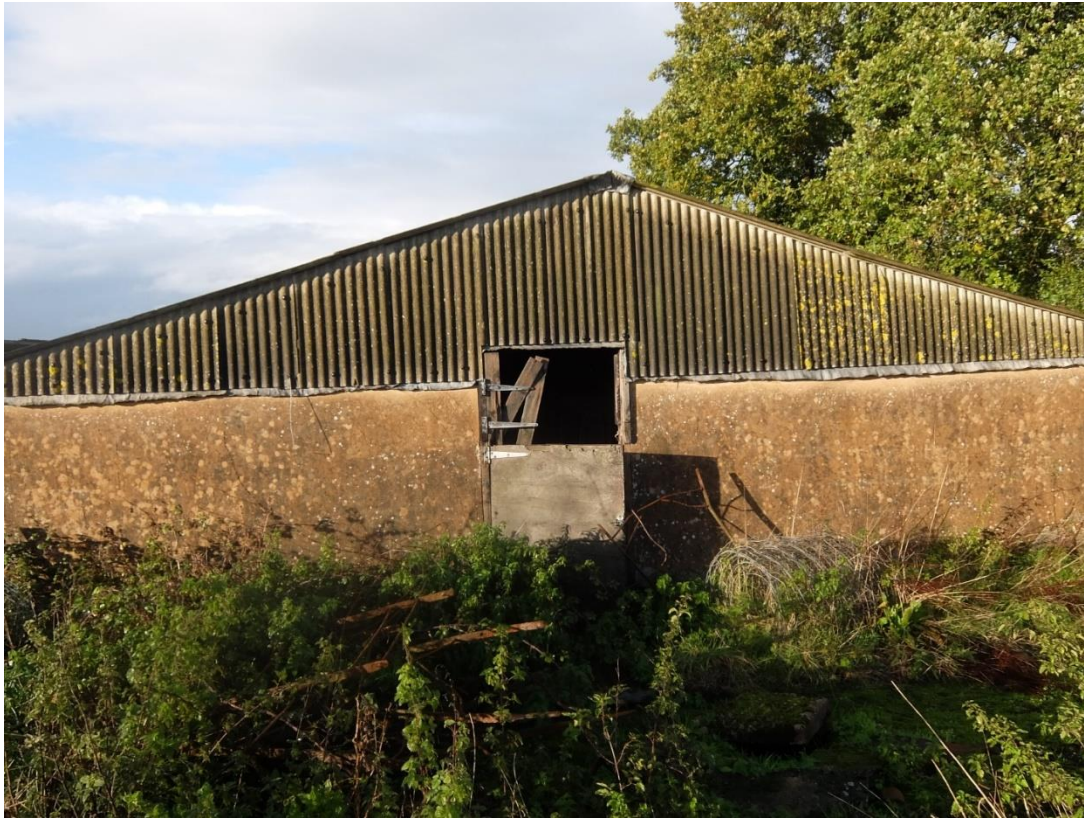
Right hand gable wall

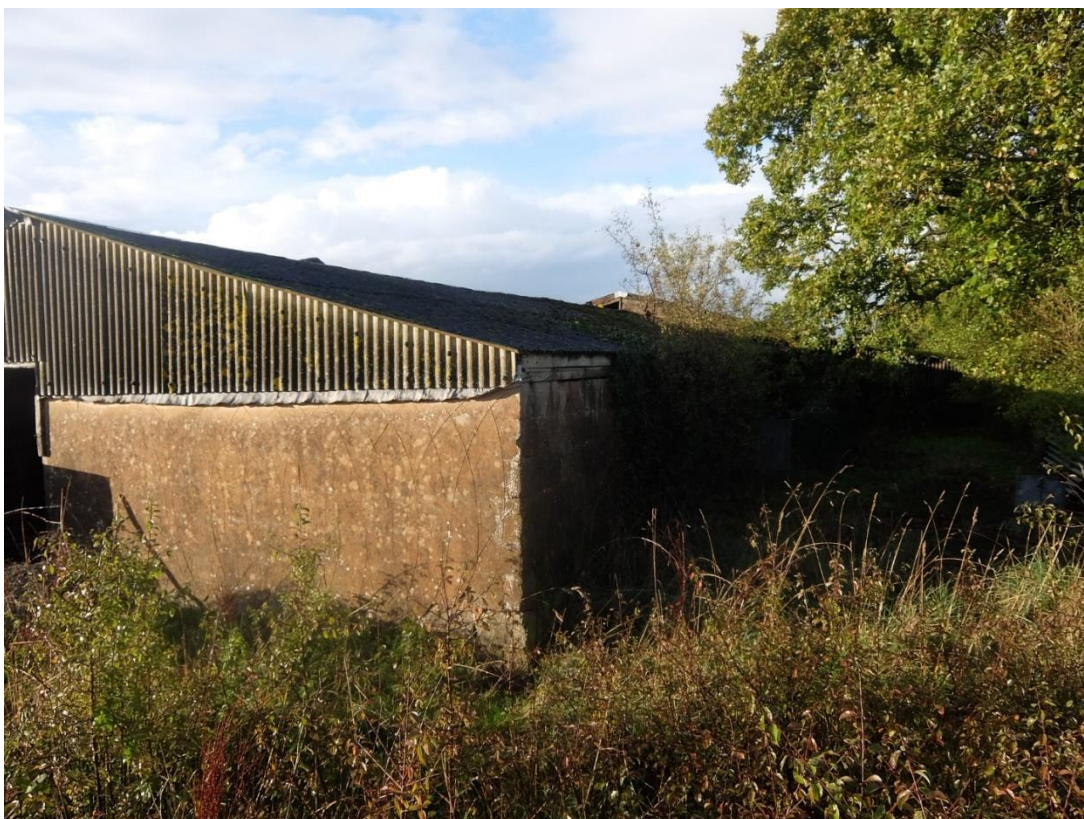
Part rear and right side

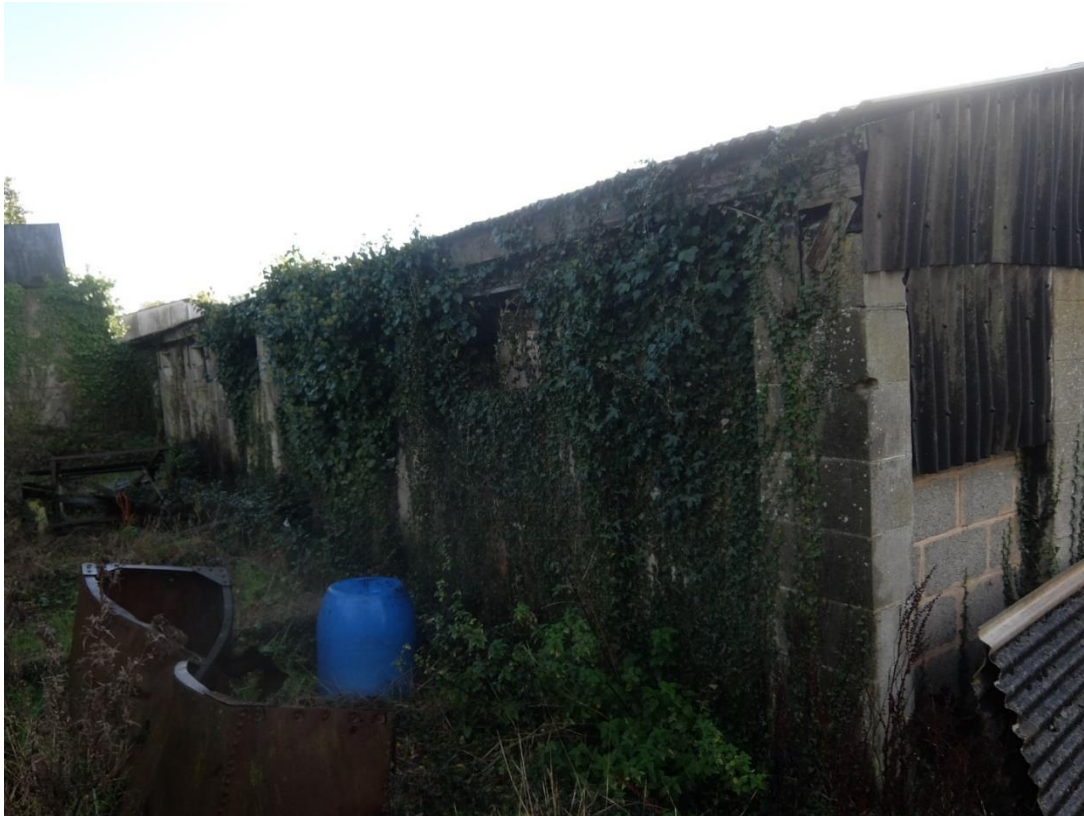
Part rear from left hand end

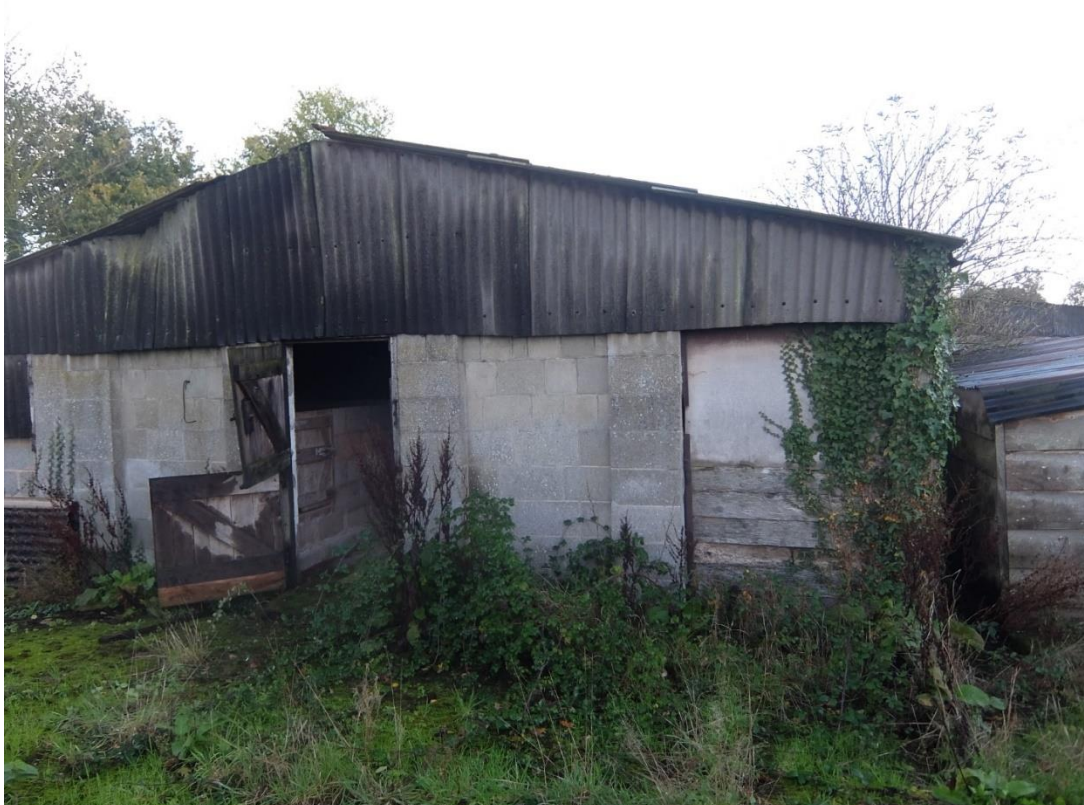
Left side gable wall
