**APPRAISAL OF BUILDING**

**PROPOSED CHANGE OF USE AND CONVERSION**

**THE COLD STORES  
BUTLERS FARM  
HORSESHOES LANE  
LANGLEY  
ME17 3JY**

REPORT ON:	The Cold Store, Butlers Farm, Horseshoes Lane, Langley Heath, Maidstone, Kent ME17 3JY	PROJECT NO:	2223
INSPECTOR:	M McLaren	SHEET:	1 of 8
		DATE:	11 10 2022 (11.00am)

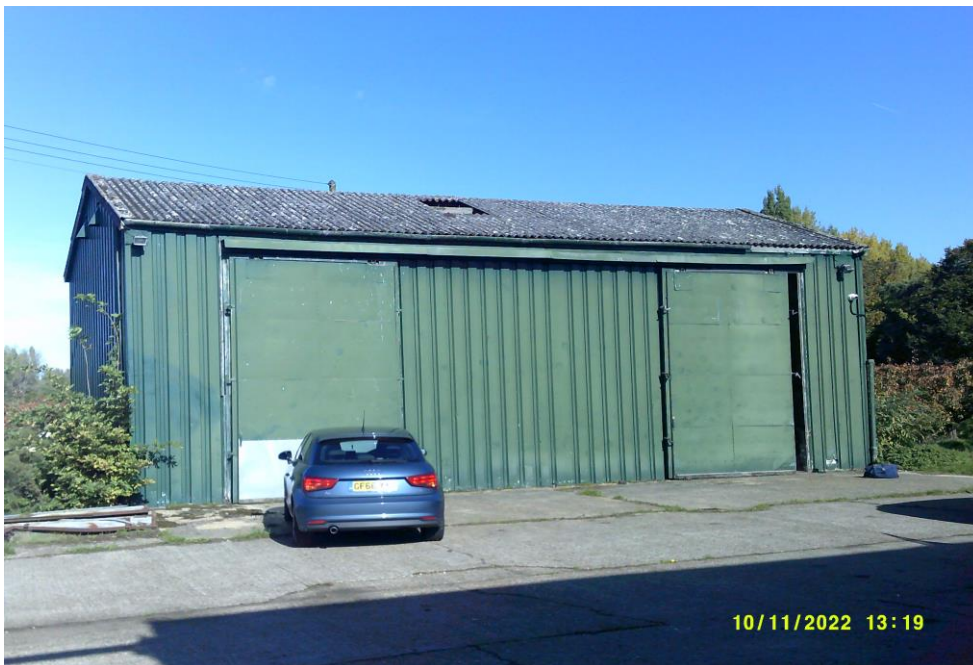
Visually the building was in an acceptable condition with the vertical profiled steel sheet walls showing no obvious structural deformations, only some local surface damage. There are 2No large openings with sliding doors in the front wall that have afforded vehicular access. No openings exist in the side walls and the rear wall.

Frame No: 01  
Location: The Cold Store, Butlers Farm, Horseshoes Lane, Maidstone, Kent ME17 3JY  
Description: Front elevation of the farm building, which has 2No storey height sliding doors  
Date: 11/10/22

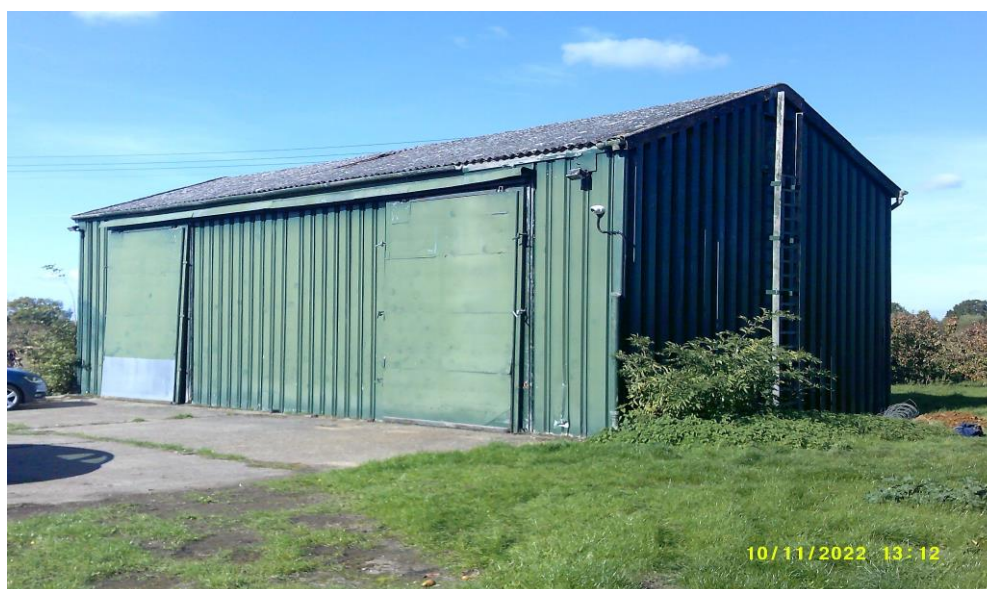
Vegetation at the site consists of a fruit orchard at a short distance from the rear of the building (photos 02 & 03).

Frame No: 02  
Location: The Cold Store, Butlers Farm, Horseshoes Lane, Maidstone, Kent ME17 3JY  
Description: Angled view of the building with a fruit orchard to the rear that extends around on the left and right  
Date: 11/10/22

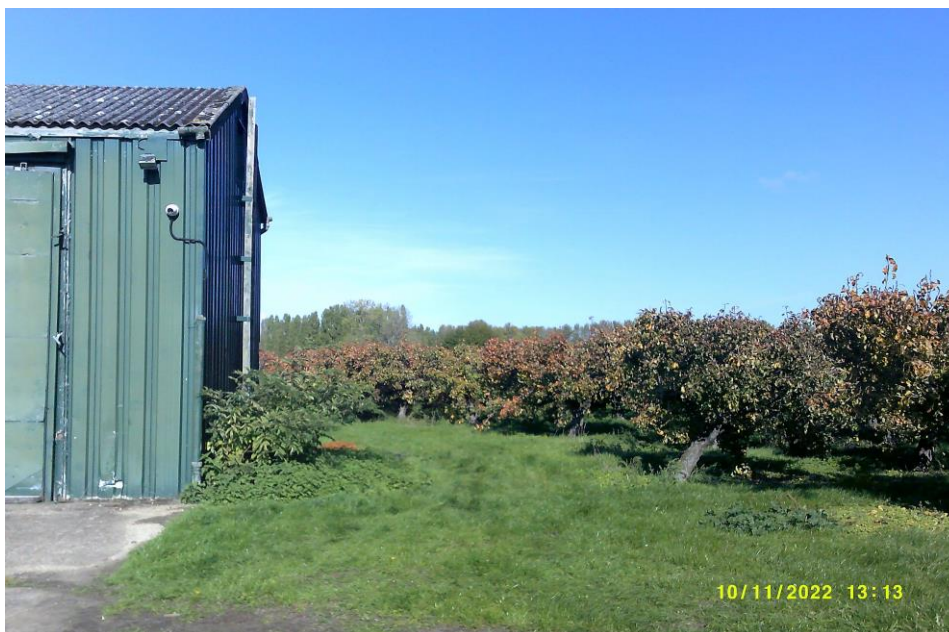
Frame No: 03  
Location: The Cold Store, Butlers Farm, Horseshoes Lane, Maidstone, Kent ME17 3JY  
Description: A view of the right end of the building with the fruit tree orchard curving round from the rear

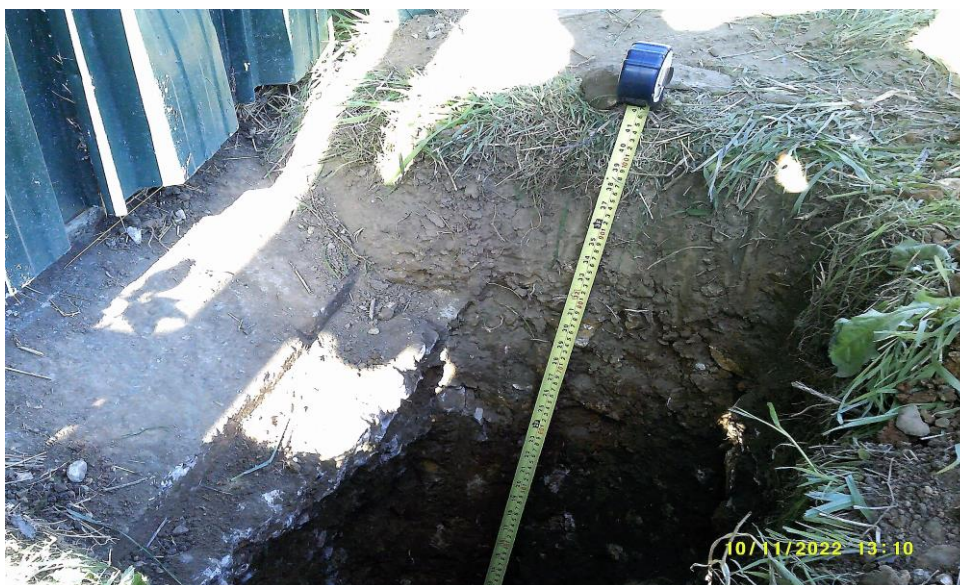
A trial pit was dug near the right hand rear corner to determine the depth of the foundation to the steel stanchion at the corner. This was measured as 950mm below the grass surface. The ground at this depth was a stone head clay material (photos 04,05 & 06).

Frame No: 04  
Location: The Cold Store, Butlers Farm, Horseshoes Lane, Maidstone, Kent ME17 3JY  
Description: A trial pit dug to reveal the foundation at the right hand end of the building with the angled tape measure showing an approximate depth of 950mm  
Date: 11/10/22

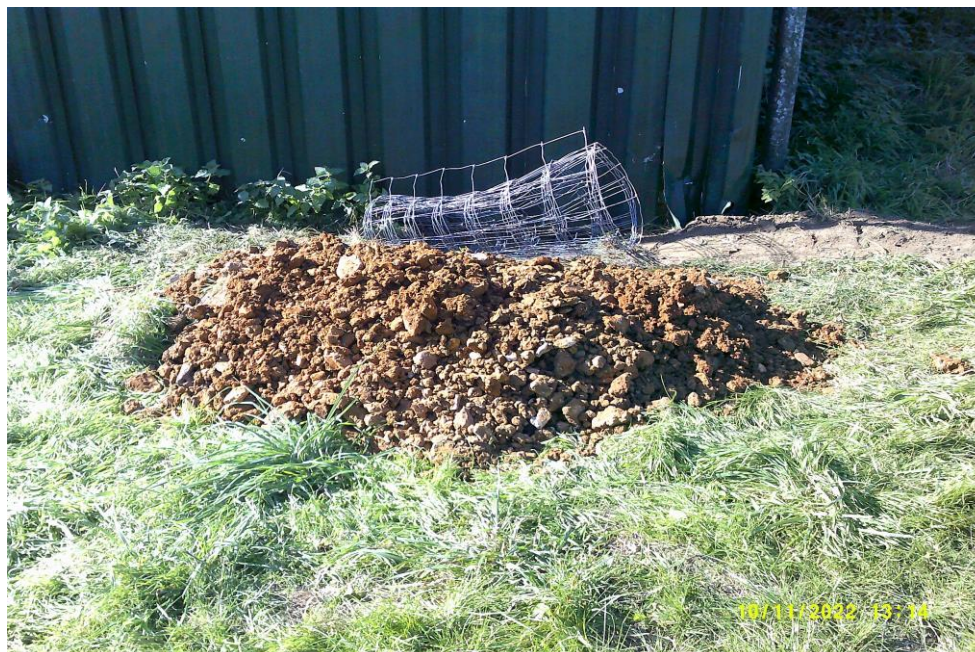
Frame No: 05  
Location: The Cold Store, Butlers Farm, Horseshoes Lane, Maidstone, Kent ME17 3JY  
Description: The material from the trial pit in photo 4, a stone clay head material  
Date: 11/10/22

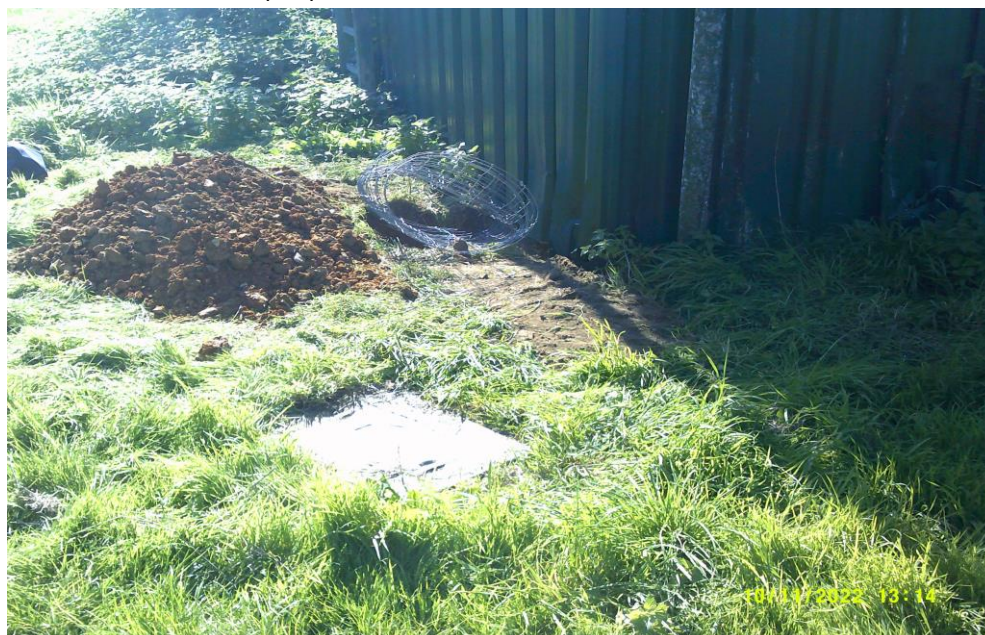
Frame No: 06  
Location: The Cold Store, Butlers Farm, Horseshoes Lane, Maidstone, Kent ME17 3JY  
Description: A drain manhole cover adjacent to the rear right hand corner of the building and near the trial pit in photo 04  
Date: 11/10/22

The condition of any existing drains serving the building is not known and if any drain is to be retained in the conversion, then it will need to be examined and tested.

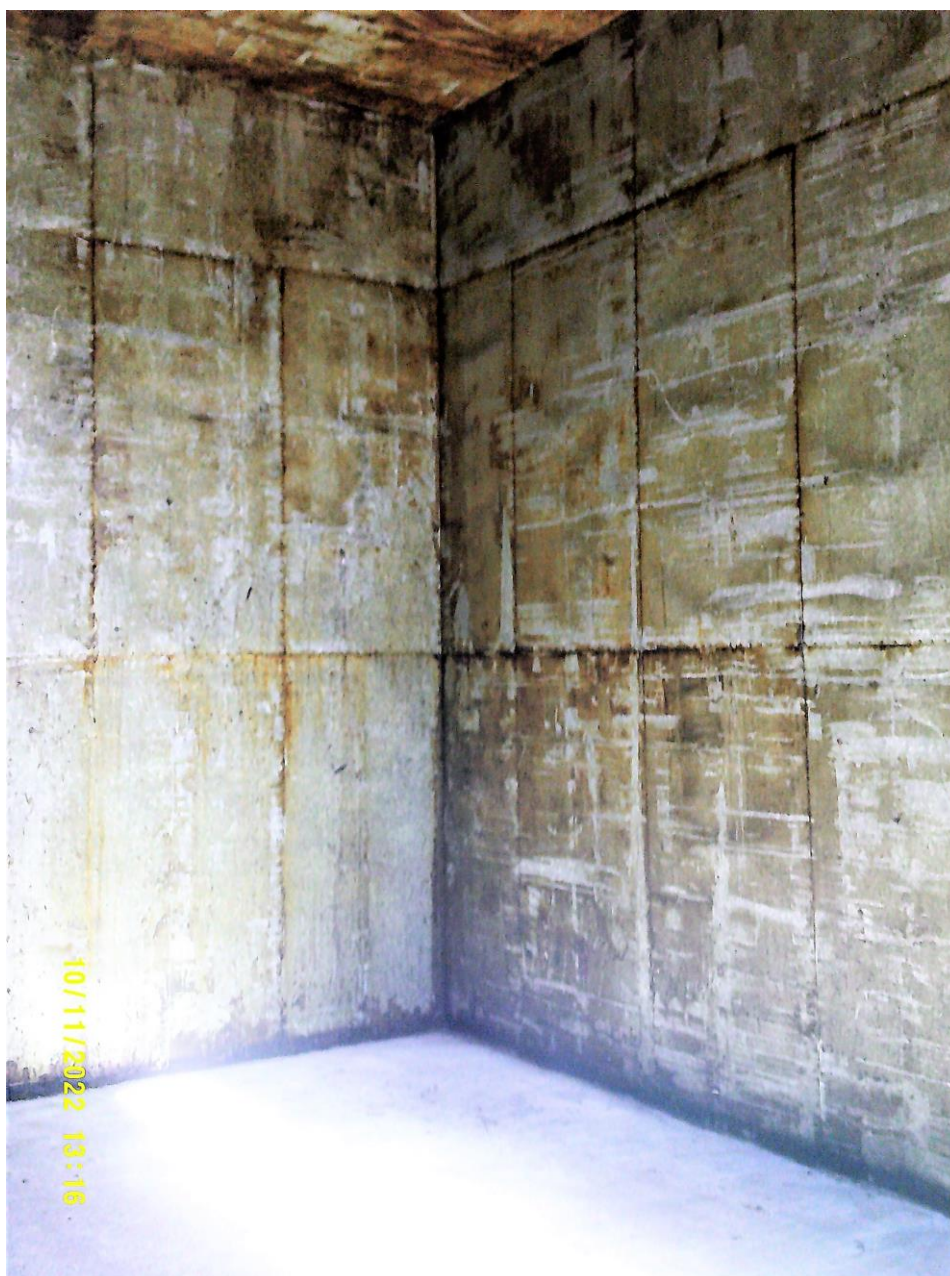
- 1) The floor slab understood to be approximately 200mm thick appears to be in good condition and it may have a concrete screed finish (photos 07 & 10). The level appeared uniform with no signs of structural movement. There were no internal partition walls and no stored items.

- 2) The external walls have an apparent metal sheet cladding that is stained or greased but are generally in good condition (photo 07).
- 3) The ceiling is at eaves level and covered with panels like those used on the walls. From floor level they appeared generally to be in good condition and level with some age-related staining. There is an access hatch in the ceiling but without a long enough ladder no inspection of the roof space was possible (photo 09).

Frame No: 07  
Location: The Cold Store, Butlers Farm, Horseshoes Lane, Maidstone, Kent ME17 3JY  
Description: A view inside the Store of the rear right hand corner from floor to ceiling with metal faced wall panels

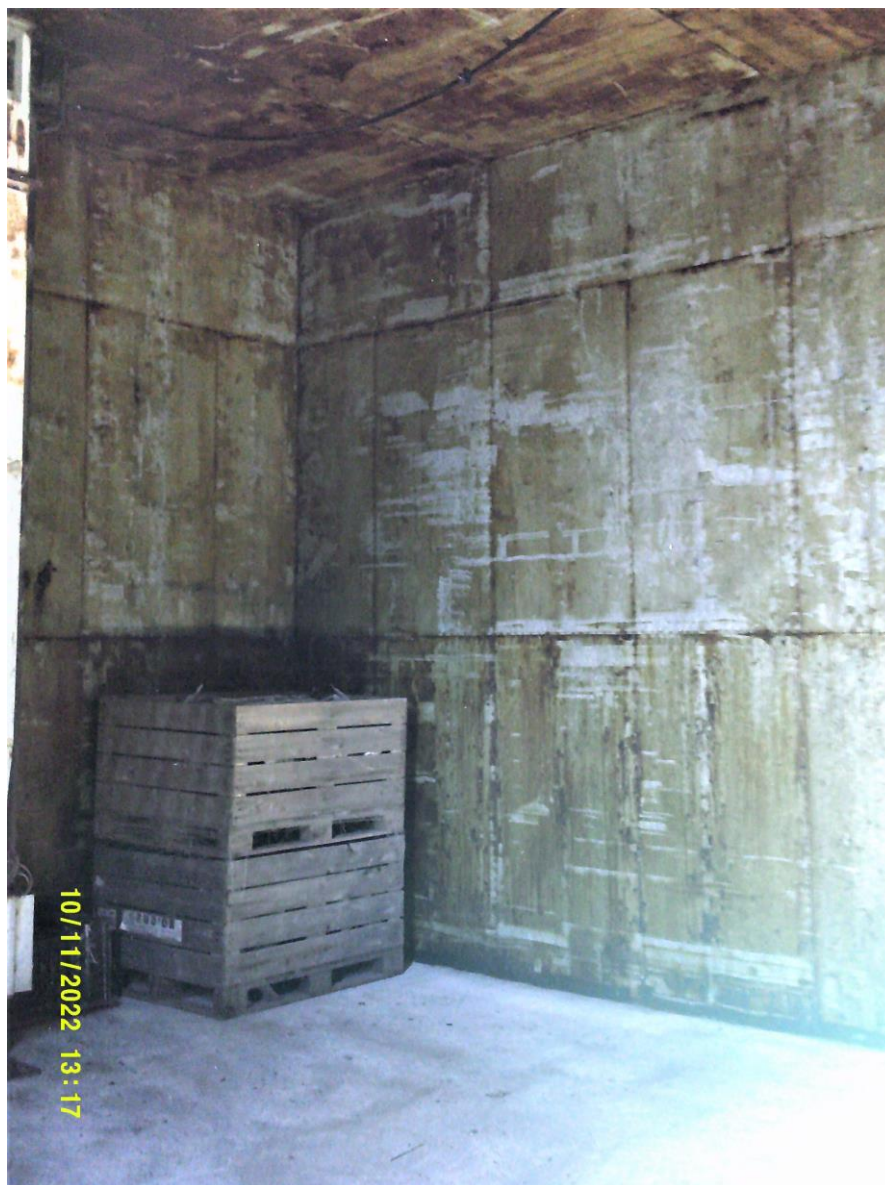
- 4) Harvested apples and pears would have been stored in timber rectangular bins over the ground floor area stacked in columns of 5 bins high as was demonstrated (photo 08).

Frame No: 08  
Location: The Cold Store, Butlers Farm, Horseshoes Lane, Maidstone, Kent ME17 3JY  
Description: The same corner as in photo 07 showing how the timber bins would be stacked filled with fruit  
Date: 11/10/22

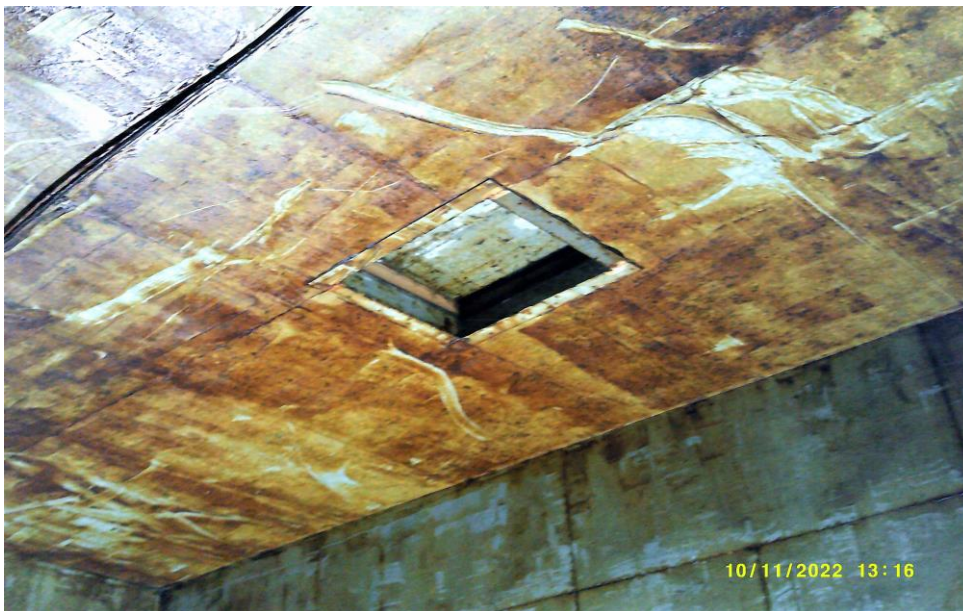
Description: View of the access panel in the flat ceiling giving access to the roof loft space

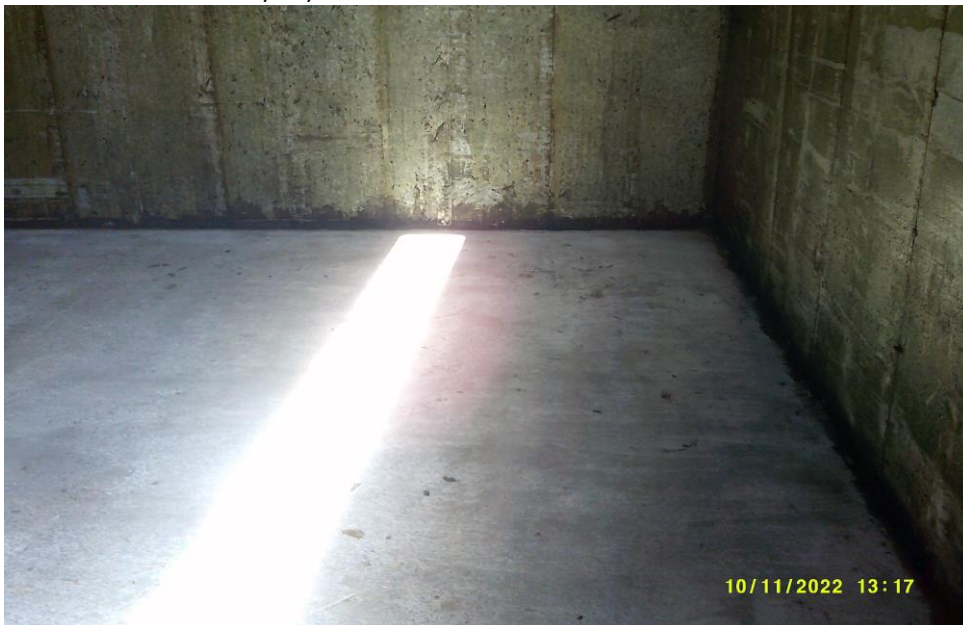
Description: A closer view of the concrete floor slab, as in photo 07 with a dense float finished surface
