STRUCTURAL INSPECTION
MANOR FARM, ELKERSLEY (PHASE 2)
SOUL ARCHITECTS

JOB NO: 11727/5.0/DF
JULY 2019

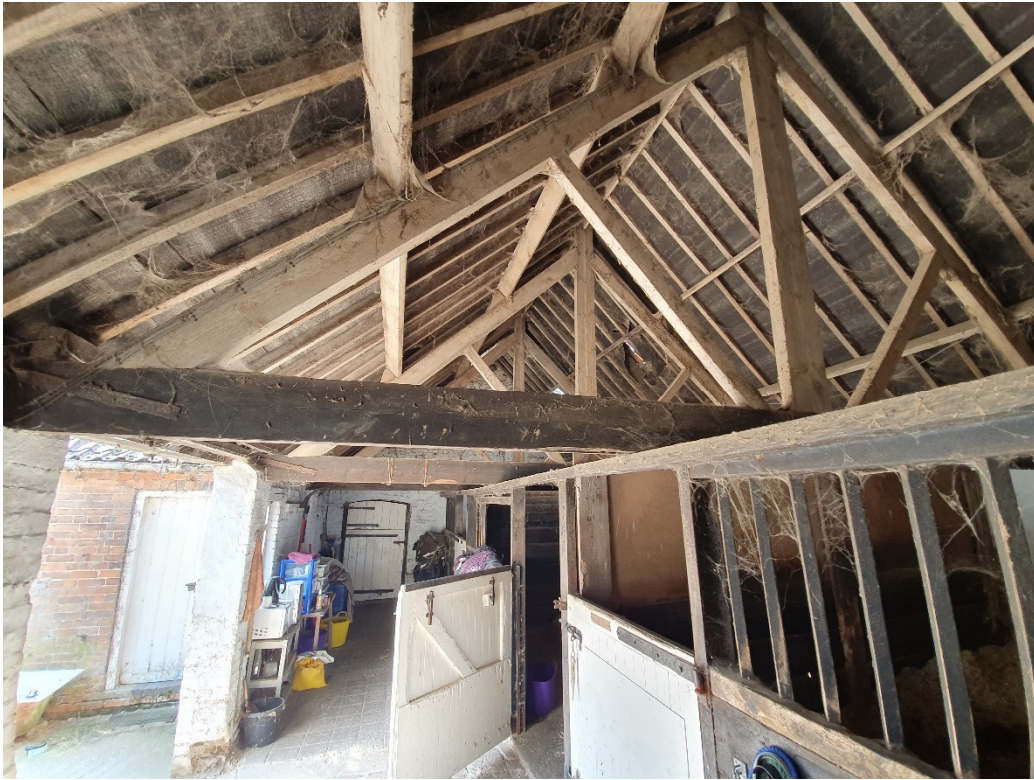
2.2.1 This is a single storey stable block 'L' shaped on plan. The roof consists of pantiles on battens and common rafters. There is a single purlin per slope spanning between king post trusses and masonry walls (Photograph 1). There are four trusses in total. The walls are 225mm solid brick.

Photograph No. 1 – Roof to building No. 1

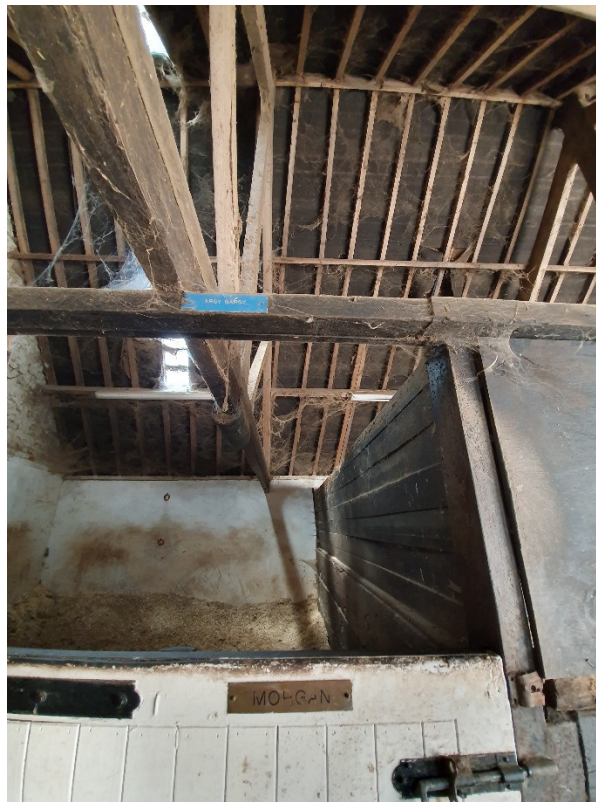
- a. The whole of the roof structure is leaning towards the North gable end of the building with the apex being approximately 150mm out of plumb (Photograph 2). This has resulted in the North gable wall also being out of plumb by a similar amount.
- b. There is a semi mature Ash tree directly next to the North gable wall (Photograph 3) and there are cracks to the masonry in this location (Photographs 4 and 5).
- c. There is a significant outward bulge to the West facing external wall (Photograph 6). This affects approximately the mid third of the wall.

Photograph No. 2 – Timber truss to building no. 1 out of plumb

3.3.1 The roof needs to be replaced due to movement and being out of plumb.

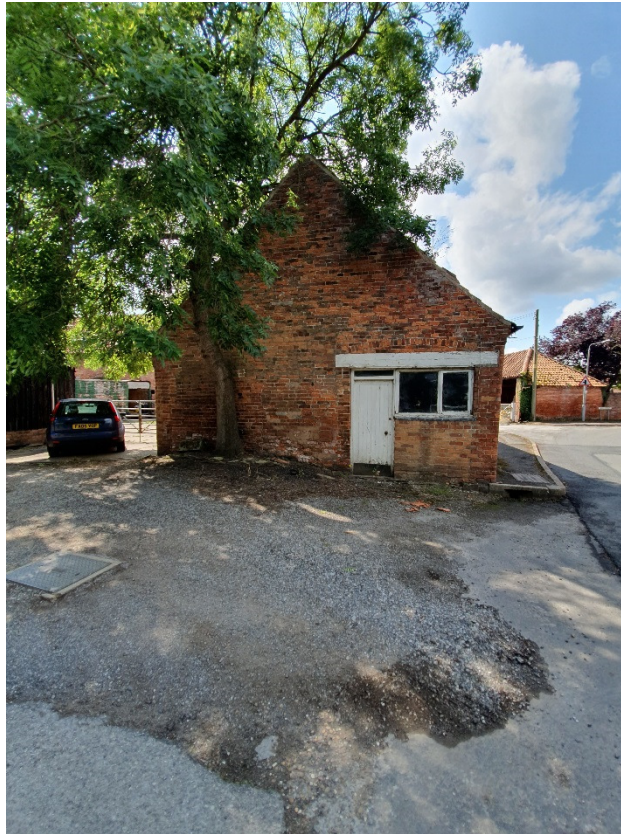
Photograph No. 3 – Ash tree adjacent to the North gable of building no. 1

3.3.2 The Ash tree adjacent to the North gable wall needs to be removed. If the subsoil is clay there may be an issue with clay heave. Because the gable wall is out of plumb at high level and there are cracks at low level, it would be prudent to completely rebuild this wall on a new foundation.

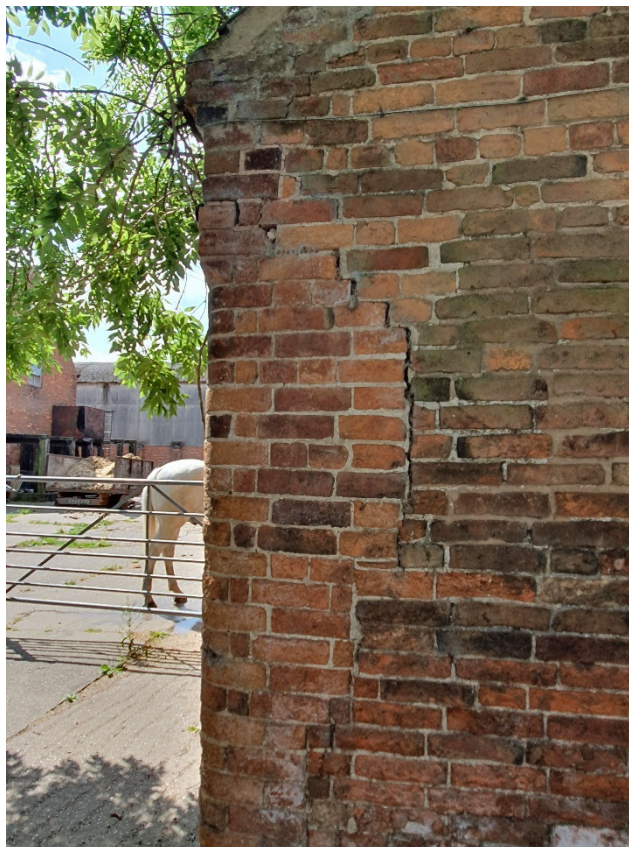
Photograph No. 4 – Cracking to the North gable wall of building no. 1

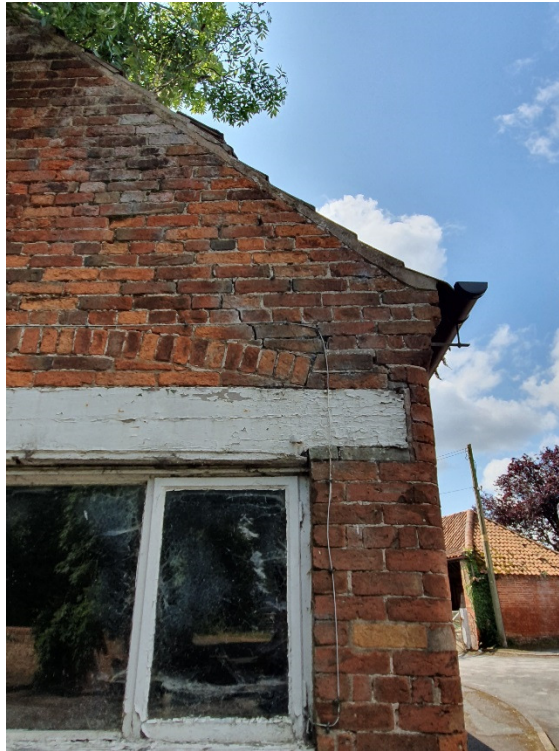
Photograph No. 5 – Cracking to the North gable wall of building no. 1

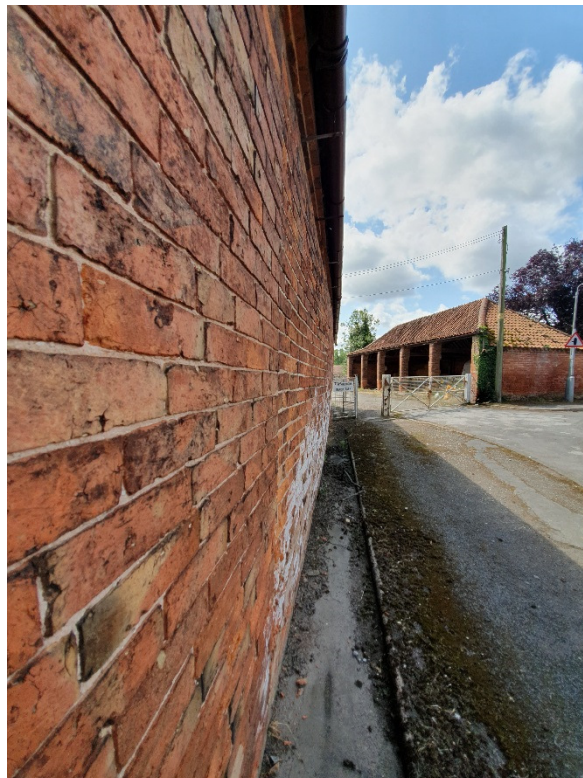
Photograph No. 6 – Outward bulge to the West wall of building No. 1

3.3.3 The bulged section of the West facing external wall needs to be taken down and rebuilt on a new foundation.

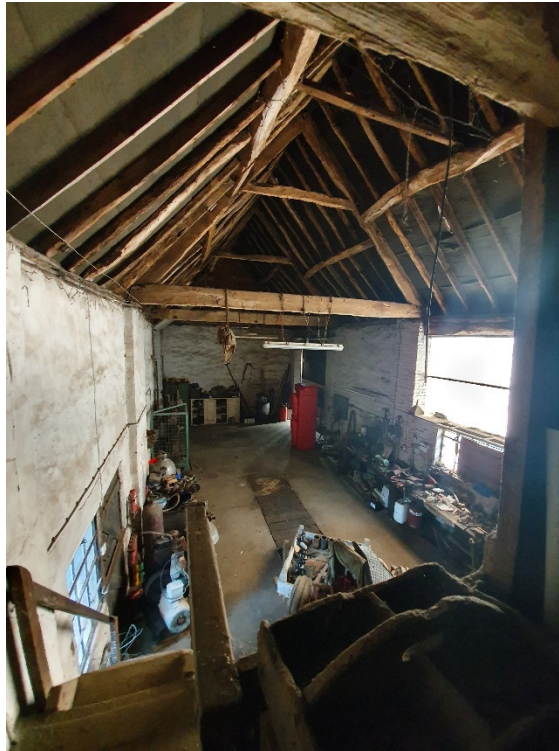
2.4.2 The roof consists of pantiles on battens and common rafters. There is a single purlin per slope which spans between principle timber frames and the gable walls (Photograph 7). The principal

Photograph No. 7 – Internal view of building no. 3

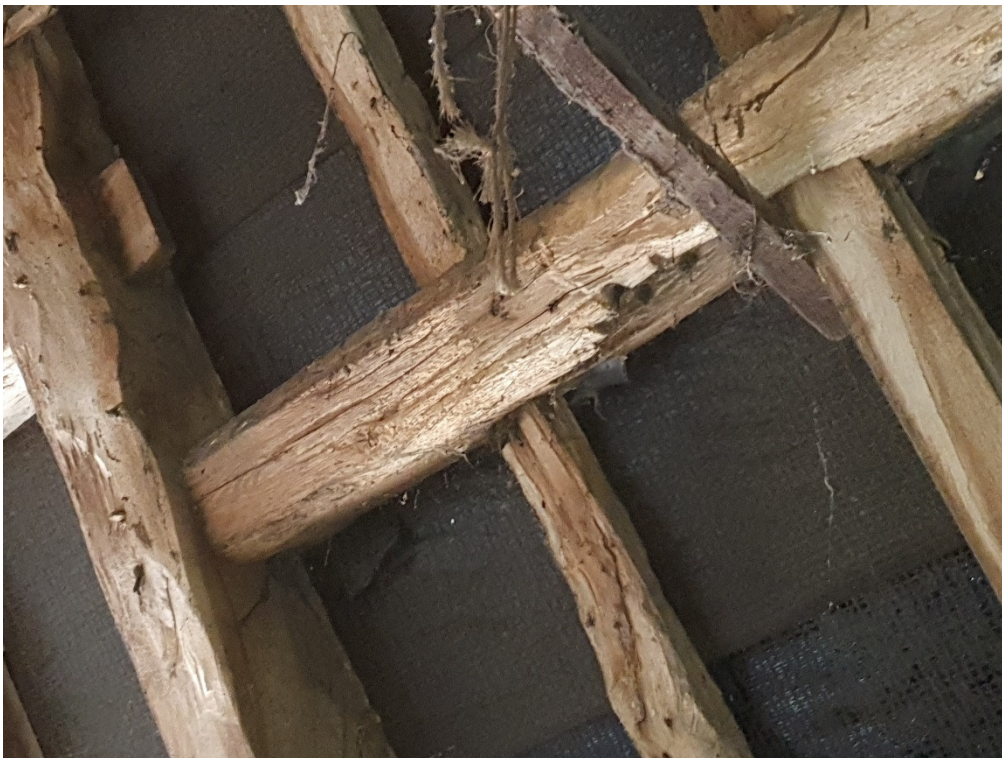
- a. There is evidence of rot and beetle infestation to some of the roof timbers (Photograph 8).
- b. Many of the roof timbers are irregular in shape (Photograph 9) and undersized (Photograph 10).
- c. To both gable ends the high level masonry on the internal face is poorly bonded and has missing mortar to the joints (Photographs 11 and 12).

Photograph No 8 – Defective roof timbers to building no. 3

3.5.1 The roof needs to be replaced due to its poor condition and to create sufficient head room for the first floor.

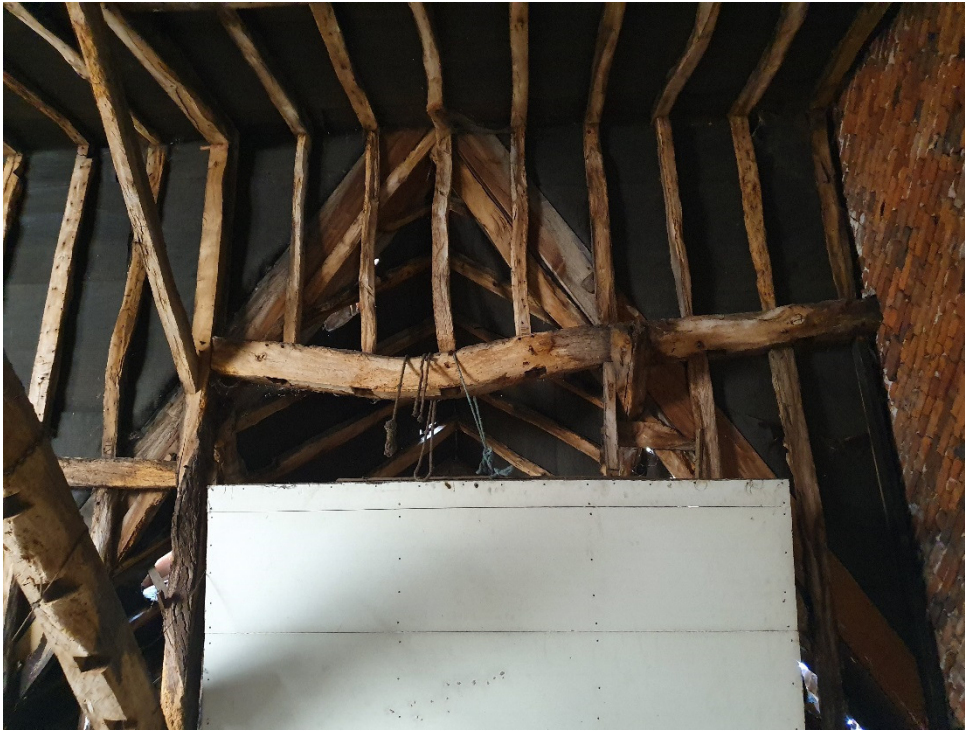
Photograph No. 9 – Irregular roof timbers to building no. 3

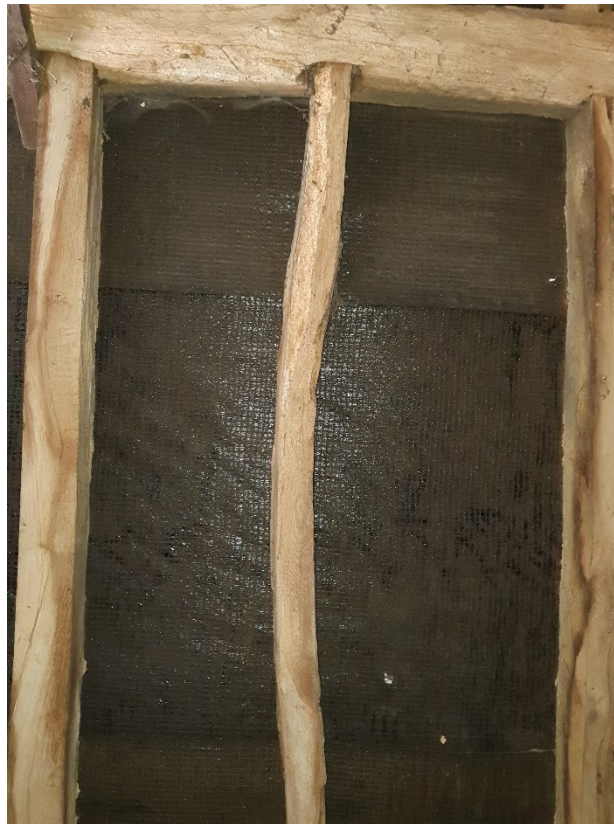
Photograph No. 10 – Undersized rafter to building no. 3

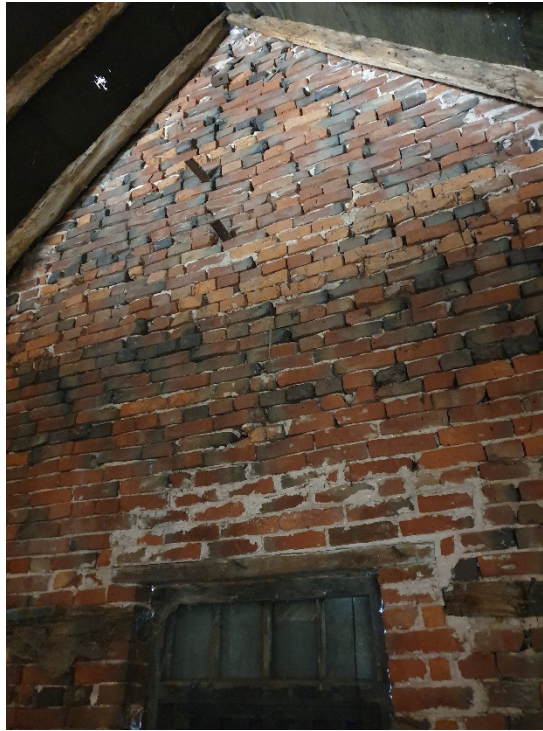
Photograph No. 11 – Internal view of high level masonry to the gable wall of building no. 3

3.5.2 The high level internal faces of the gable walls need pointing.

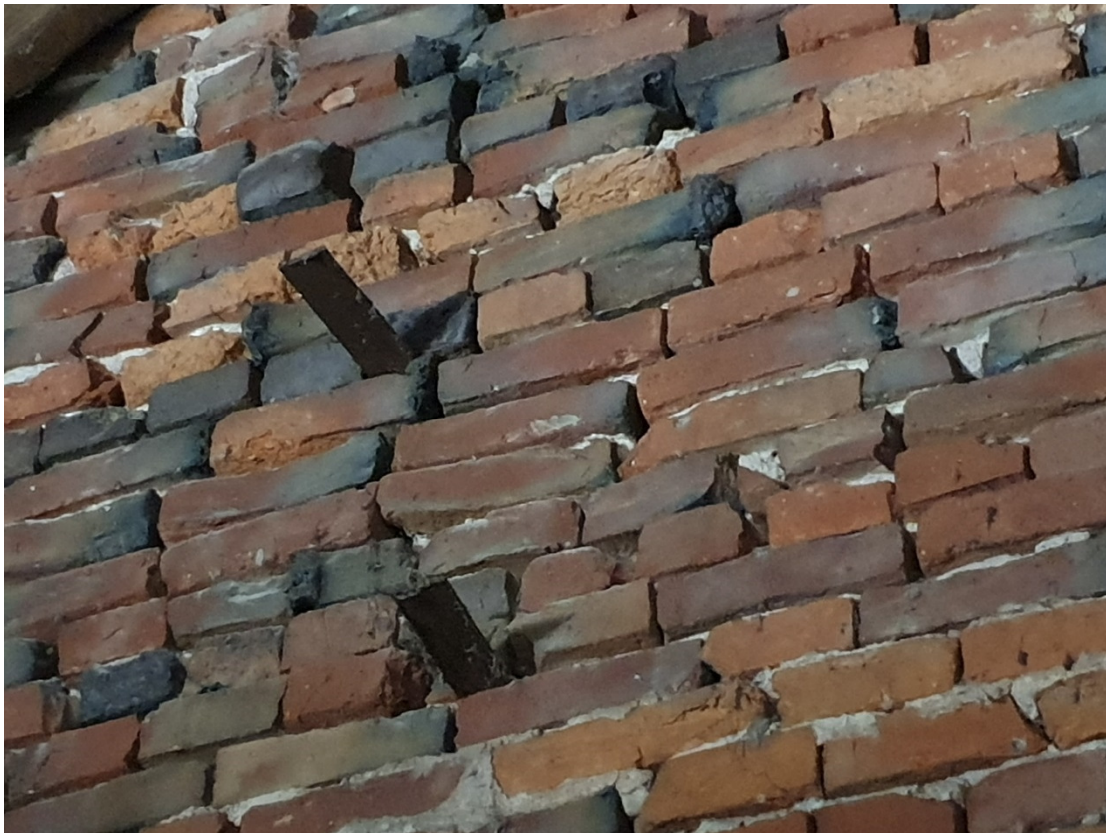
Photograph No. 12 – Poor bonding and missing mortar to the internal face of the gable wall to building no. 3

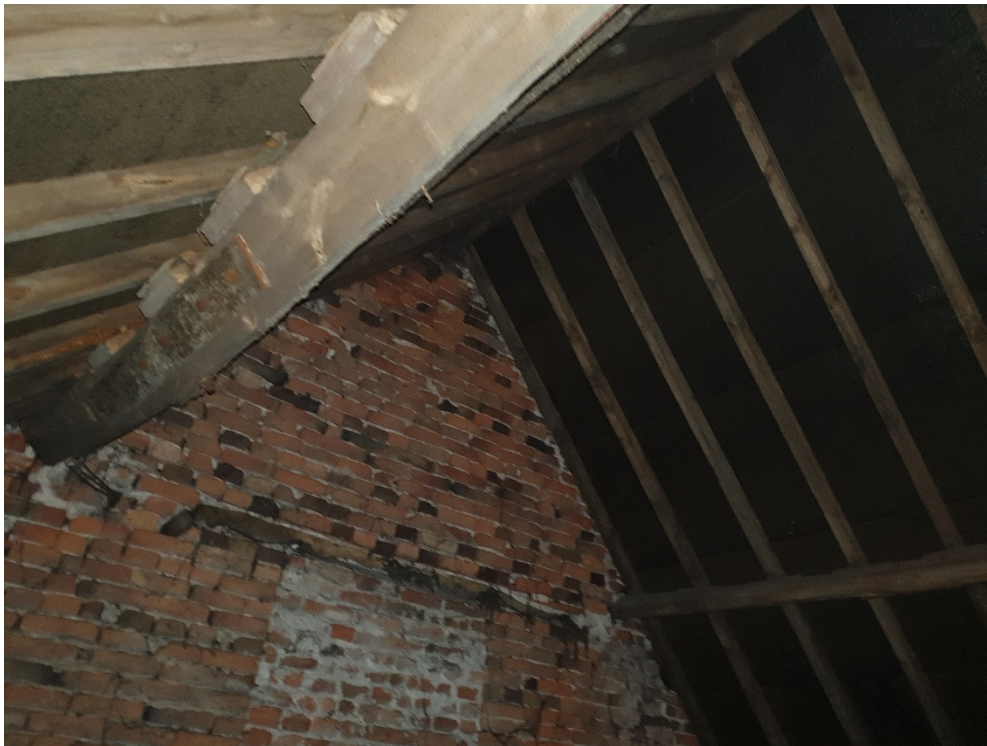
- a. The area of roof that could be viewed revealed that many of the timbers are in poor condition with deflected and split purlins and deformation of the principal timber frames (Photographs 13 and 14). It is not possible to state if the hidden areas of the roof are in a similar condition but it would be reasonable to assume that they are.
- b. There is evidence of cracking and movement above the shallow brick arches to door and window openings (Photographs 15 and 16).
- c. There is loose and missing brickwork at low level externally to the NW corner (Photograph 17).
- d. There is loose and deflected brickwork at eaves level over window openings due to the lack of a lintel (Photograph 18).

Photograph No. 13 – Deflected and split purlin to building no. 4

- 3.6.1 The roof needs to be replaced due to its poor condition and to create sufficient head room for the first floor.
- 3.6.2 The raised ground level to the East facing external wall needs addressing either by lowering the level or tanking the wall.
- 3.6.3 The loose and missing brickwork to the NW corner at low level need to be made good.

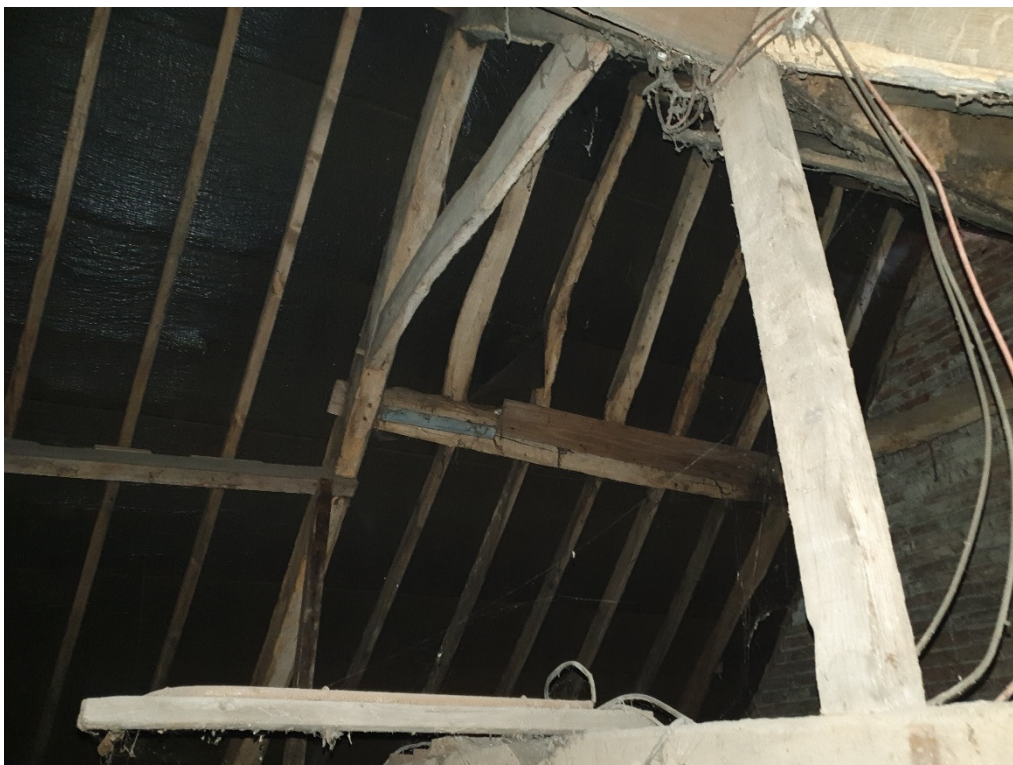
Photograph 14 – Bowed member to principal timber roof frame to building no. 4

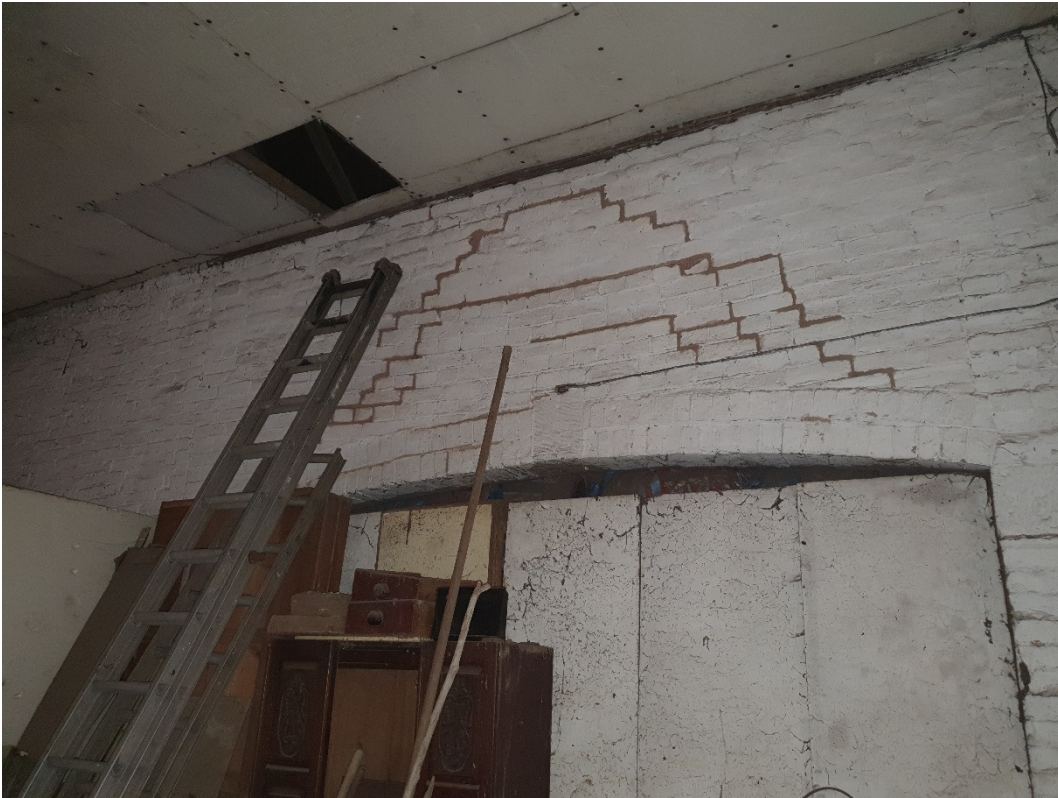
Photograph No.15 – Masonry movement and cracking over shallow arched opening to building no. 4

- 3.8.1 New lintels are required to all existing openings to the masonry walls and any localised cracking above made good.
 - 3.8.2 Where previous alterations have resulted in none bonded vertical joints to the masonry these should be stitched using Helibar repair products.
 - 3.8.3 All external masonry should be repointed.
 - 3.8.4 All masonry walls should have a chemical injected DPC.
 - 3.8.5 All ground floor slabs need to be removed and replaced.
- 3.9 When designing the conversion works the new roofs and first floors need to be anchored to the masonry walls to ensure the lateral stability of the buildings.

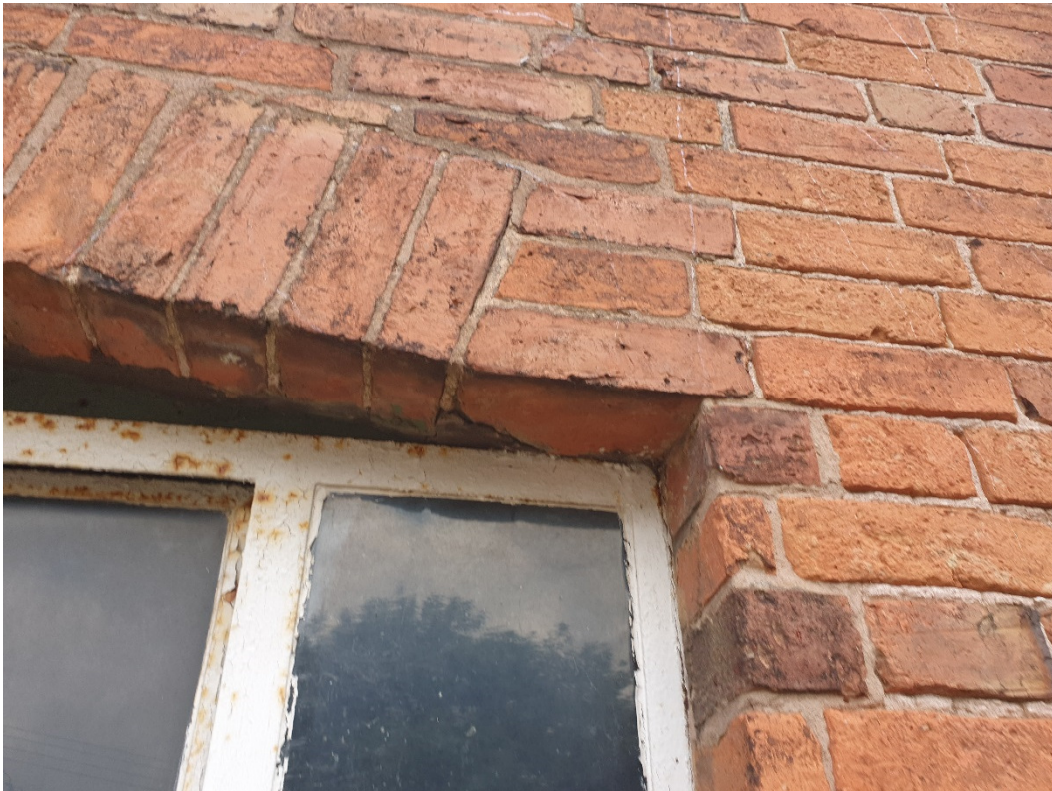
Photograph No. 16 – Defective arch springing point to opening in building no. 4

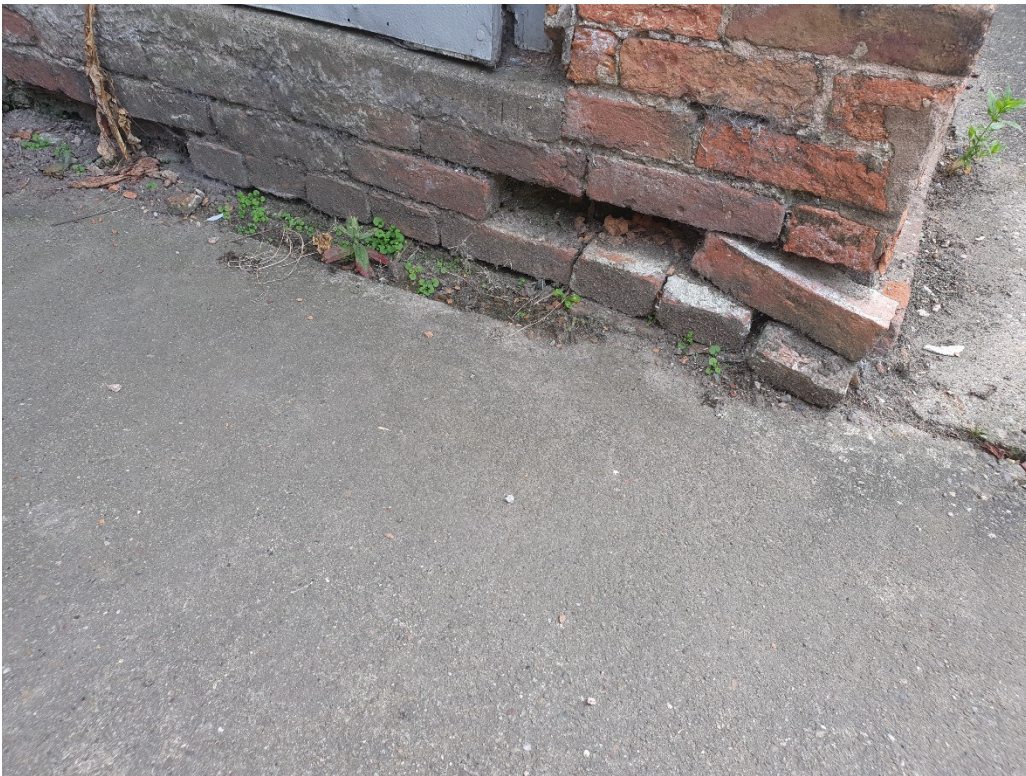
Photograph No. 17 – Missing and loose low level brickwork to the NW corner of building no. 4

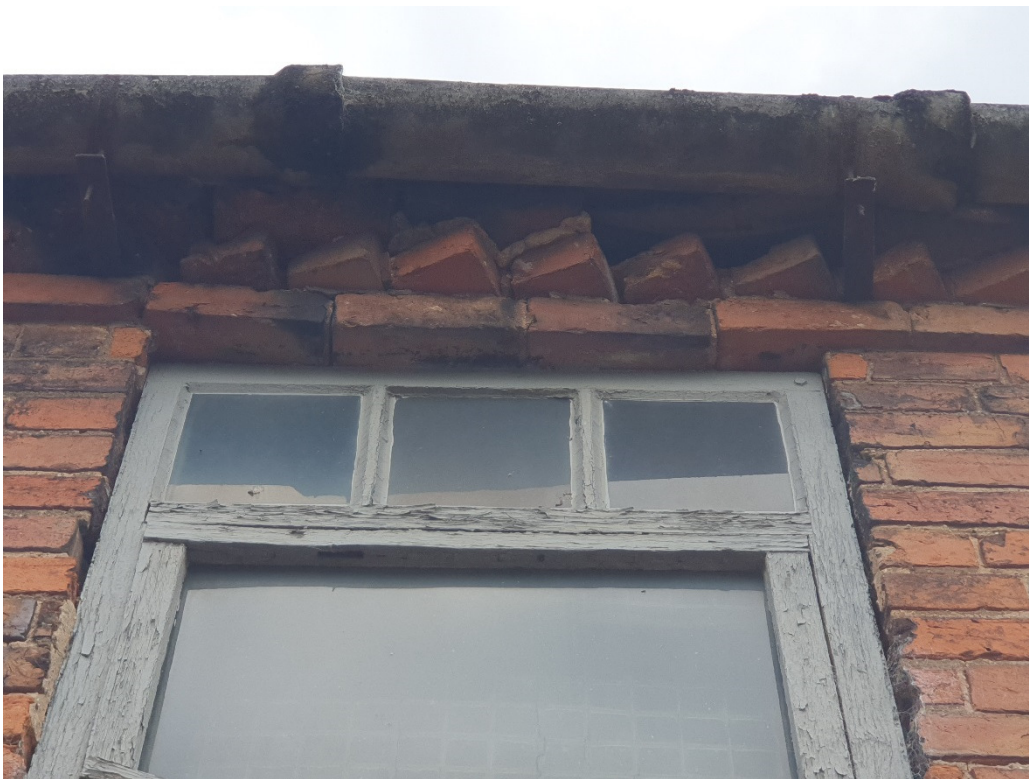
Photograph No. 18 – Loose and deflected brickwork over opening to building no. 4

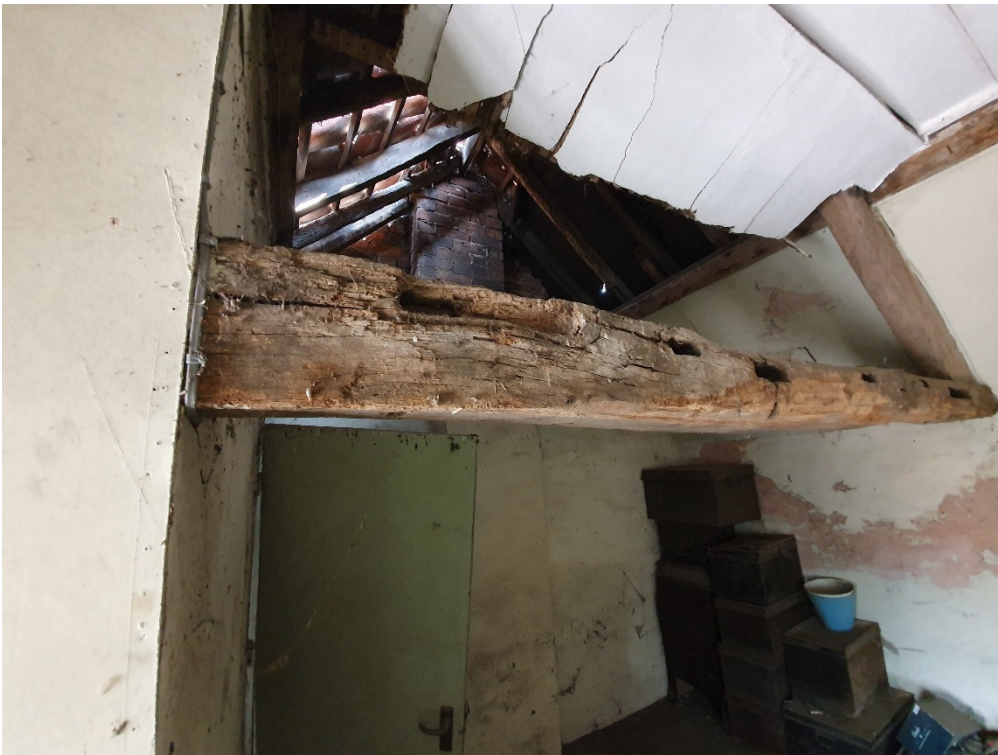
- a. The roof timbers are in poor condition due to water ingress where pantiles are missing (Photograph 19).
- b. The first floor timbers are in poor condition again due to water ingress,

Photograph No. 19 – Defective roof frame to building no. 5

- 3.7.1 The roof and the first floors need to be replaced due to their poor condition.
- 3.7.2 The raised ground level to the East facing external wall needs addressing either by lowering the level or tanking the wall.
