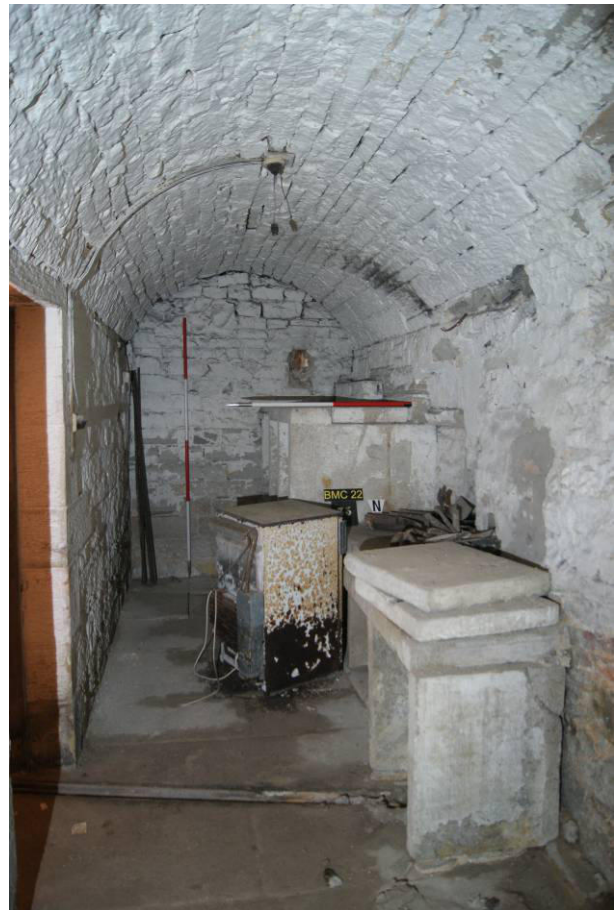
P72. R15 'Cellar' looking south showing stone shelving of the 1801-4 larder. Though absent from the currently proposed plans these appear to be being retained.

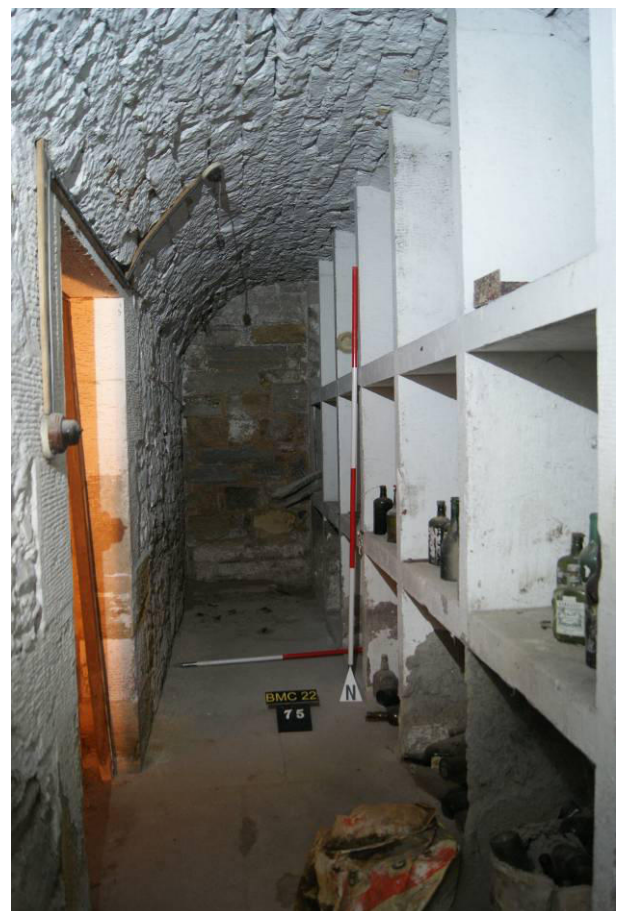
P73. R16, passage, north end, showing 20th century blocking proposed to be removed, and a new blocking wall built across the passage further south, forming a space for a W C

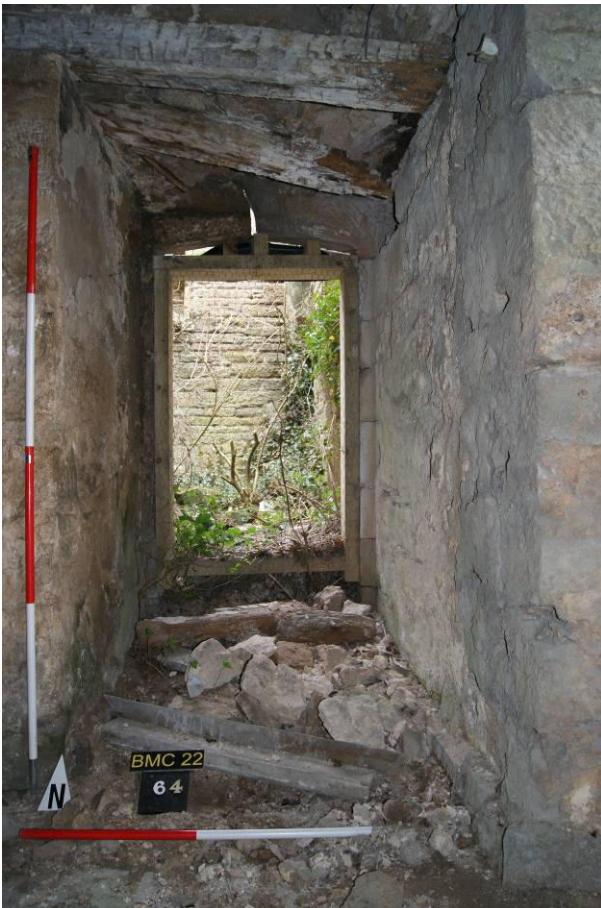
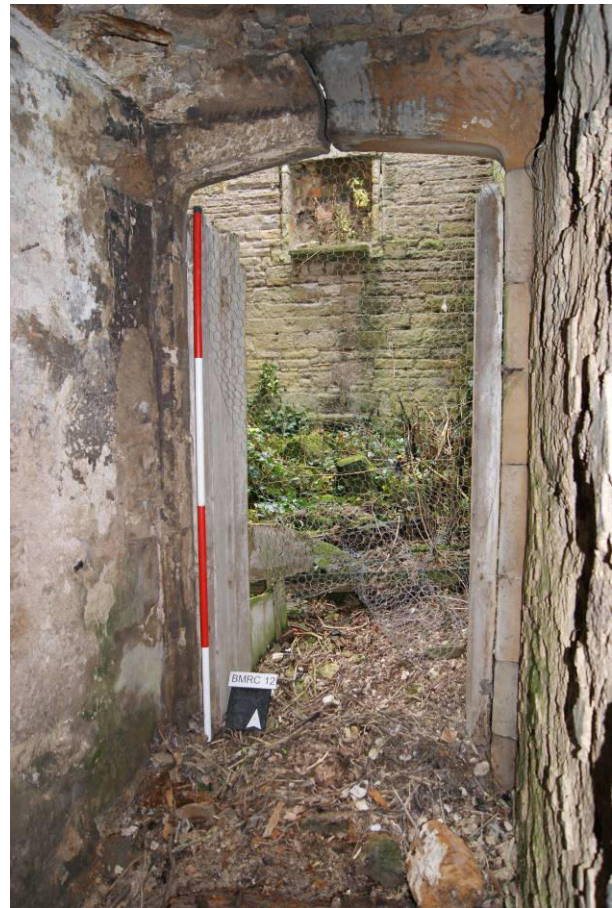
P78 - 79. R19. 'Servants Hall'. Doorway [64] in 2022 (left), showing that significant deterioration has occurred since it was photographed in 2012 (right).

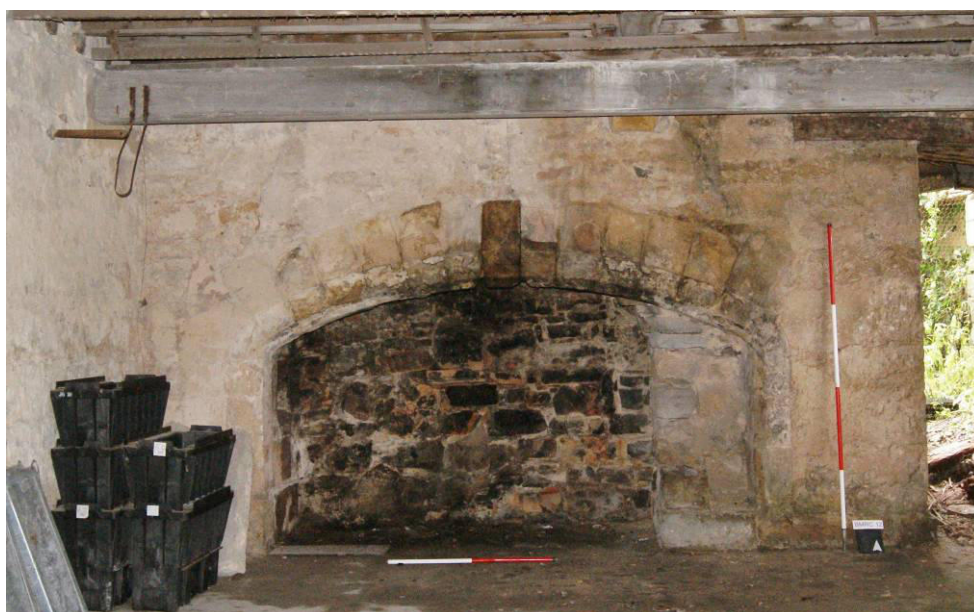
P81. R19 'Servants Hall' looking north to fire [63], showing loss of part of a right-hand voussoir of the arch and evidence of instability in the centre of the arch.

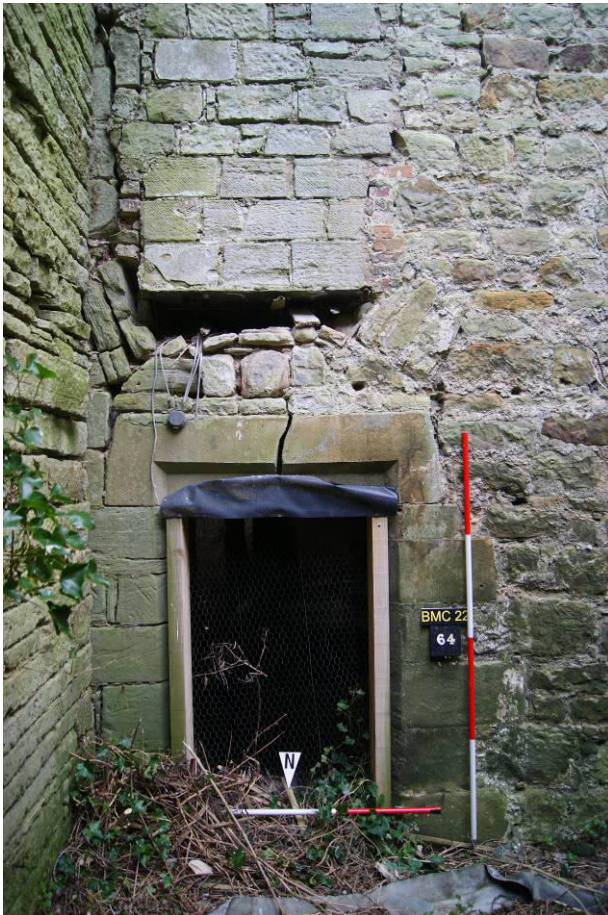
P83. R20. Door [64] to the 'kitchen' or 'Servant's Hall' of the late 16th/early 17th century wing, showing cracked lintel. Above is the 20th century blocking of a door inserted in 1801-4 [128] which removed most of the relieving arch above [64], causing this damage. Door [128] is proposed to be reopened.

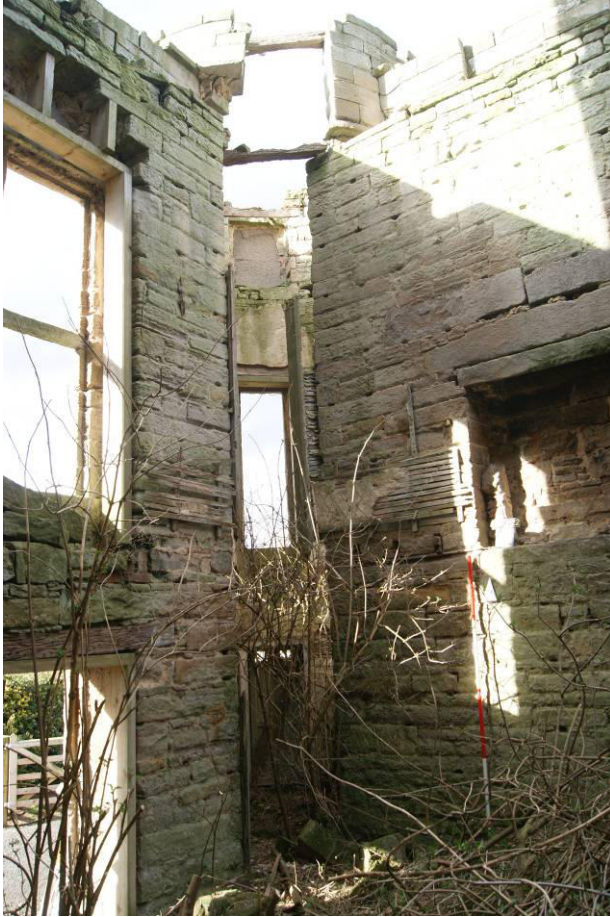
P94. R24. Looking north-west to turret rooms R25/48 showing unstable masonry at parapet level.

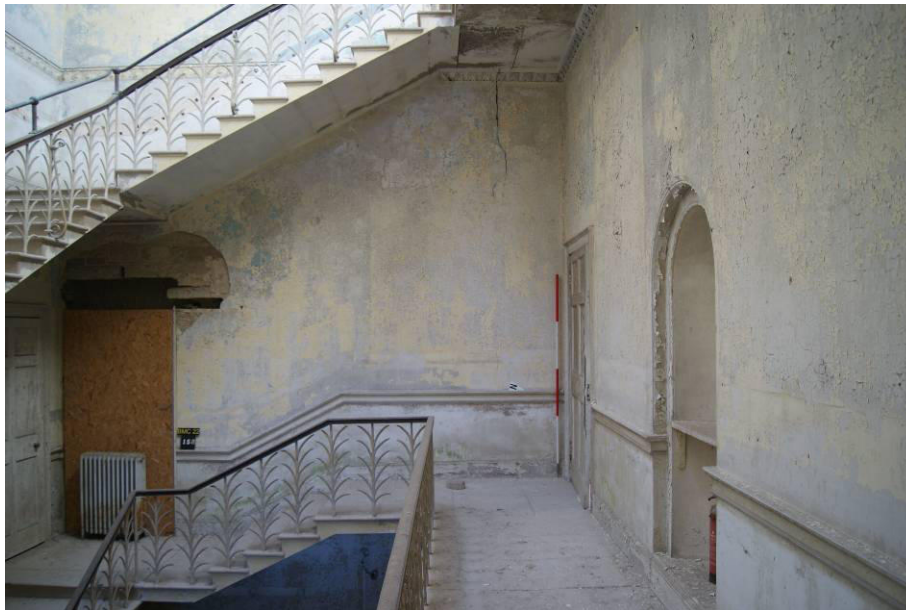
P109. R35, Great Stair first landing looking west, showing cracking in end wall plaster. Door [158] (left) with lintel missing and plaster damaged is proposed to be reinstated. Door [118] and alcove [120] are on the right.

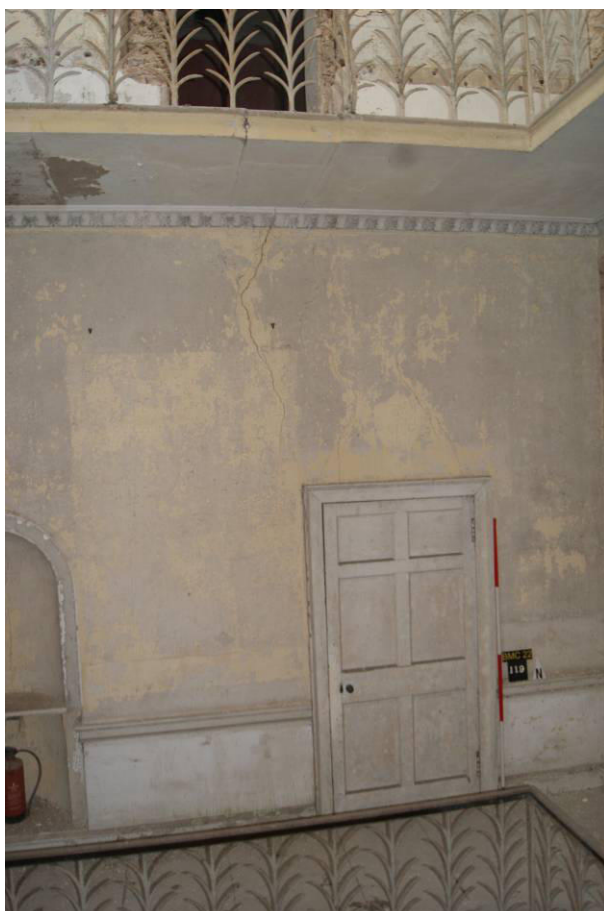
P110. R35, looking north from the second flight of the Great Stairs to door [119]. Note the displaced slab of the landing above.

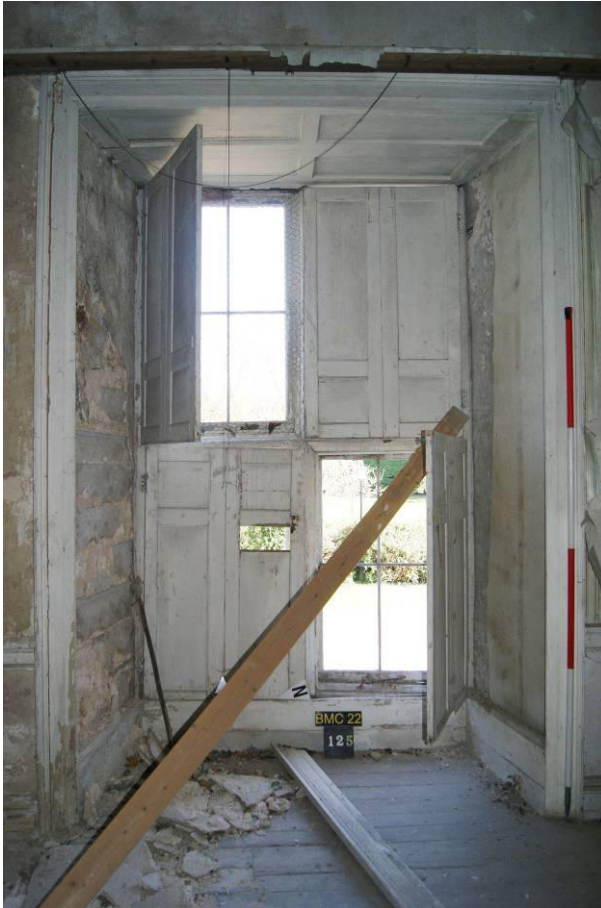
P131. R42. Window [125] showing plaster fallen from north reveal and delapidation since 2012.

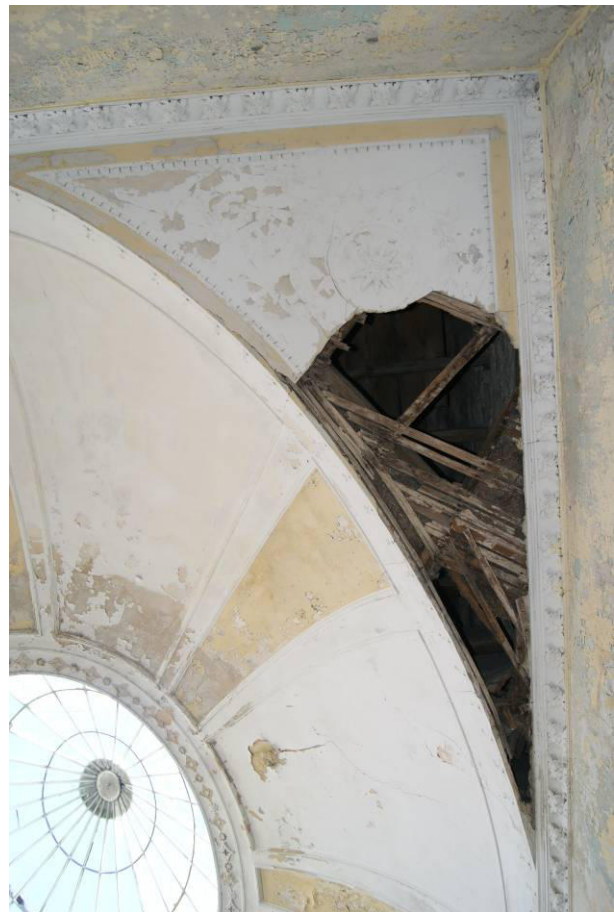
P147. R56. The second floor landing of the Great Stair, looking up in the south-west corner showing loss of decorative plasterwork to this spandrel of the cupola.

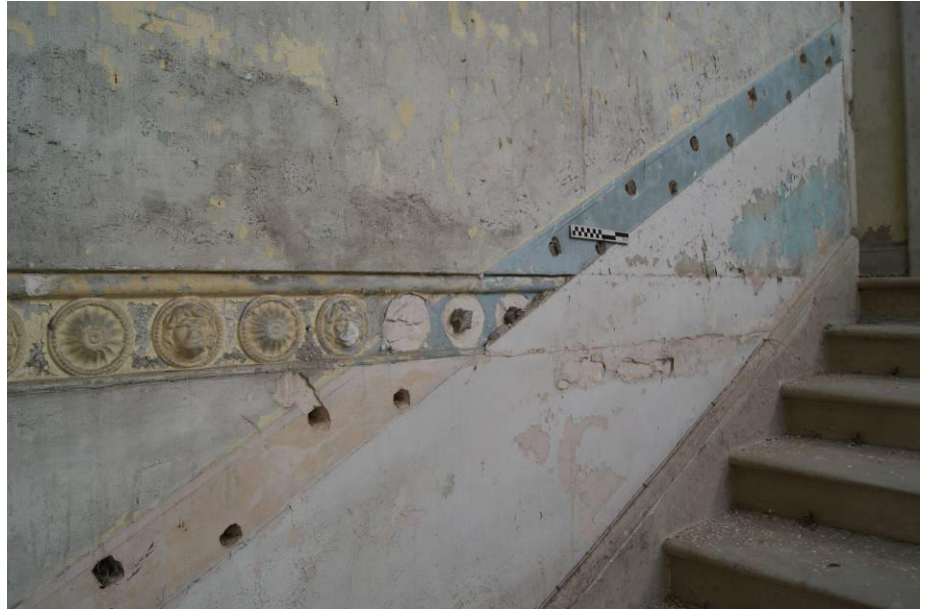
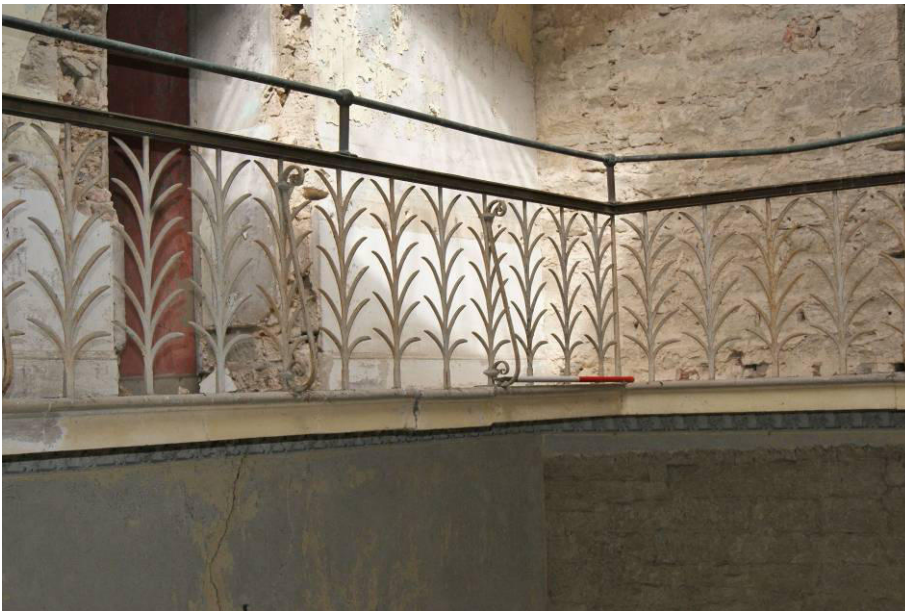
P149. R56, looking from the last flight of stairs to the second floor landing where one floor-slab is displaced. This also shows the wrought-iron scroll brackets bracing the railing, and the secondary brass tubular handrail.

P150. R56 looking east along the landing, showing areas of damaged cupola plasterwork, the line of a missing bannister or dado, and the doorway to R57 in the centre of the east wall which has been stripped of plaster. At the level of the landing infilled sockets in the masonry here may relate to a pre-1801-4 floor level.

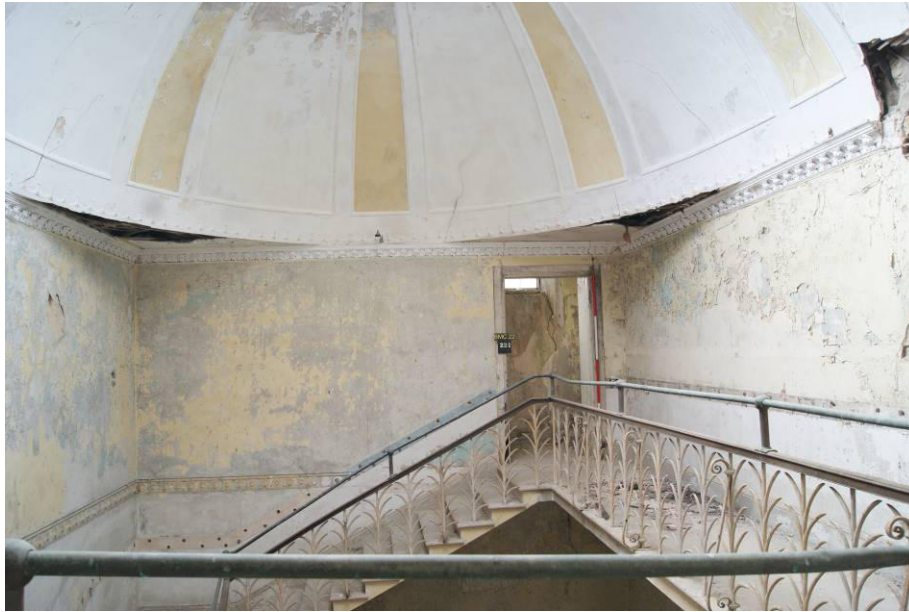
P151. R56 looking west, showing areas of lost decorative plasterwork on the spandrels of the cupola, and door [221].

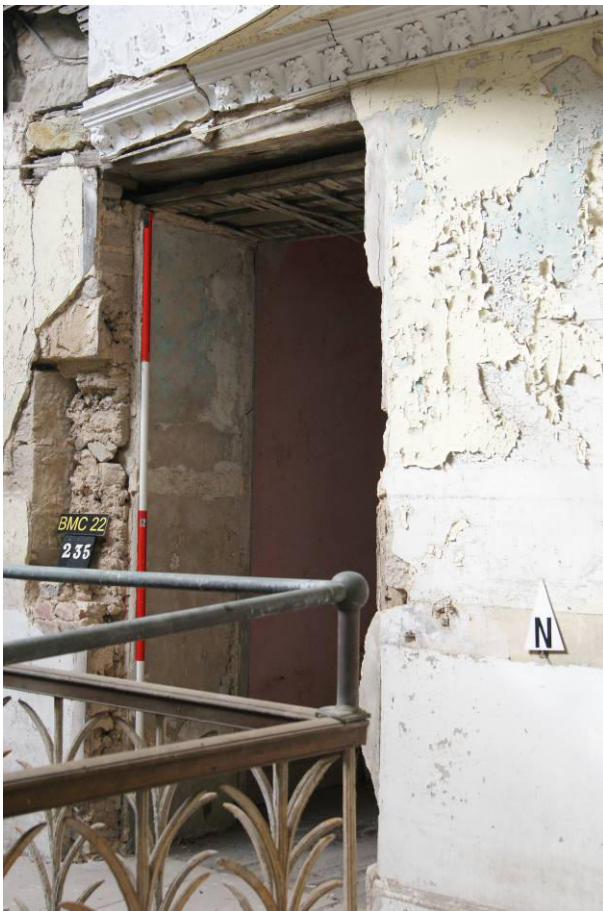
P152. R56. Door [235] showing that an earlier, wider, opening has been blocked. Also showing a loose section of the 1801-4 plaster cornice above.

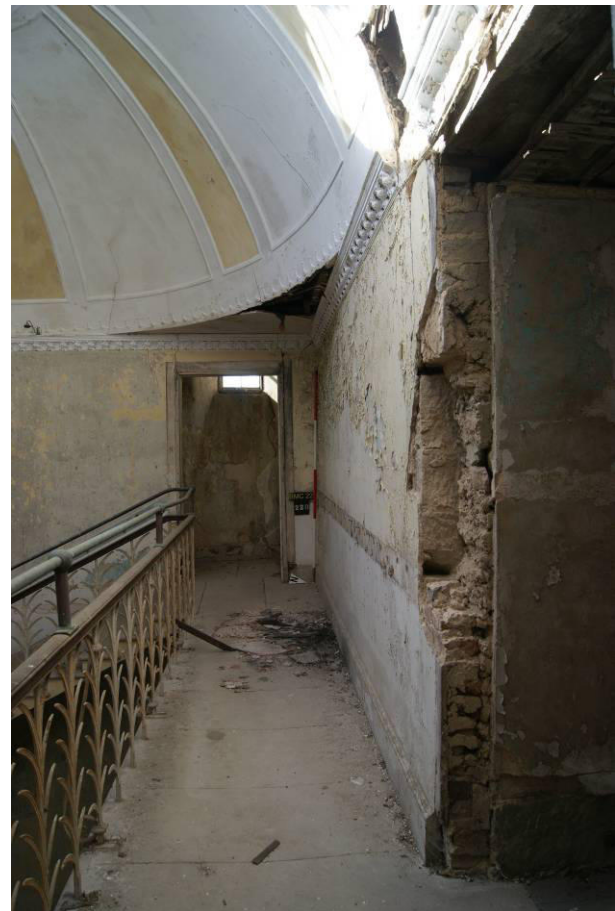
P153. R56. Looking west along the landing with door [235] on the right. Fallen plaster and rotted laths from the north-west spandrel are lying on the landing slabs.

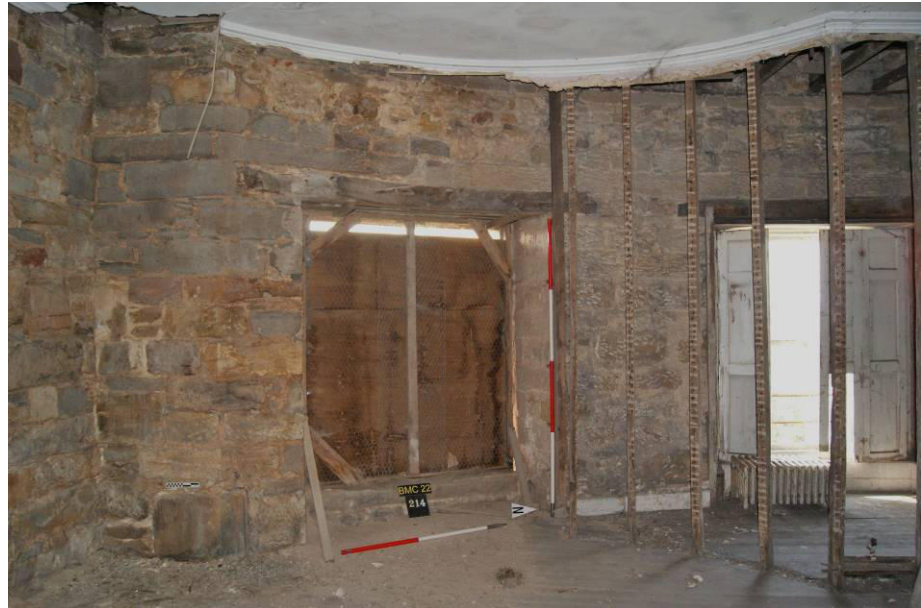
P162 R66 looking south to fire [215] and the south wall stripped of plaster. Shows loss of some ceiling plaster and cornice (fallen fragment on the mantelpiece).

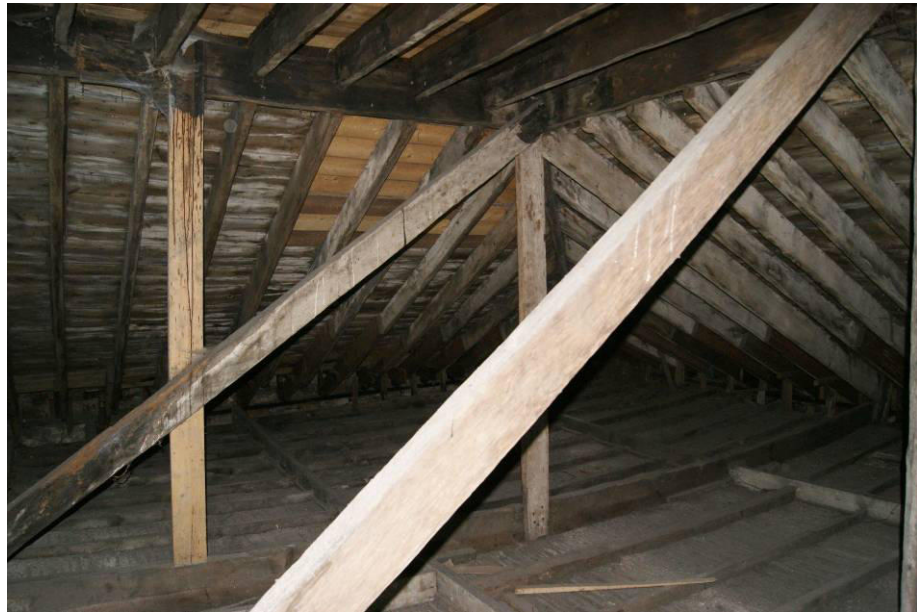
P172. Attic space R72 looking north showing trusses [313] and [314]. The joists to the ceiling of R62 below show evidence for deflection on the tie-beams. Loft hatch [236] is at bottom left.
