Arboricultural Assessment Of Trees at 2 North Lodge,
Chester le Street, Co. Durham, DH3 4AZ

Report 1037

14 January 2023

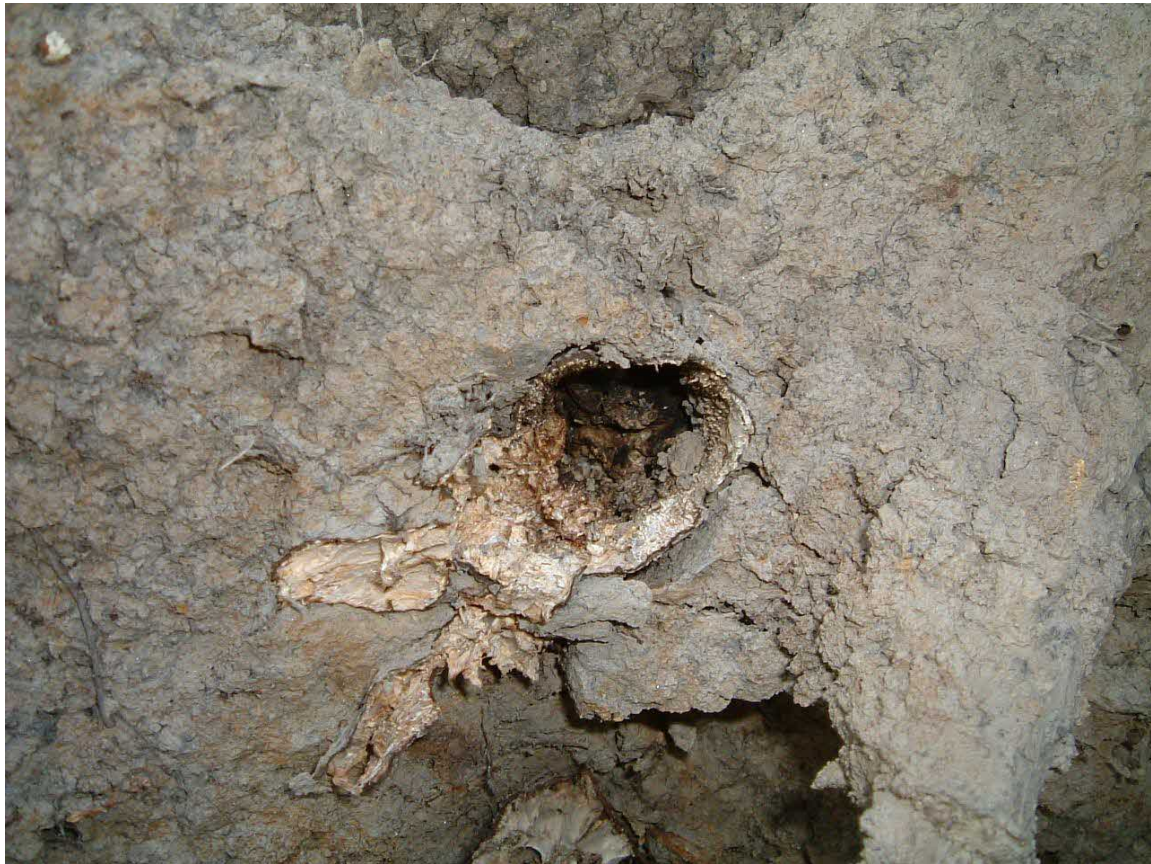
Image 3 – Uprooted Beech host to Meripilus. Photo shows anchorage root hollowed out by the fungus

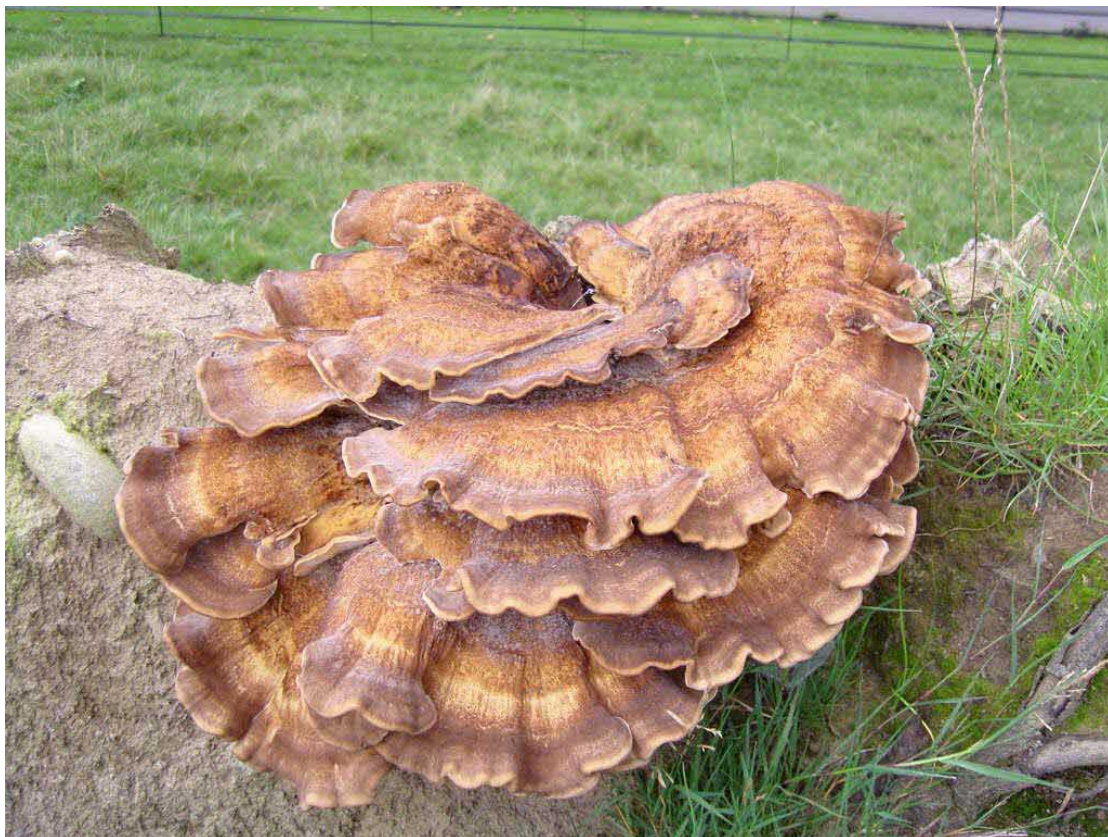
Image 4 - Example of a fresh fruiting body of Meripilus

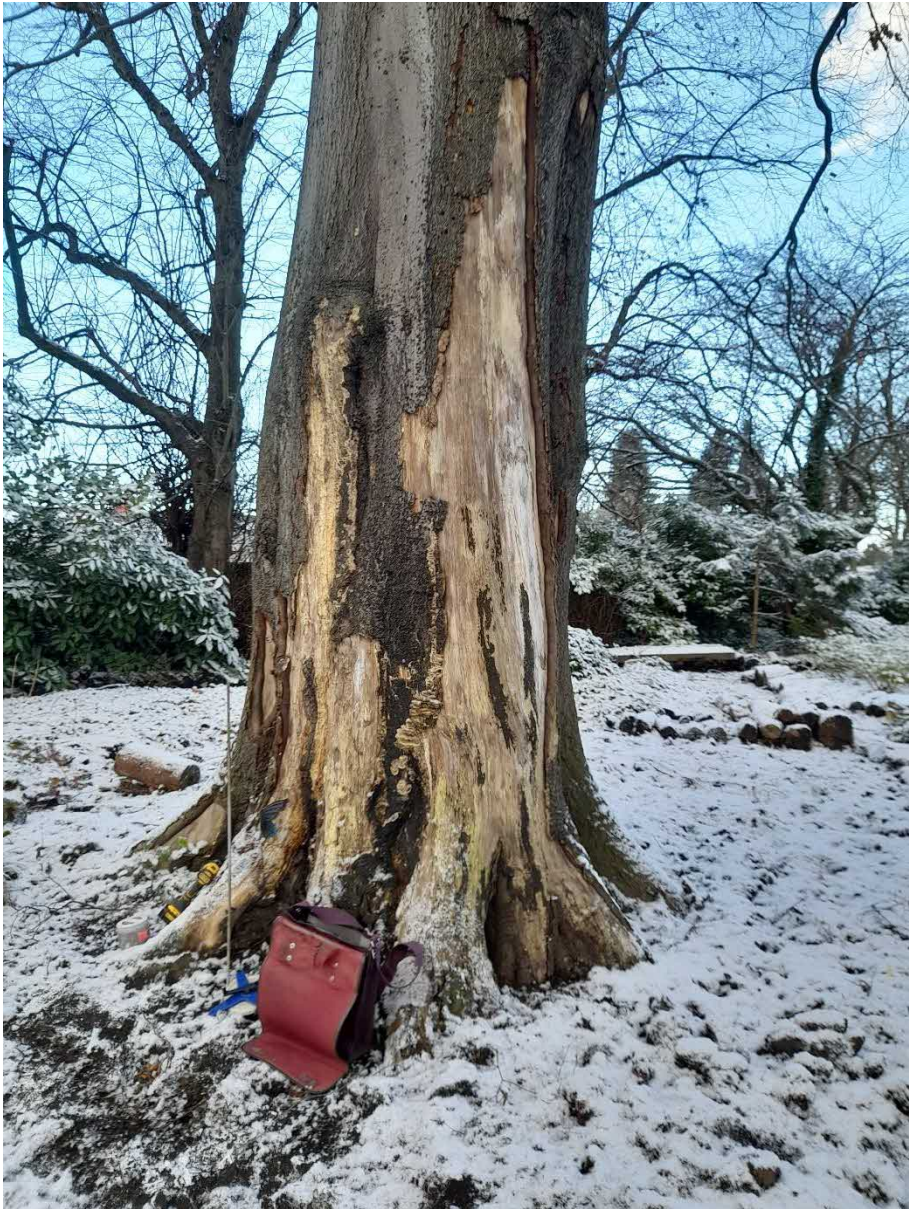
14. Two trees were considered to warrant assessment beyond a simple visually assessment -T476 and T477, both mature Beech trees.
15. T476 has suffered bark loss due to fire damage but the damage at this stage appears superficial with saprophytic fungi consuming the dead bark and sapwood. The impact on the heartwood at this stage is negligible.

Photo 1- extent of bark damage to T476

23. The suggested works schedules can be seen in the Data Table at Appendix 1.
24. The next step would be to submit a formal planning application to Durham County Council to gain consent to carry out the works in Appendix 1.
25. T476 should be monitored for the presence of decay pathogens with the next tree inspection carried out in September 2028.

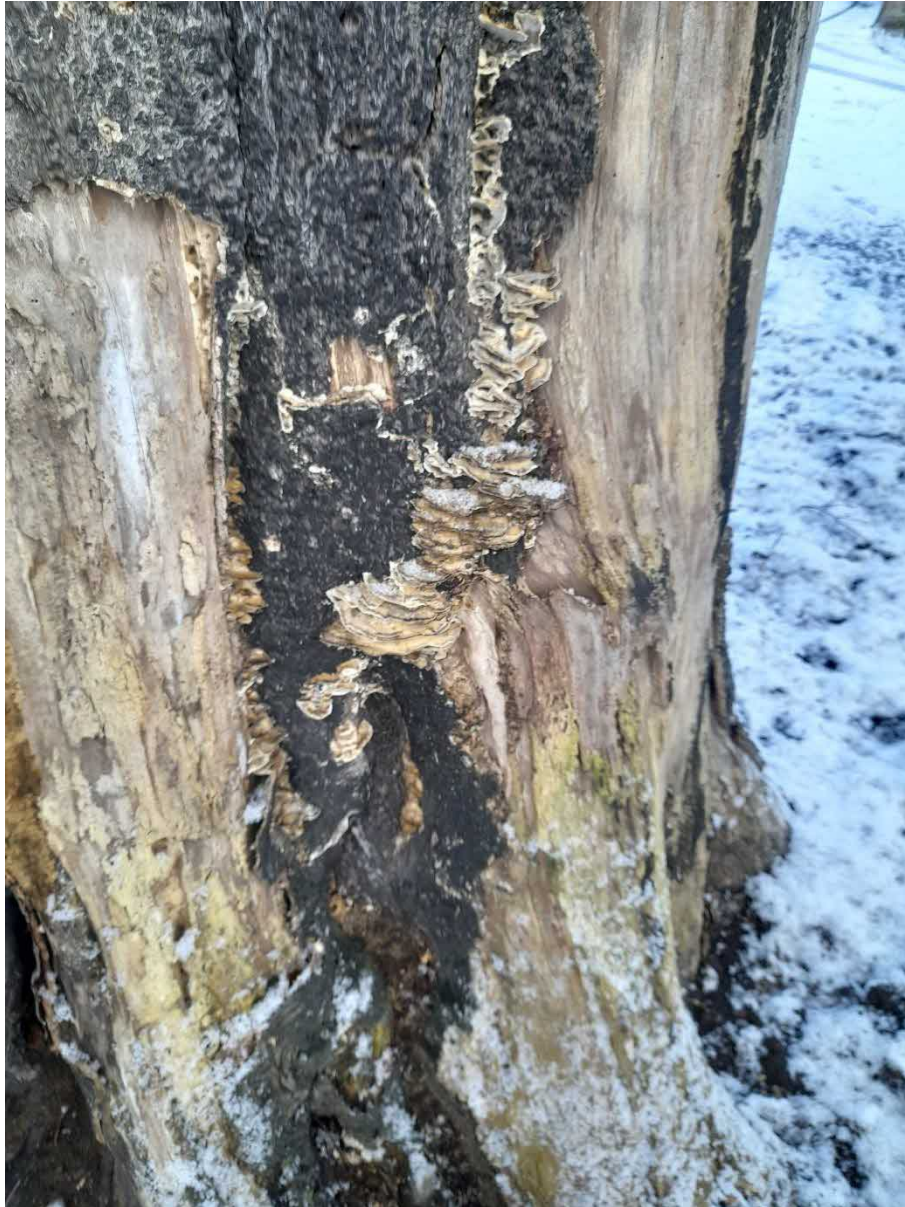
Photo 2 – T476 – Detail of Turkey Tail fruiting bodies (*Coriolus versicolor*)

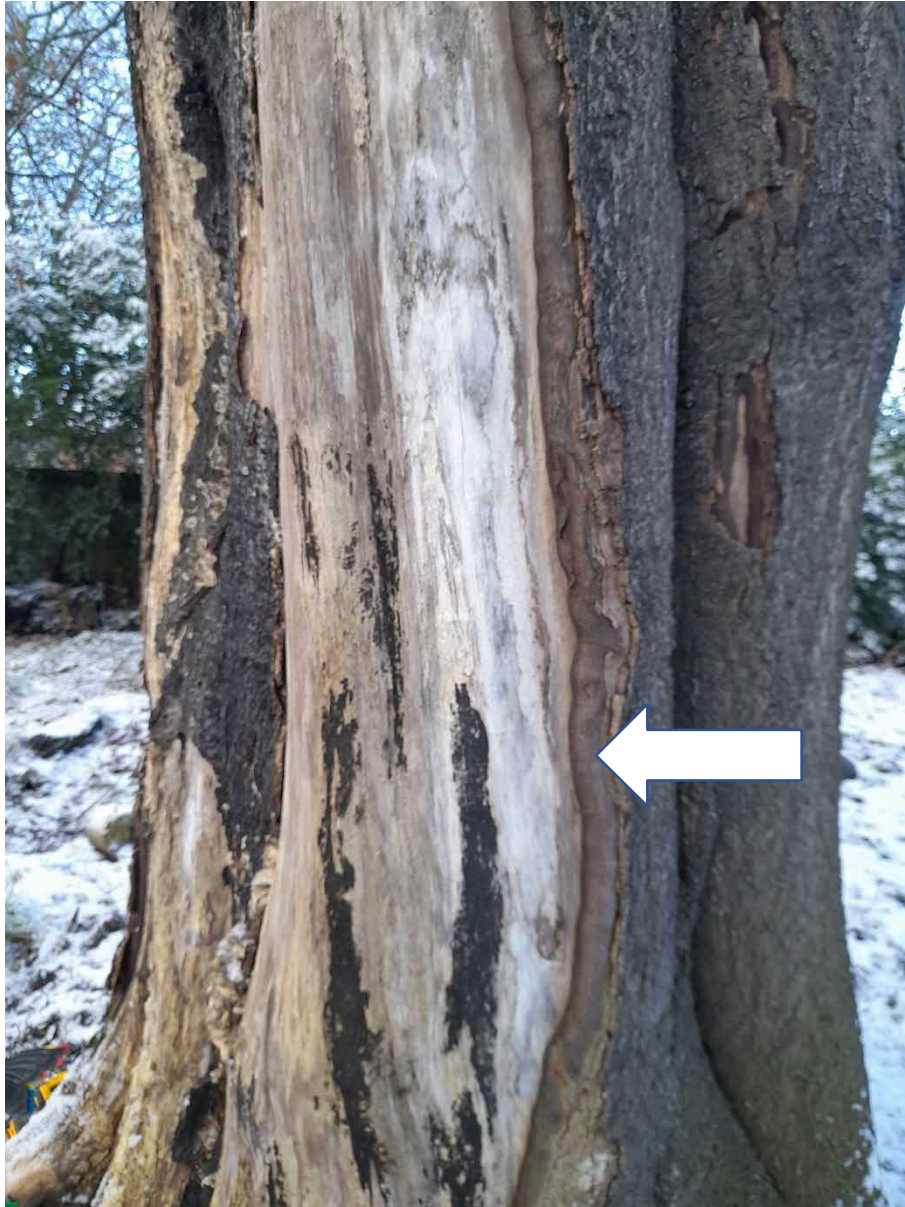
Photo 3- T476. Arrow shows new bark trying to bridge damaged area.

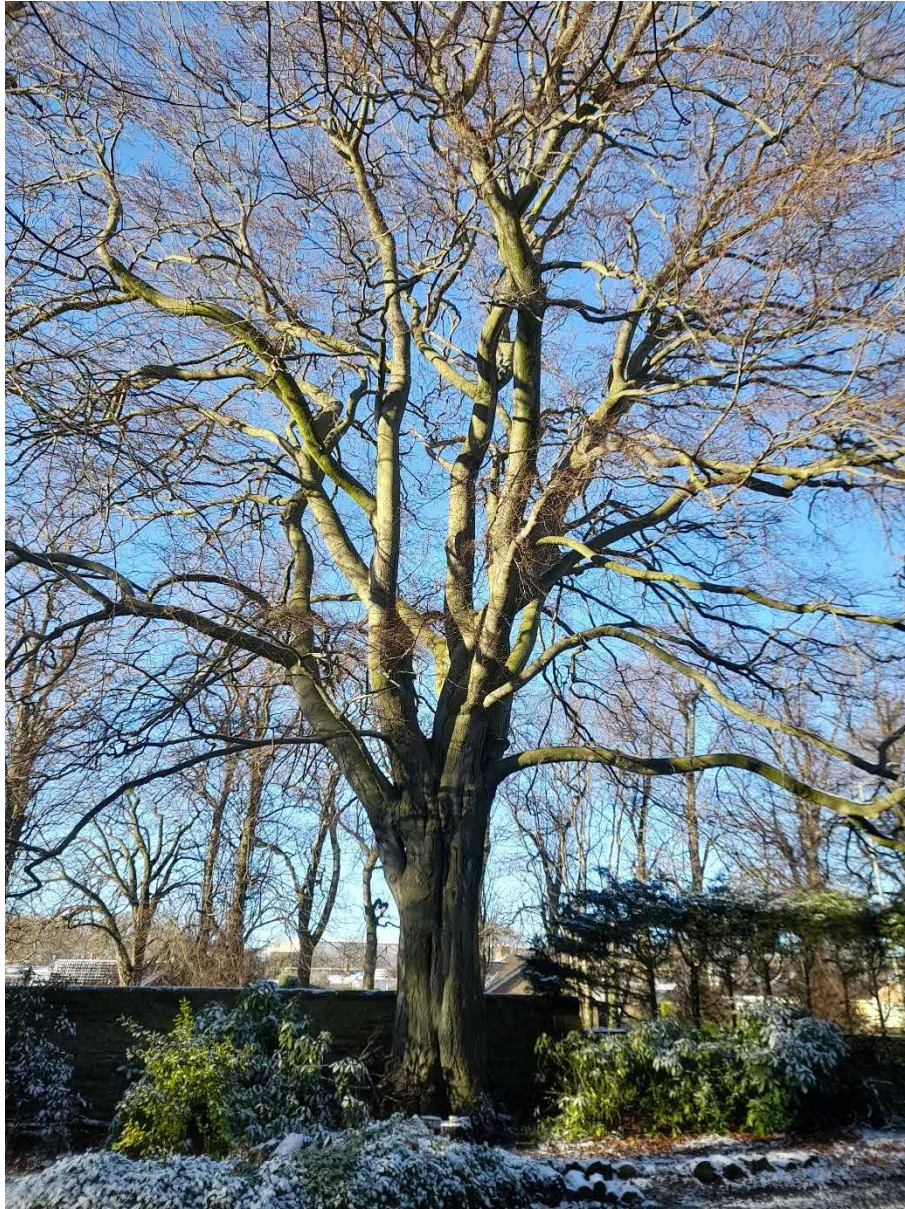
Photo 4- T477

16. Of more concern is the fate of T477, a magnificent mature Beech that contributes significantly to the street scene. The canopy is full and symmetrical with very little deadwood and no obvious defects. However, there are three sites around the base that have fruiting bodies at the soil interface. These fruiting bodies belong to a root decay fungus Giant Polypore (*Meripilus giganteus*).

19. A VALID tree risk/benefit assessment was carried out and the risk was Not Tolerable.
20. Some reassurance can be had from the fact that the tree is still standing following 3 major storms in the last 12 months and I conclude that the infection is relatively new, but my recommendation is to remove this tree as the targets are very high value (A167) and the effect of the infection is well documented.

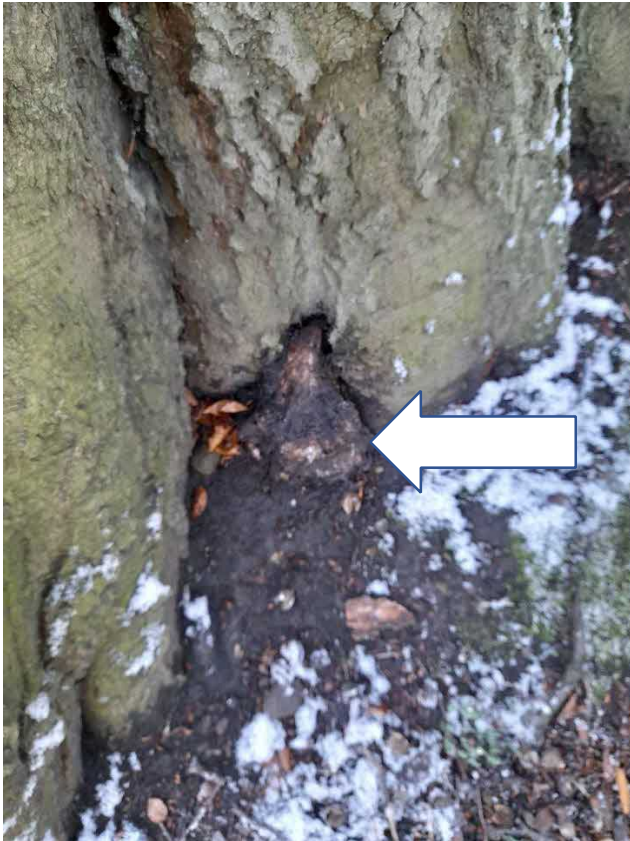
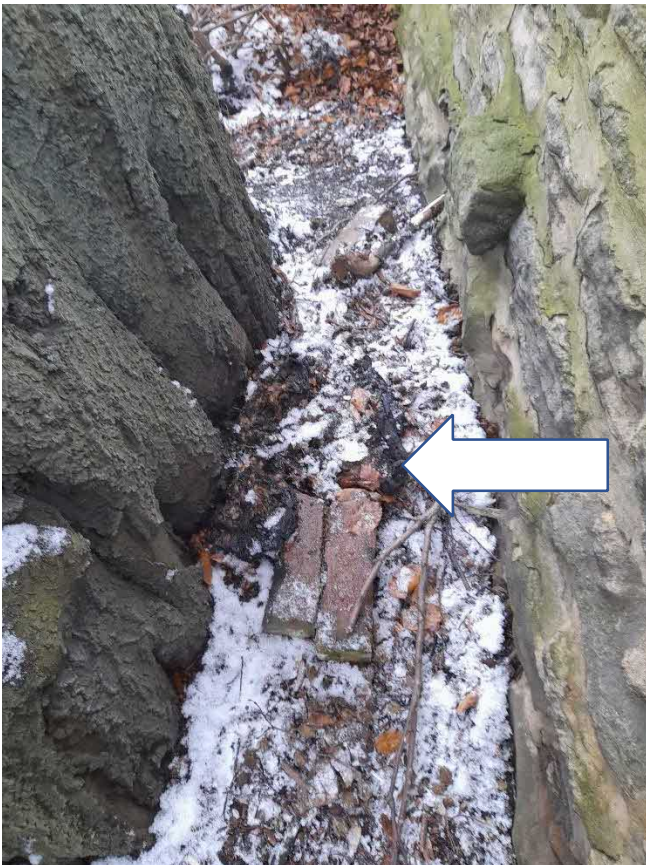
17. This fungus is particularly dangerous as it hollows out the roots, degrading tensile strength whilst still conducting water via the root sapwood. The tree can appear in rude health with a full canopy immediately prior to the whole tree uprooting, particularly whilst in leaf.

Photos 5 and 6 - 2 of the 3 locations of fruiting bodies of *Meripilus giganteus* (Giant Polypore)

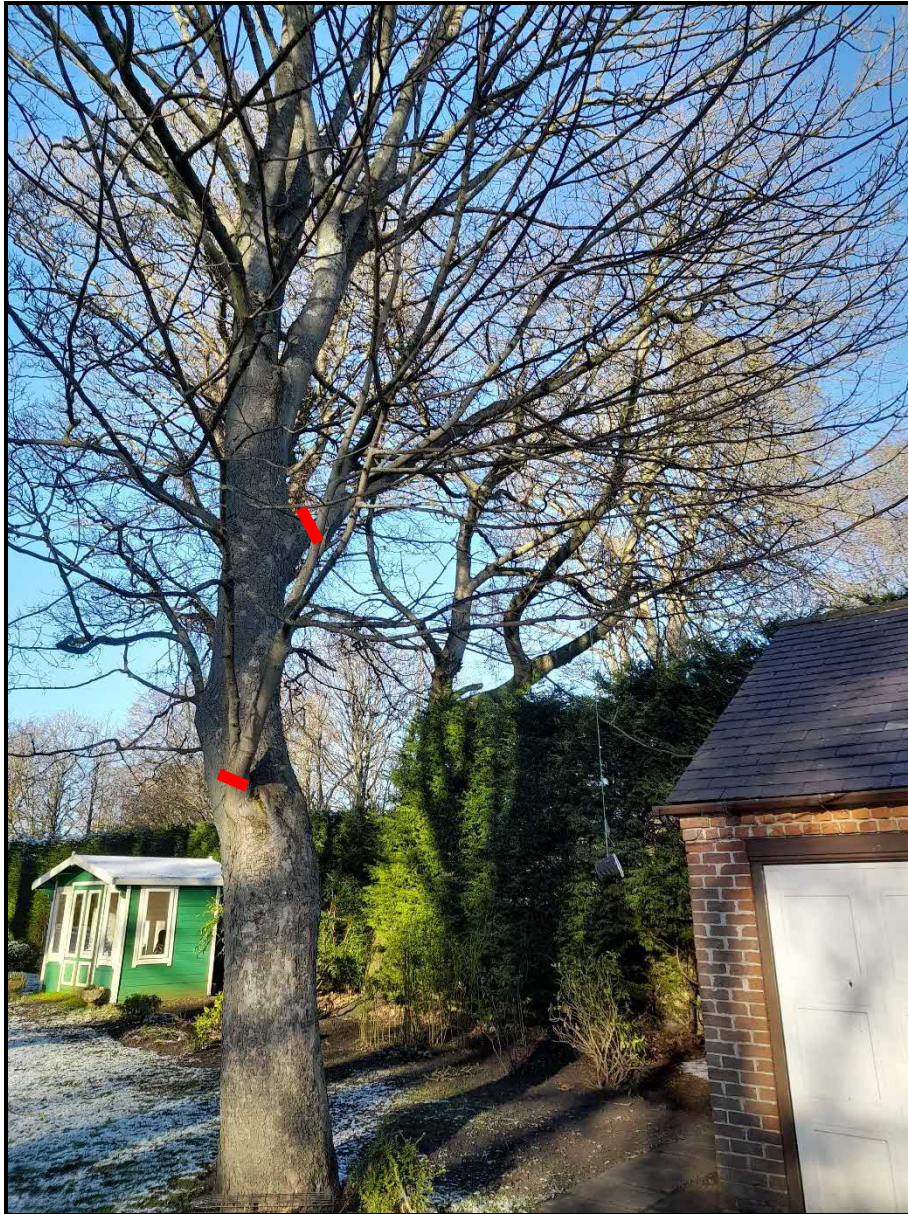
Photo 7 – T480. Red lines indicate proposed pruning cut locations

Tree No.	Species Common Name Genus species	Height (M)	Crown Spread (M)				Trunk Dia. (MM)	Age	Physiological Condition	Structural Condition	Estimated Remaining Contribution (Years)	Tree Quality Assessment	Observations	Suggested works	Ultimate Size For Species (M)		Works Priority
			N	S	E	W									Height	Spread	
T480	Sycamore (Acer pseudoplatanus)	16	3	5	5	6	550	Semi mature	Fair	Good	40+	A1	Stem divides above 1.5m. Branches encroaching upon building.	Apply for consent to crown lift to 5m.	22	16	C
