Buildings at East Field House
Mickleton
Co Durham

archaeological building recording

report 5173
October 2019

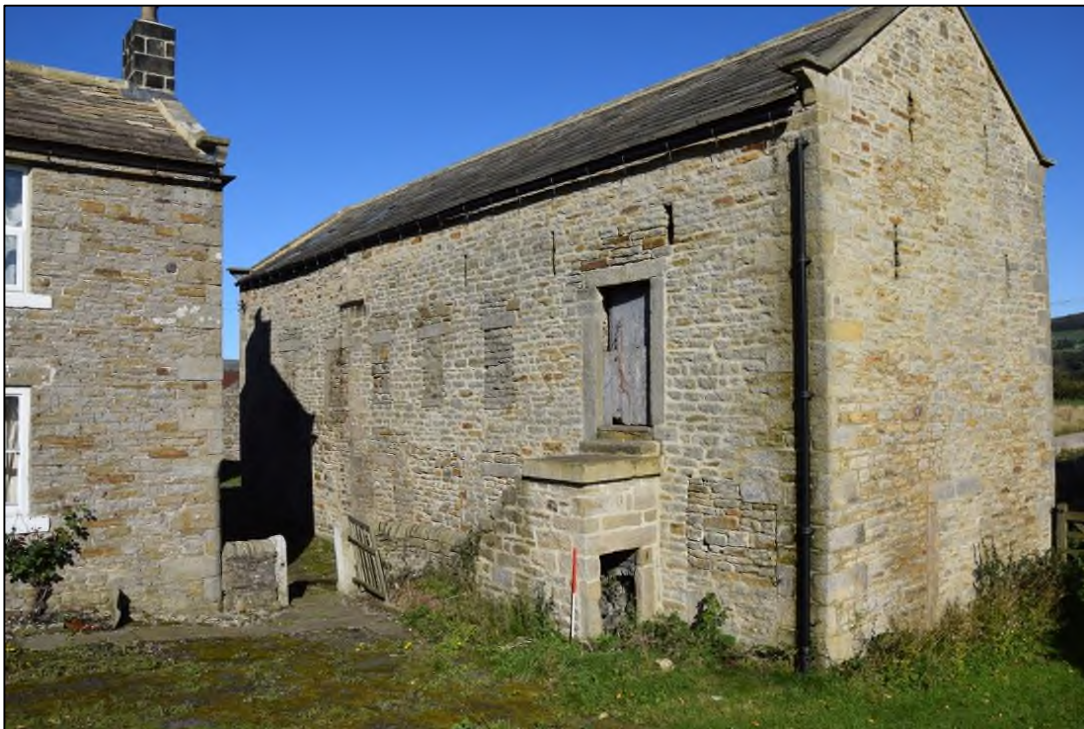
Photograph 4: Building 1. Note the placement of the blocked windows with reference to the floor height shown by the door. A dark line below the eaves, left of centre, is the iron strap that reinforces the junction between the older block and the extension at the far end

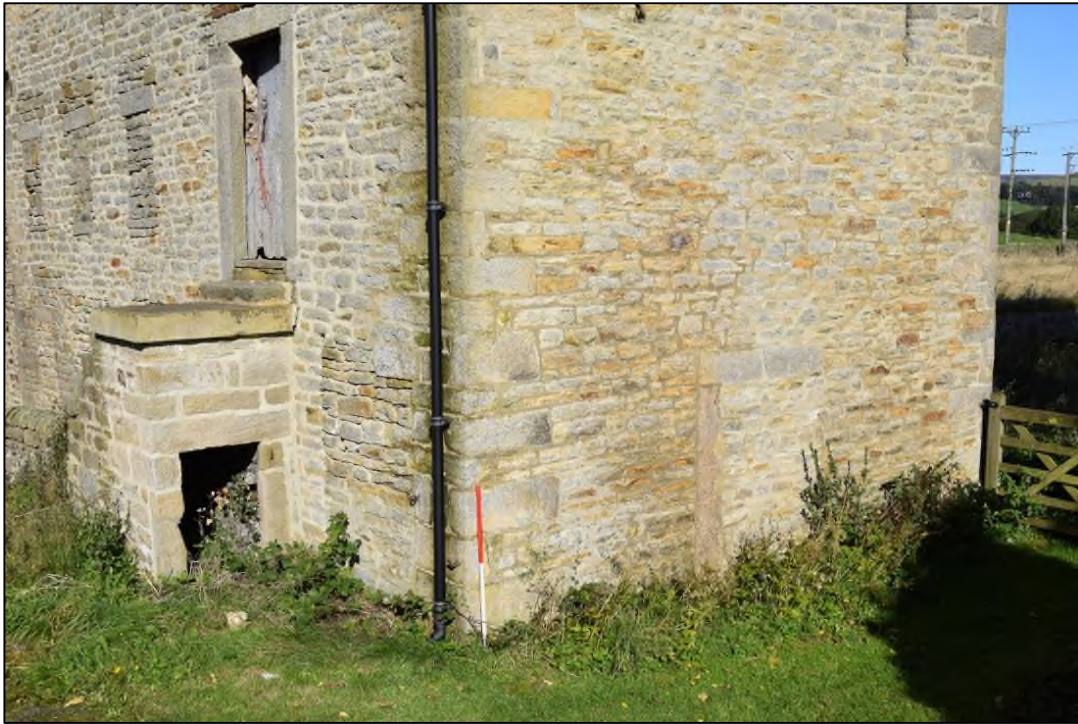
Photograph 5: The blocked opening at the east end of building 1. Recent repointing is apparent, as is the rebuilding of the stone staircase

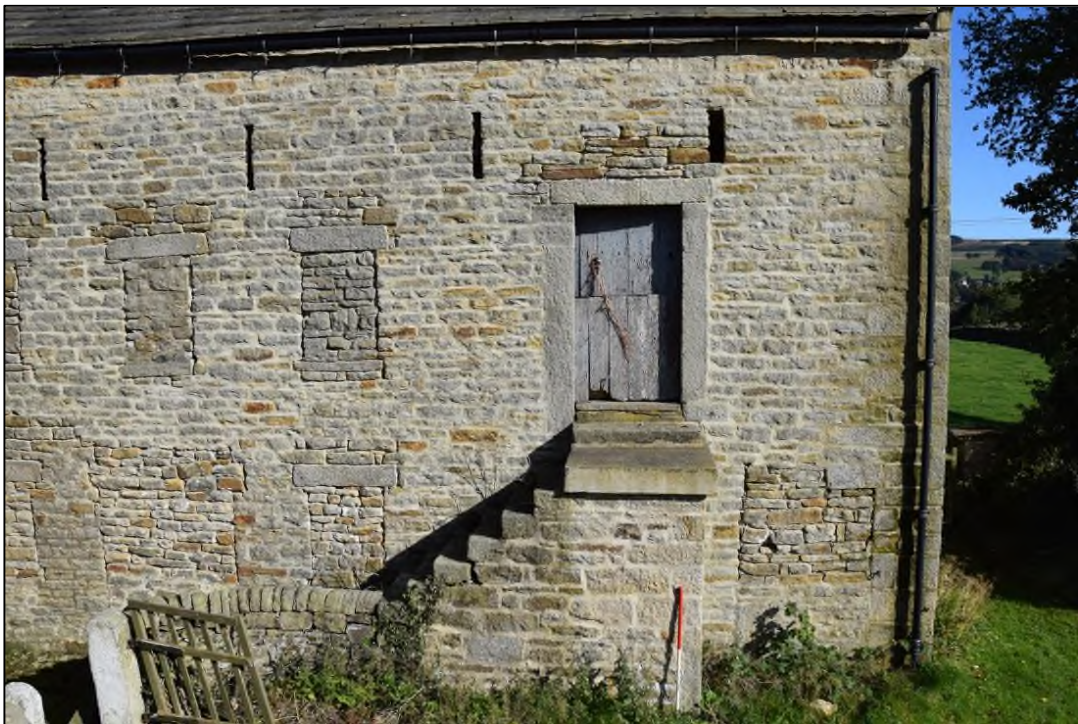
Photograph 6: The hay loft entrance near the south-east corner of building 1. Blocked doors can be seen to the right of the staircase and above the wooden gate

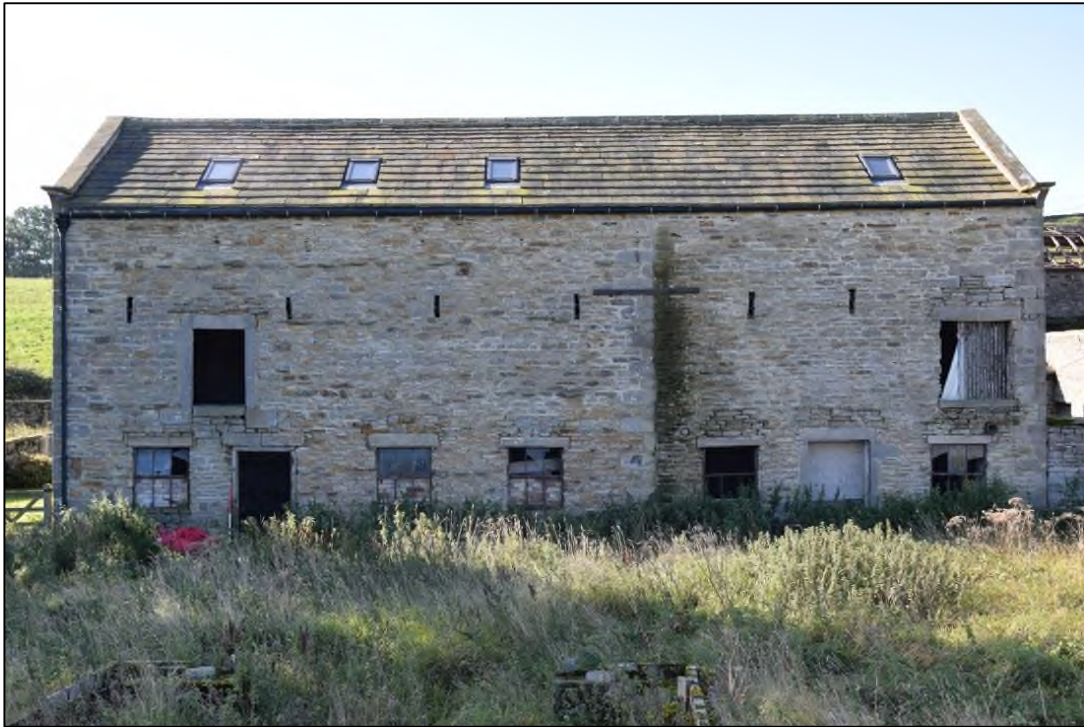
Photograph 9: The division between the two parts of building 1 is very clear in this view of the north face. The open stonework above the openings is the result of repair of the door and window lintels

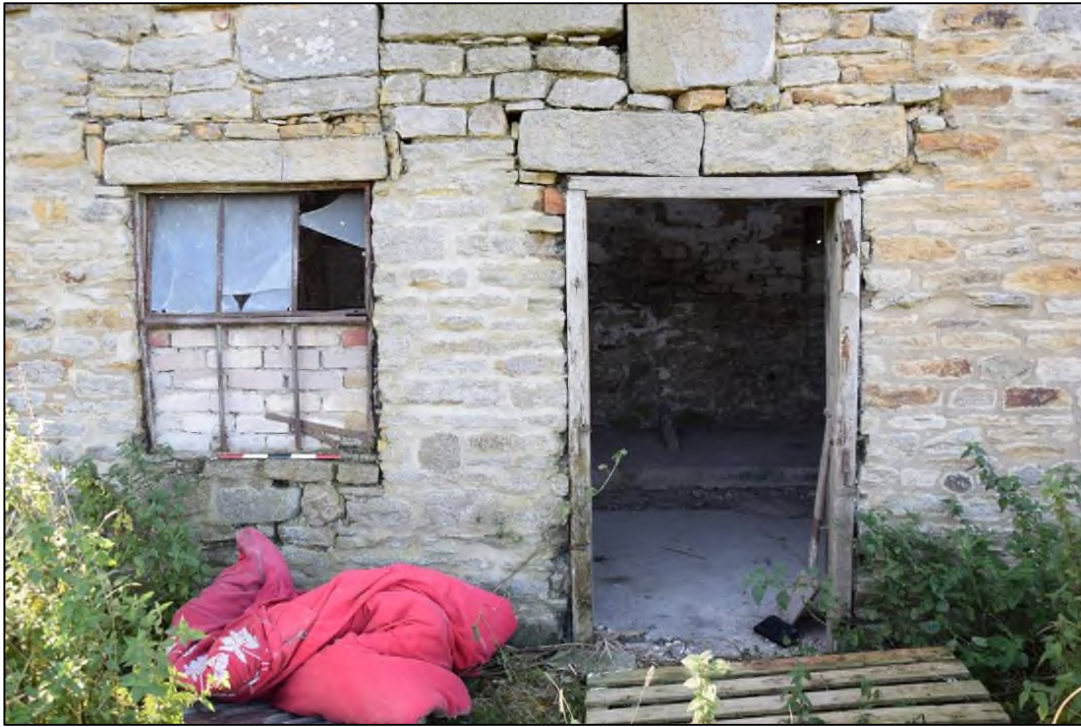
Photograph 11: Detail of the door and window at the east end of the north face. The loading door above has been altered

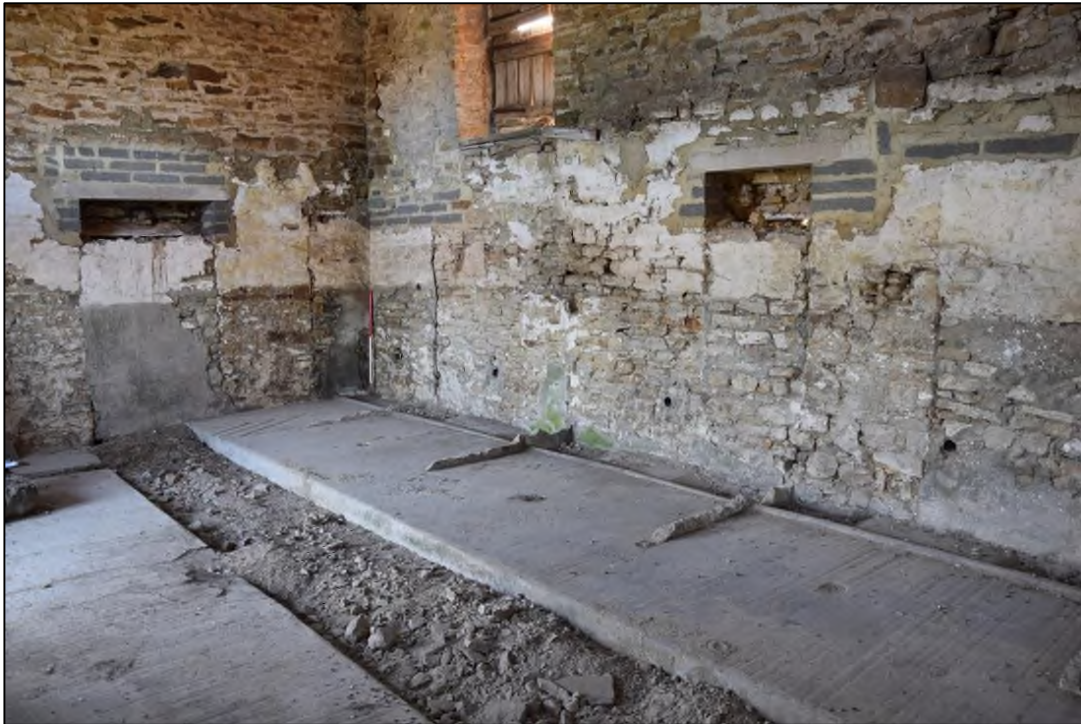
Photograph 15: Inside building 1 are the remains of 20th-century cow stalls and a large floor drain. Recent repairs to the door and window lintels can be seen. A view looking south-east

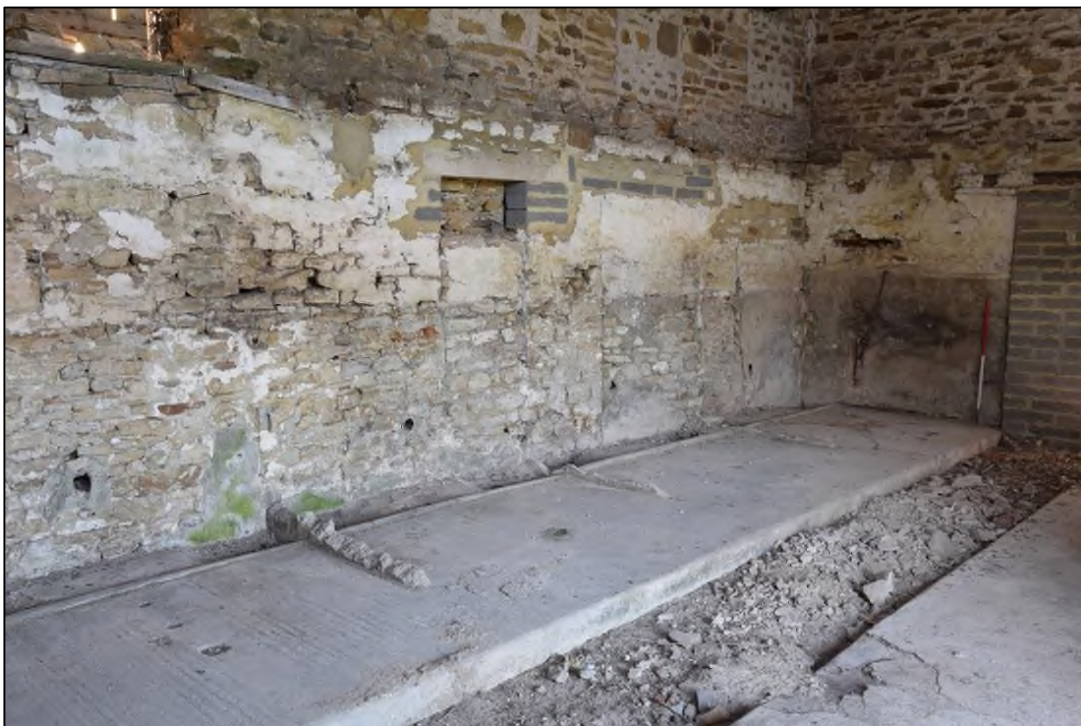
Photograph 16: A view looking south-west in the old part of the building. Older masonry fills the first-floor windows, above the recent repairs

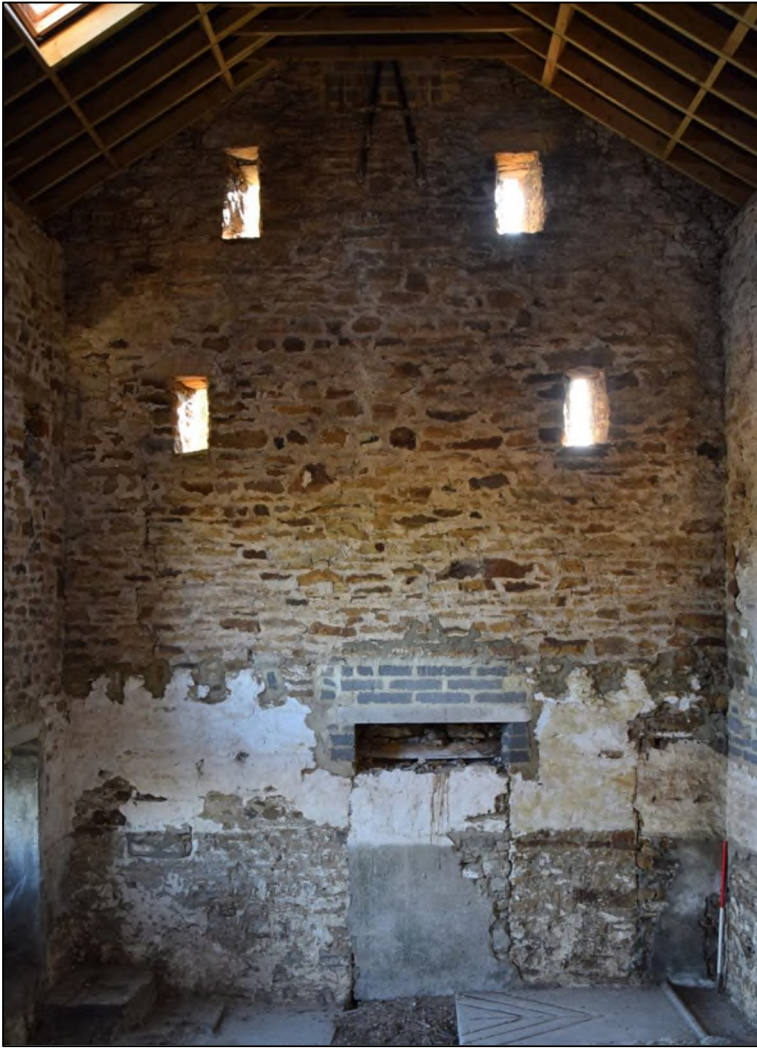
Photograph 17 (left):
The east end of building 1, showing the wall finishes restricted to the byre. There is no sign of a loft; the roof is new

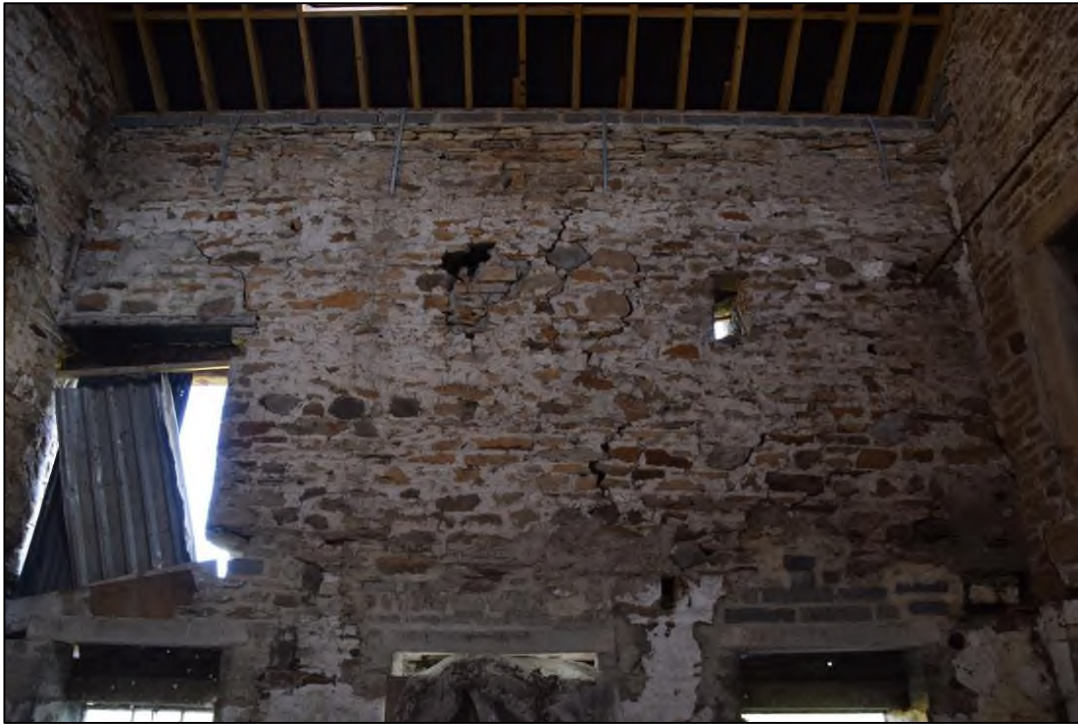
Photograph 25 (above): Settlement cracks can be seen in the north wall of the hay loft at the west end of building 1

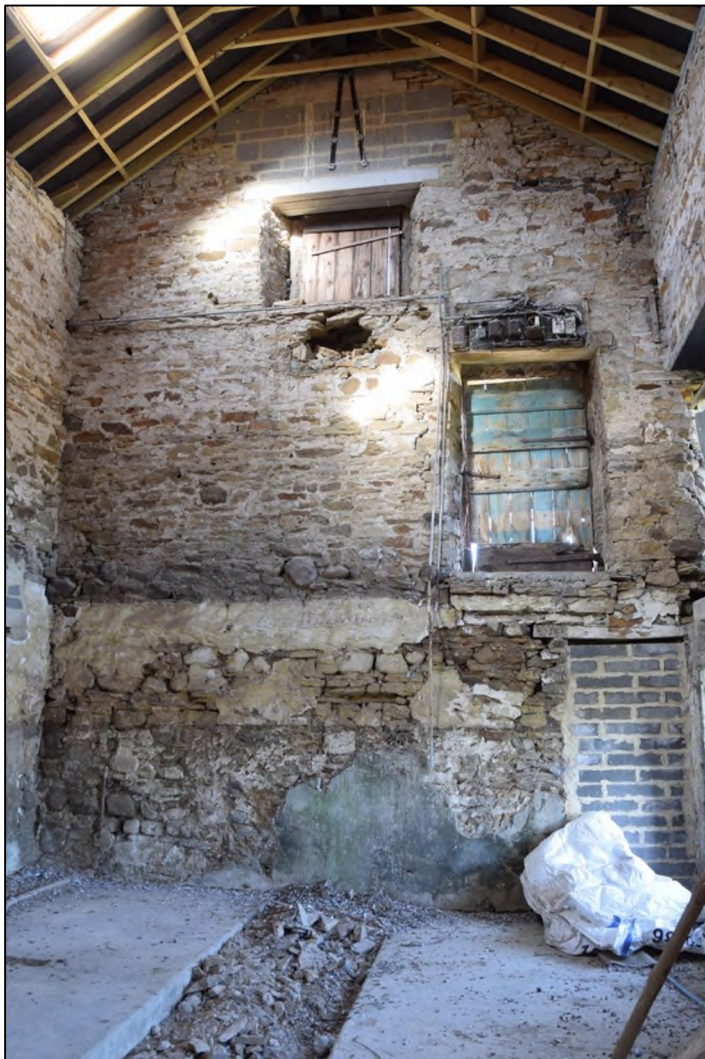
Photograph 26 (left): The west end of the building. The ground-floor door, forced through the wall at the corner, has a thin timber lintel. The door above is served by the external staircase. An apparent floor line below the upper door is an electric cable duct

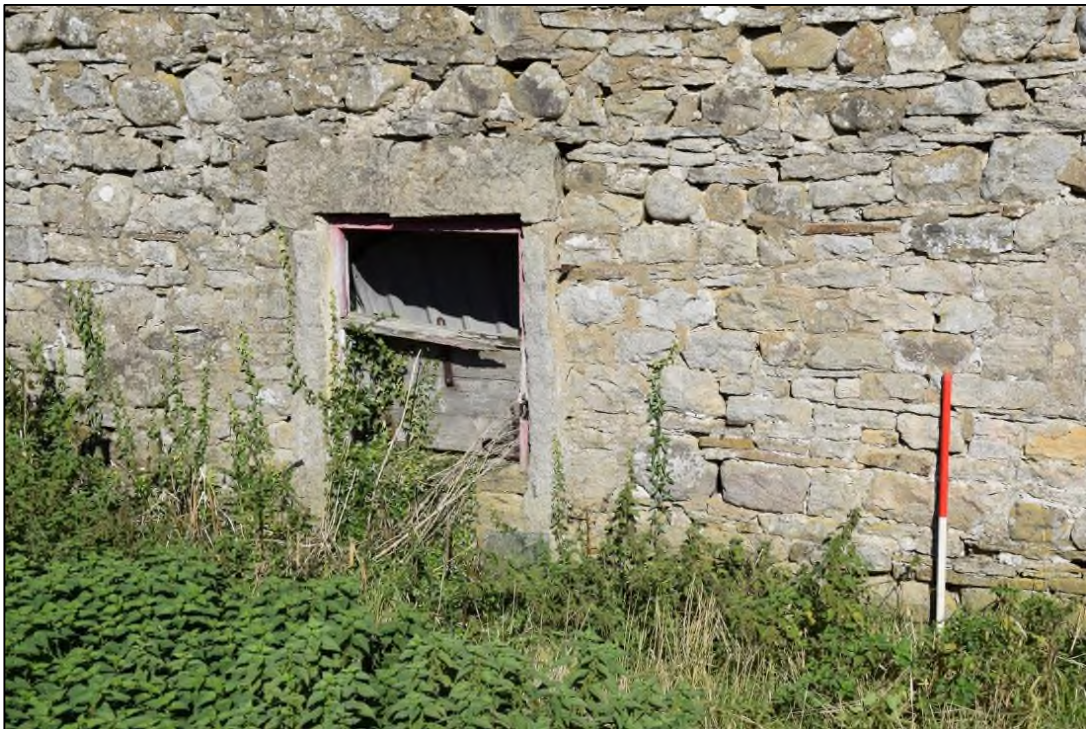
Photograph 34: The west door is partly blocked to form a window for the byre

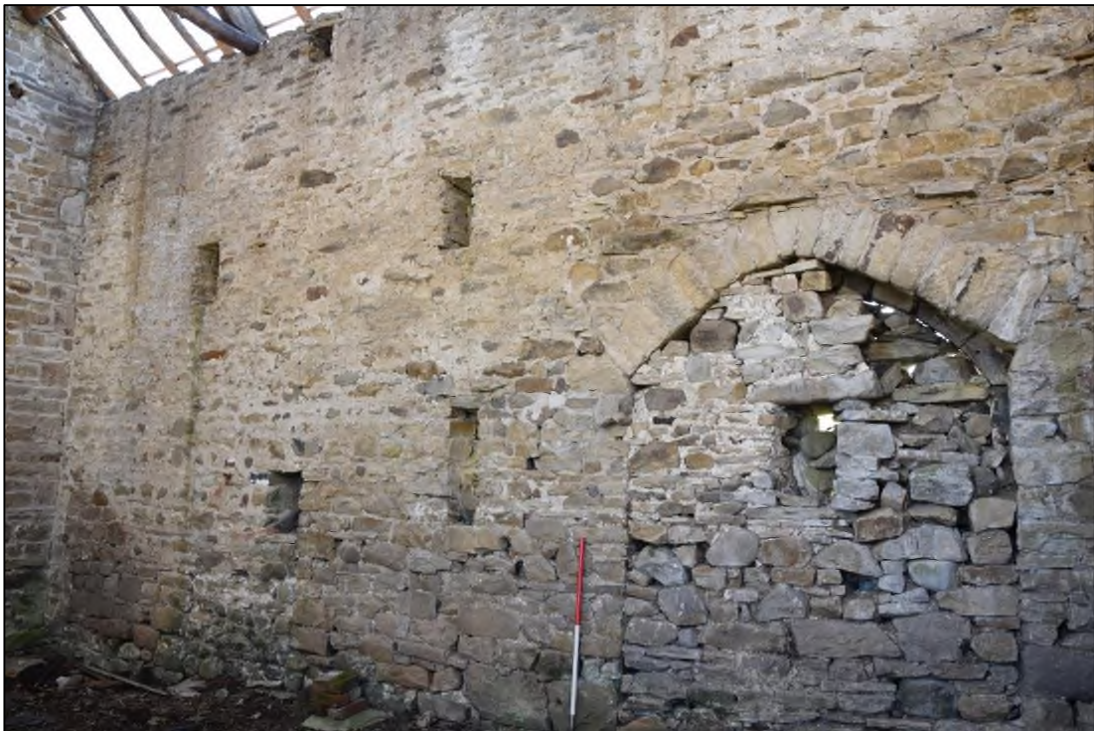
Photograph 40: The rebuilt south wall on the eastern part of the building. Note the change of masonry low down at the far corner

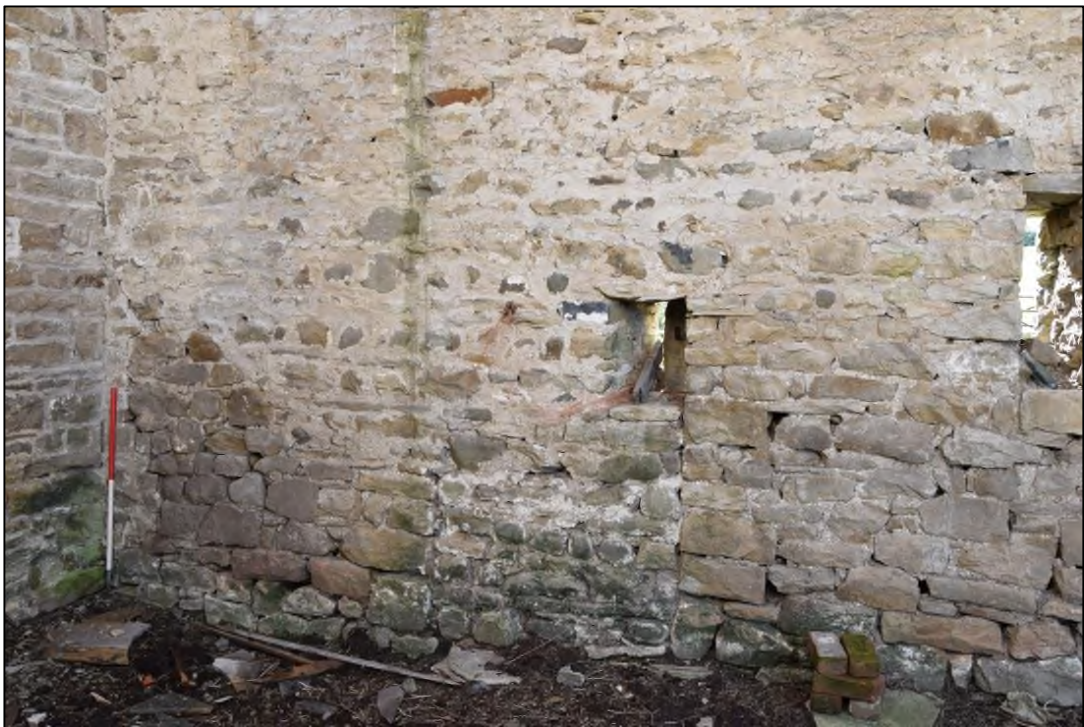
Photograph 42: The truncated blocked door at the south-east corner. The jamb can be seen in the low breather slit. Older masonry survives low down, beside the scale

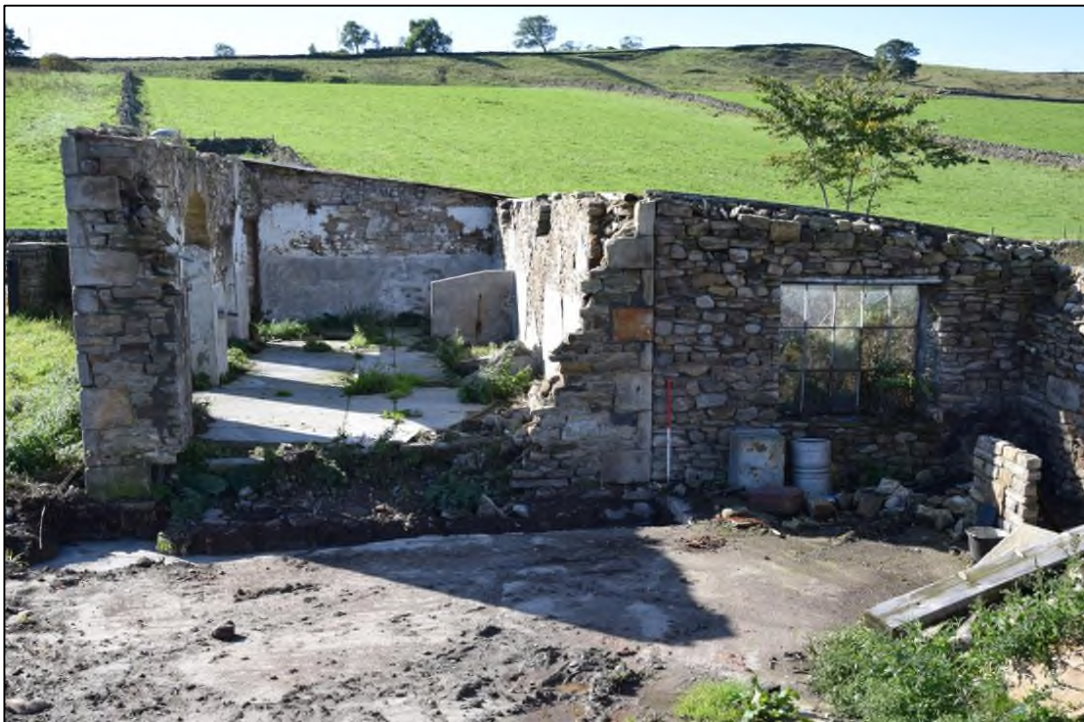
Photograph 50: Most of the north end of the building has been demolished. The wall with the window is what remains of an adjoining single-storey building

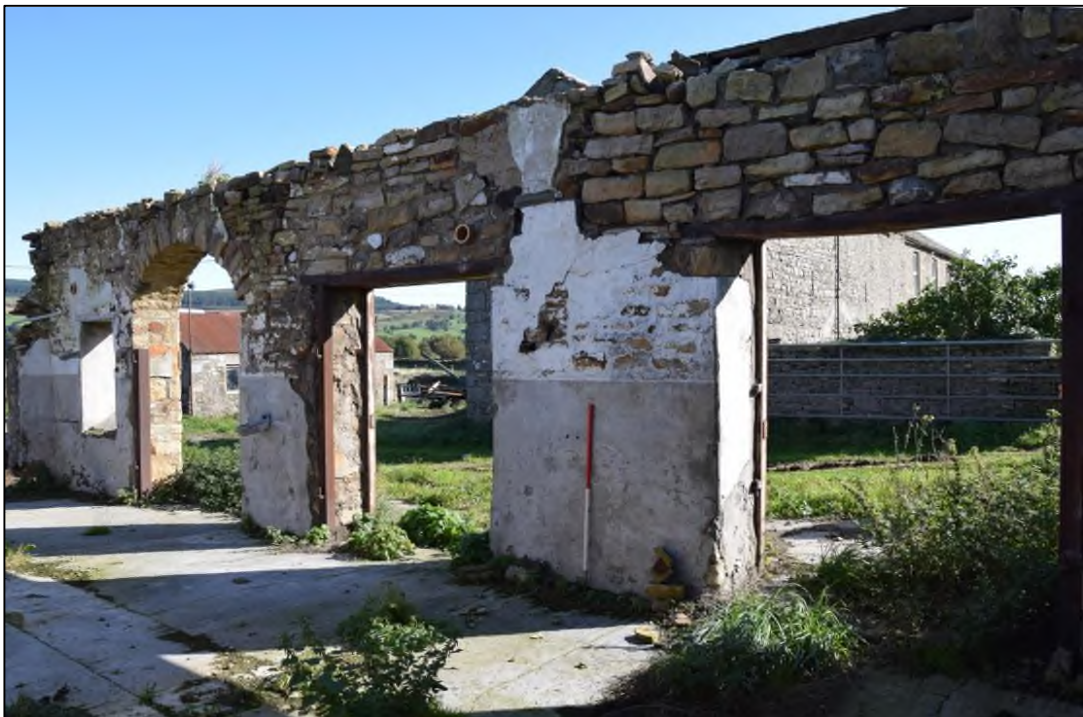
Photograph 58: Much of the upper part of the east wall has been rebuilt in recent times

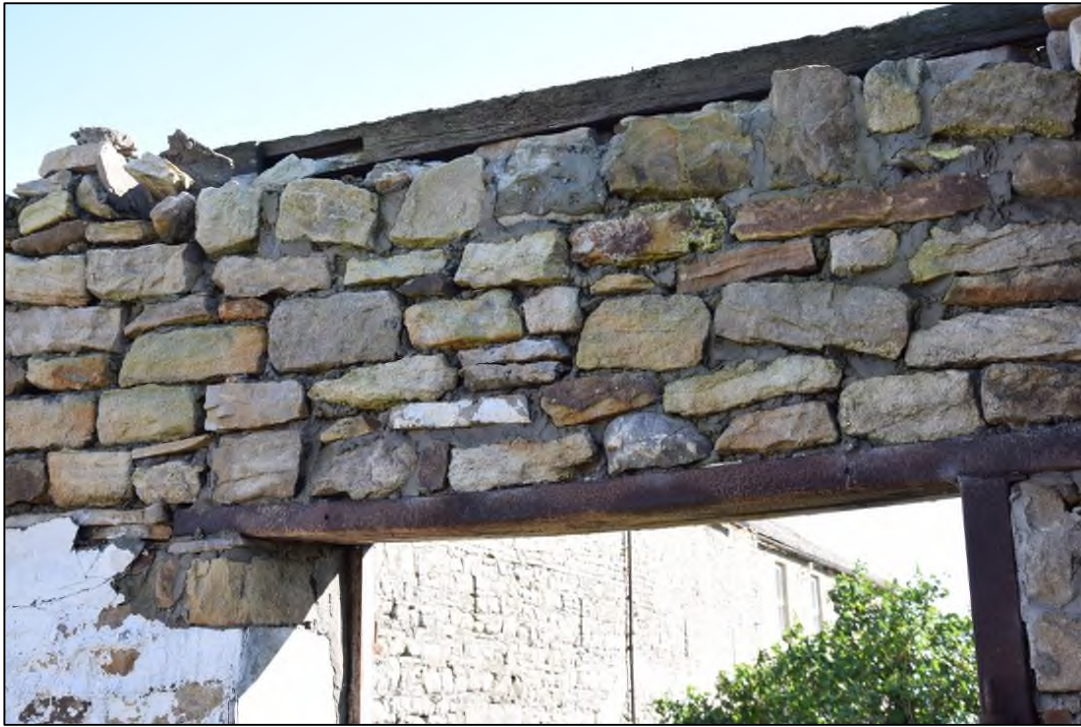
Photograph 59: Detail of steelwork and reset masonry above the south door

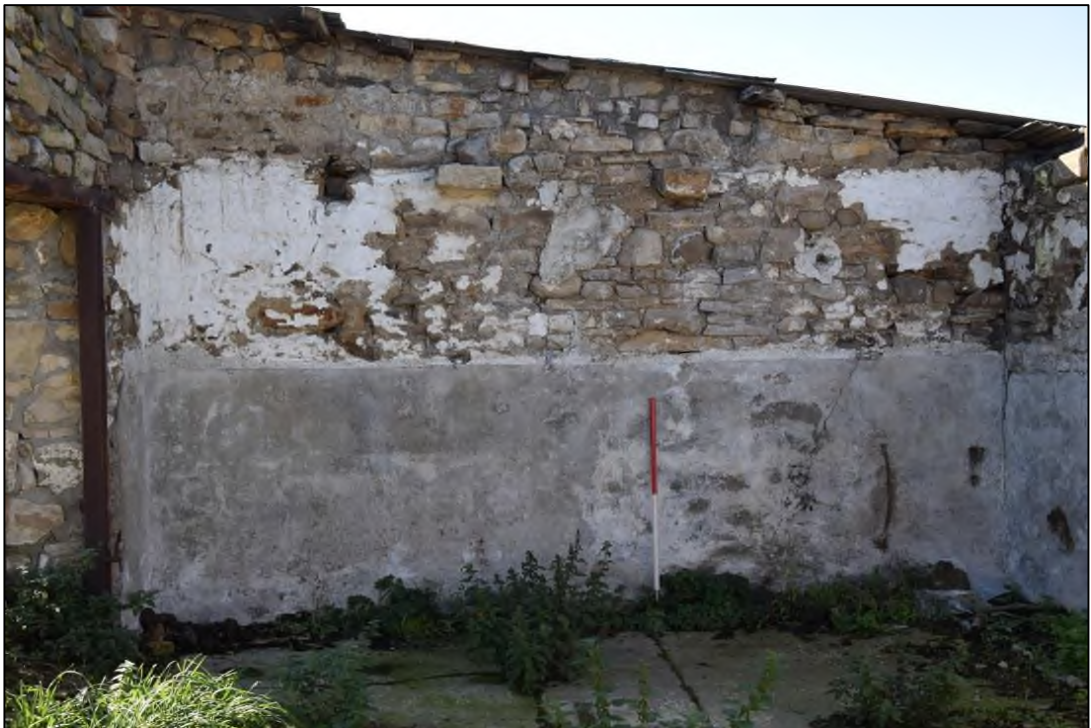
Photograph 62: Cement render on the south wall. The whitewash above indicates the line of the old ceiling
