Schedule of Repairs to Listed Building

Including Photographic Condition Schedule

**South Barn
Tharbies Farm
Rook End
High Wych
Hertfordshire
CM21 0LL**

February 2023

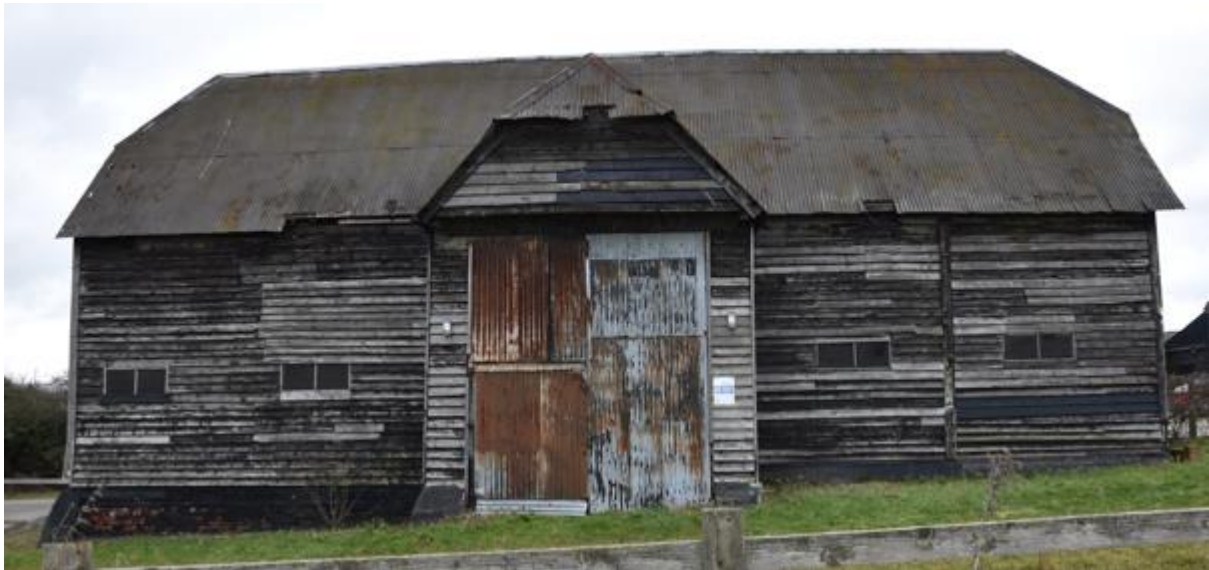
Fig1. South Elevation – Repair projecting top plates. Replace Corrugated Sheeting with slate. Install new metal gutterwork & downpipes. Glaze doors and ventilation gaps. Replace cladding with large section sawn weatherboarding in black.

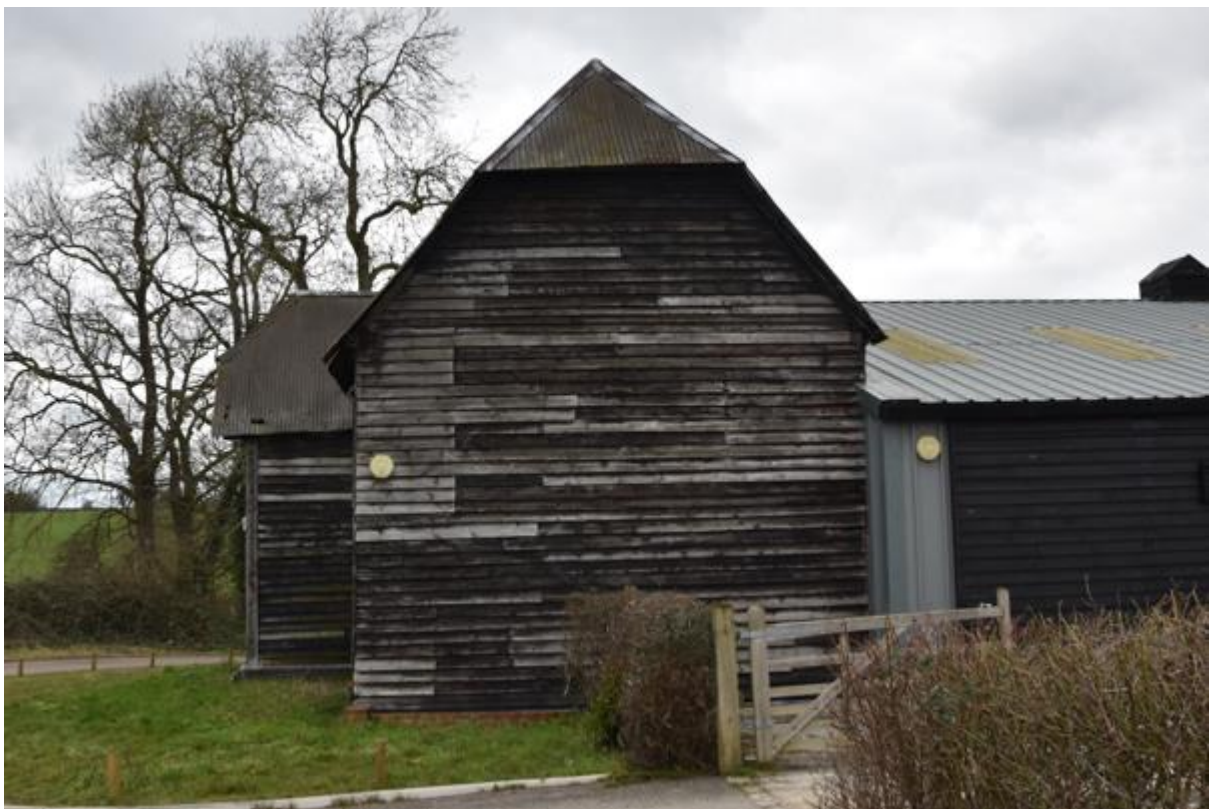
Fig2. East Elevation. Replace gable rafters

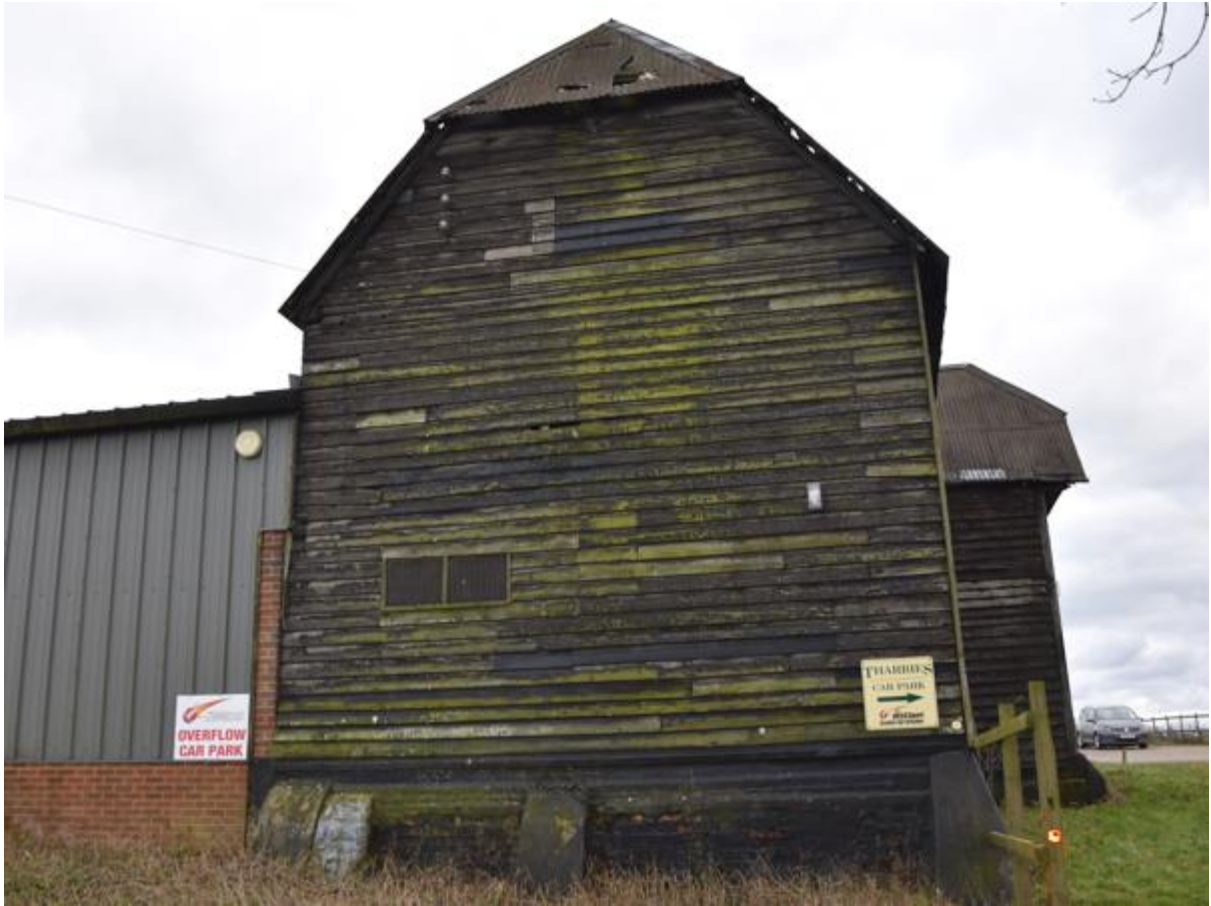
Fig3. West Elevation. Remove redundant electrical equipment. Glaze ventilation gap.

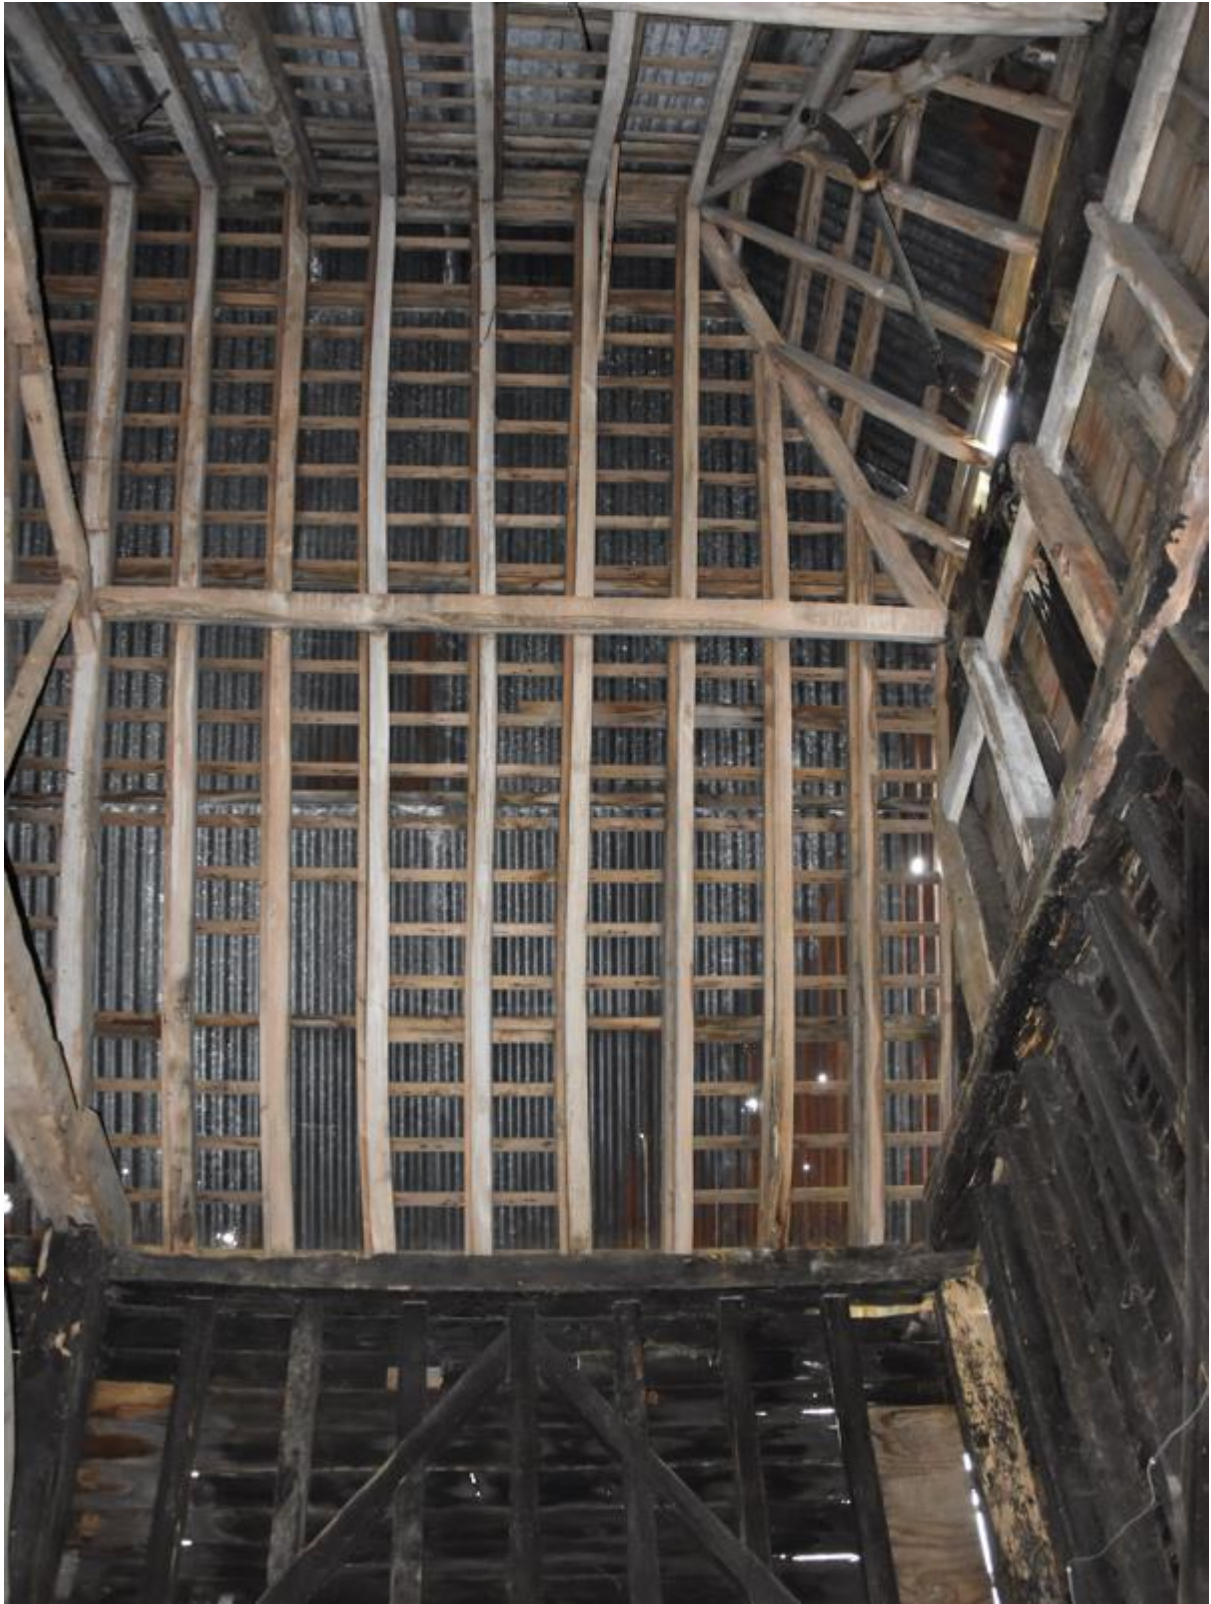
Fig5. Bay 1 South Roof Structure. No repairs required.

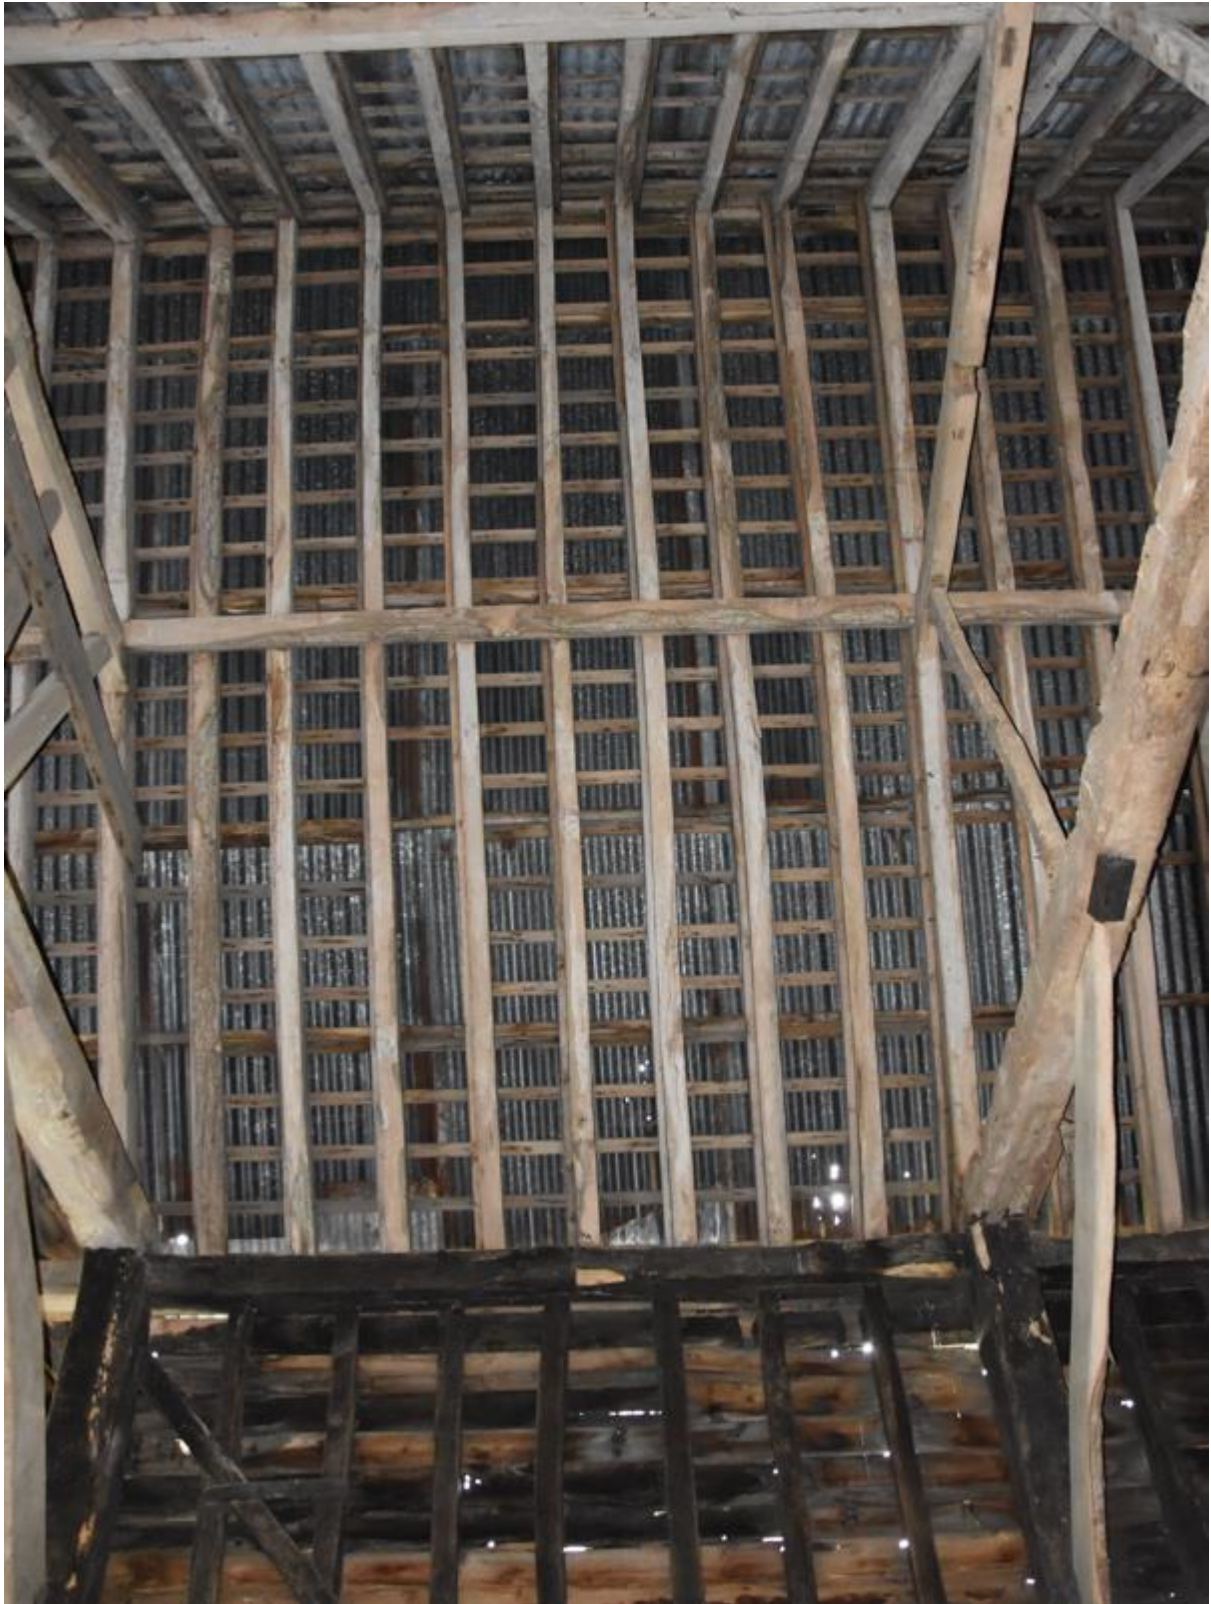
Fig7. Bay 2 South Roof Structure. No repairs required.

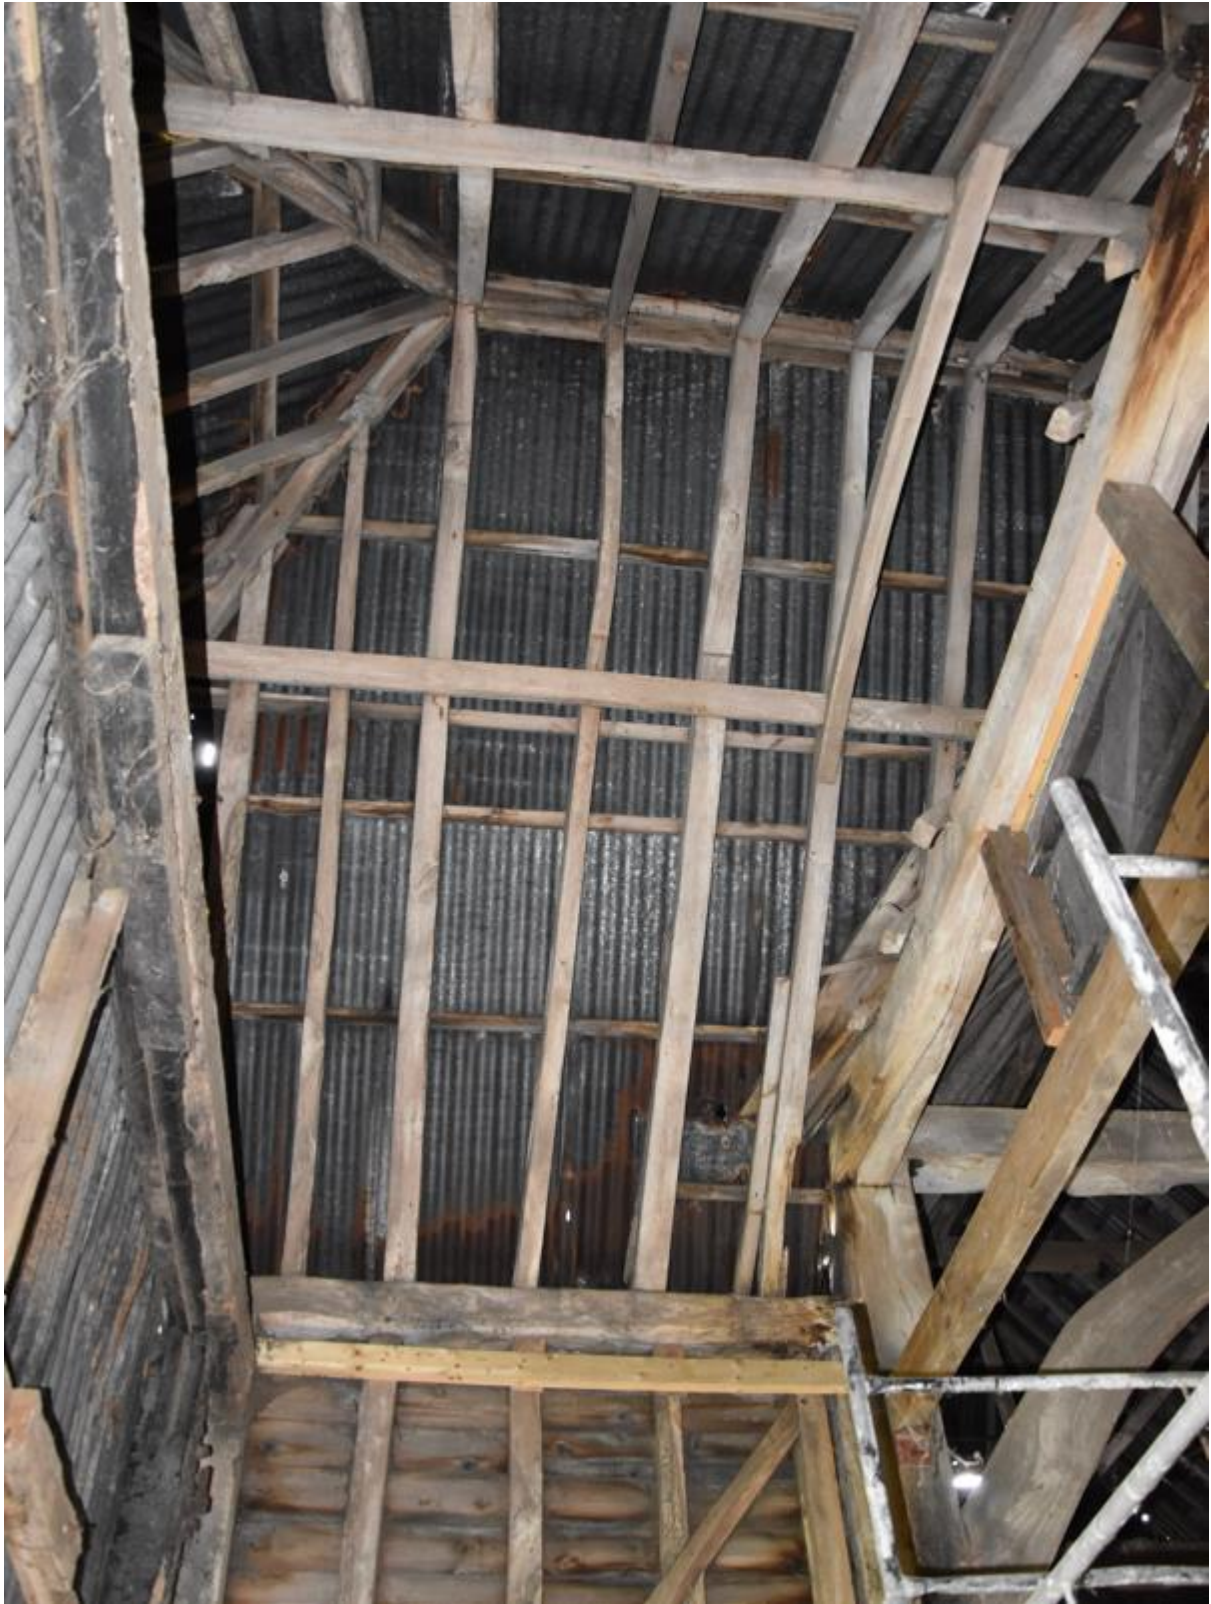
Fig9. Midstrey West Roof Structure. No repairs required.

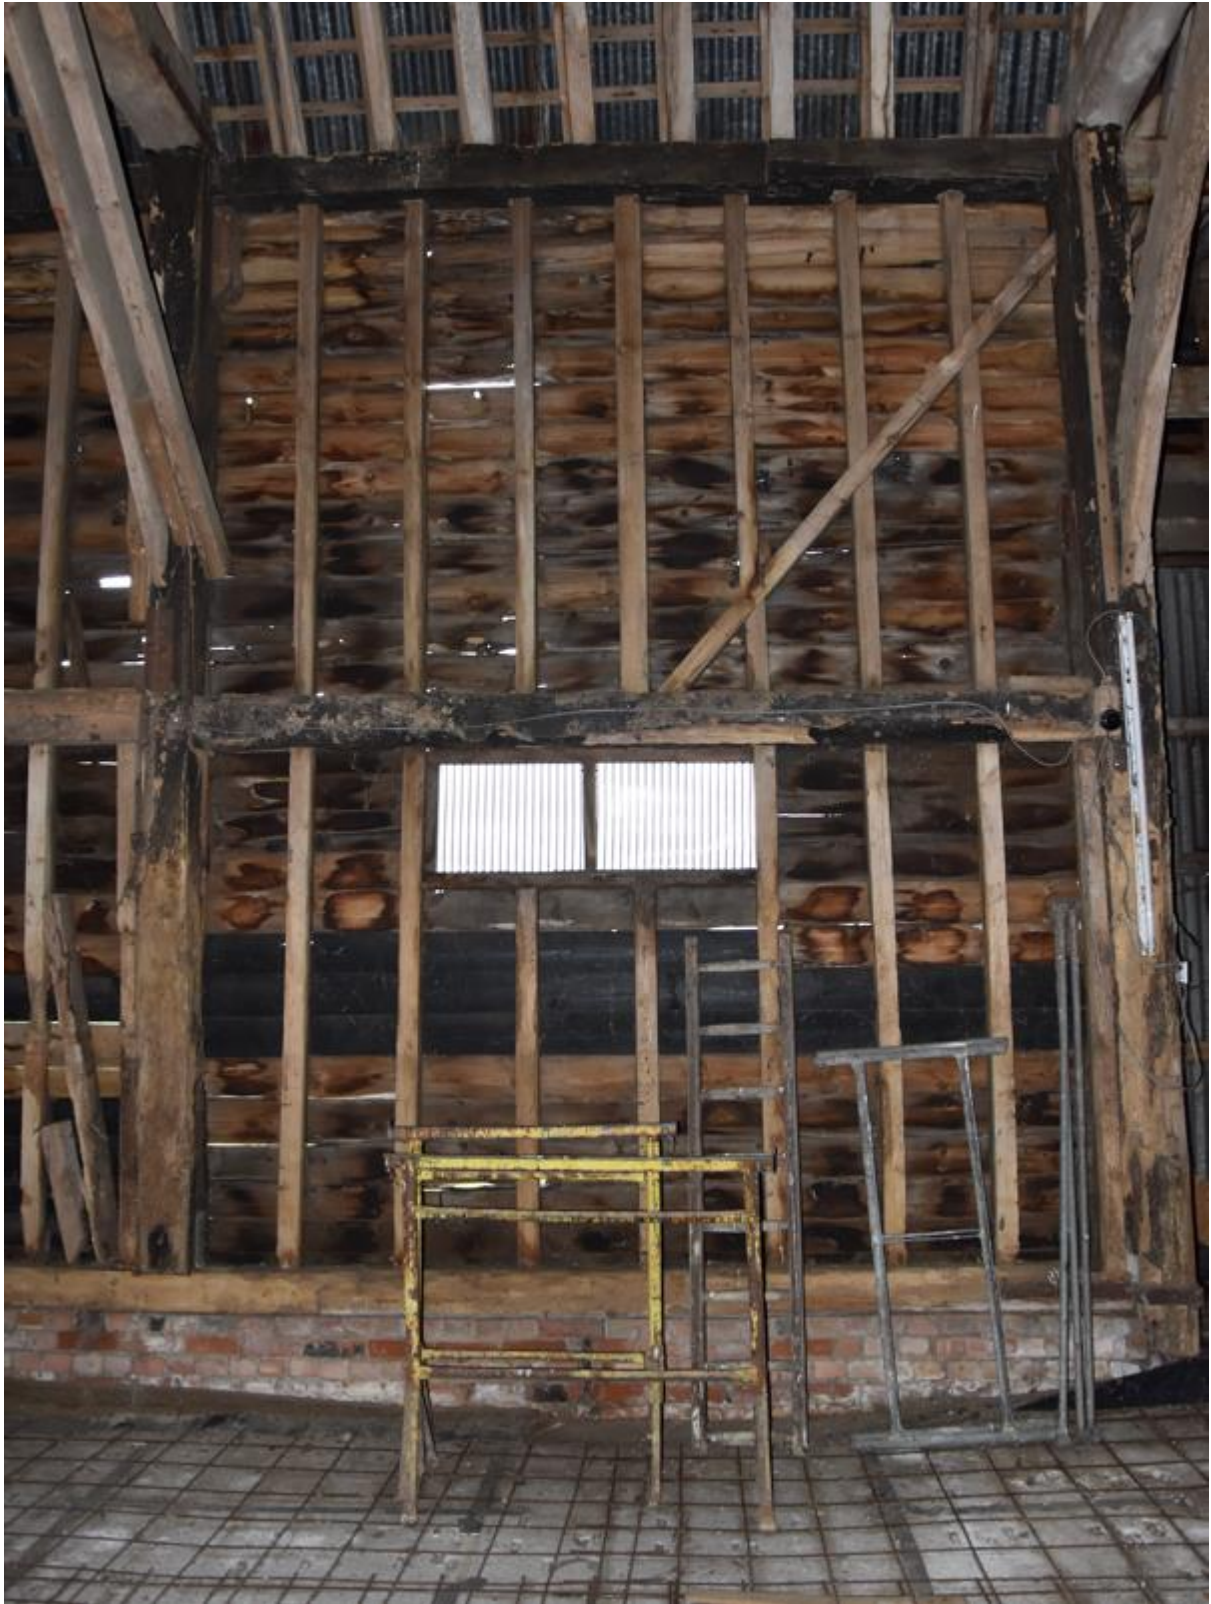
Fig14. Bay 4 South Wall. No repairs required.

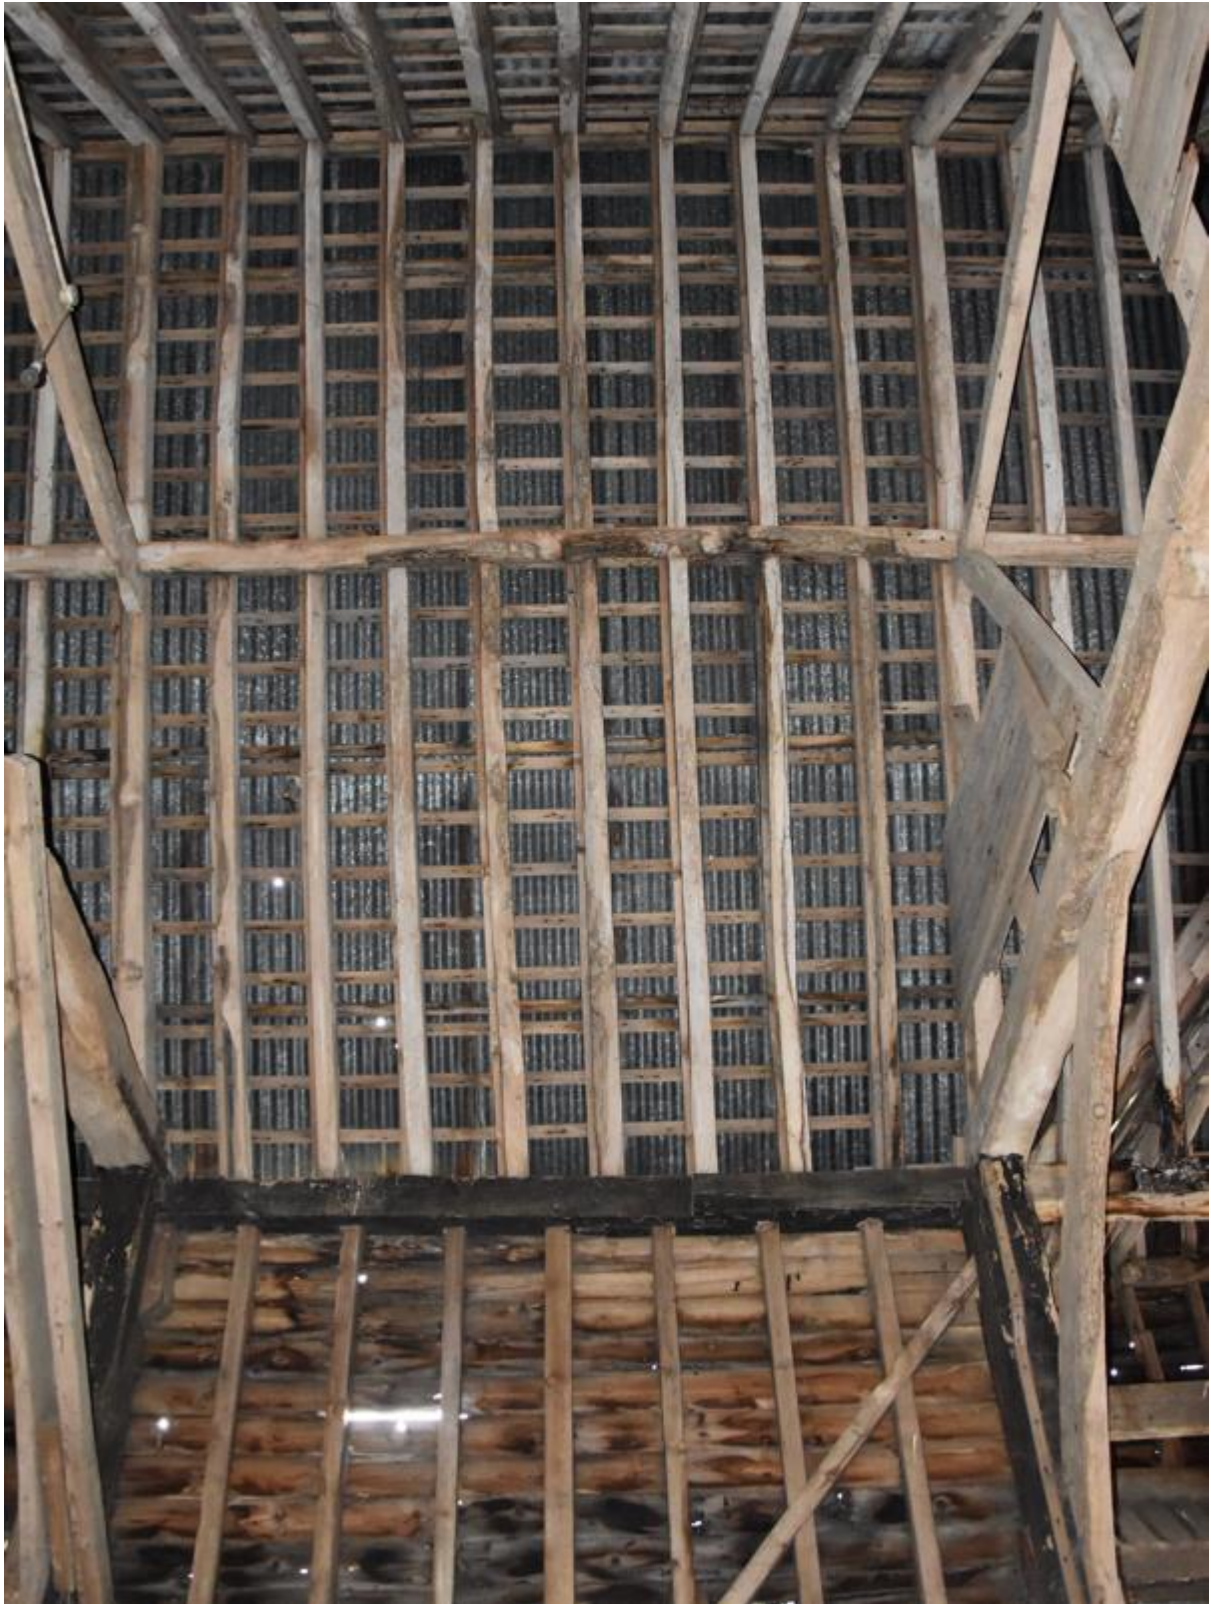
Fig15. Bay 4 South Roof Structure. No repairs required.

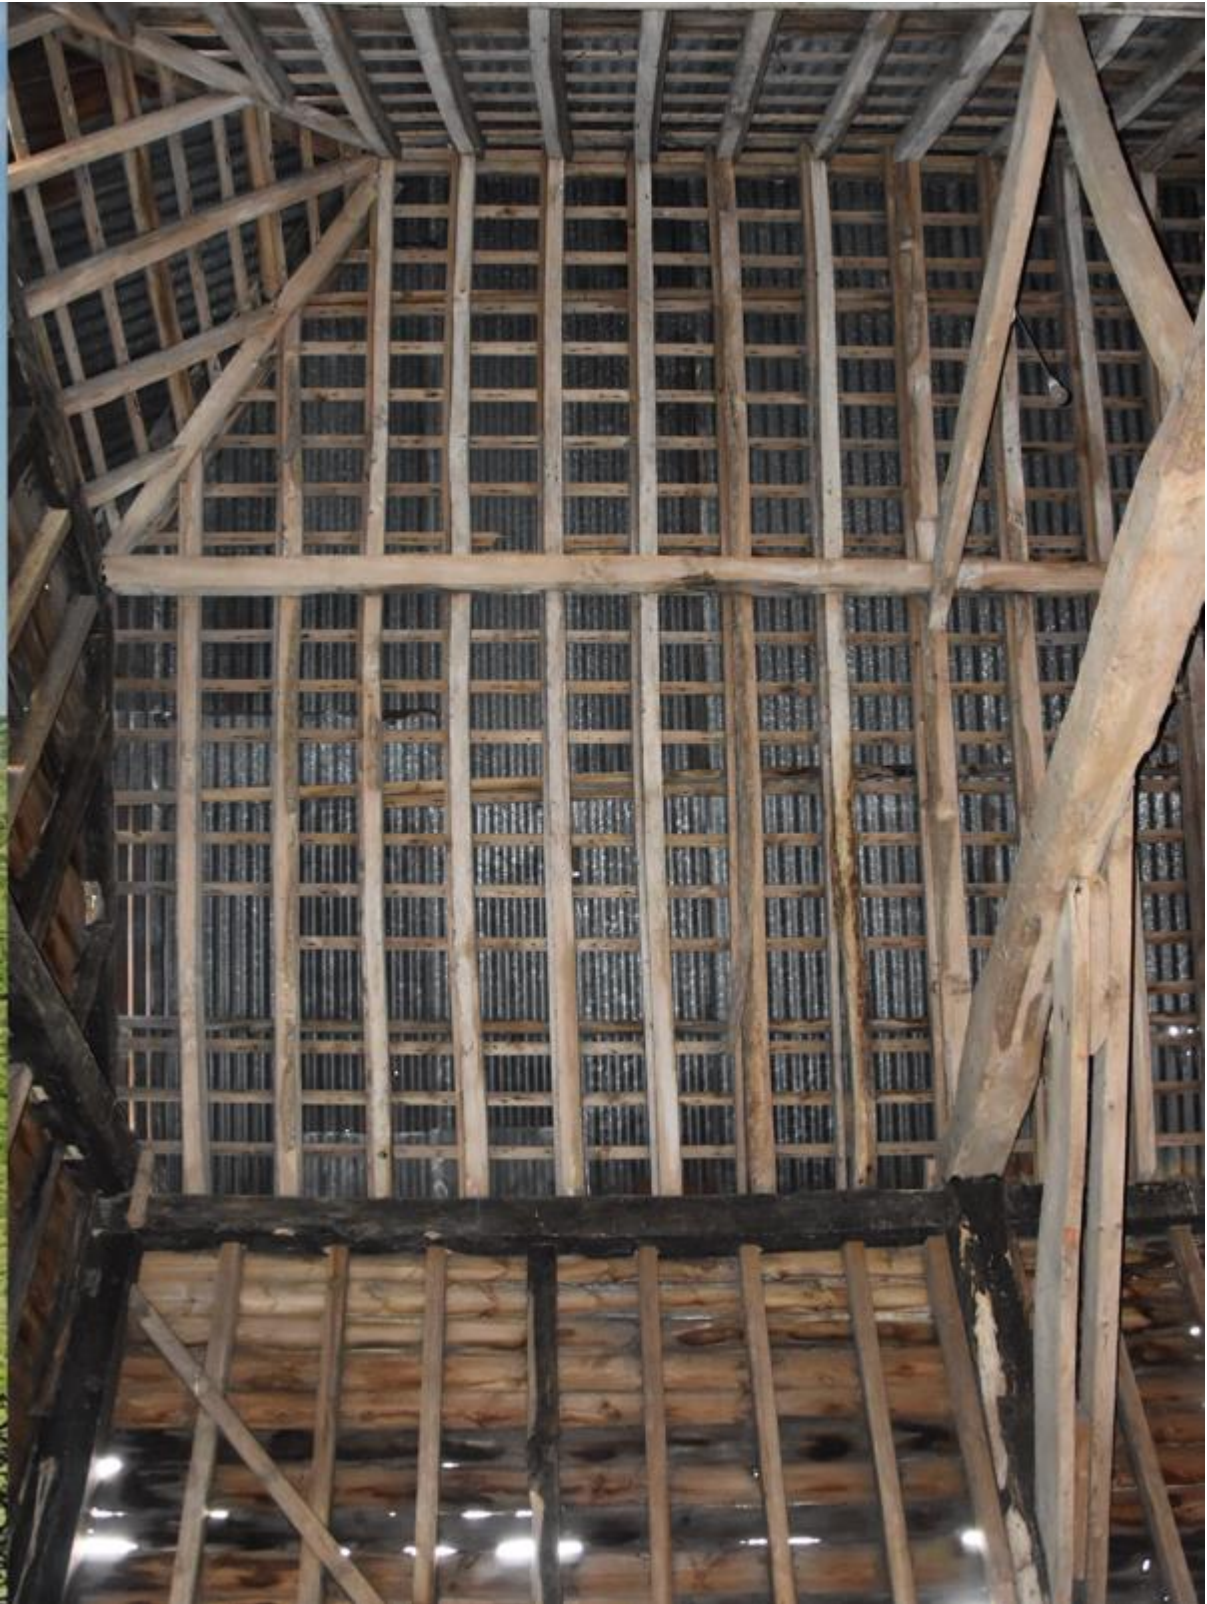
Fig17. Bay 5 South Roof Structure. No repairs required.

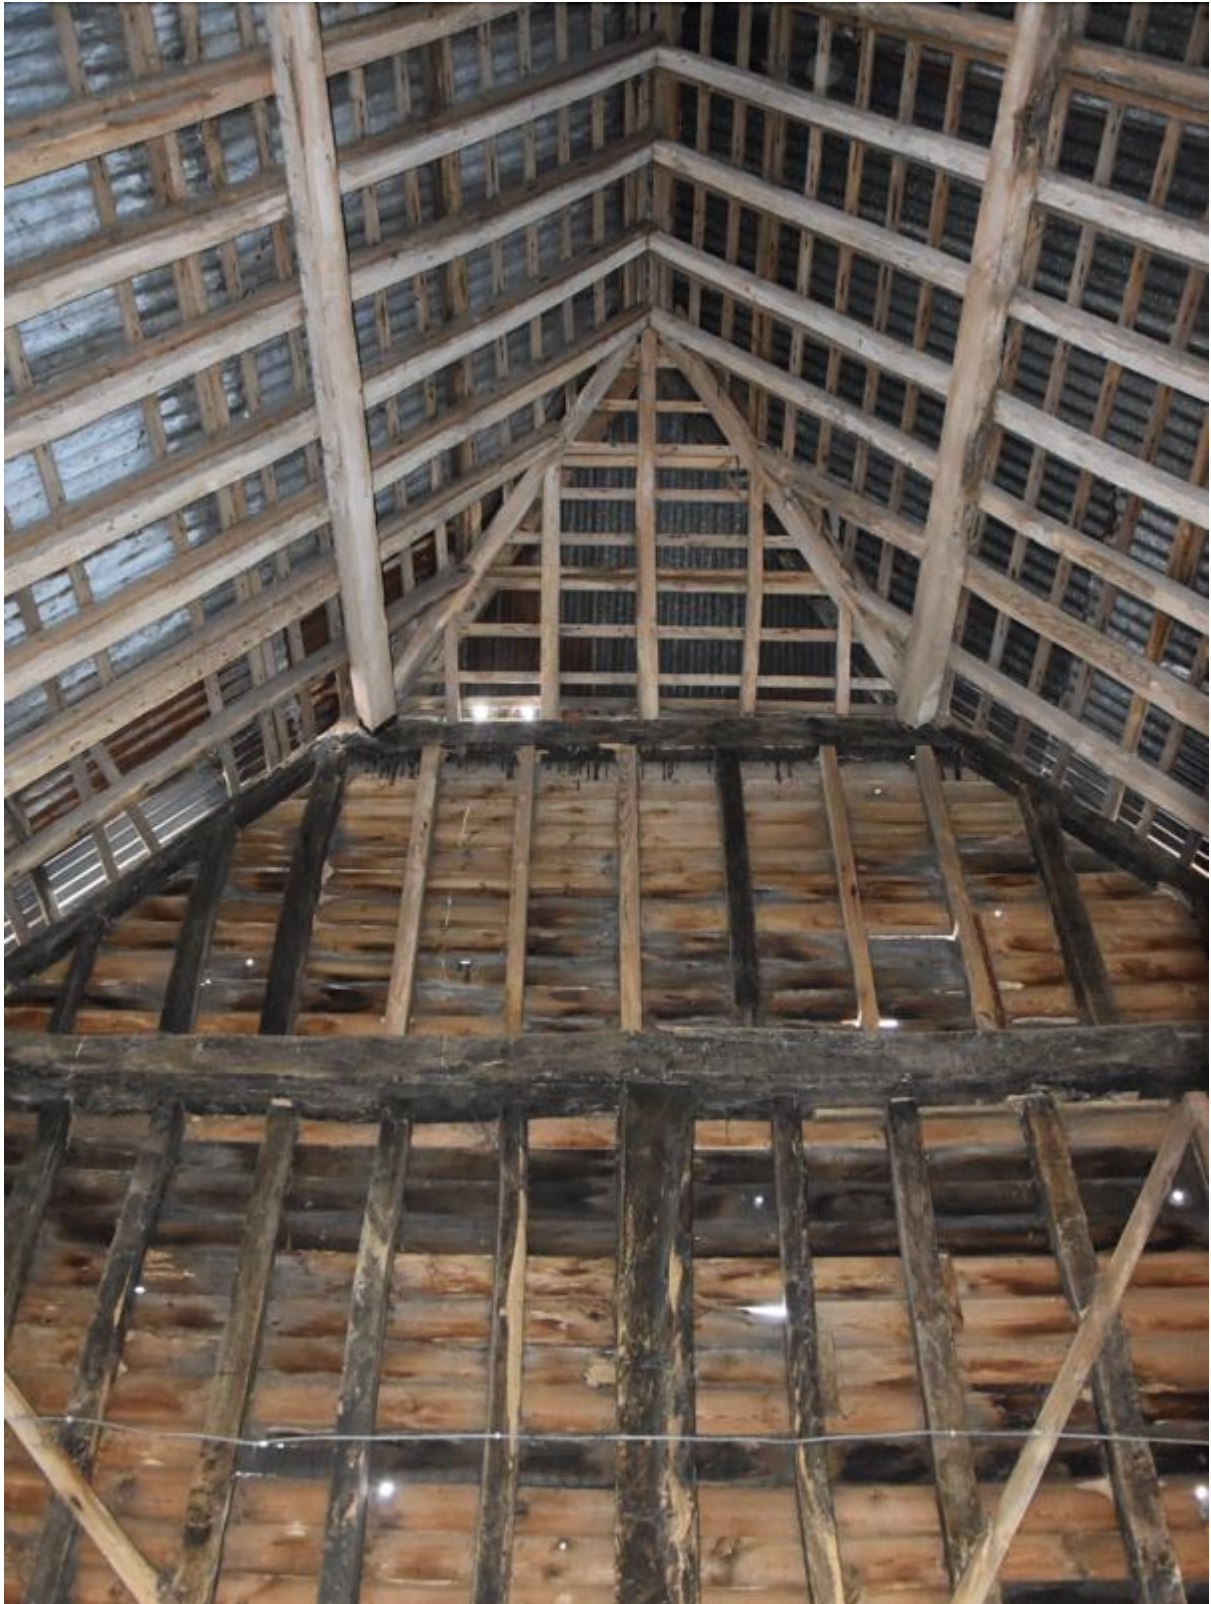
Fig19. East Wall Half Hip Roof Structure. No repairs required.

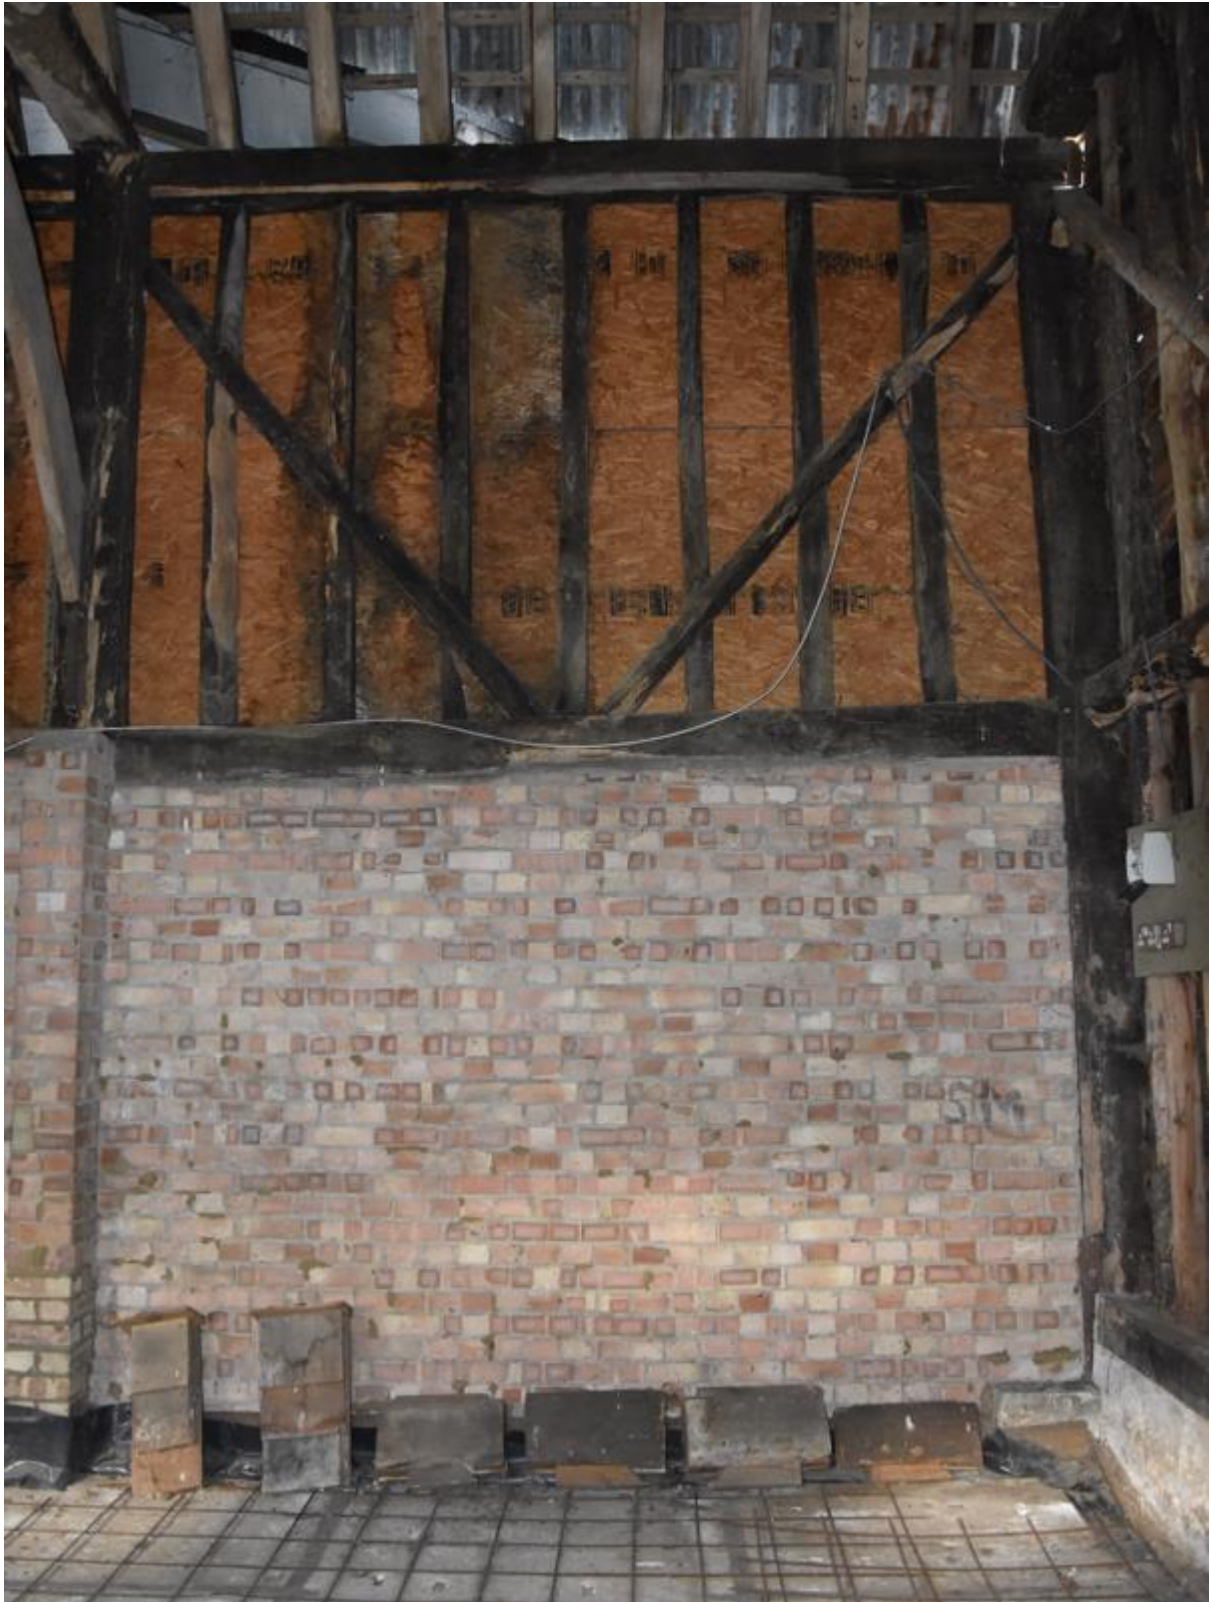
Fig20. Bay 5 North Wall. No repairs required.

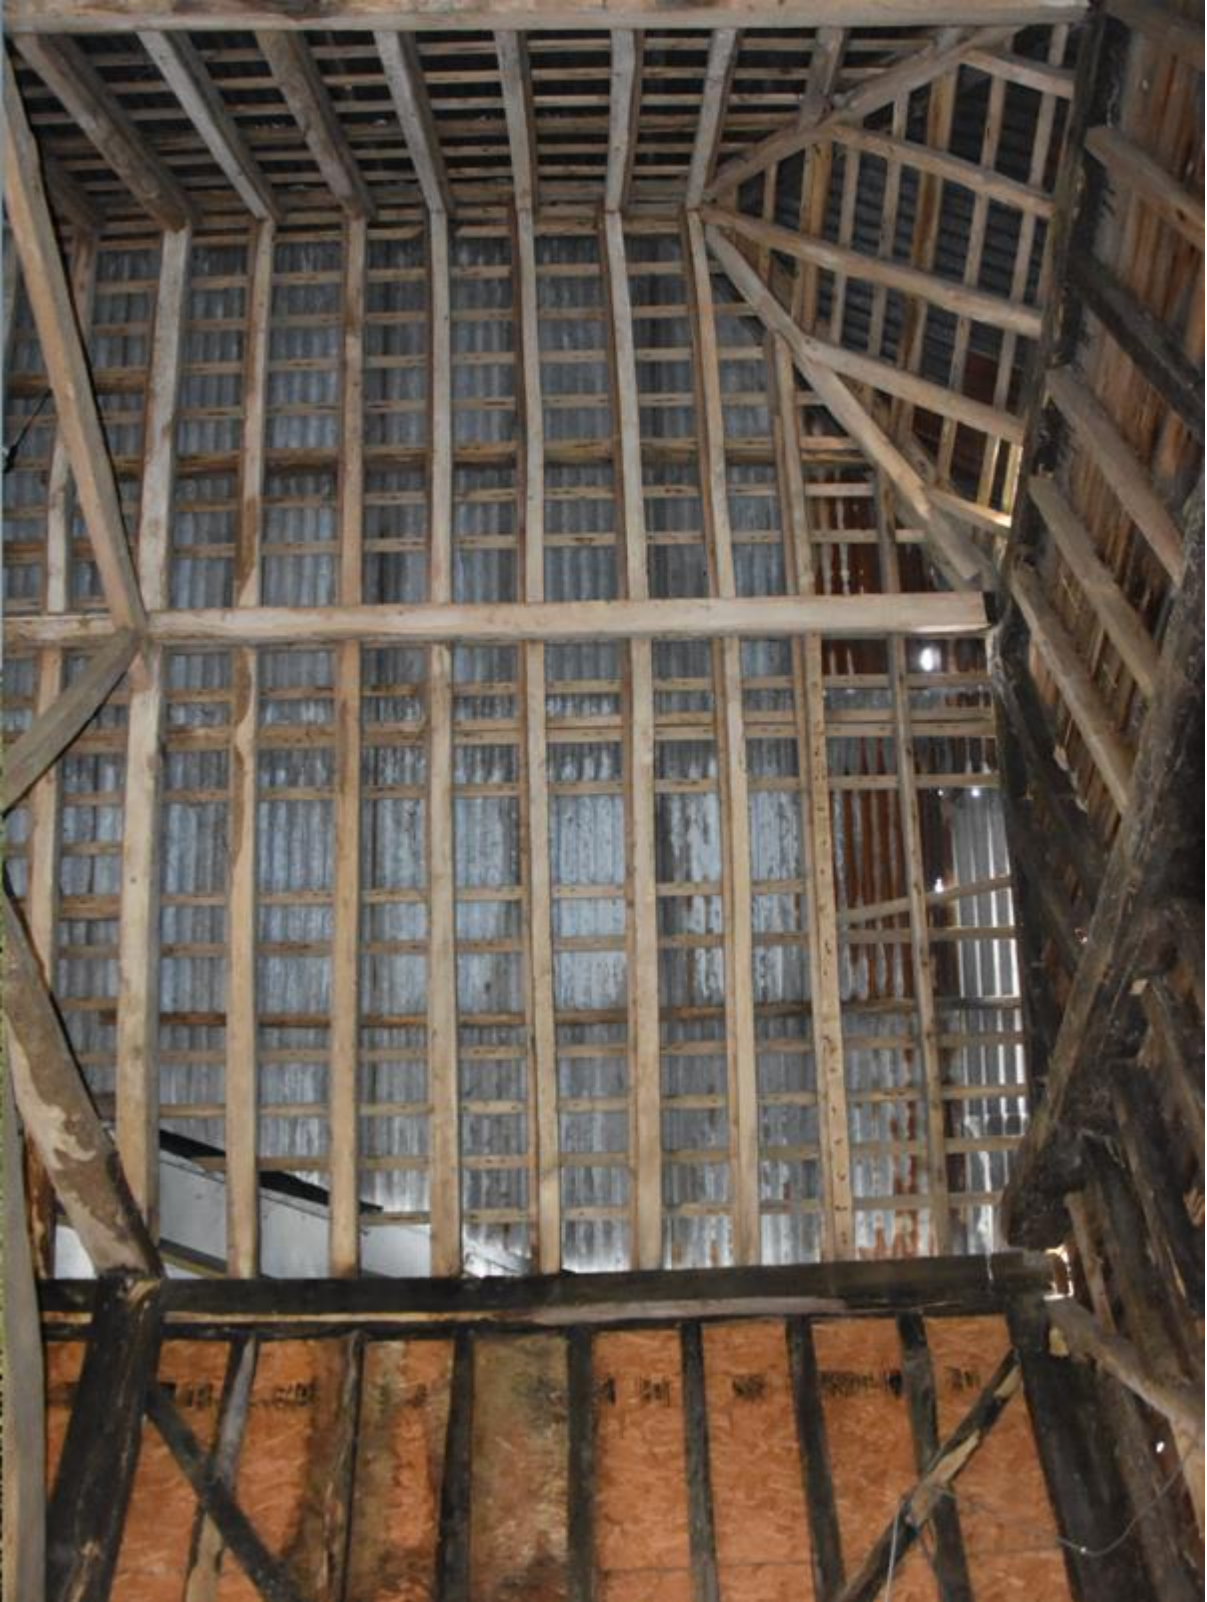
Fig21. Bay 5 Roof Structure. No repairs required.

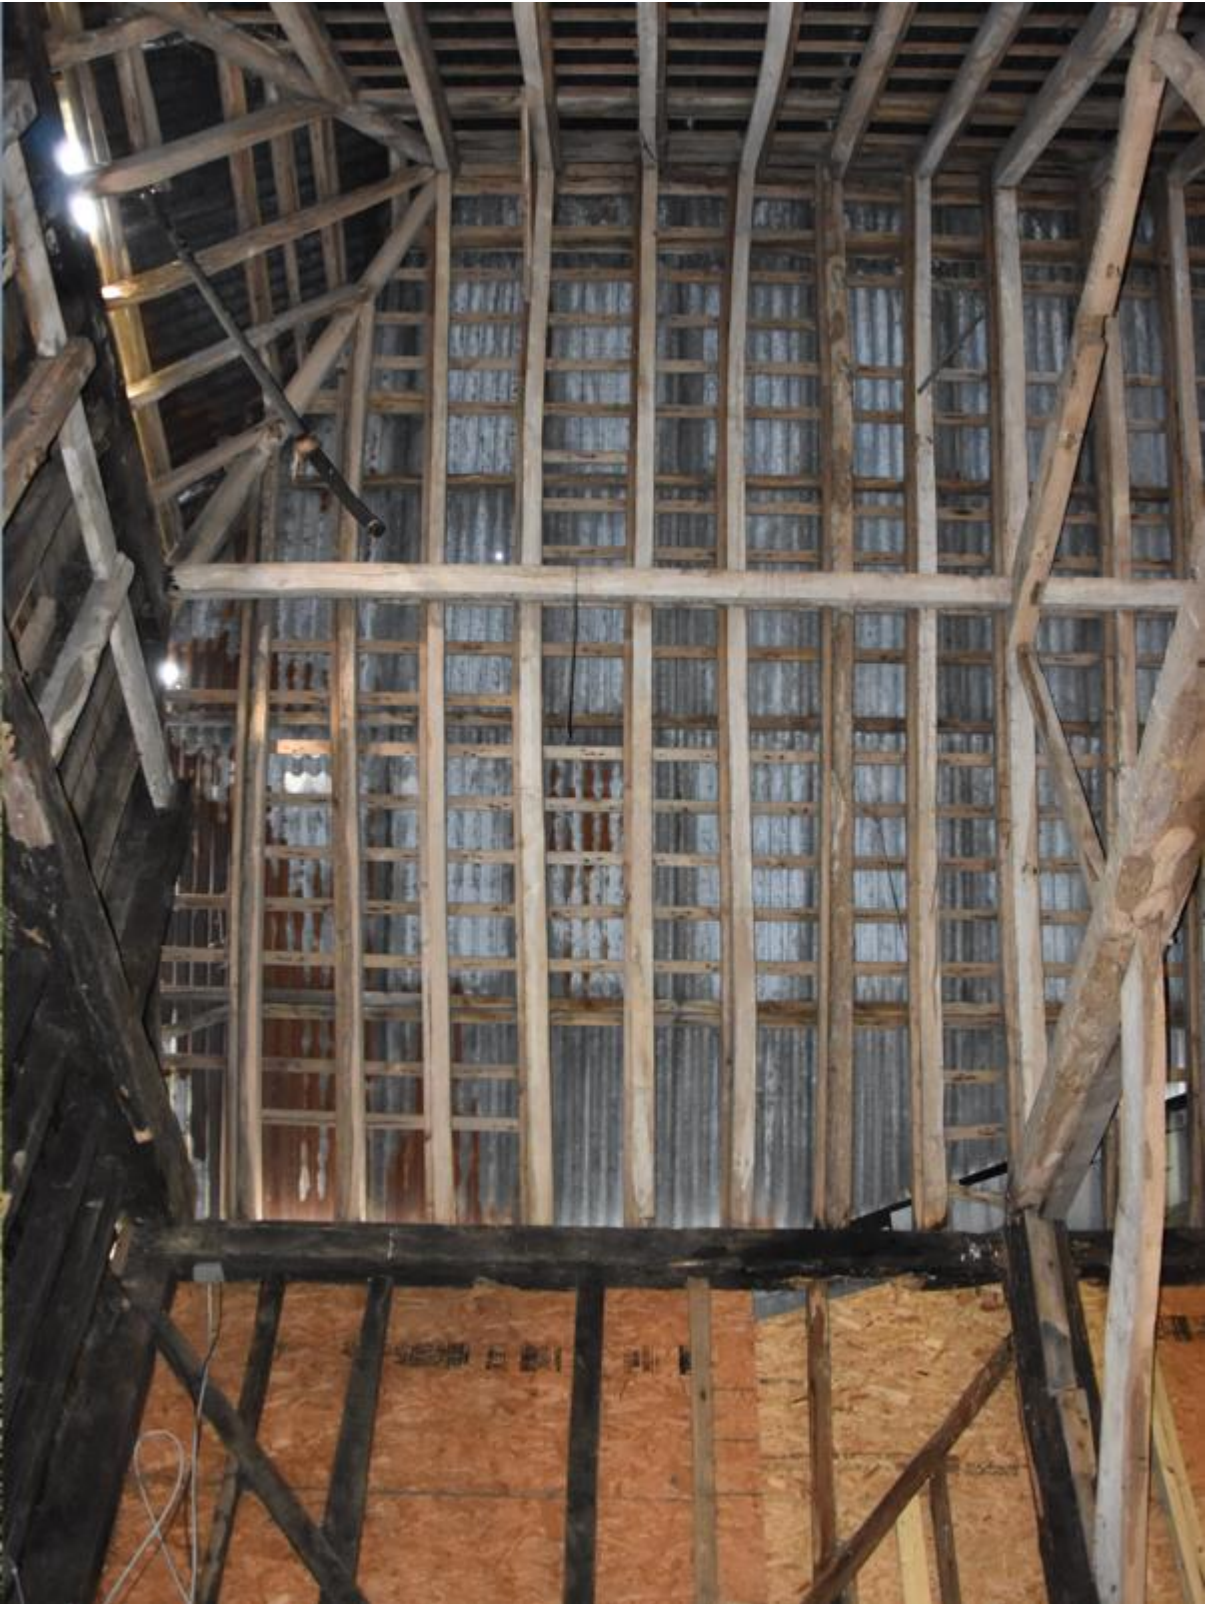
Fig29. Bay 1 Roof Structure. No repairs required.
