# Arboricultural Consultancy for Lloyds Bank

Insured	Dr and Mrs Bennett	Address	Hawthorn House, Main Street, Nocton, LN4 2BH		
Client	Subsidence Management Services	Contact	Ian Domigan	Claim No.	IFS-LBG-SUB-22-0103204
ES Ref	SA-251162	Consultant	Giles Mercer	Contact No.	0330 380 1036
Report Date	28/12/2022

# GEOTECHNICAL

Hawthorn House, Main Street, Nocton, LN4 2BH

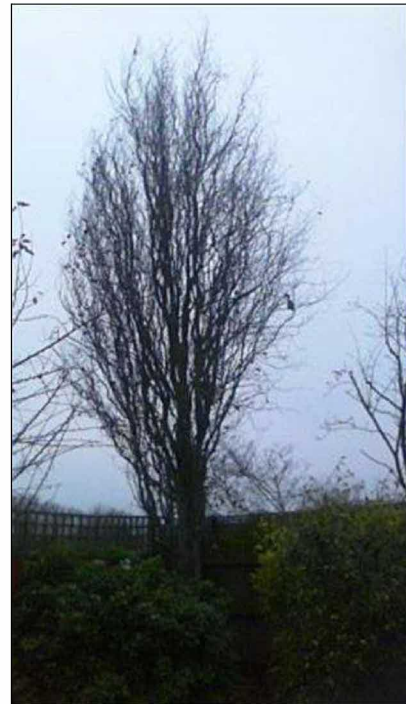
T2 - Beech

With due regards to species profile, size and proximity, the Beech (T2) is considered the dominant feature proximate to the focal area(s) of movement and accordingly, where vegetation is confirmed as being causal, we have identified it as the primary cause of the current subsidence damage.

The size and proximity of the above vegetation is consistent with the advised location(s) of damage and it is our opinion, on balance of probability, that roots from the above vegetation will be in proximity to the footings of the insured property.

Sub Sample	Species Identified	Root Diameter	Starch	
TP/BH1:				
0.93-2.1m	Fagus spp.	1	2 mm	Moderate

Fagus spp. include common beech and copper beech.

Consequently, we have advocated the complete removal of T2 as it will offer the most certain arboricultural solution likely to restore long-term stability.

Tree No.	Species	Age Cat	Approx. Height (m)	Distance to Building (m) *	Ownership	Action	Requirement
T2	Beech	1	11.2	8.2	C - Insured	Remove	Remove close to ground level and treat stump to inhibit regrowth.

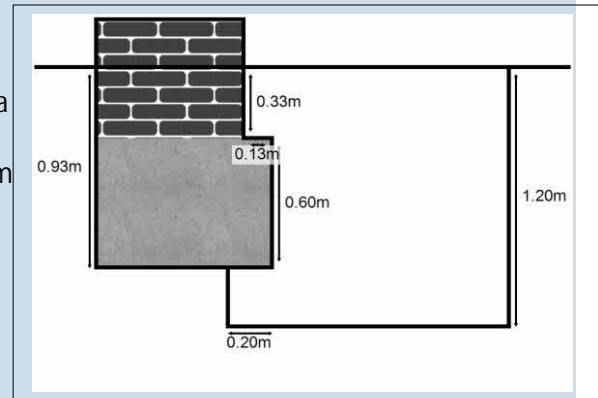
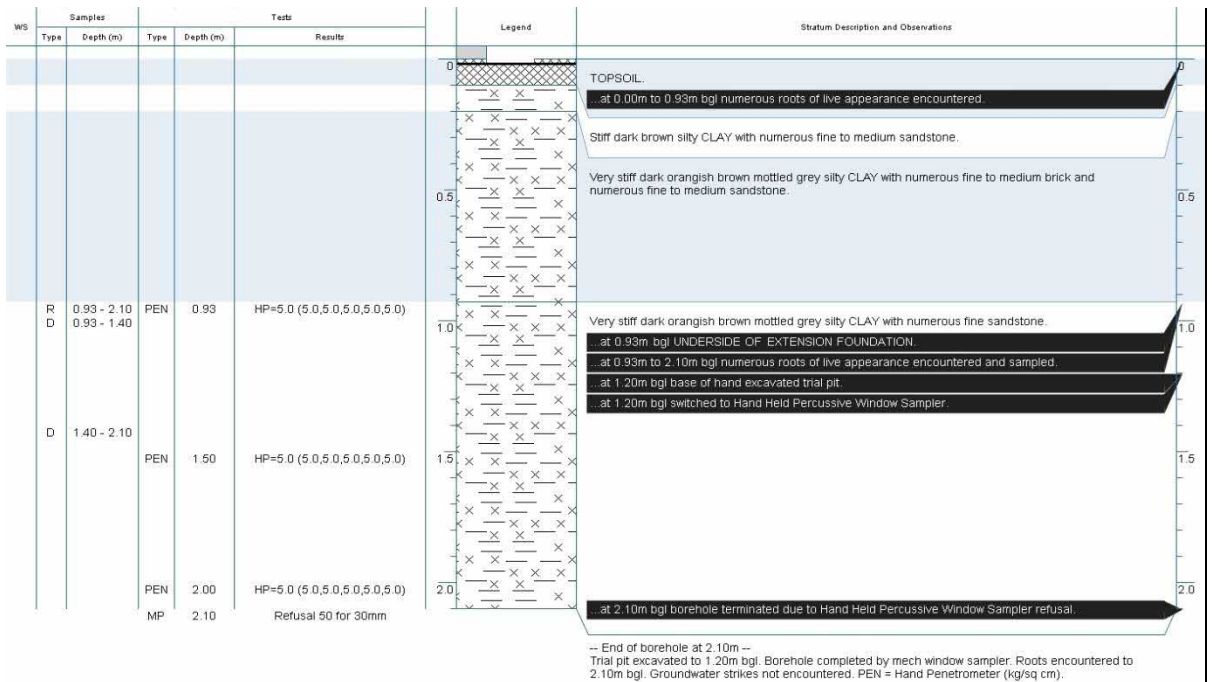
## TP/BH1 Foundation Detail and Borehole Log

Extension foundation comprised of brick wall to 330mm bgl, bearing on concrete to 930mm bgl, with a total projection of 130mm from the elevation. Underside of foundation (USF) was exposed to 200mm back from the face of the foundation and probed 200mm back from the face of the foundation.

At 0.93m bgl UNDERSIDE OF EXTENSION FOUNDATION in TP/BH1.

At 0.00m to 0.93m bgl numerous roots of live appearance encountered in TP/BH1.

At 0.93m to 2.10m bgl numerous roots of live appearance encountered and sampled in TP/BH1.
