Preliminary Arboricultural Assessment

For trees at

New Farm, Felton

9th March 2023

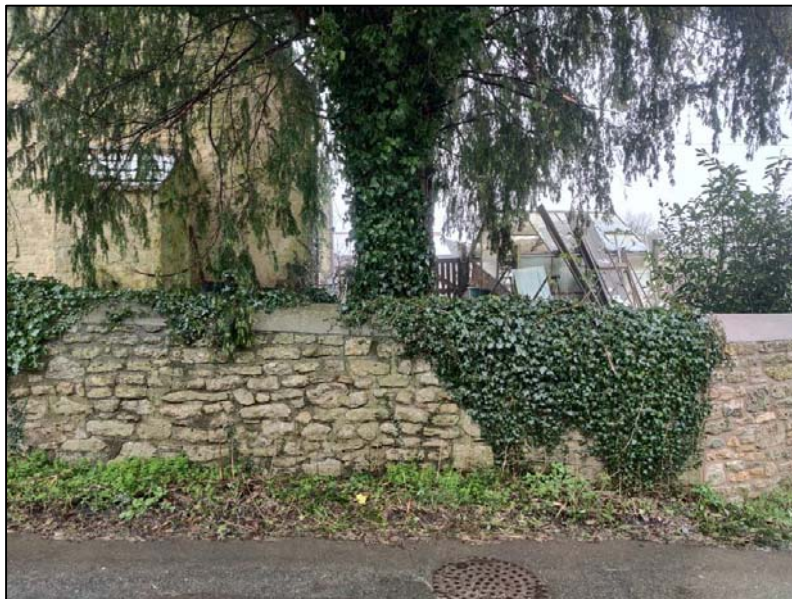
It is likely that over time the yew tree (T1) will cause direct damage to the adjacent retaining wall. Currently there is a hairline crack in this wall and as the base of the tree grows incrementally this damage is likely to become progressively worse. However this process will take years, and there are various ways that the wall could be repaired without needing to cut the tree down.

Figure 1: The yew tree is likely to cause cracking of the retaining wall over time.

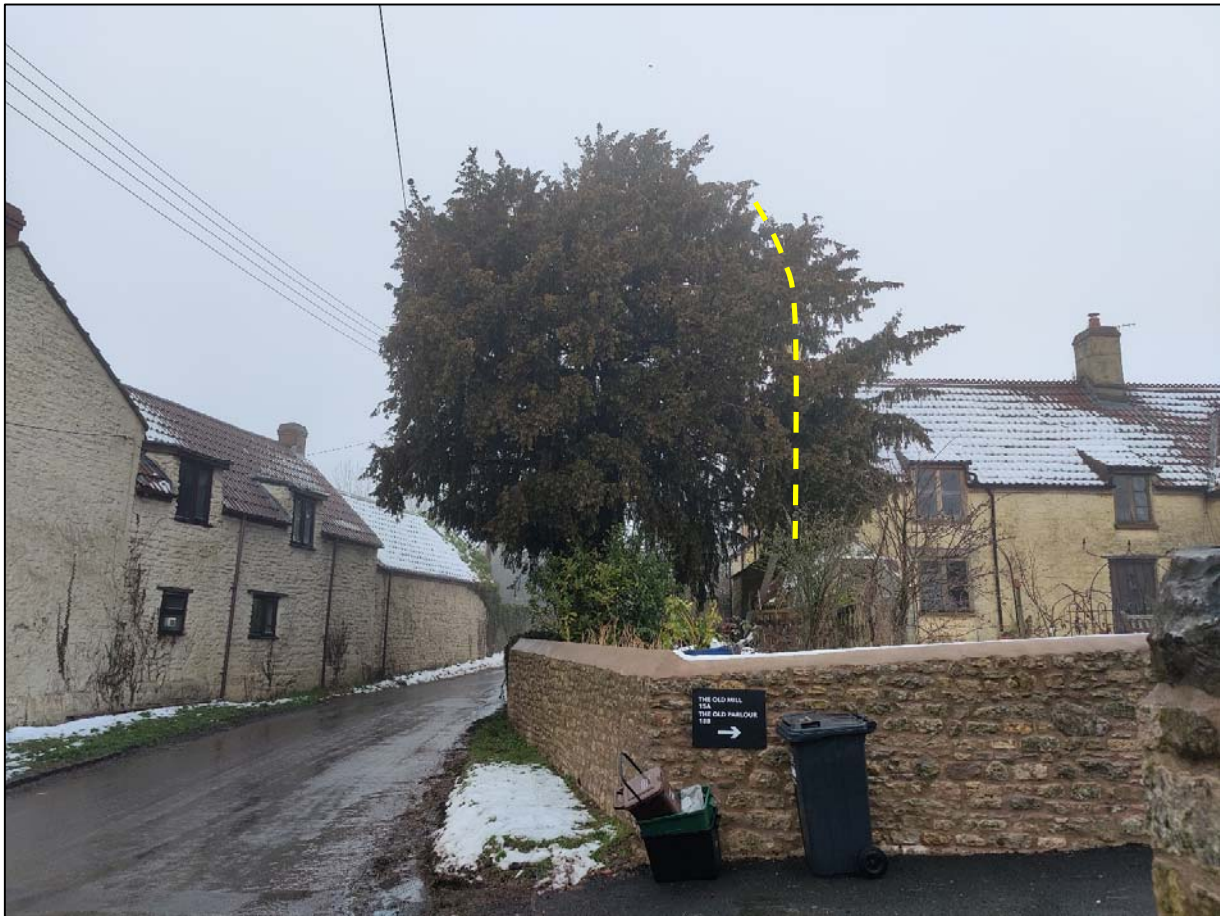
The crown of the yew tree currently overhangs the house, and it is advised that the branches closest to the building are pruned to prevent damage to the roof and guttering.

Figure 2: The extent of the recommended pruning is indicated with the yellow dotted line.

On the conclusions drawn from the appraisal, no remedial works are considered necessary to reduce the potential for subsidence damage. However, I have recommended that the yew tree is pruned to give clearance from the roof of the house.

The extent of the pruning works are identified in Figure 2, and further details of the recommendations are provided in the accompanying tree schedule.

Tree No.	Species	Recommendation	Category ²
T1	Yew	Prune to give 1m clearance from the house and shape to give the tree a balanced crown outline (refer to Figure 2). Also, sever ivy at base using hand tools only.	2
T2	Cherry laurel	Maintain at a desired size by regular trimming.	2
