**Arboricultural  
Report to BS  
5837:2012**

Land at The Drove  
Osournby  
NG34 0DH

20<sup>th</sup> October 2022

221019

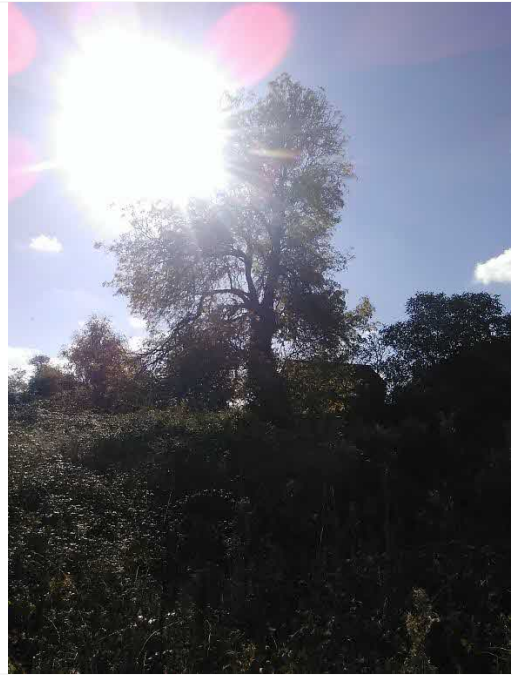
Image 4 – T9 viewed from The Drove

T9	Common Ash	Mature	17.5	980				11.8	7.5	8.5	5	5	B1/3	20 to 40 yrs	Good	Good	Heavily ivy clad preventing detailed inspection. Large limb ascending from 3.25m to N. Notable storm damage mid crown to S. Otherwise a reasonable specimen.	
G1	A Group	Young	9.5	300# <sup>a</sup>				3.6	4	4	4	4	C2		Good	Fair	Three young ash growth in close competition. All slender in form. Ivy and dense vegetation prevented detailed inspection.	
G2	A Group	Semi-mature	12	330 <sup>a</sup>				4.0	4	4	4	4	C2		Good	Fair	Boundary group of predominantly multi-stemmed self-set ash with hawthorn understory. Dense vegetation and ivy prevented detailed inspection.
