# Arboricultural Report

5 Newark Road  
Bassingham  
Lincoln  
LN5 9HA

*Inspection date:*

**26<sup>th</sup> February 2023**

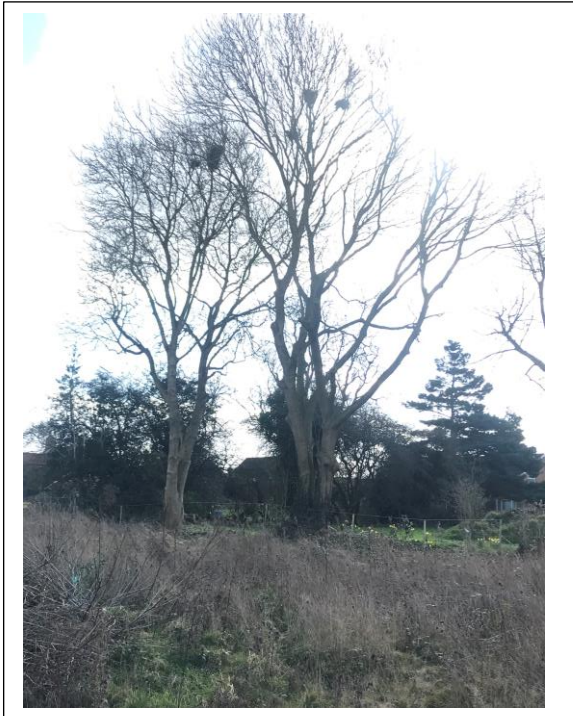
T1 (right) and T2 (left) Photograph taken looking north-east

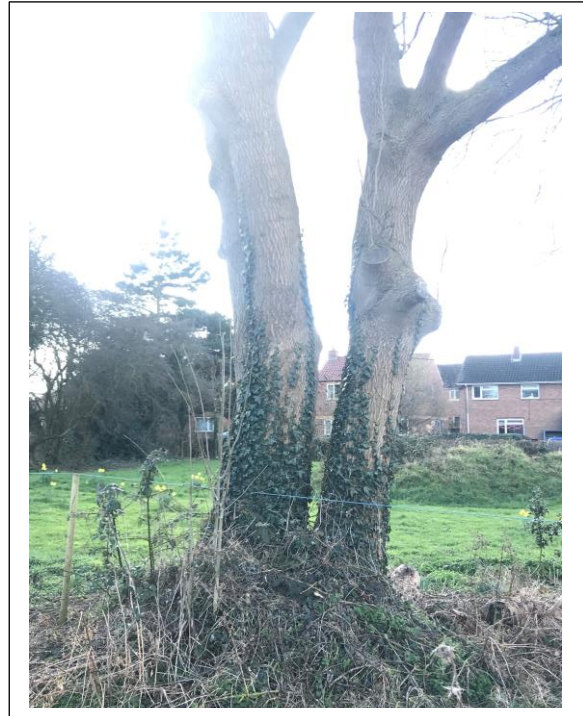
T1 is a mature ash located off-site adjacent to the boundary to the south. The crown was sparse with evidence of pruning wounds with partial occlusion from a previous crown lift. The main stem forks into 2 from the base, at 1.5m from ground level one stem forks again with a compression fork and reactive growth present (see Appendix 'B').

T1 Photograph showing main ivy covered stem

The recommendations put forward in Table 1 for the removal of T1 and T2 are based on the current condition and form of the trees, the predicted SULE and the proximity to the site.

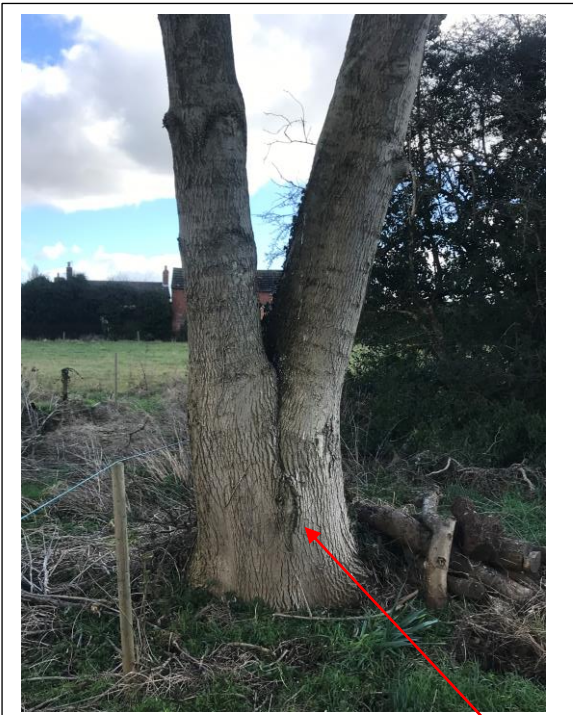
T2 is a mature ash located off-site adjacent to the boundary to the south. The crown was sparse with evidence of pruning wounds with little occlusion from a previous crown lift. The main stem was co-dominant, forking at 1.5m with evidence of an included union present. Partially occluded wounding was present to the north east aspect of both stems up to 4.5m from ground level (see Appendix 'B').

T2 Photograph showing included union on co-dominant stem

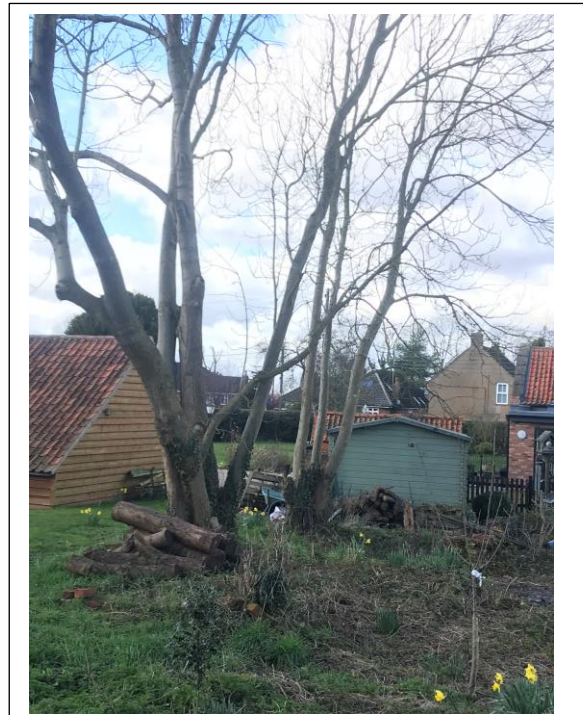
T3 (foreground) and T4 Photograph taken from southern boundary

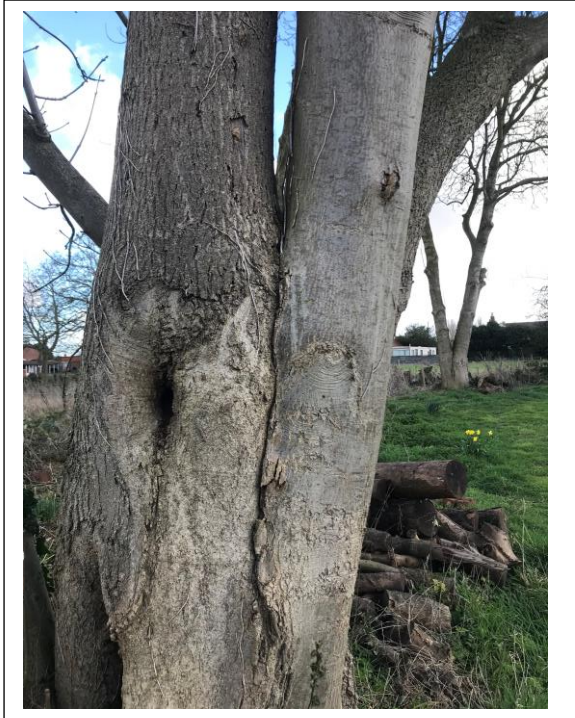
T3 is a mature ash located off-site to the south. The crown was sparse with pruning wounds present. The specimen was multi stemmed and crowded, forming at ground level. Decay was present at the base of the stems to the east and the south (see Appendix 'B').

T3 Photograph showing weak included union

T3	Ash <i>Fraxinus excelsior</i>	16	60	N - 6 E - 7 S - 7 W - 5	M	F	<10	<p>Fair condition</p> <p>A mature ash located off-site to the south. The crown was sparse with pruning wounds present. The specimen was multi stemmed and crowded, forming at ground level. Decay was present at the base of the stems to the east and the south.</p> <p>Poor form</p> <p>Target: Clients' property, adjacent garden. Amenity value: Med</p>	No recommendation applicable to this report.	N/A	N/A
T4	Ash <i>Fraxinus excelsior</i>	15	31	N - 3 E - 2 S - 3 W - 4	SM	F	<10	<p>Fair condition</p> <p>A semi-mature ash located off-site to the south. The crown was sparse and suppressed by the adjacent ash. The specimen was multi stemmed with several stems historically removed.</p> <p>Poor form</p> <p>Target: Clients' property, adjacent garden. Amenity value: Med</p>	No recommendation applicable to this report	N/A	N/A
T5	Walnut <i>Juglans sp.</i>	9	47	N - 7 E - 7 S - 5 W - 7	SM	F	>10	<p>Fair condition</p> <p>A semi-mature walnut located on-site in the north-east corner. The crown was balanced with pruning wounds to the north at 2m with decay onset. A dead branch to the south with an approximate diameter of 75mm was present along with further deadwood throughout the crown. The main stem had a slight lean to the north with a bark wound to the south, evidence of possible historical fungus around root plate area.</p> <p>Fair form</p> <p>Target: Clients' grounds Amenity value: Med</p>	Remove and poison stump	4	3

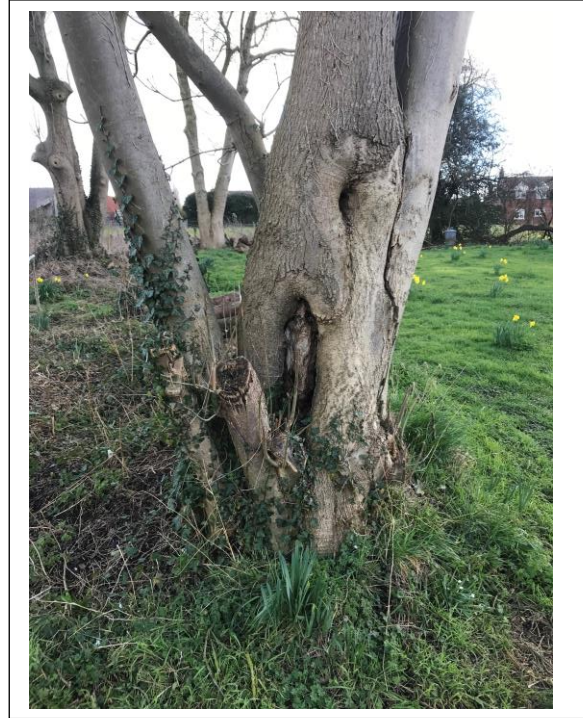
T4 is a semi-mature ash located off-site to the south. The crown was sparse and suppressed by the adjacent ash. The specimen was multi stemmed with several stems historically removed (see Appendix 'B').

T4 Photograph showing decay pocket

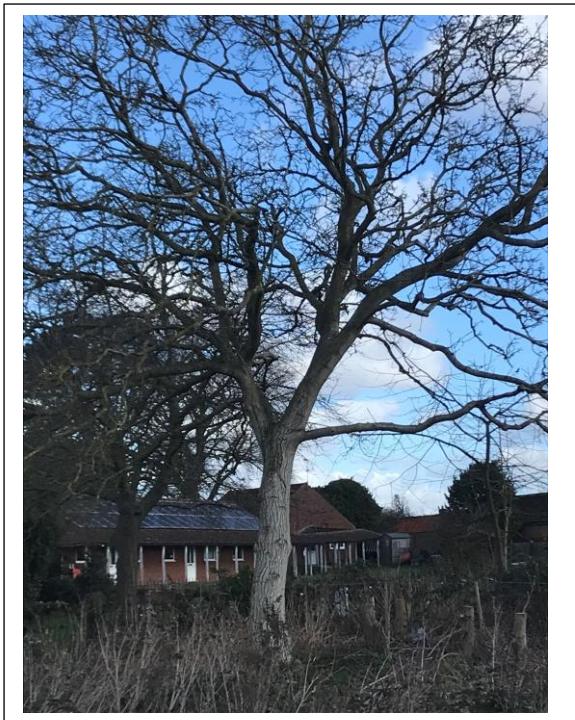
T5 is a semi-mature walnut located on-site in the north-east corner. The crown was balanced with pruning wounds to the north at 2m with decay onset. A dead branch to the south with an approximate diameter of 75mm was present along with other deadwood throughout the crown. The main stem had a slight lean to the north with a bark wound to the south, evidence of possible historical fungus around root plate area. (see Appendix 'B').

T5 Photograph taken looking north east

T5 recommendations are based on the current condition, the predicted SULE and the evidence of historical fungus around the root plate area.

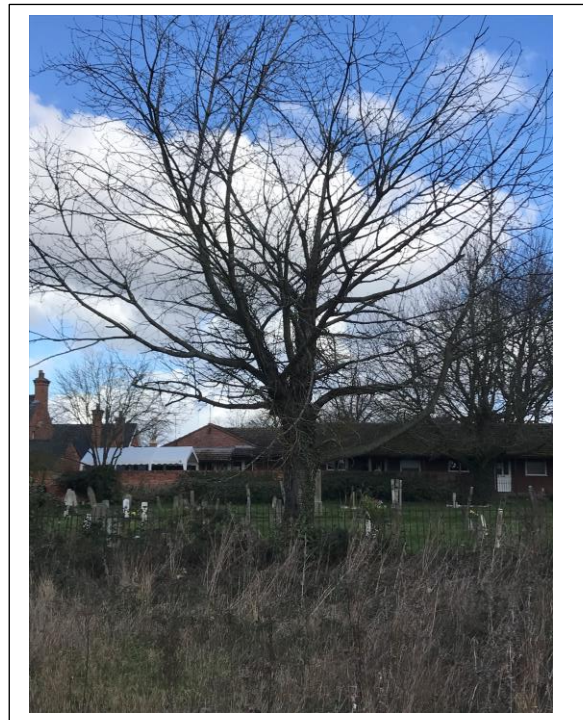
T7 is a semi-mature cherry located off site adjacent to the boundary to the north, standing on a slightly raised elevation in comparison to the site. The crown was balanced with moderate deadwood present, evidence of a fruiting body was noted to the east at 3.5m from ground level. The main stem was straight with ivy attached which had previously been severed. A bleeding wound was present at the base to the south (see Appendix 'B').

T7 Photograph looking north to graveyard

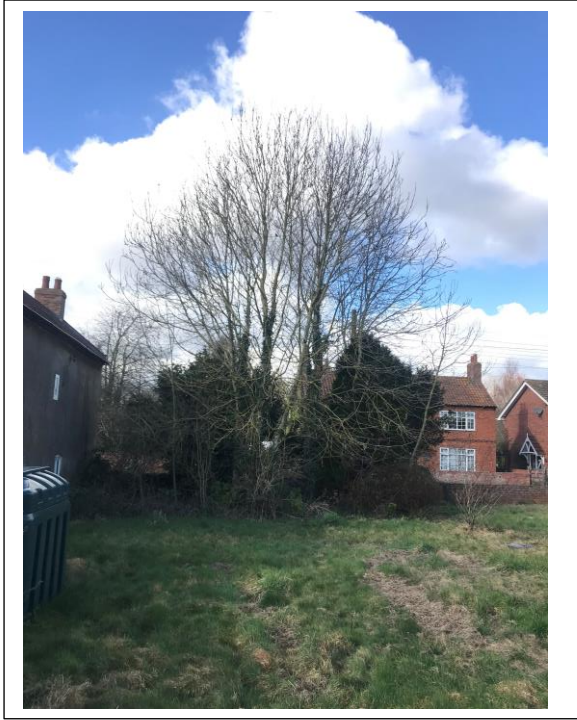
TG1 is a group of semi-mature mixed species of varying heights, located on-site in the south-west corner adjacent to the boundary and the neighbouring property. The ash are likely to be self-set and stand within 4m of the adjacent property. The crowns form as one visual crown. The stems are generally straight within the group (see Appendix 'B').

TG1 Photograph taken looking south

TG1 recommendations to remove seven of the existing trees is based on the intention to add value to the remaining trees by removing the crowded area of self-set ash, cherry and leylandii, allowing the remaining two yews and one laurel to grow in a light and healthy atmosphere, with the intention of improving the aesthetic and amenity value for this area within the village.

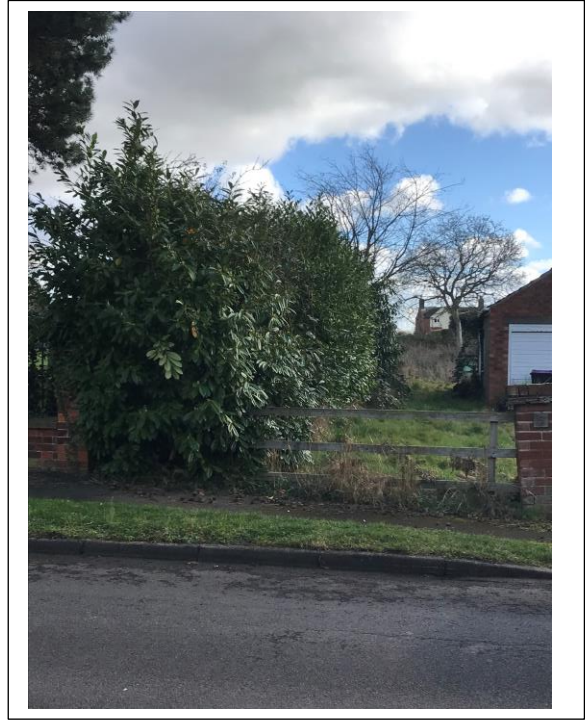
H1 is a semi-mature linear group of cherry laurel, forming an unmaintained hedge along the boundary to the north.

H1 Photograph taken from Newark Road looking east
