EXISTING BARN
WOODPECKER WOOD
DAMERHAM
FORDINGBRIDGE
HAMPSHIRE

3.1.1 Existing Structure

Conduct a building survey of the existing building to determine its current condition and suitability to convert to residential use.

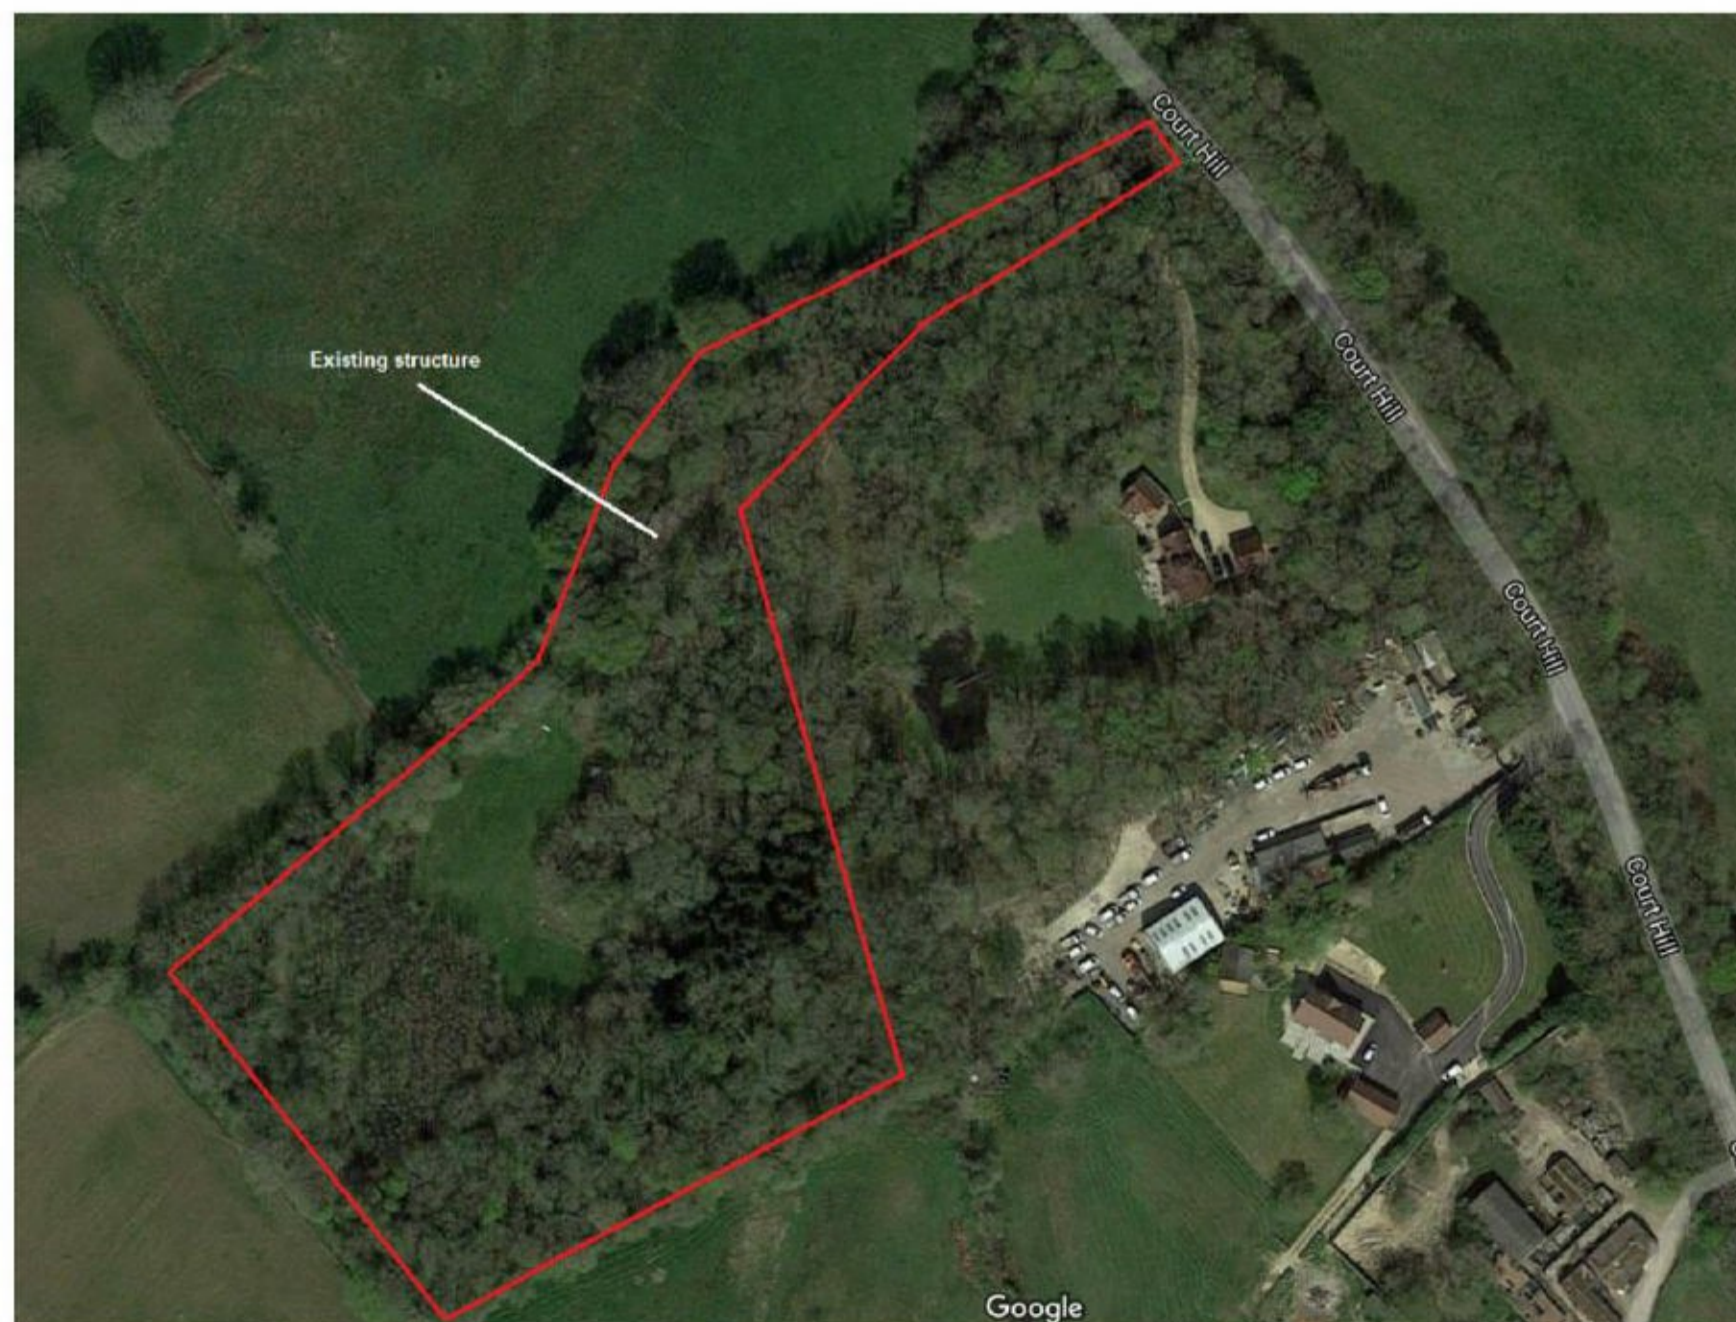
The building has a Gross Internal Floor Area (GIFA) of 60 (M²), or 645 Square Feet (Ft²). Shown in the photo below is the subject building with arrow pointing towards it.
