Arboricultural Report and Impact Assessment to BS 5837:2012

Lyme House, The Green
Nocton
Lincoln
LN4 2BG

2nd March 2023

230228

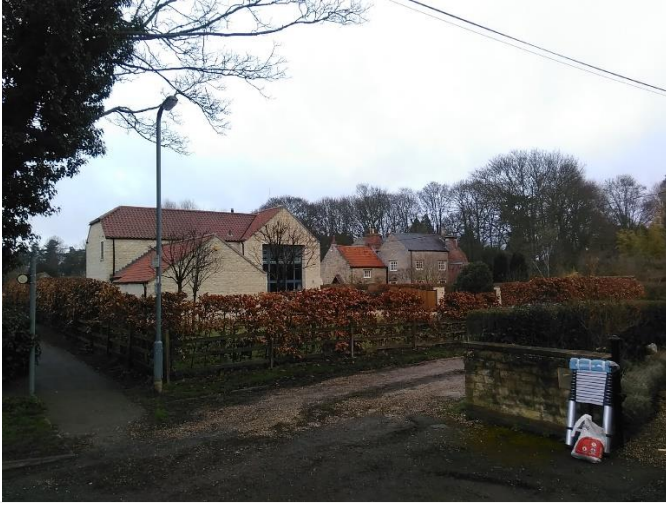
2.2.3. Trees T2, T3 and T4, and hedges H2 and H3, form a modest sized green feature when viewed from the cul-de-sac of The Green and from the public footpath adjacent to the site (see Appendix 5, images 1-3). The vegetation is modest in size, is of adequate quality and has a reasonable degree of visibility from the immediate surrounding area. This vegetation forms a minor part of the local treescape and conveys a low visual amenity value.

Image 1 – Site viewed from south west showing T1-4, H2 and H3

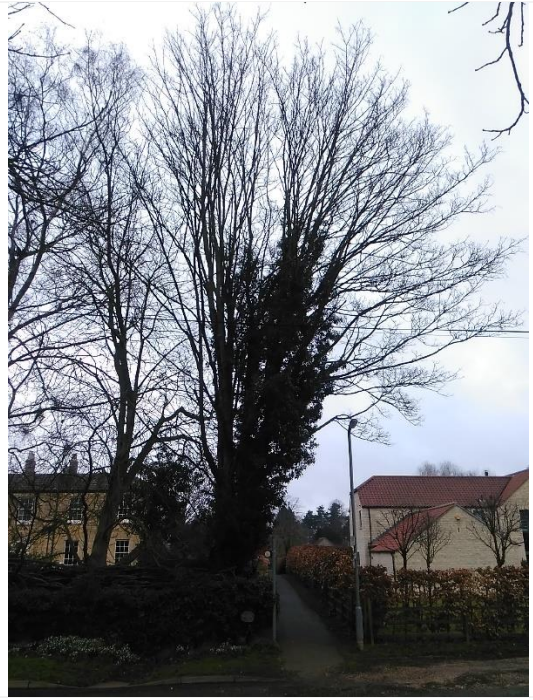
2.2.2. Tree T5 forms a moderate sized green feature when viewed from the cul-de-sac of The Green and from the public footpath adjacent to the site (see Appendix 5, images 1-3). The tree is of notable size and quality and has a reasonable degree of visibility from the immediate surrounding area. The tree forms a significant part of the local treescape and conveys a moderate visual amenity value.

Image 2 – T5

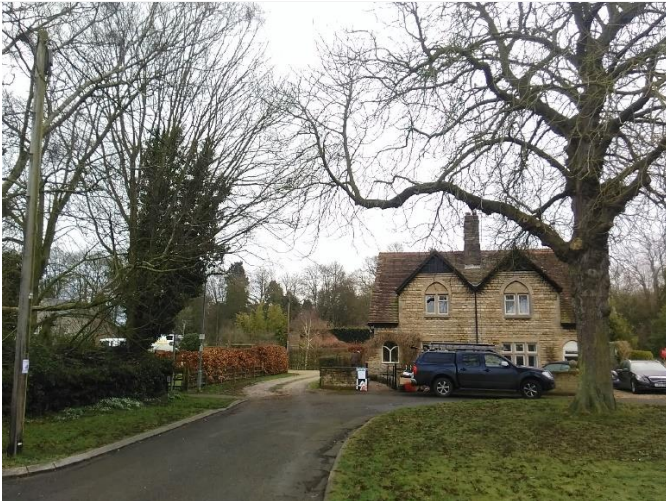
Image 3 – Site viewed from The Green, H2 and T5 left of centre
