Site Investigations Report

for Mechanical, Plumbing & Electrical Services

The Walled Garden

Ref: P453 Date: 27/12/2021 Issue: 01

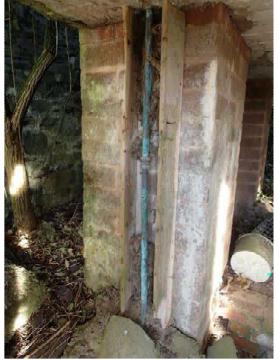
External masonry water storage cistern c. 3.5m tall.

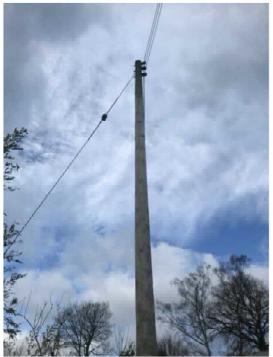
Telecoms service is available locally to the walled garden from a post on the North East side of the site and a post on site with cables crossing.

a) There is a risk of loss of telecoms supply due to trees falling onto overhead cables during storms.

- a) Client to initially liaise with telecoms provider for phone line(s), Broadband, TV availability and quote etc.
- f) It should be possible to arrange for the entry point for ducted comms cabling to cross from the neighbours drive (Wonham Firs) below ground. A wayleave will be required for this.
