RUSHFORD HALL RUSHFORD THETFORD IP24 2SF PROPOSED RE ROOFING PLAN SHOWING TIMBERS AND TO BE REPAIRED THIS SKETCH TO BE READ WITH HARPERBD REPORT P2 1.100**0**A3 21/0387/111 ACAD FILE No. 210387 100 ROOFING E

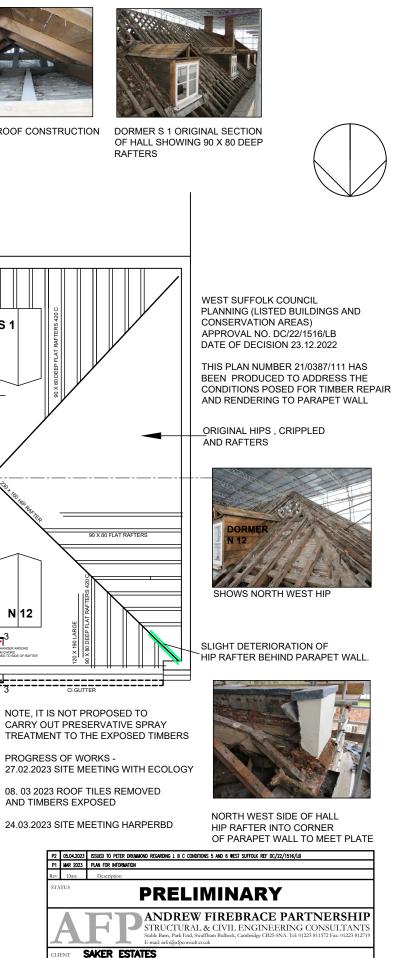
PROPOSED REPAIR TO HIP RAFTER ADJACENT TO DORMER N9 AT JUNCTION WITH WALL PLATE, THE HIP RAFTER HAS SUFFERED WHITE ROT. THIS IS TO BE REPAIRED USING STEEL

RODS AND RESIN ALL AS DETAILED BY HARPER BD SEE REPORT DATED 03.04.2023
