Report 222398/Rushford Hall/ Murfitt-1

Rushford Hall

EUSTON, THETFORD IP24 2SF (GB)

Date: Monday, April 03 2023

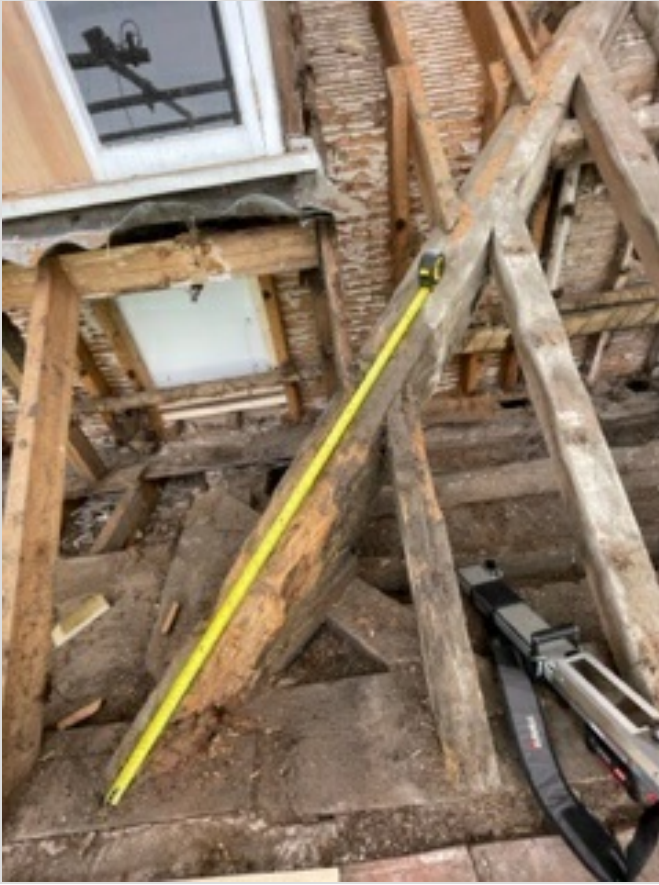
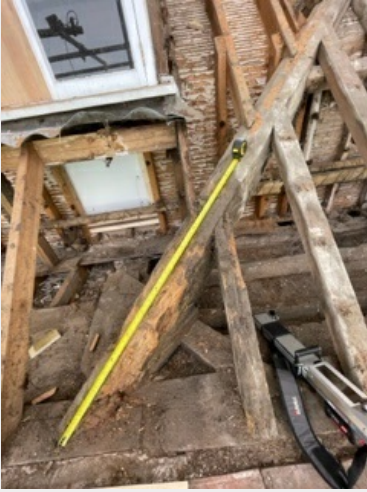
The lower section of the hip rafter (between earlier building and later addition), has suffered from an unidentified white rot infection and although the decay appears historical, it has caused significant cross-sectional loss. I tested the section of timber with a microdrill decay detection device and found low resistance (indicative of decay) in the lower 1100mm of the component, with the decay extending approximately 60% down the cross-section (from the upper face towards the bottom face). The component requires repair/support.

Figure 1: Showing defective hip rafter.

As discussed, the lower section of hip rafter requires repair, as does a section of wall plate either side of the hip rafter connection. Also, the end of the dragon piece requires repair. Considering that these three components are interconnected, the repair needs to be also considered holistically.

Another option would be to remove the rot-damaged lower section and perform a timber-resin splice, that is to insert steel or glass fibre rods into the retained section of the hip rafter, which would then connect into a new section of species-matched timber to realise the repair. This repair method would optimise access for the repair of the wall plate and dragon diagonal piece.

Cut a channel in the upper face of the existing beam, extending from the foot to approx. 1500mm (design dependant), insert steel bar or glass fibre rods and fill with structural pouring grout. This repair option retains most historical material.

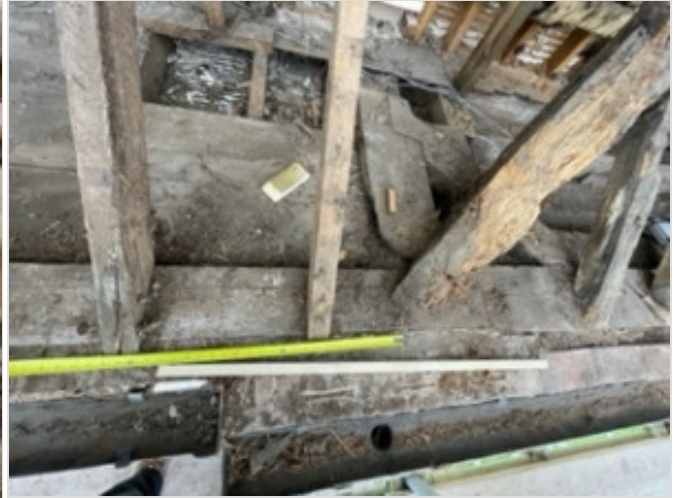
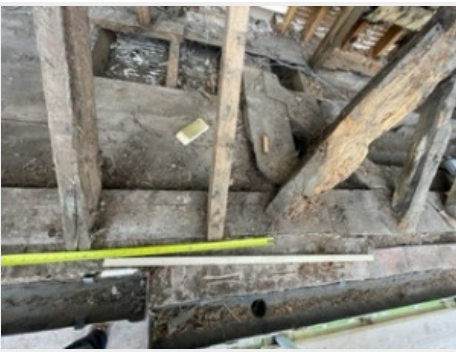
I also found the wall plate to either side of the hip rafter to have also decayed, with a section of the newer plate to the left of the hip rafter having decayed 450mm and an 800mm section of the older wall plate to the right of the hip rafter also having rotted. The decayed sections of the plates will require replacement.

Figure 3: Showing defective section of wall plate.

The decayed sections of wall plate are actually two separate ends from different periods of the buildings development, and are different widths and appear to be nailed where they join rather than benefitting from a more robust carpenters joint. Consideration will need to be given to connecting new pieces to the retained sections of the respective wall plates and to the joint between the two plates (beneath the hip rafter/dragon piece).

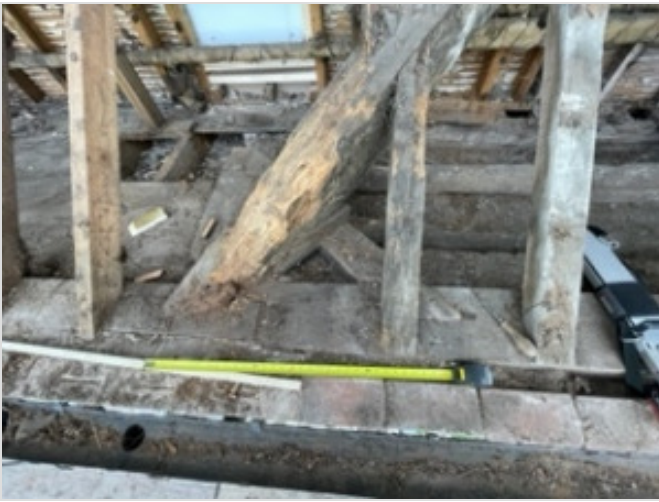
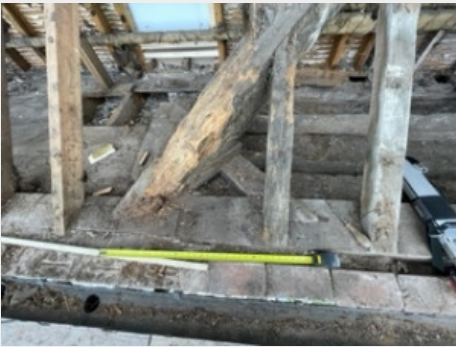
Figure 2: Showing defective section of wall plate.

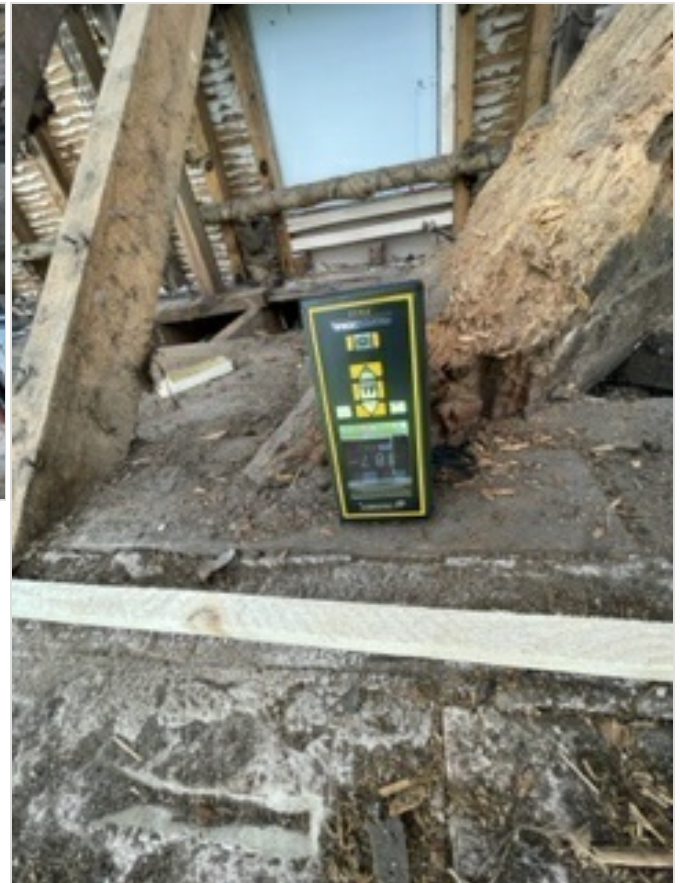
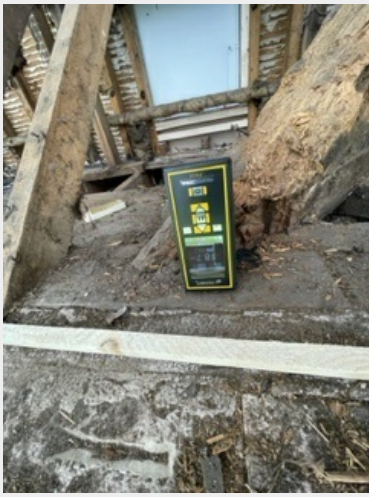
I used a resistance-type moisture measuring device to evaluate the wood moisture content (%WMC) of timber components and found most readings to be high, which is likely to reflect seasonal atmospheric conditions, due to the roof structure being currently exposed. I would expect moisture levels to recede as the seasons become drier and refurbishment works progress and the roof is recovered.

Figure 4: Recording wood moisture content.

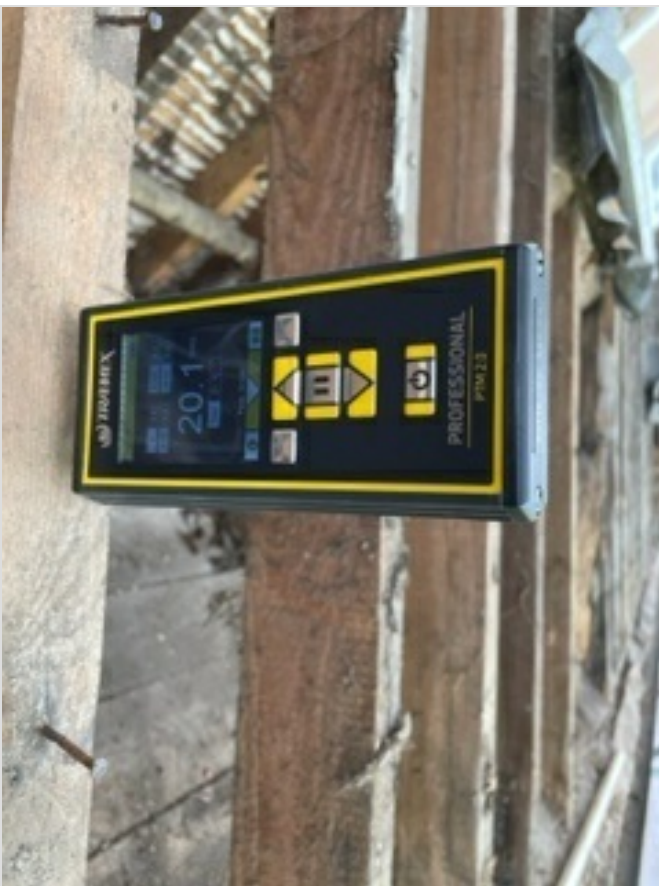
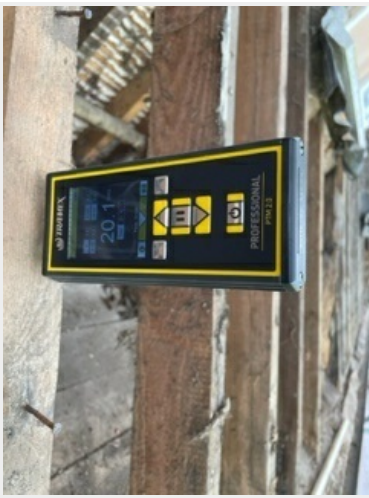
Figure 5: Recording wood moisture content.

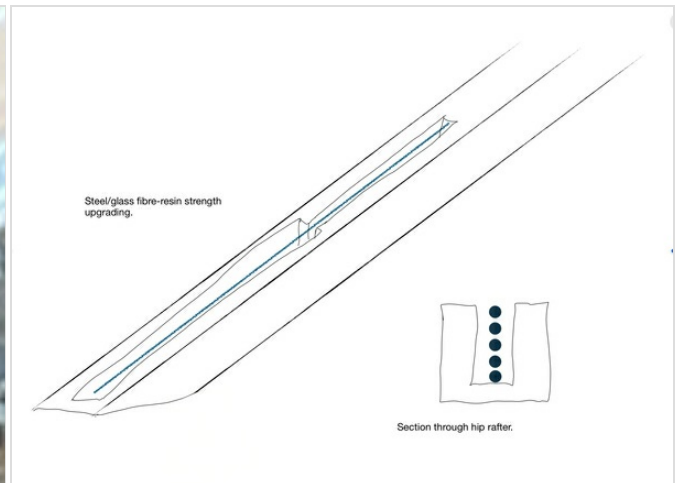
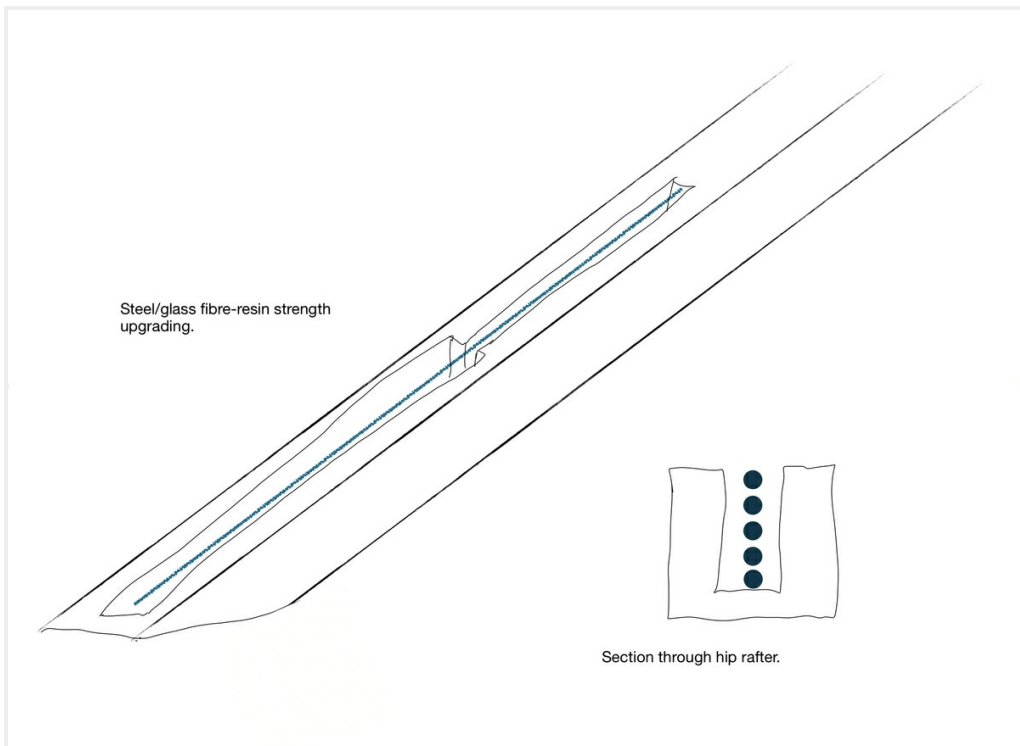
Figure 7: Showing example of steel-resin upgrade.

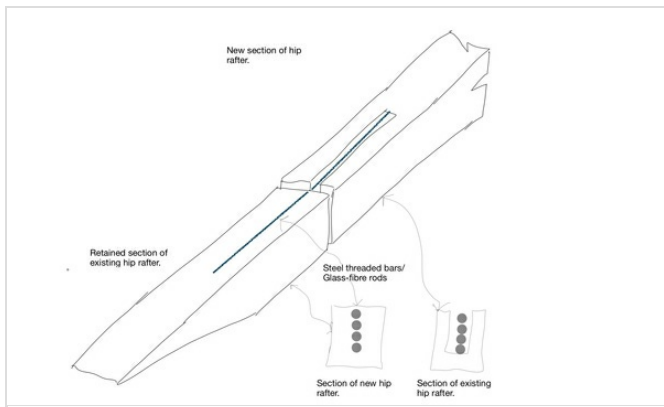
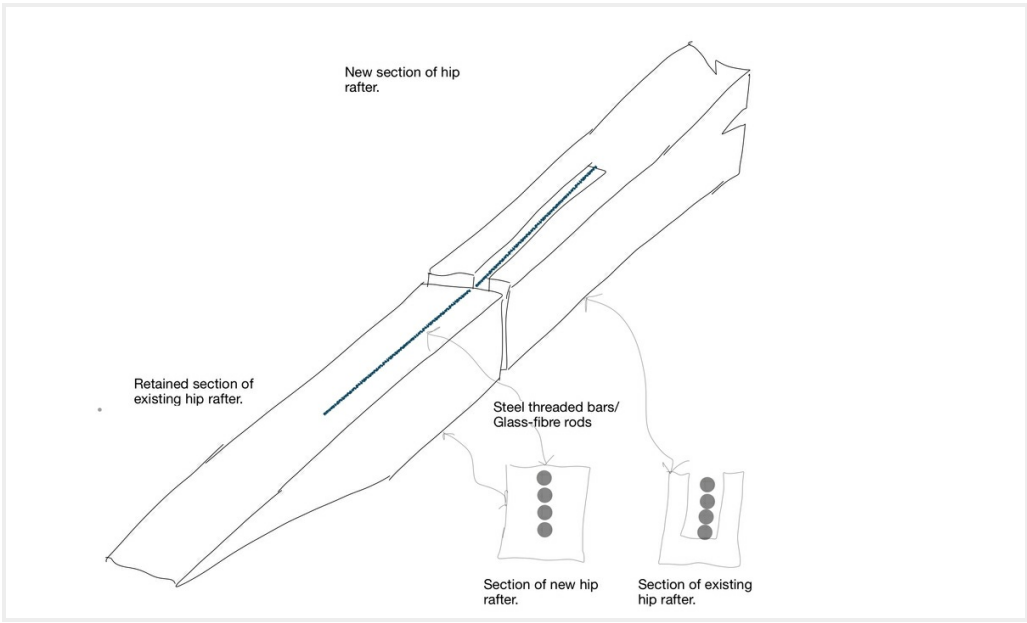
Figure 6: Showing example of timber-resin splice.

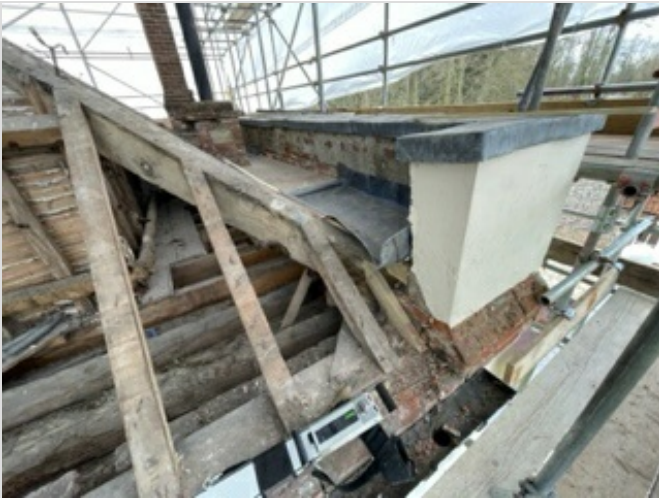
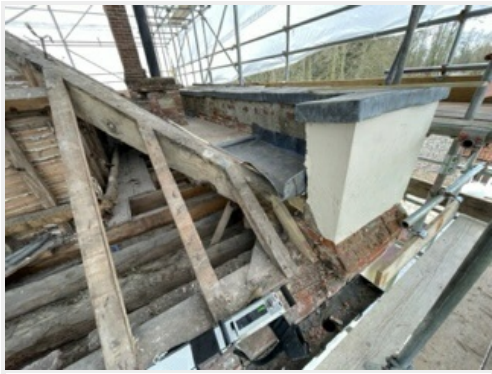
I noted some surface decay towards the foot of this hip rafter, however access was limited here, and I was unable to test with the microdrill. That said, using a blade I was able to establish that a 65mm approx. band of decay had damaged the base of the hip rafter where it connects to the dragon tie.

Figure 8: Showing northwesterly hip rafter.

This area will require further investigation to establish condition. A common rafter may need to be removed and leadwork peeled back to facilitate access.

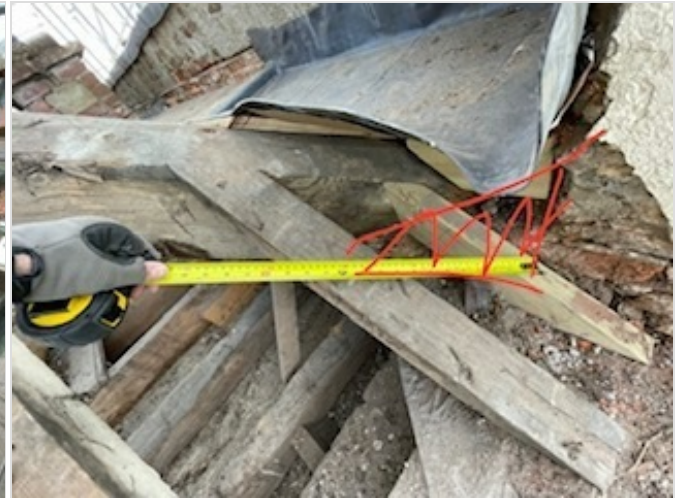
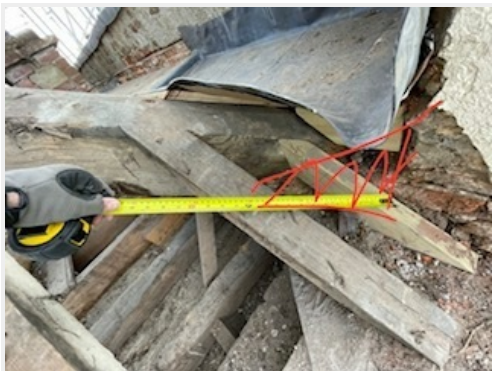
Although I was unable to establish the condition of the adjacent wall plate or dragon tie components, it is thought likely that they have also been affected by the decay that caused damage to the foot of the hip rafter.

Figure 10: Showing position of decay identified thus far.

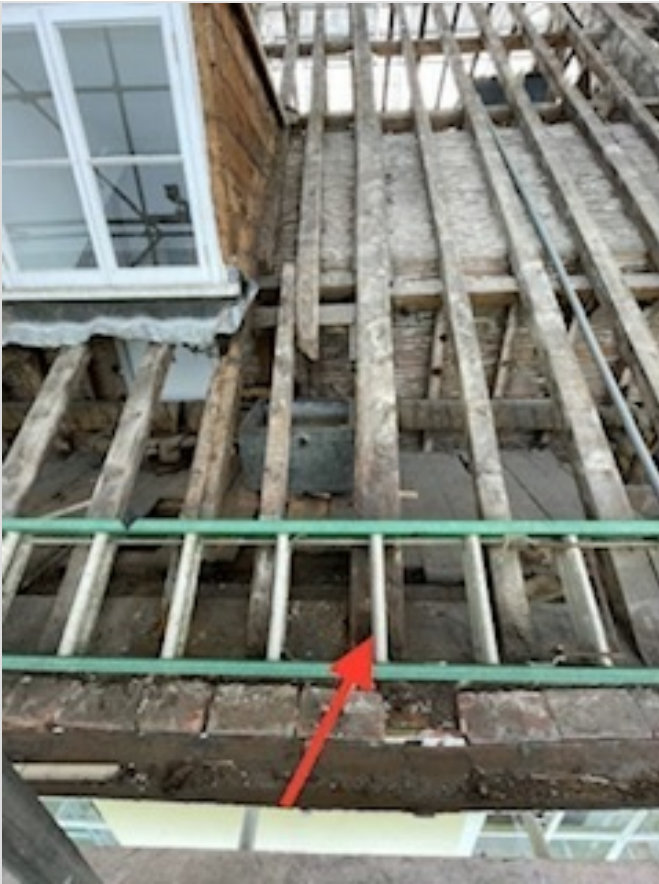
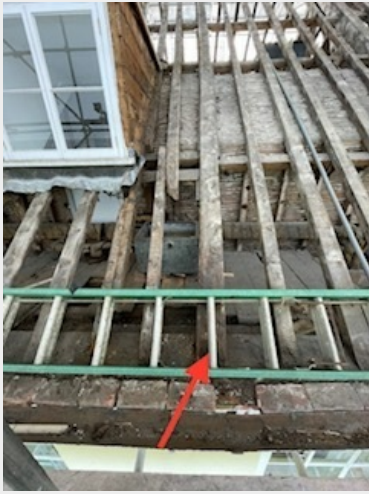
I noted the end of an intermediate rafter to have white rot damage towards the foot. The decay extended approximately 80mm deep into the easterly face and 180mm up from the rafter foot. The decay appears historical.

Figure 11: Identifying rafter.

I recommend that a new section of timber is fixed to the side to partner the existing component.

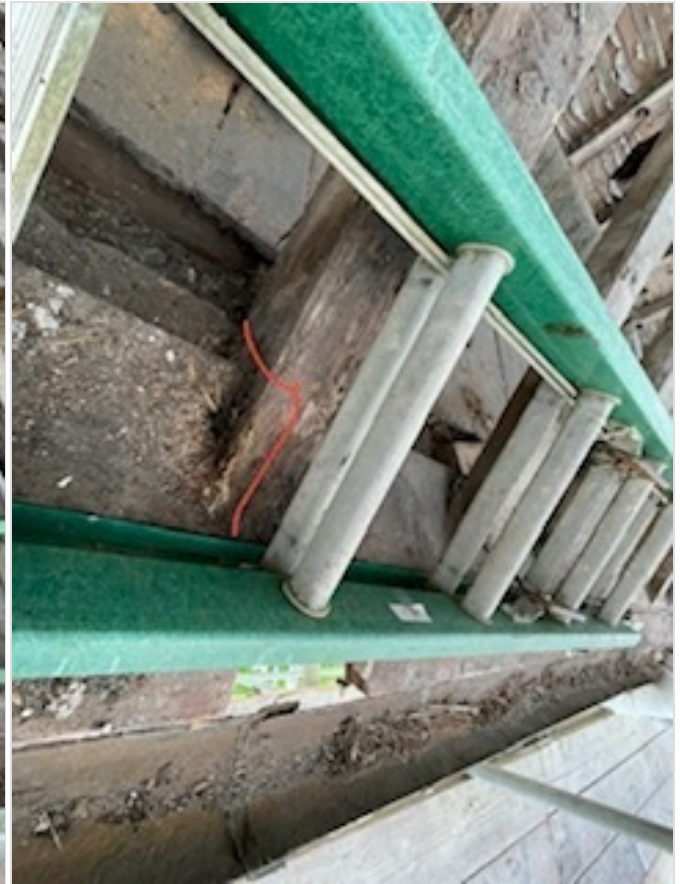
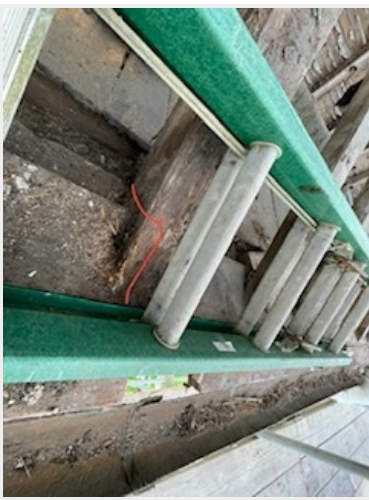
Figure 12: Showing area of decay.
