**Condition Survey / report**

**An agricultural building**

**Hill Farm, Main Road, Mappleton, HU18 1XS**

**Condition Survey / Report on an agricultural building at  
Hill Farm, Main Road, Mappleton, HU18 1XS**

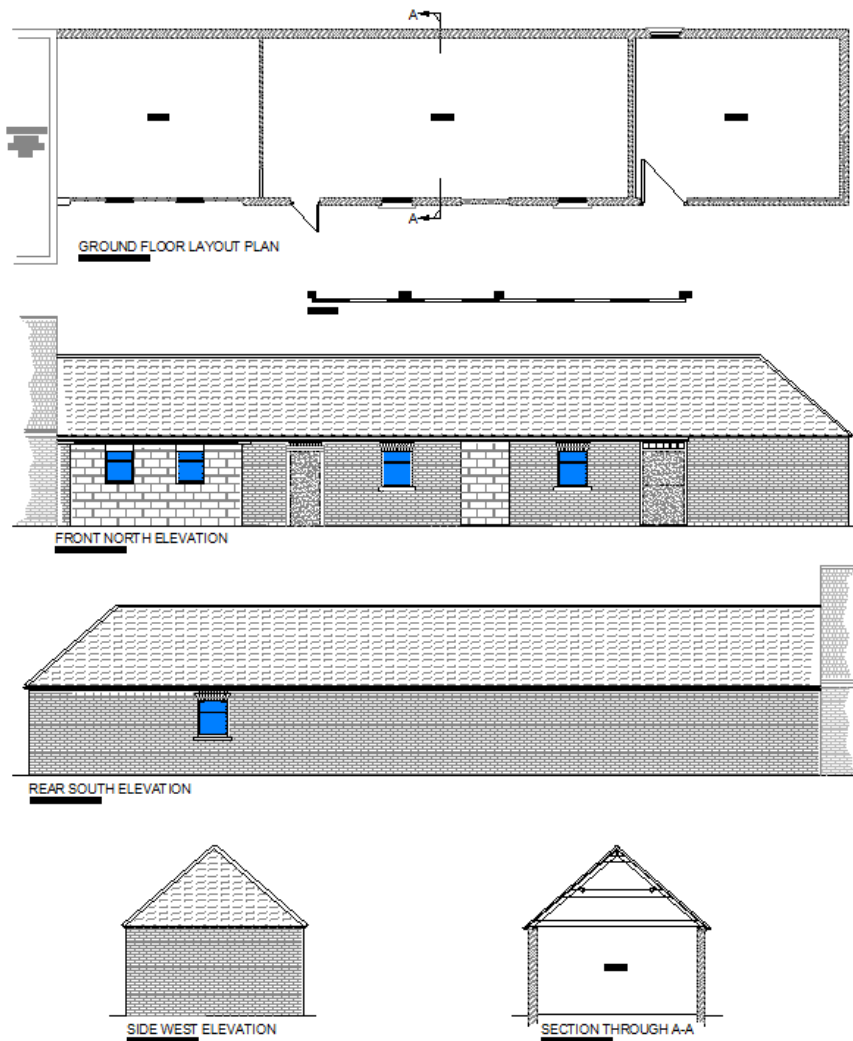
Detail below showing the plan, elevations and sections through the existing outbuilding (not to scale shown)
