HERITAGE ASSESSMENT

Project: 1332 The Old Blacksmiths, Todenham, Gloucestershire GL56 9PF

Document issue: Final/May 2014

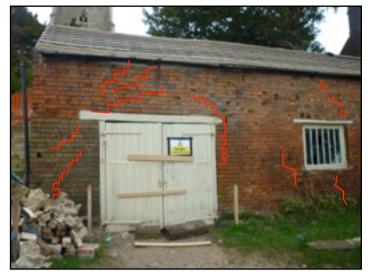
Top Left: Front Elevation showing lines of cracking and movement Top Right: Rear Elevation showing extent of collapse Bottom Left: View of Rear elevation from Churchyard Bottom Right: View into collapsed area

Following the damage caused to the rear wall as a result of the collapse of the churchyard wall, there has been considerable movement within the structure of the building. This has led to the visible bowing of the front wall, which in turn means that the main doors no longer shut properly. They are currently held in place with boards.

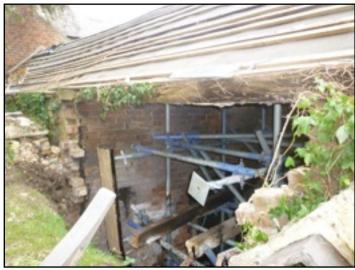
As a direct result of the church yard wall collapsing, a significant proportion of the rear wall was pushed in and the front elevation twisted and bowed, making the whole building unstable.

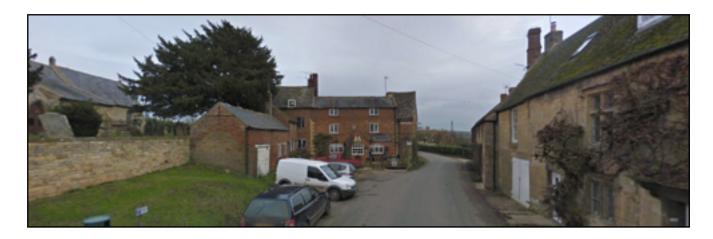
Top: View of site prior to collapse Middle: View of site following collapse Bottom: View of site from Churchyard
