Arboricultural Appraisal Report

Subsidence Damage Investigation at:

42 Shipton Road
York
YO30 5RF

CLIENT:	Crawford & Company
CLIENT REF:	SU2203607
MWA REF:	SUB230208-12292
MWA CONSULTANT:	John Graham B.Sc. Hons PhD
REPORT DATE:	20/03/2023

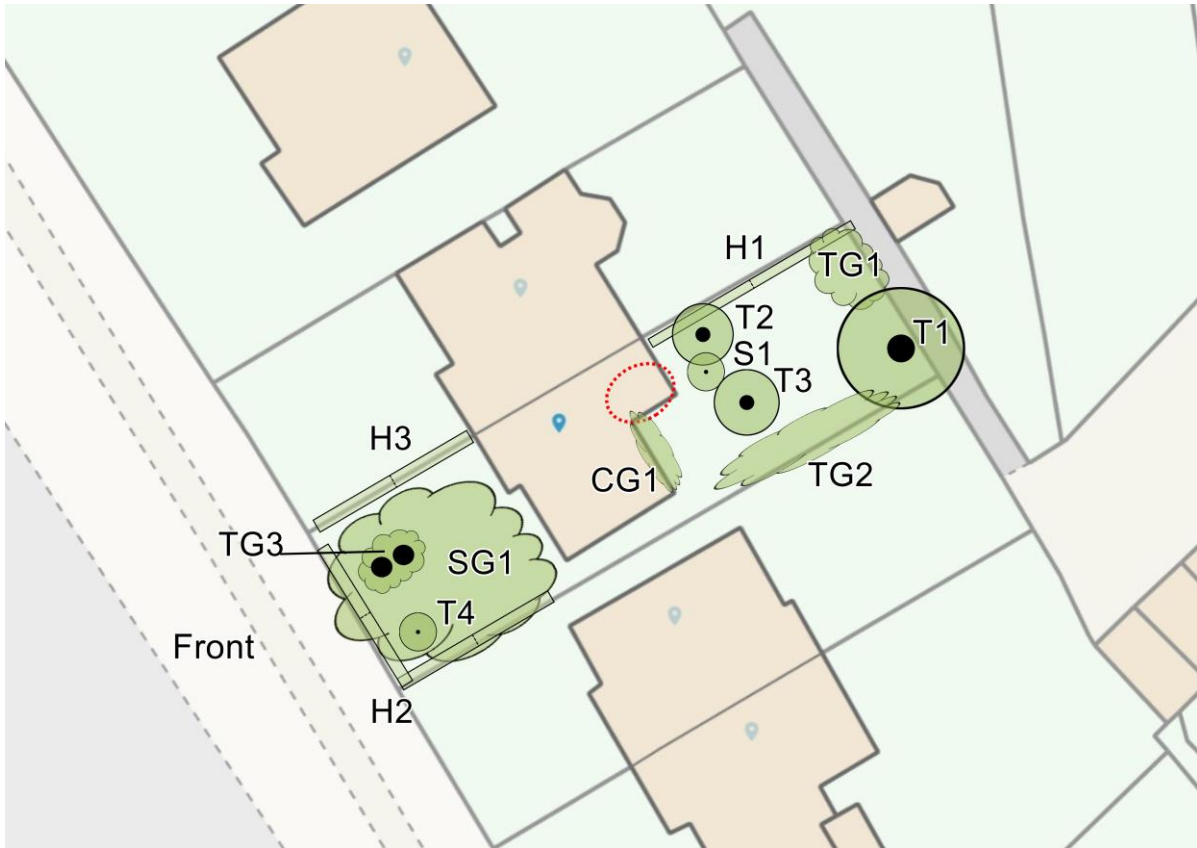
Site Plan

Approximate areas of damage

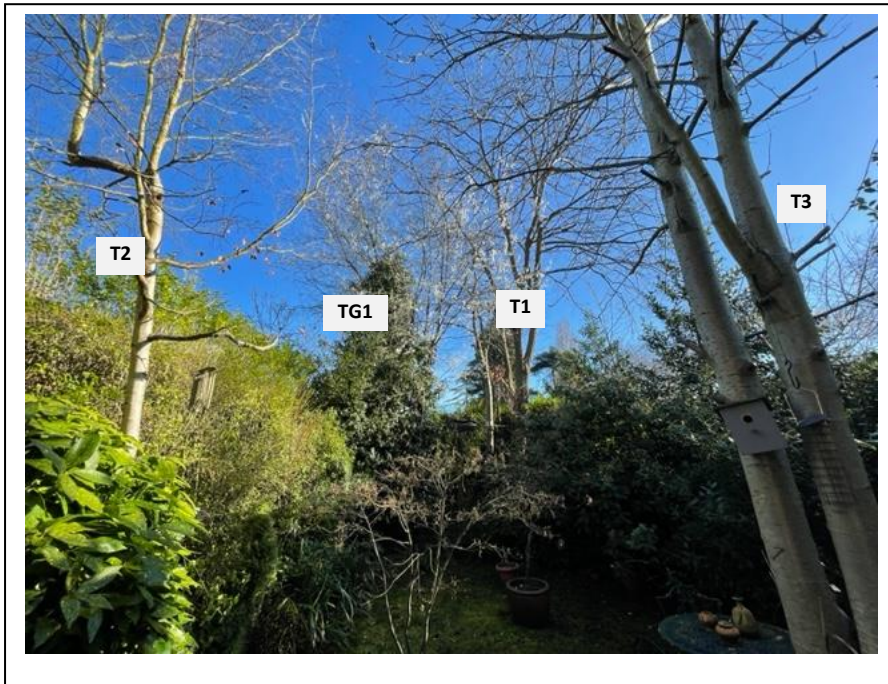
View of rear

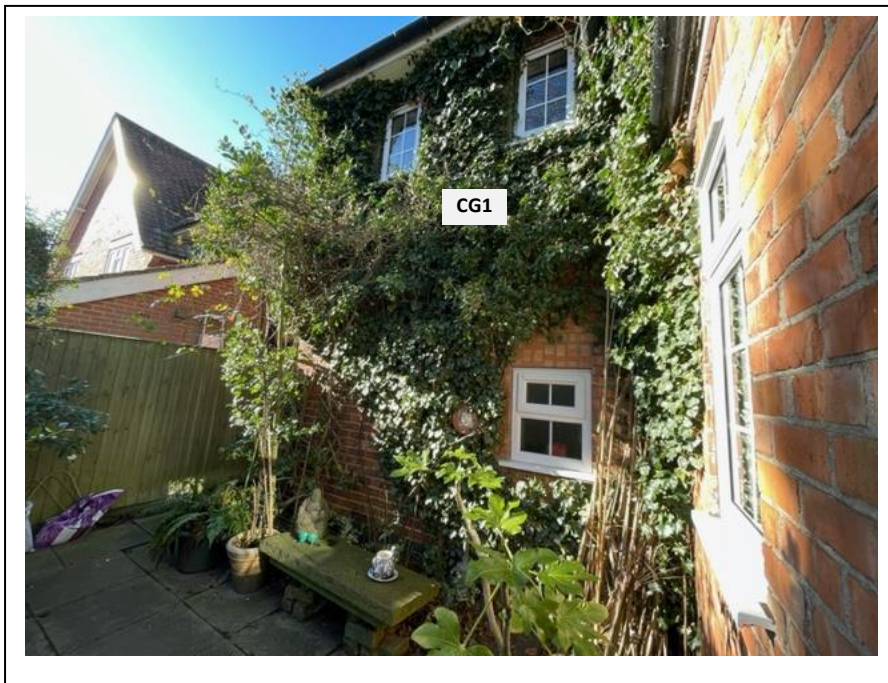
Our survey has identified vegetation within influencing distance of the building with a current potential to influence soil volumes below foundation level. The vegetation considered to be most significant in relation to the current damage is T1, T2 and T3 with a potential contribution from CG1.

View of CG1

If an arboricultural solution is to be implemented to mitigate the influence of the trees/shrubs considered to be responsible for the damage we recommend that T1, T2, T3 and CG1 are removed. Other vegetation recorded presents a potential future risk to building stability and management is therefore recommended.

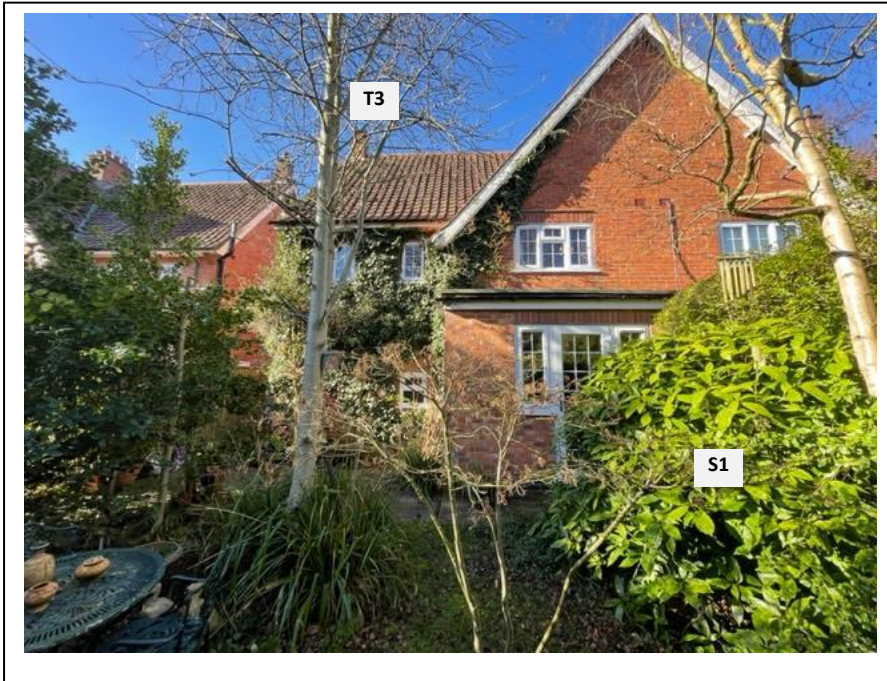
View of T3 and S1
