JETTY BEAM PROPOSAL

Job No. 26632

The Manor House
Westgate
Great Walsingham
Norfolk
NR22 6DY

April 2023

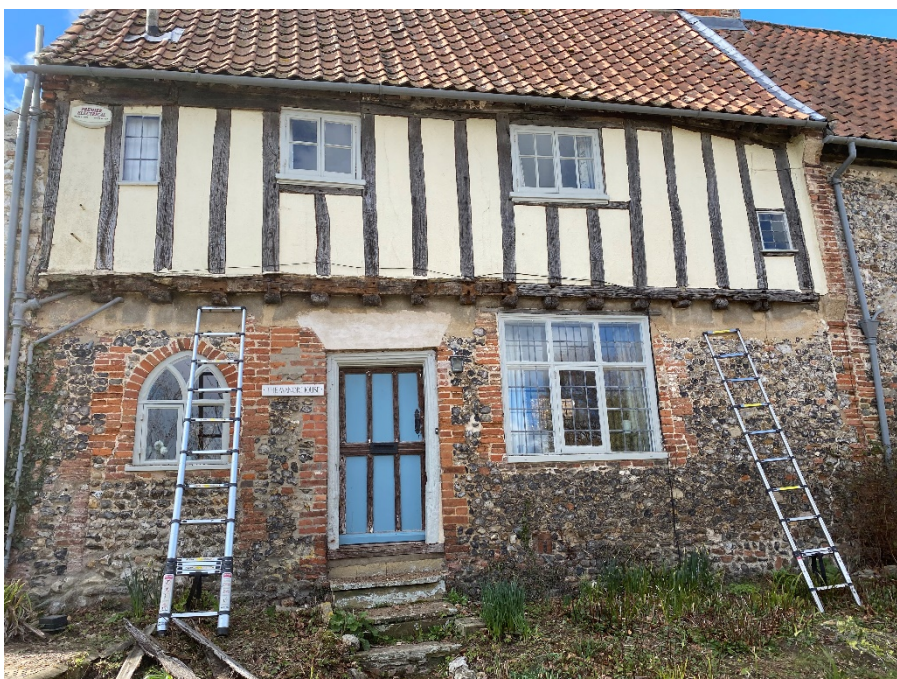
- The jetty beam is formed in two sections, both had an average section size of 125mm x 125mm along their length, although this is much diminished in places.

- The close studding render is formed of roughly 35mm thick cement-sand, this is not considered an appropriate material for the surrounding fabric of the wall

- The close studding contains soft friable daub with the wattle ends visible in two locations above the bressummer beam
- Much of the bressummer beam has been lost to wet rot, particularly around the morticed joints of the studding

- Six of the seventeen joists supporting the jetty beam will require some form of strengthening or repair
- Eight of the seventeen timber studs have lost their tenons entirely with five having lost up to 50%

- Several of the close stud panels have cracks and bossed render, it will be important that this is removed and replaced as part of the repair work
- We were able to undertake a thorough condition survey without the need to remove the base of the close studding panels.

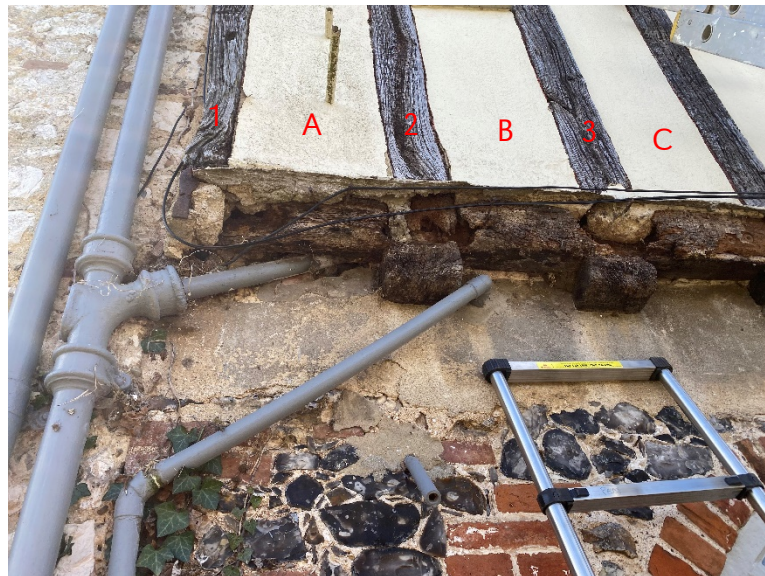
- 1 - Close studding, joist, and jetty beam missing
- A - More than half of jetty beam missing or rotten
- 2 - Tenon half missing, more than two thirds of jetty beam missing or rotten
- B - Up to one third of jetty beam missing or rotten
- 3 - Tenon missing, nearly one third of joist missing, more than two third of jetty missing or rotten
- C - Cracking in panel. One third of the jetty beam in missing or rotten

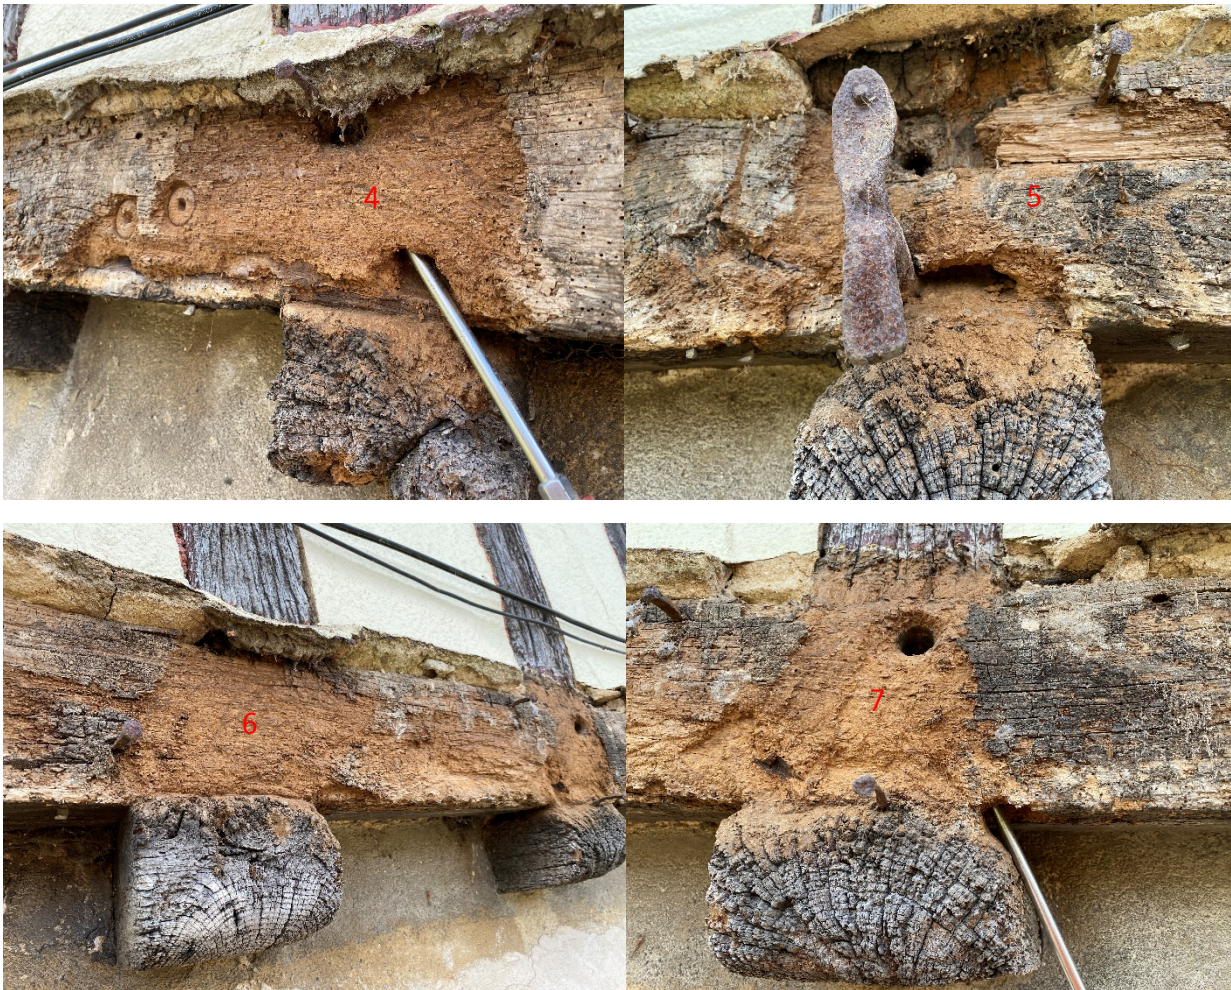
- 4 - Part of tenon missing, front of beam rotten, significant wood boring beetle activity to the rear of the beam and underside. Large shake parallel to beam face
- D - Less than a third decayed, the shake is still present making new joints difficult
- 5 - Tenon half missing, more than two thirds of jetty beam missing or rotten
- E - Panel has significant cracking and slump. Up to one third of jetty beam missing or rotten
- 6 - Nearly one third of jetty beam missing or rotten
- F - Cracking in panel. Less than one third of the jetty beam in missing or rotten
- 7 - One third of the jetty beam lost, face is soft and rotten
- G - Cracking in panel. Less than one third of the jetty beam in missing or rotten

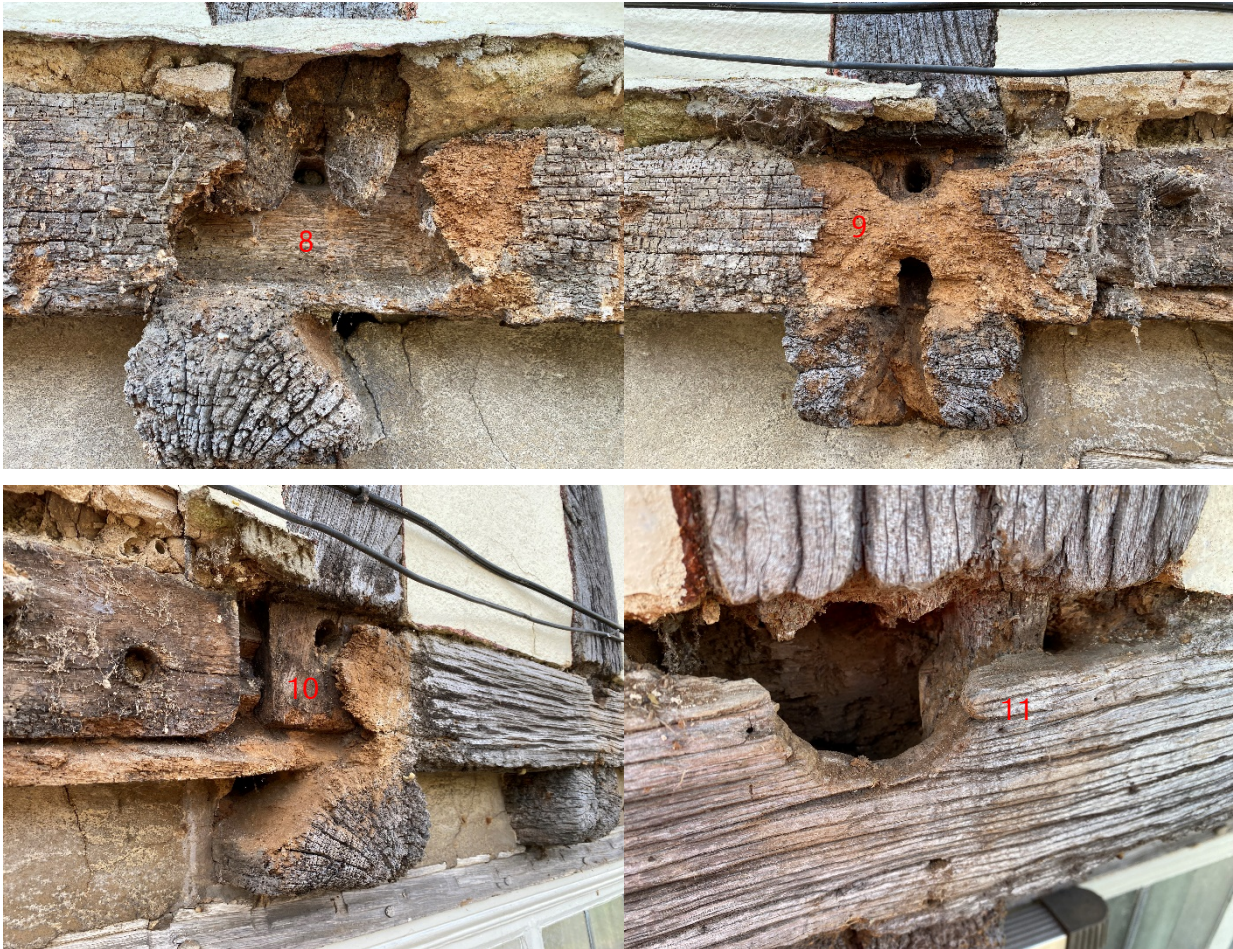
- 8 - Half of tenon missing or rotten, front of beam missing. Half of joist is missing
- H - Significant decay in top and south of beam
- 9 - Tenon half missing or rotten, one third of joist missing or rotten, more than two thirds of jetty beam missing or rotten
- I - Panel cracked and bottom exposed. Significant decay to lap joint.
- 10 - Over one third of jetty beam missing or rotten. One third of joist missing or rotten
- J - Less than one third of the jetty beam in missing or rotten
- 11 - Half of tenon missing or rotten. Two thirds of the jetty beam missing or rotten
- K - Panel significantly cracked. Underside of beam rotten up to one third total section

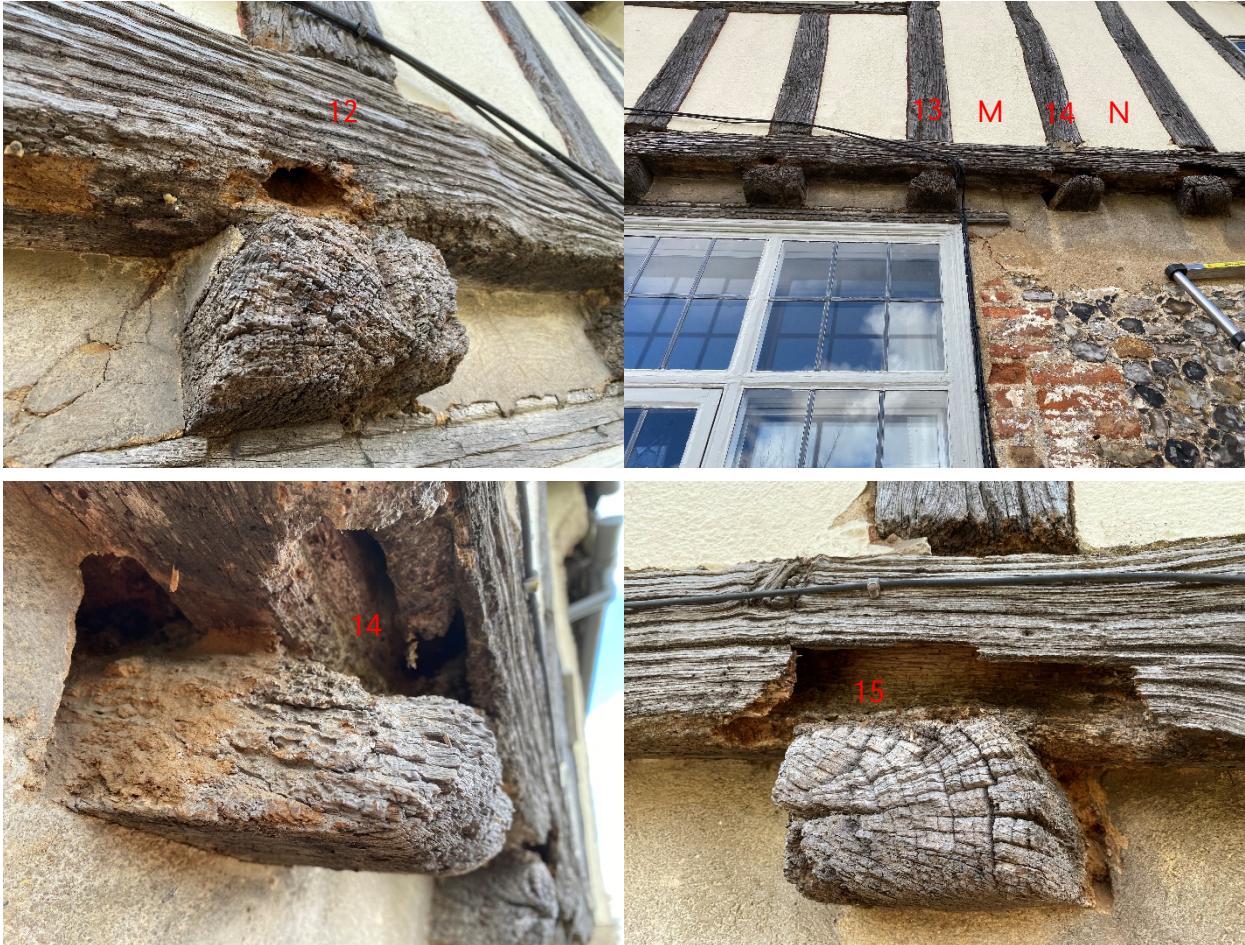
- 12 - More than half of tenon missing or rotten, nearly a third of beam missing or rotten
- L - Panel cracked and slumped. Underside of the beam is hollow sounding
- 13 - Joist has deep cracking, nearly one third of jetty beam missing or rotten due to run-off into jetty beam
- M - Panel cracked. Nearly one third of beam hollow or rotten
- 14 - Most of tenon missing. Over one third of jetty beam missing or rotten. Half of joist missing or rotten
- N - Panel is cracked. One third of the jetty beam is rotten.
- 15 - Tenon missing. Two thirds of the jetty beam missing or rotten

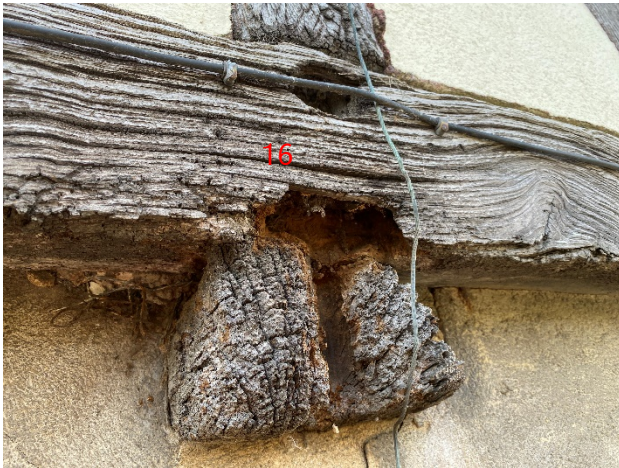
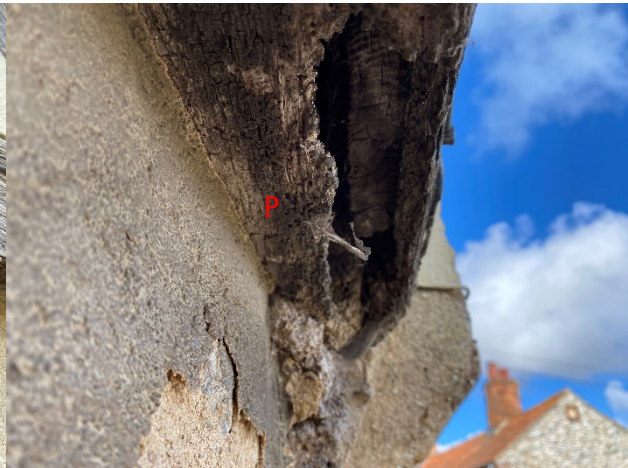
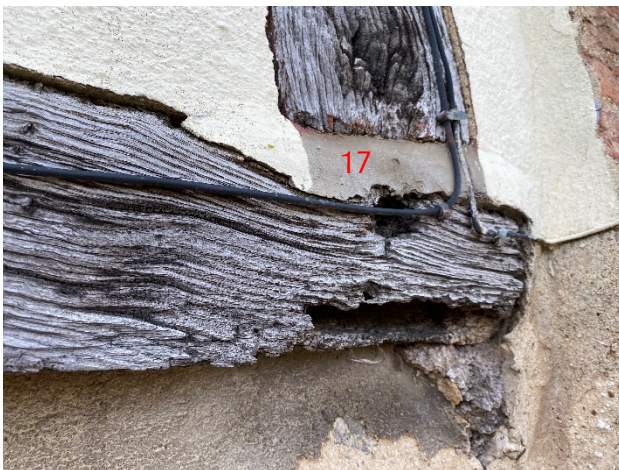
- O - Panel cracked. Beam is rotten on the underside and hollow sounding up to a third of the section is missing
- 16 - No tenon. Joist is degraded through its centre. Jetty beam missing or rotten across more than two thirds of its section
- P - Jetty beam has deep cracking and rot within most of its section.
- 17 - No tenon. Joist is missing. Jetty beam missing or rotten across more than two thirds of its section.
