JACKDAWS FORD

Chelsworth

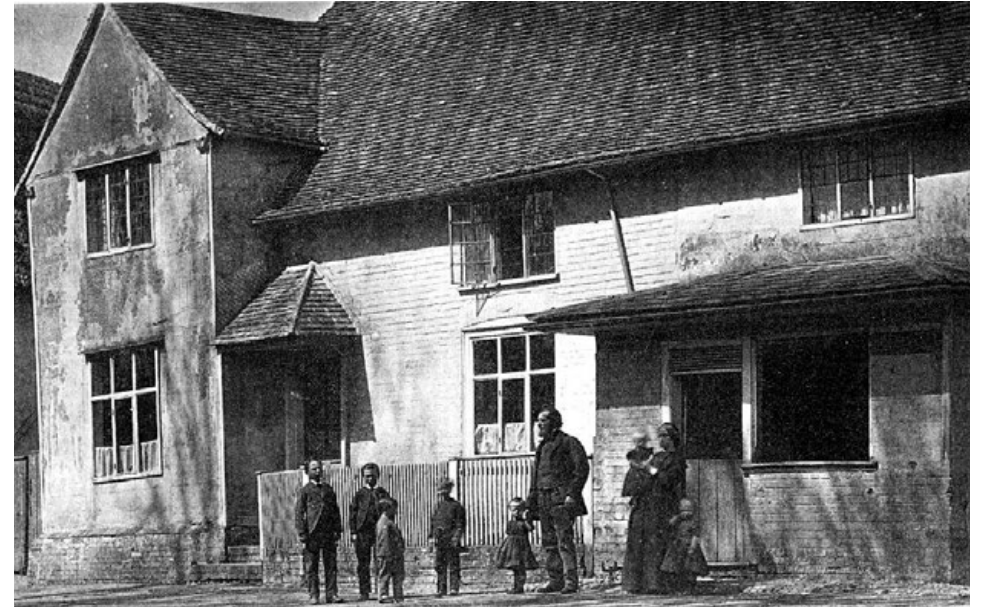
Jackdaws Ford in 1870 showing render finish over exposed studwork, and lead roll hips and gutters over former Butcher's shop (Image published online at Chelsworth.org.uk)

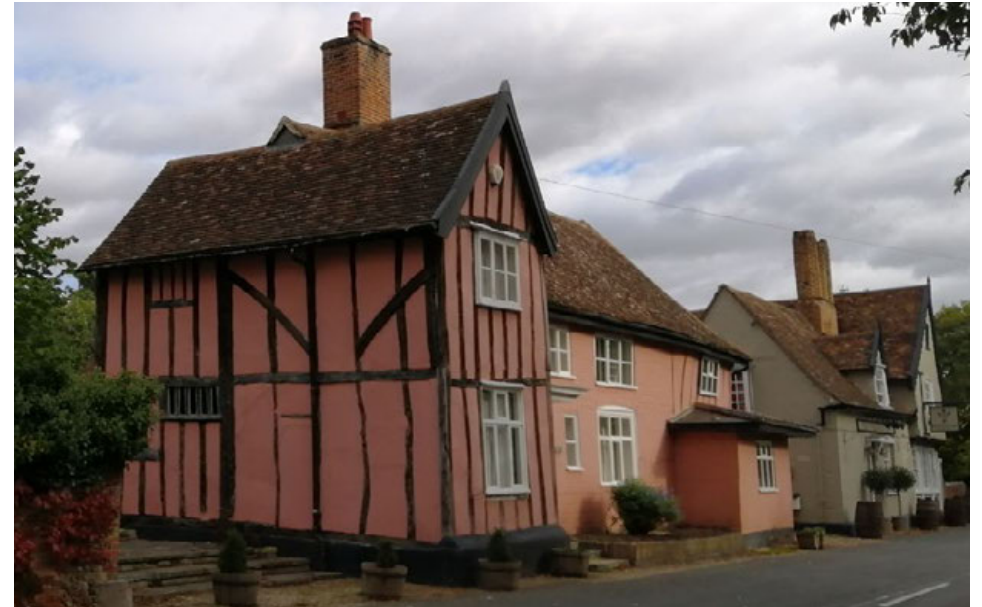
Jackdaws Ford as seen from south west showing the west and south elevations. Blocked upper mullion window of west elevation is proposed to be reopened

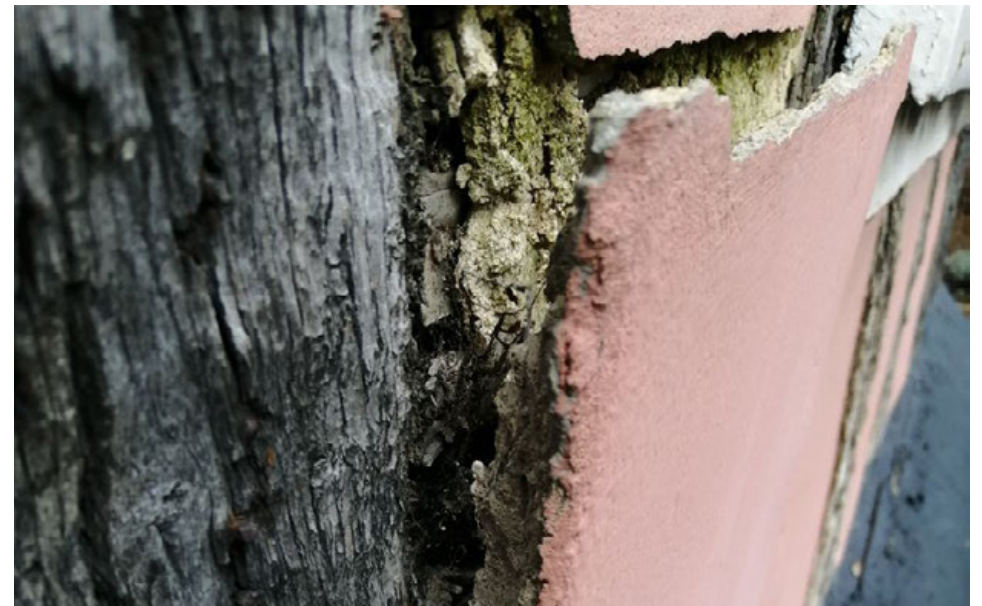
Image showing failing cement render

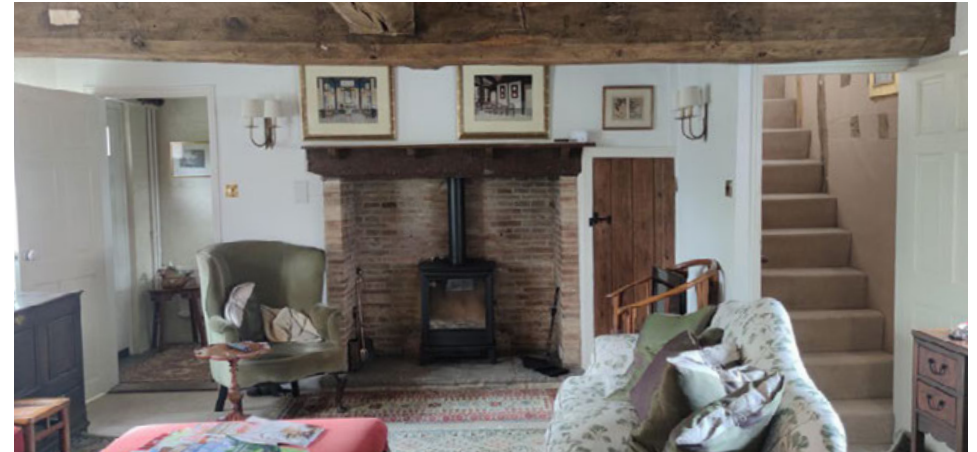
Drawing Room (as seen from the adjacent corridor) showing the existing staircase intruding into the north side of the room

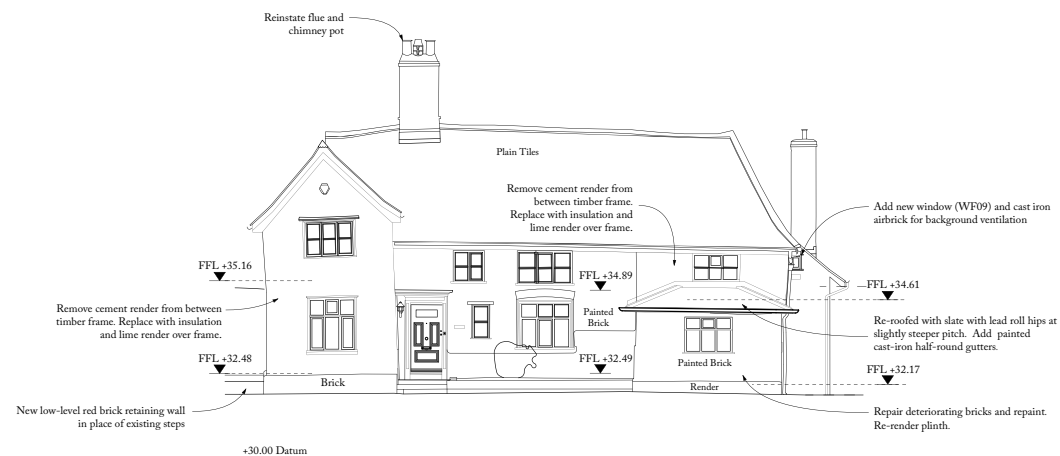
1 SOUTH ELEVATION
As Proposed, 1:100

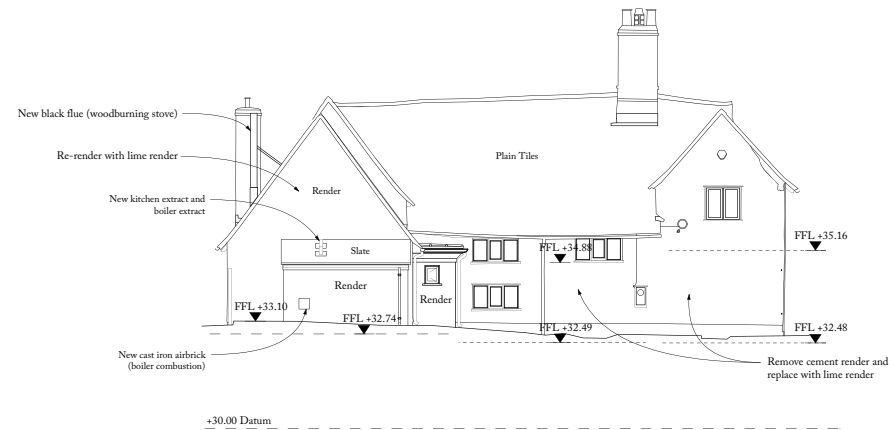
3 NORTH ELEVATION
As Proposed, 1:100

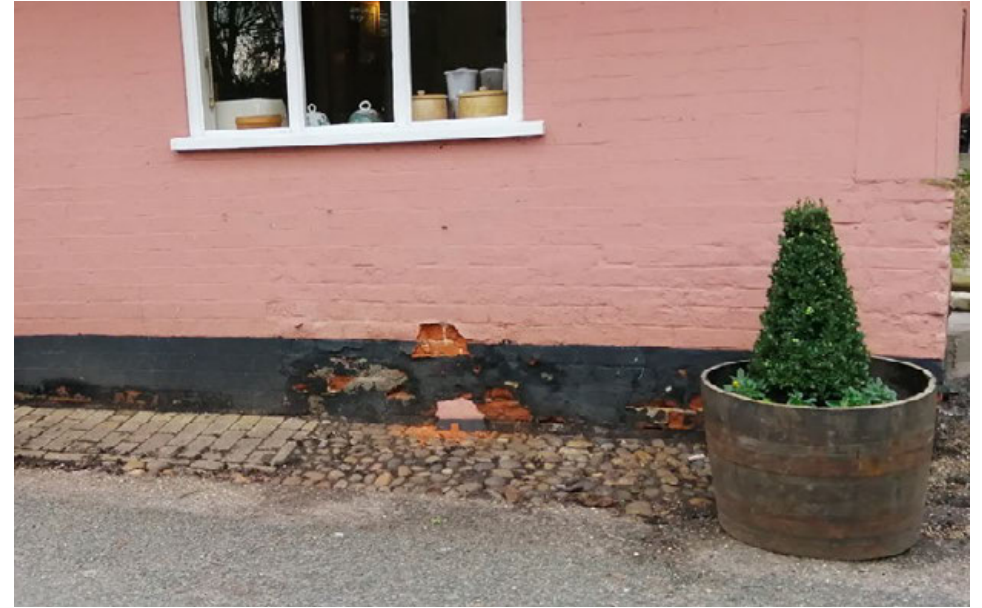
Deteriorating brickwork at low level of former butcher's shop needing repair/replacement and redecoration

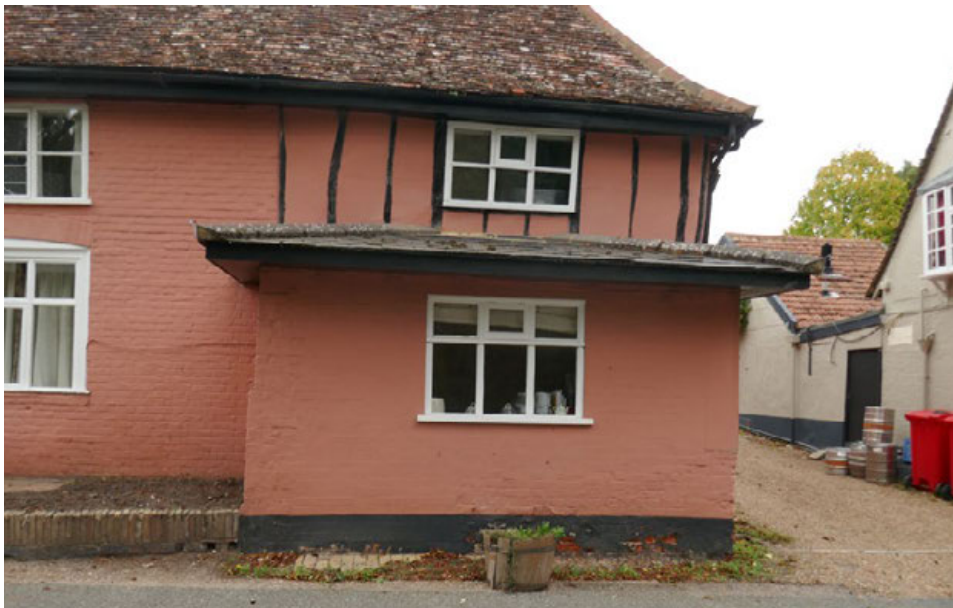
Existing shallow pitched roof of former butcher's shop is proposed to be re-roofed with slate with lead roll hips at a slightly steeper pitch and painted cast iron gutters are to be added

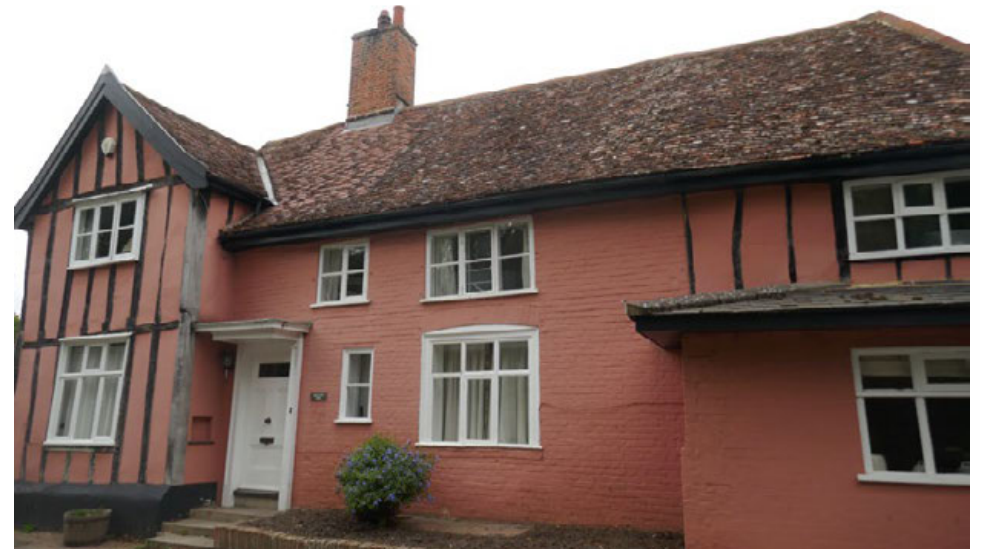
South elevation of Jackdaws Ford. It is proposed to remove the cement render between the existing timber frame and replace with breathable insulation and lime render over the frame

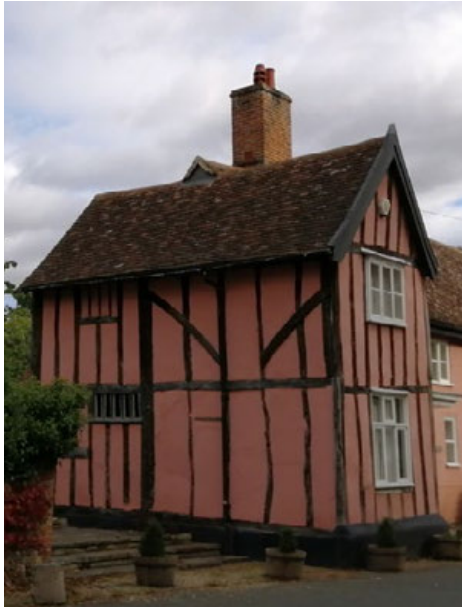
West elevation of the western cross wing of Jackdaw Ford as seen from the south west

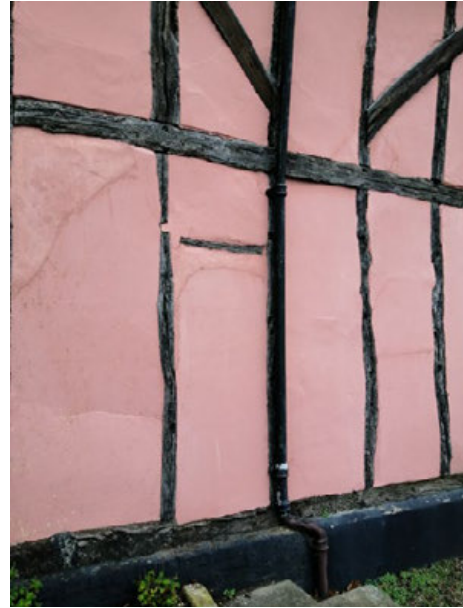
Existing rainwater pipe on western elevation to be altered and plinth to be repaired

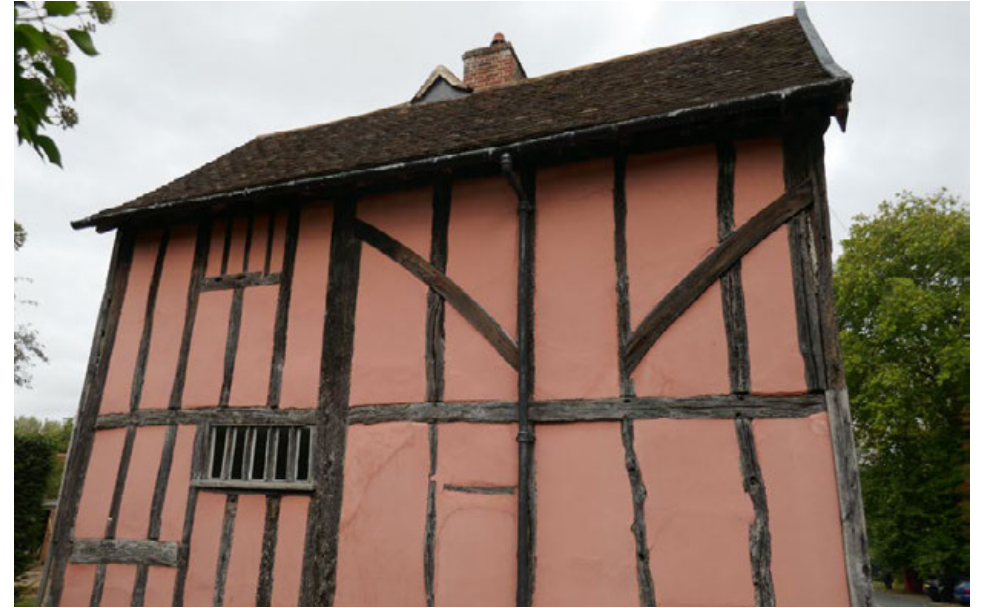
Infilled mullion window on first floor to be reopened

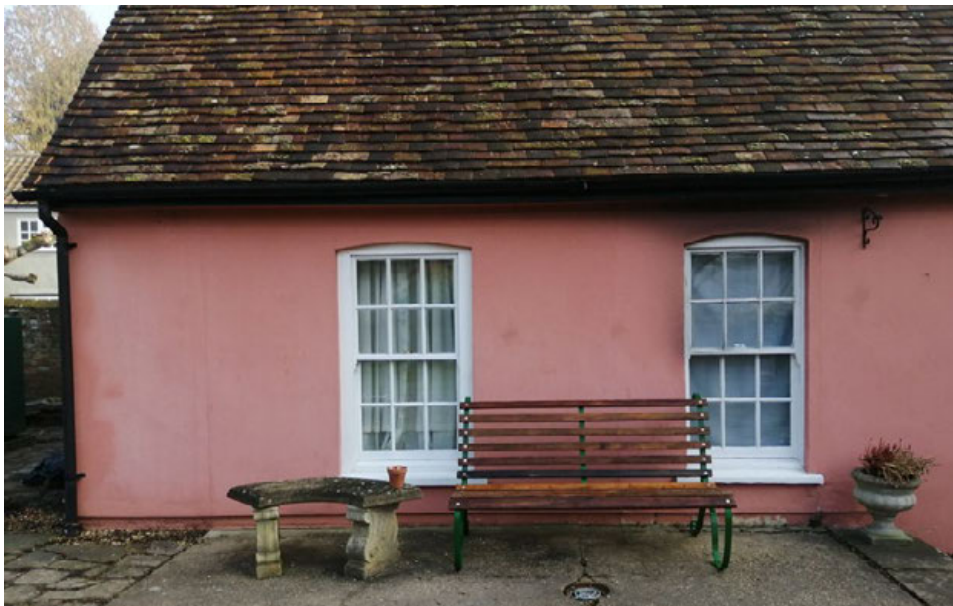
West elevation of northern range showing the former garage opening in the northern end. The location of the former garage opening is discernable by render cracks between the corner and left-side window and just to the right of the right-side window. The redundant lintel is also visible just below eaves level.

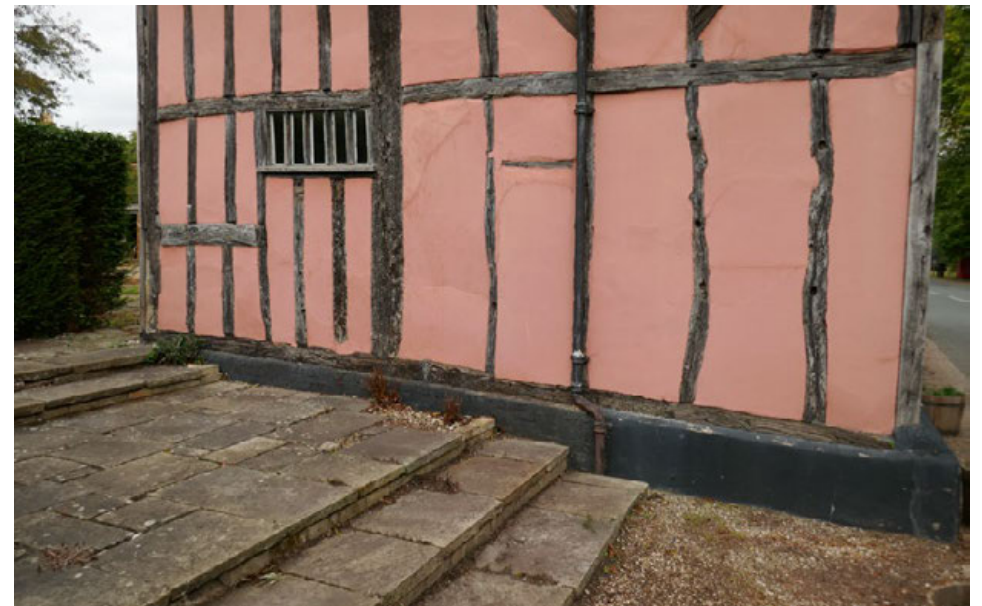
Concrete steps to the west elevation where it is proposed to replace with a low-level brick retaining wall and evergreen hedge

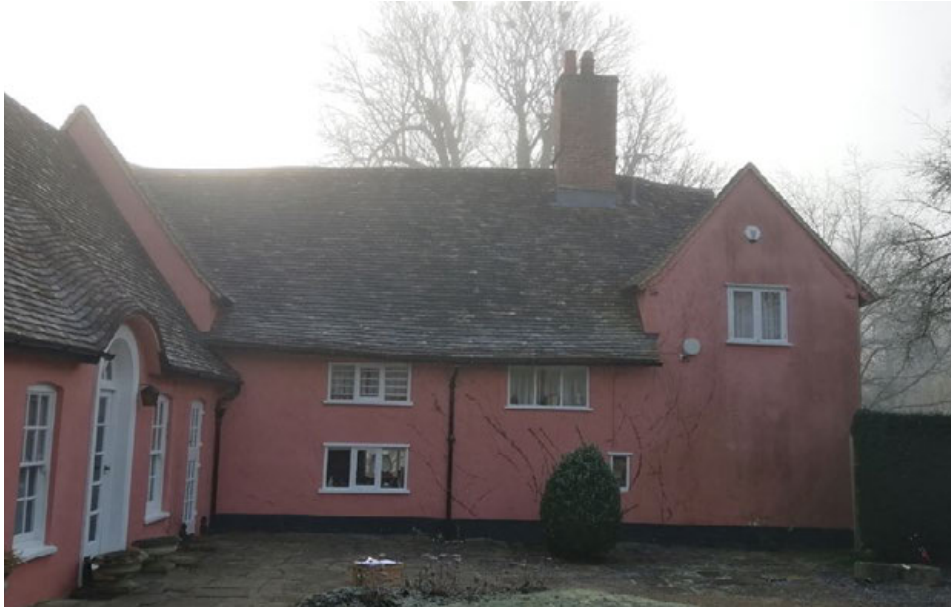
North elevation showing area of cement render to be removed and replaced with lime render

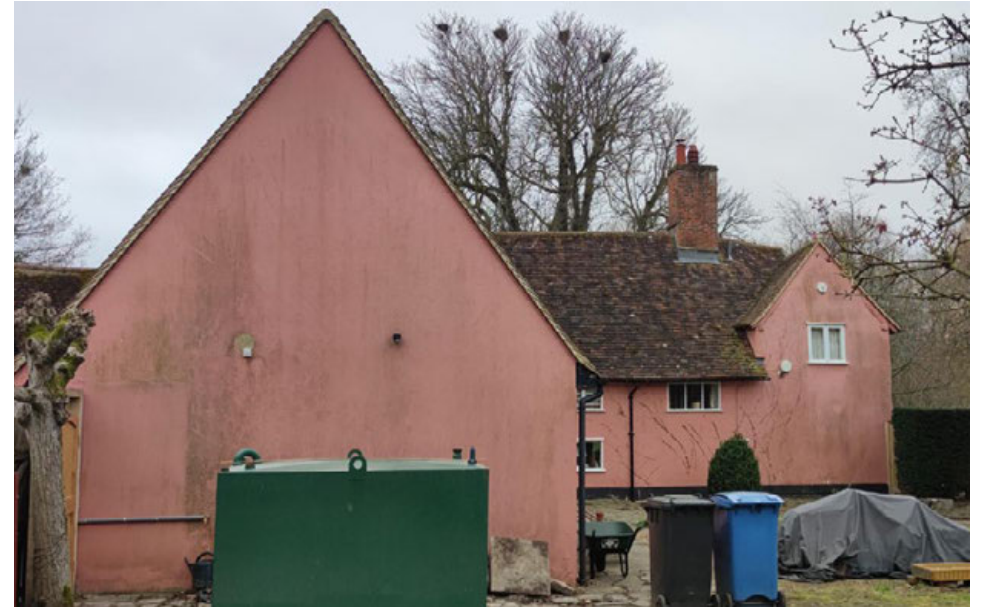
North gable end (in foreground), where a new lean-to for a Larder & Plant Room is proposed

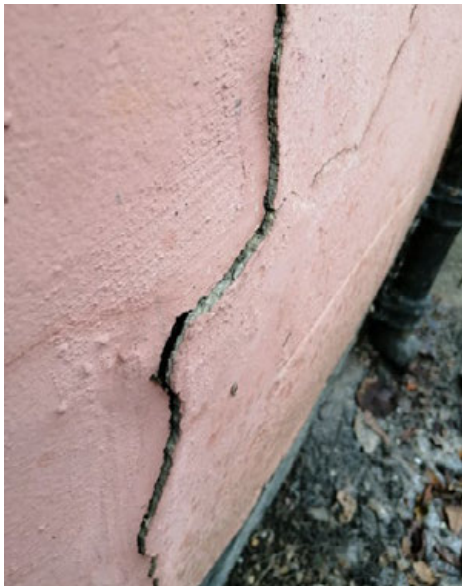
Detail of cracked render on east side of former butcher's shop

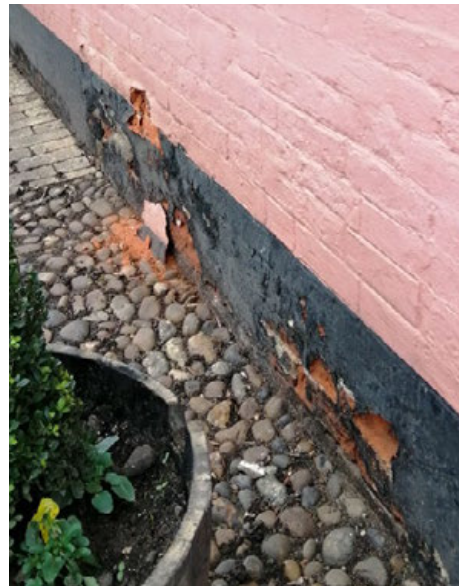
Detail of deteriorating brickwork in need of repair on south side of former butcher's shop

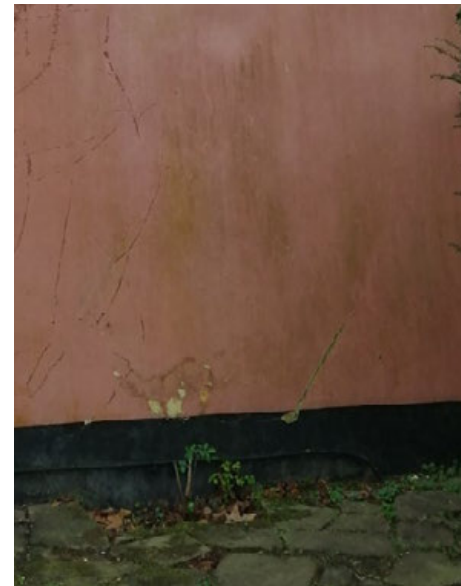
Detail of cracked render on north elevation

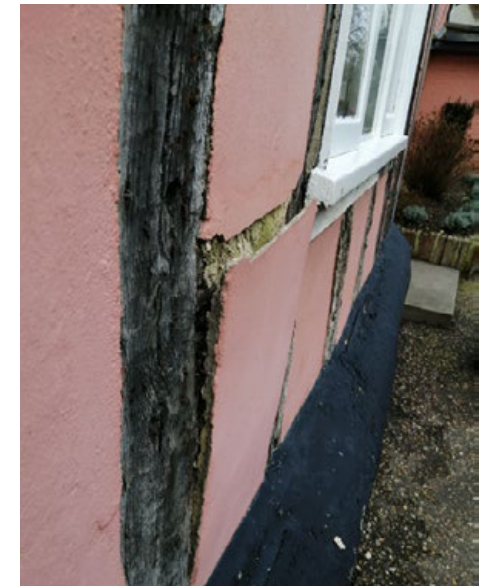
Detail of cement render infill panel coming away on south elevation of western cross wing

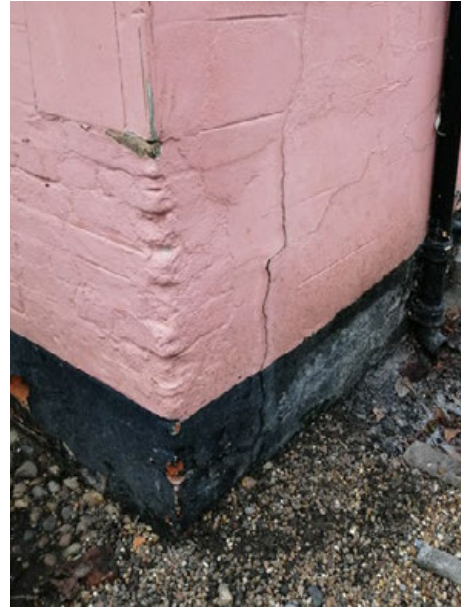
South east corner of former butcher's shop where render over brickwork is deteriorating

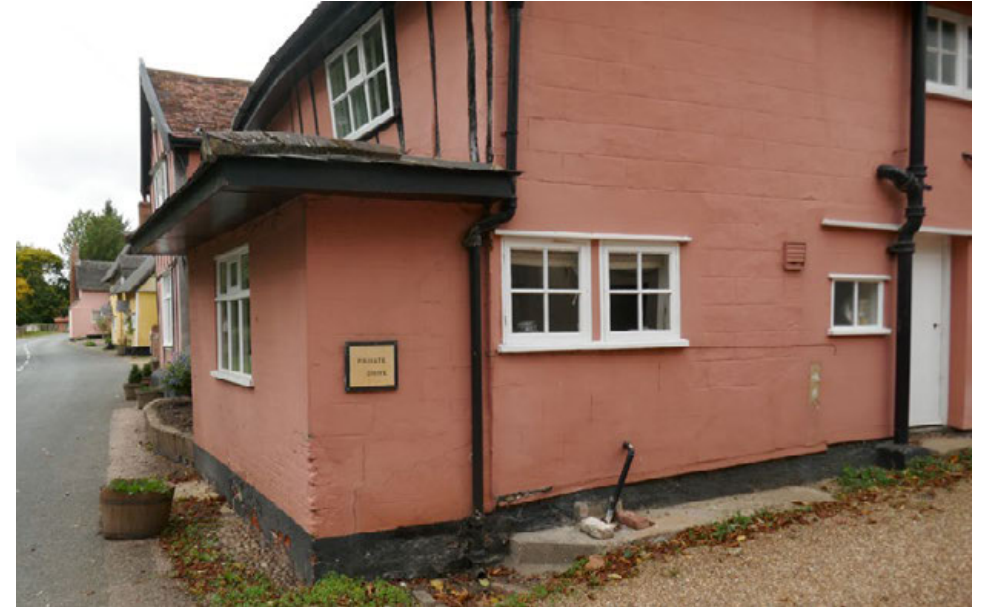
Southern end of east elevation showing deteriorating render and leaking shallow pitch roof with concrete hip tiles and eaves without gutters

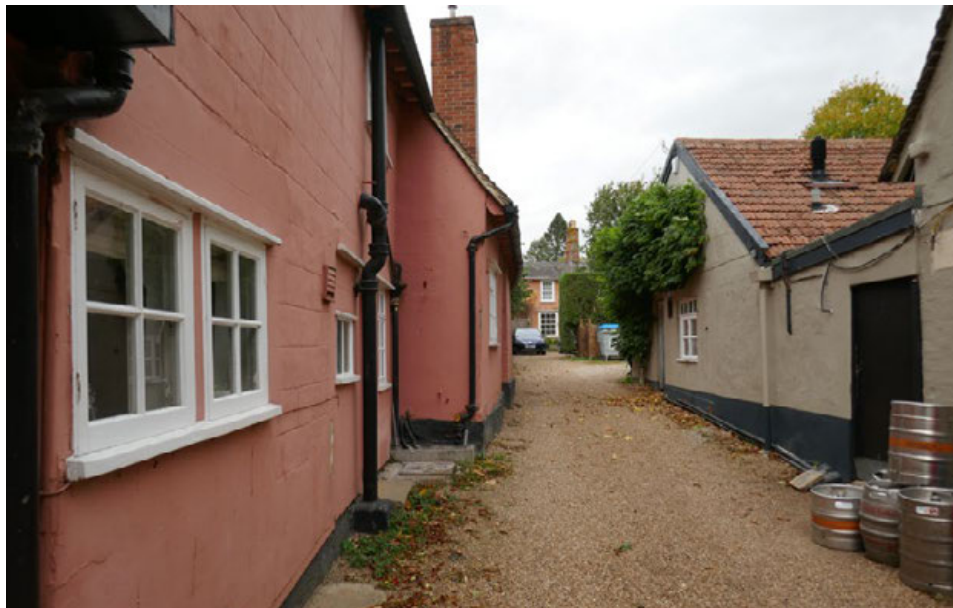
East elevation of Jackdaws Ford looking north at the southern end of the northern wing where it is proposed to introduce a small squint window for a new bedroom in the currently unused attic space

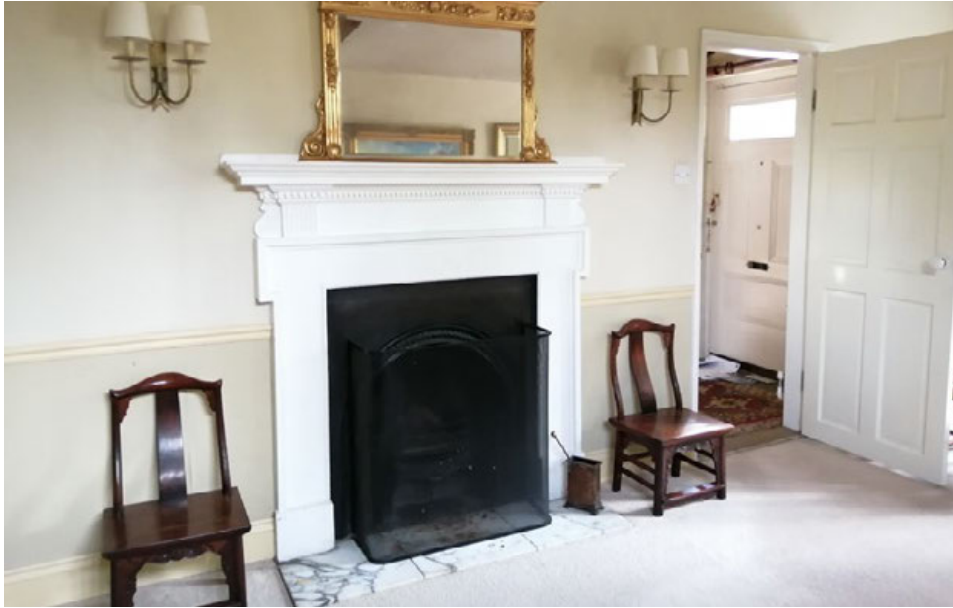
1 Snug - Replace carpet with oak floorboards laid over existing concrete floor

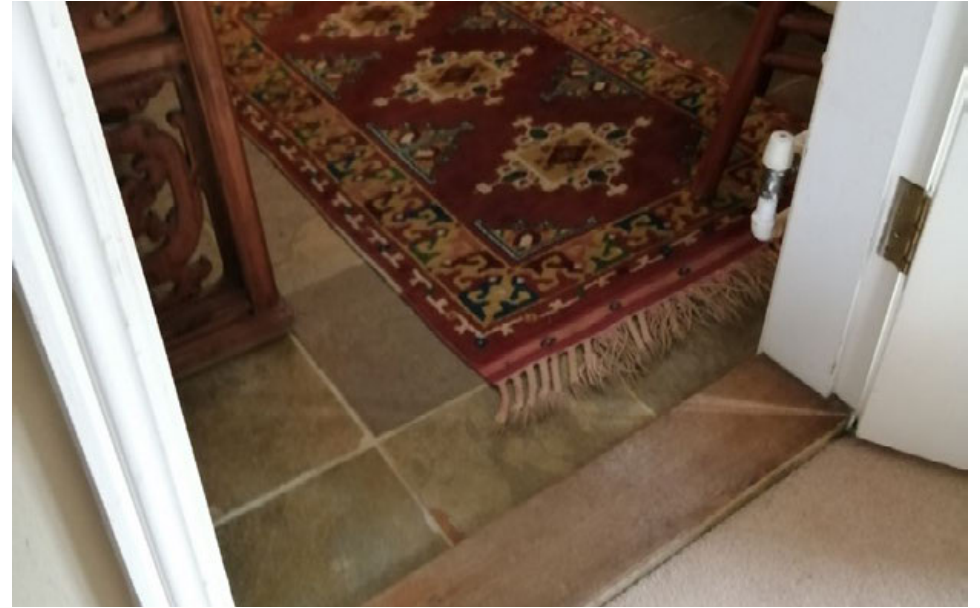
2 Lobby - Modern floor tiles to be removed and replaced with oak floorboards

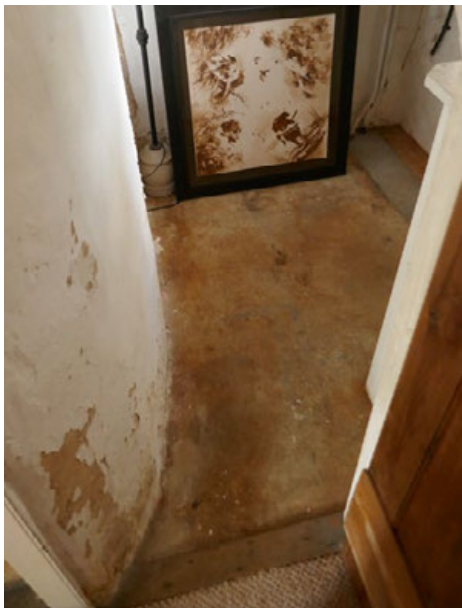
3 Cupboard - New carpet to be installed over existing concrete floor

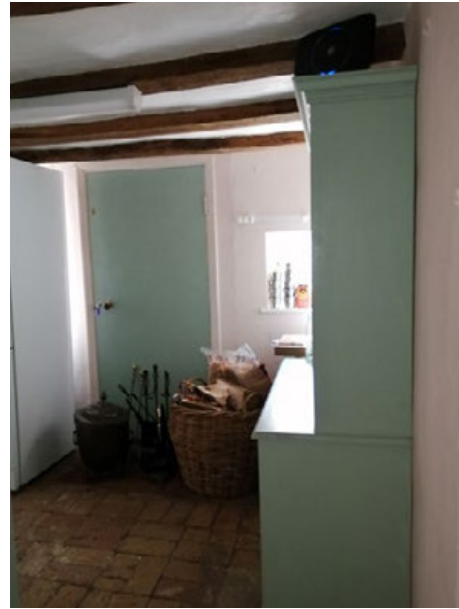
7 WC & Boots - External door to be replaced and floor bricks to be retained

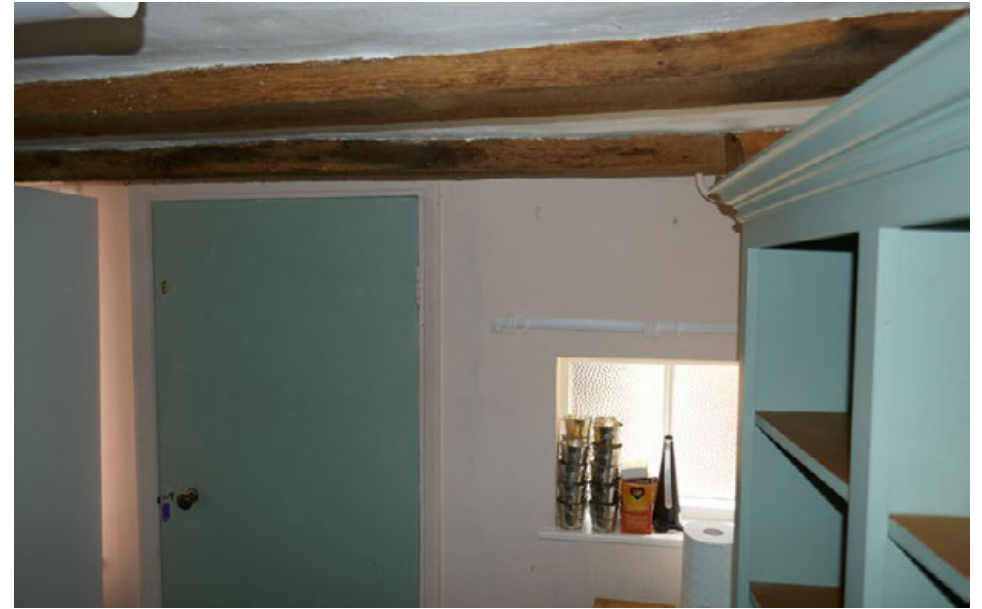
7 WC & Boots- External door and window to be replaced in adjusted window opening

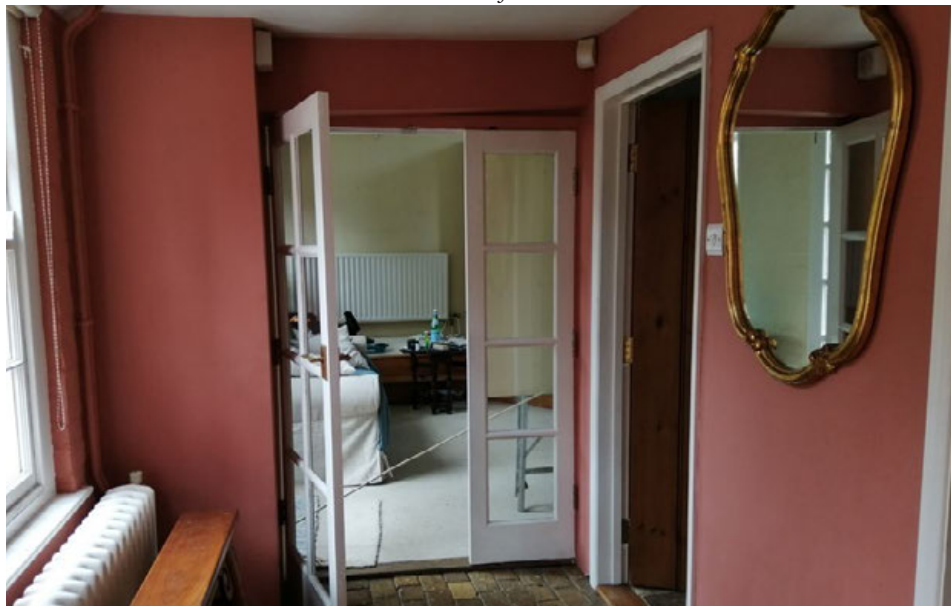
8 Back Hall - Plasterboard partition walls and internal doors to be removed and floor bricks taken up and relaid over new insulated floor buildup

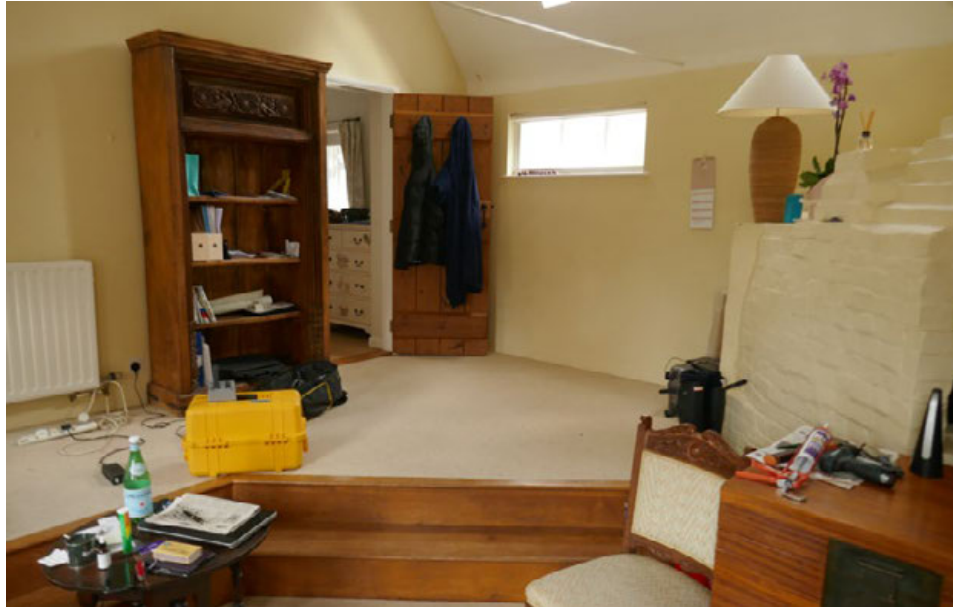
11 Kitchen - Remove existing stepped-level floor and replace with new insulated floor on single level and flagstone floor tiles. Existing bread oven (on right) to be retained.

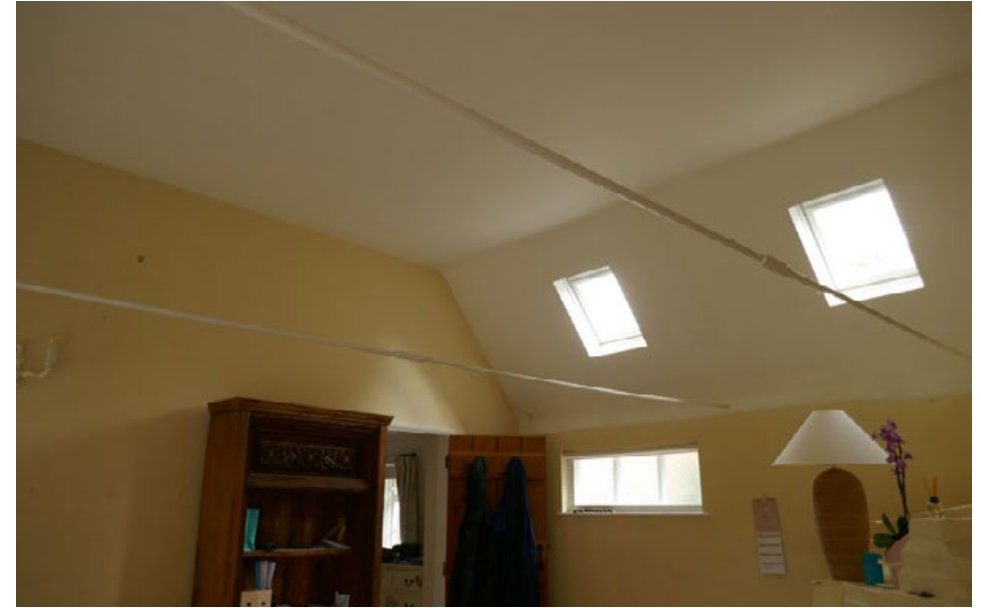
11 Kitchen - Steel tie bars, rooflights, ceiling, and blockwork partition wall (left hand side) to be removed. A queen post truss is to be installed in place of the blockwork partition wall.

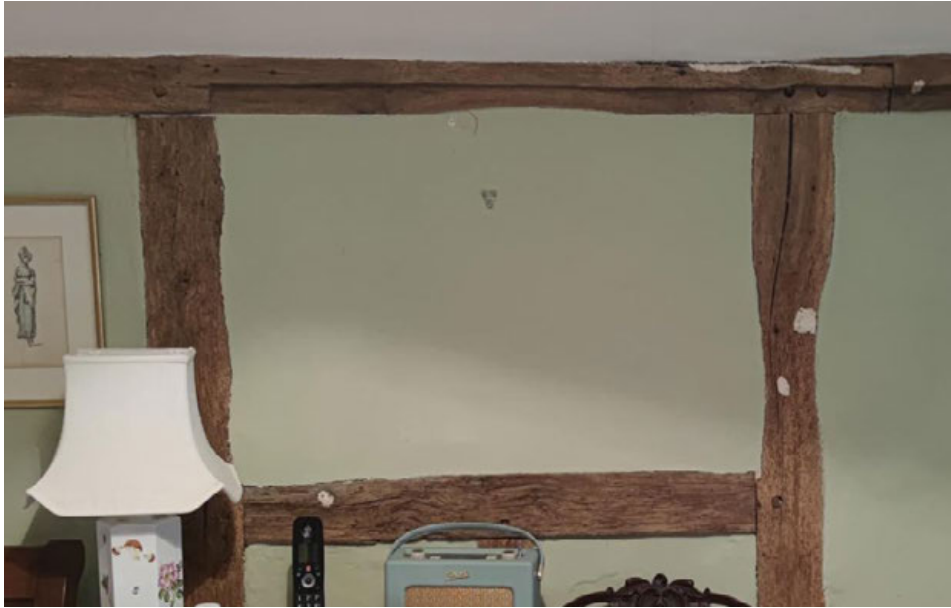
14 Bedroom 1 - Blocked mullion window to be reopened

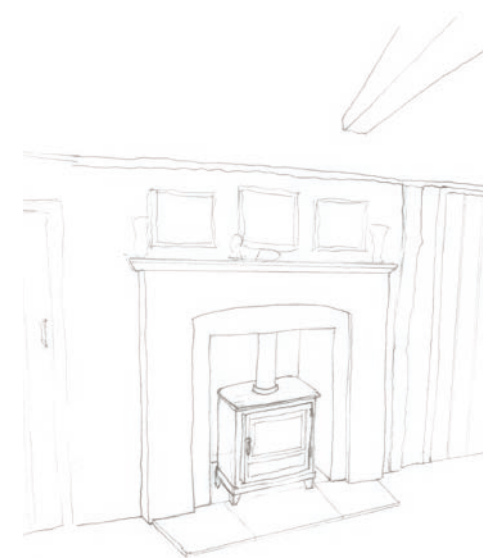
14 Bedroom 1 - Proposed sketch of reopened fireplace with wood-burning stove

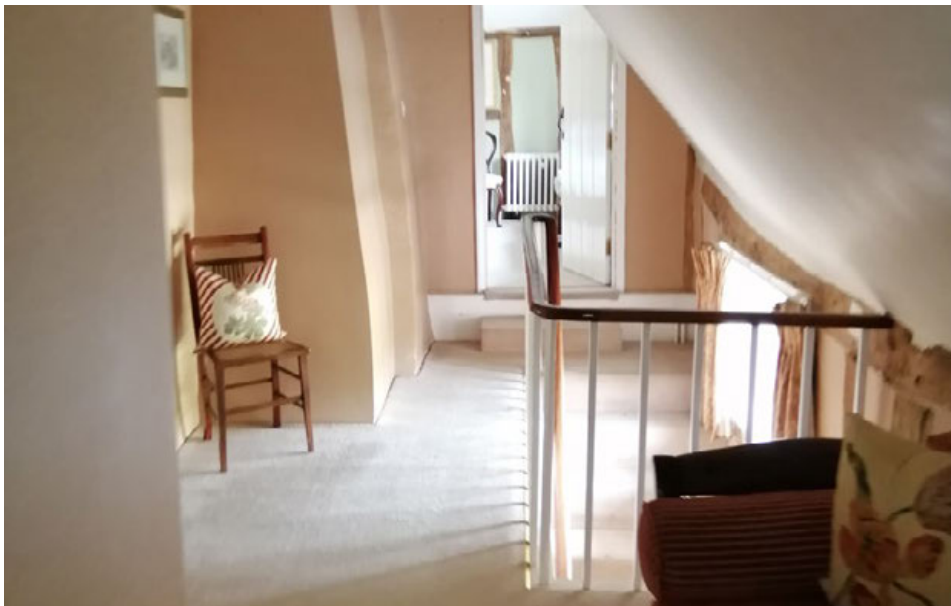
16 Bedroom Lobby - Area of proposed Bedroom Lobby showing awkward head height and unsafe landing in front of bedroom, along with late 20th century balusters and handrail to be removed

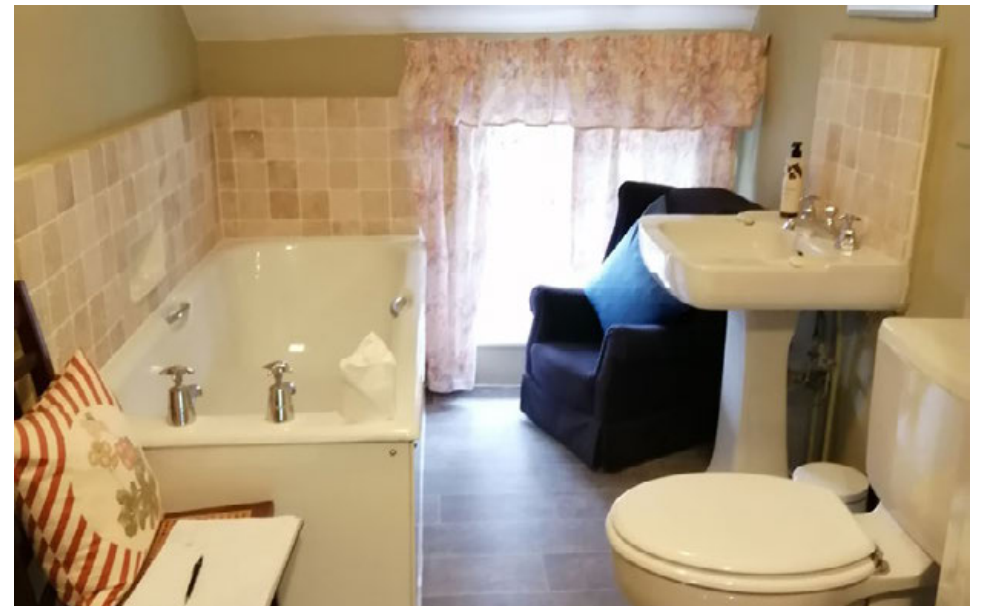
17 Bath 1 - Sanitaryware within Bath 1 to be replaced, including replacement of bath with shower. Existing vinyl floor to be replaced with tiles.

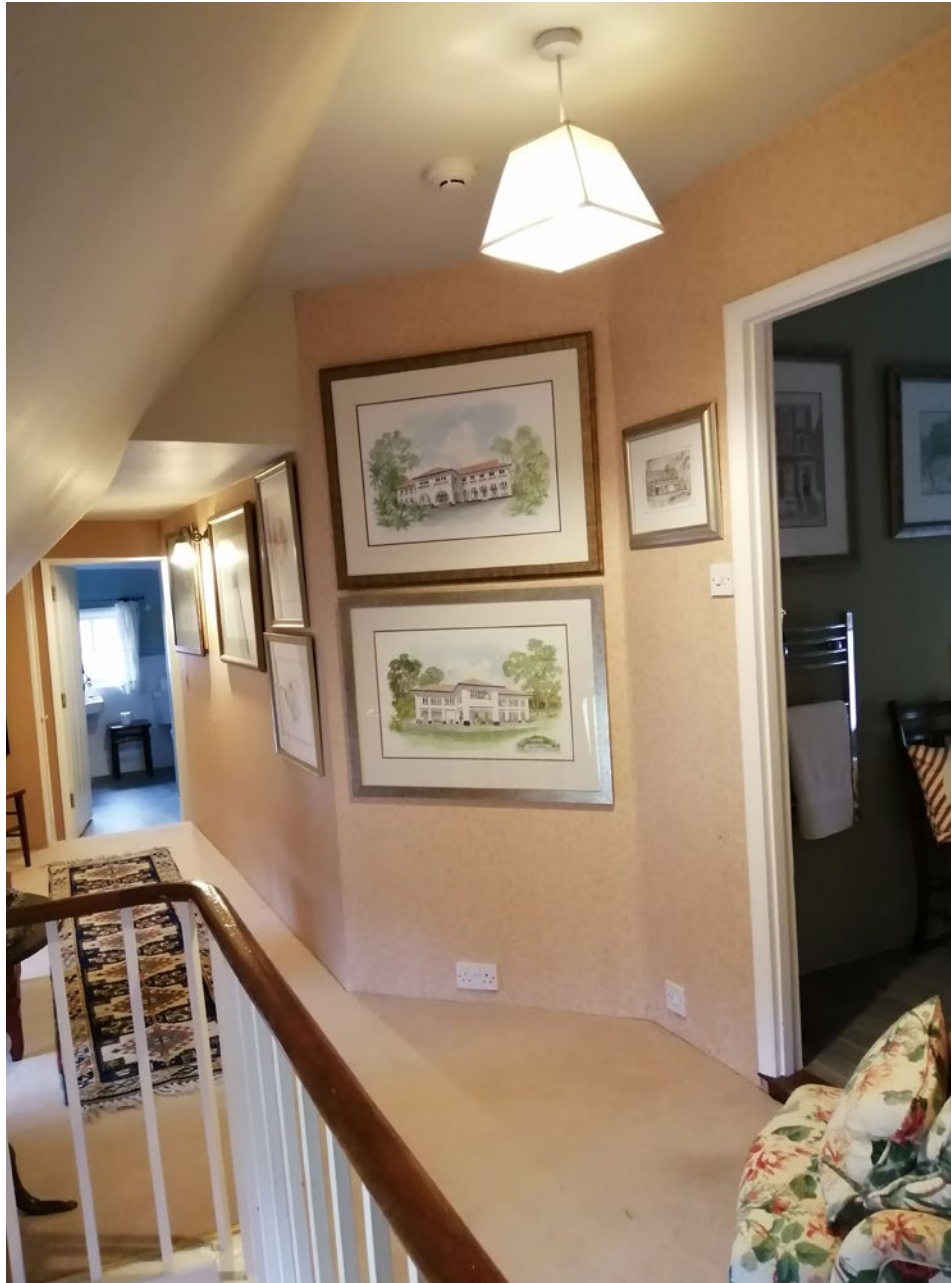
16 & 18 Bedroom Lobby & Upper Corridor- Existing 20th century studwork partition to be replaced in modified location and existing dropped ceiling to be removed

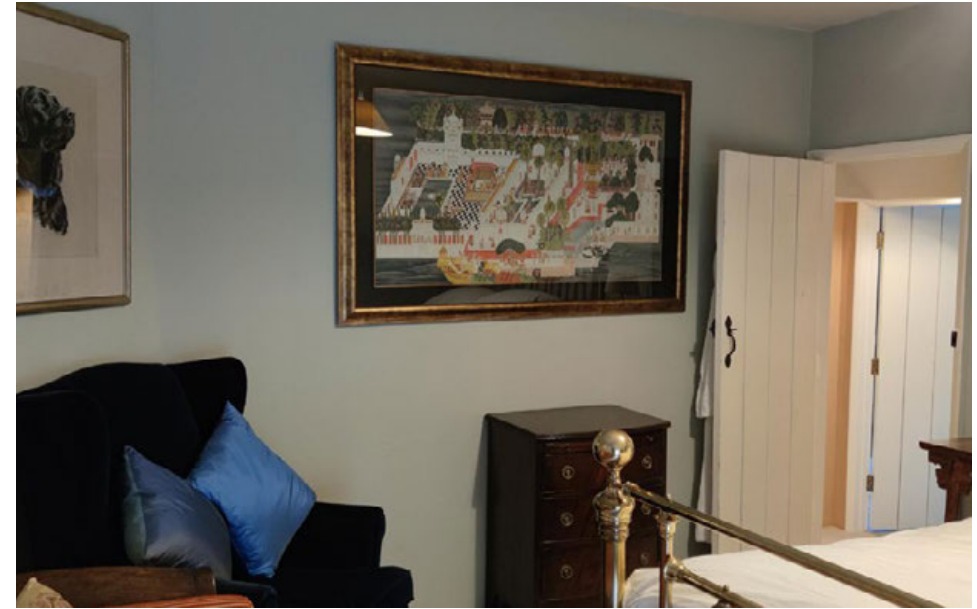
19 Bedroom 2 - 20th century partition to be replaced in modified location. Door leaf to be moved to new opening in rebuilt partition wall.

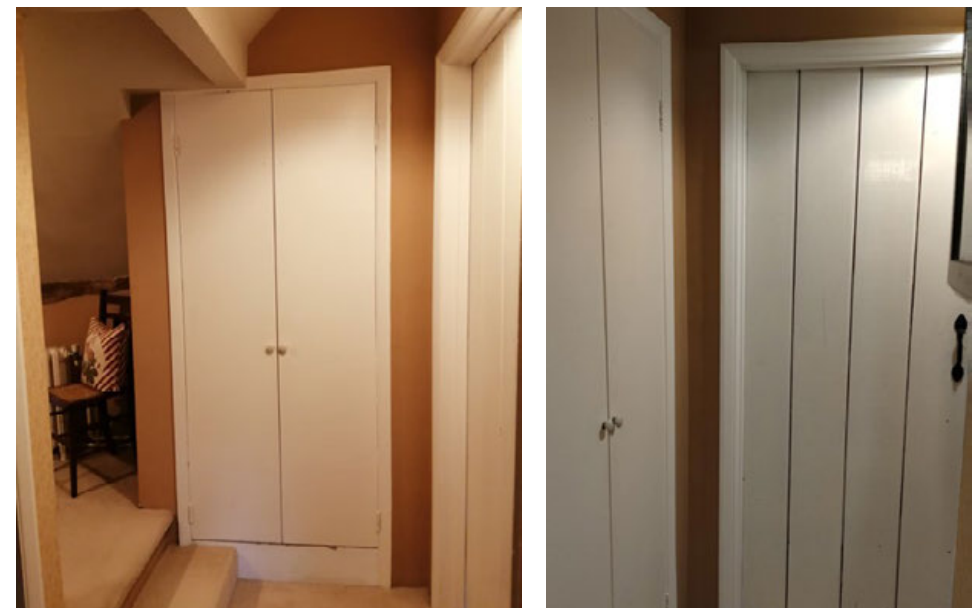
20 FF Lobby - Cupboard to be removed and steps extended. Lobby expanded into previous bathroom space and new stud partitions built as per proposed plan. Existing bathroom door (in image on right) to be moved to new opening in rebuilt partition wall.

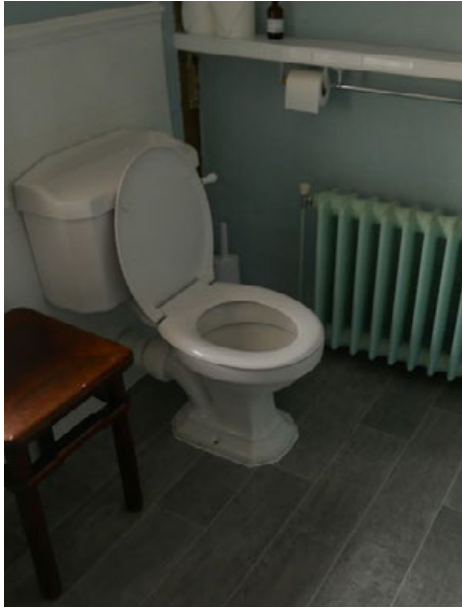
22 Bath 2 - Replace sanitaryware and radiator. Replace vinyl flooring with tiles.

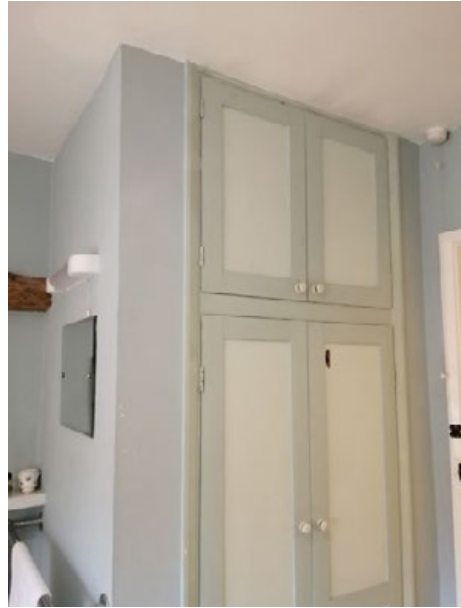
22 Bath 2 - Cupboard to be removed

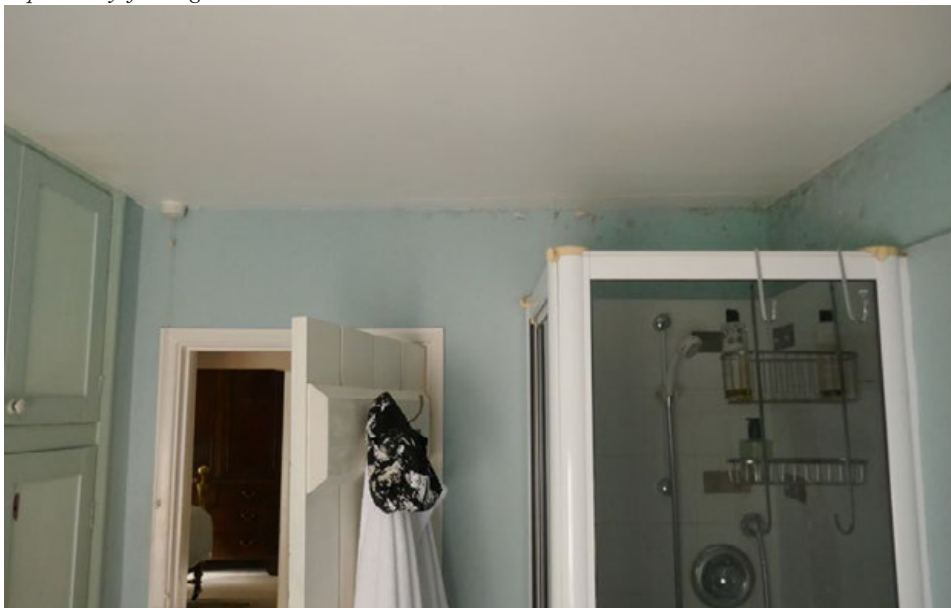
22 Bath 2 - Sanitaryware to be replaced including shower. 20th Century partition wall to be rebuilt in modified location. Existing door leaf to be moved to new opening in rebuilt wall.

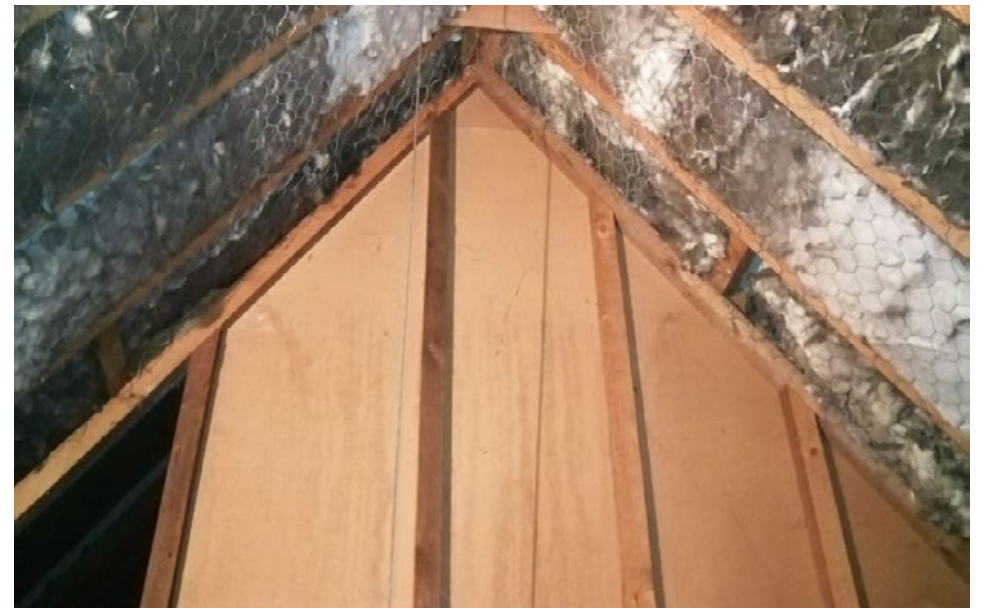
23 & 24 Stair & Bedroom 4 - View of 21st century partition wall and roof structure on north side of proposed new stair and Bedroom 4

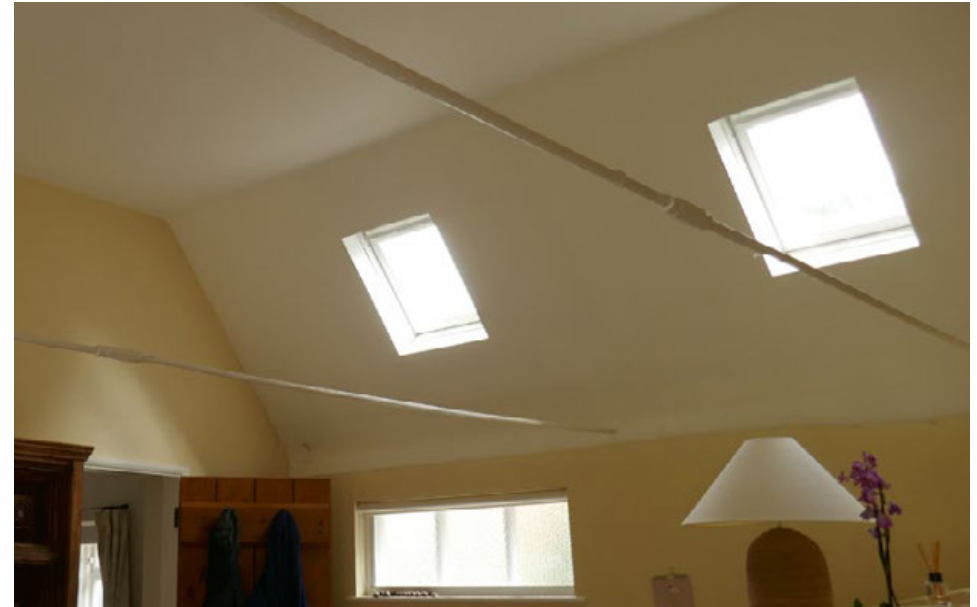
Interior of proposed Kitchen showing steel tie bars and rooflights to be removed. The new Queen Post Truss is to be in the location of wall on the left, and the flat ceiling is the location of collars to be retained.
