JACKDAWS FORD

Chelsworth

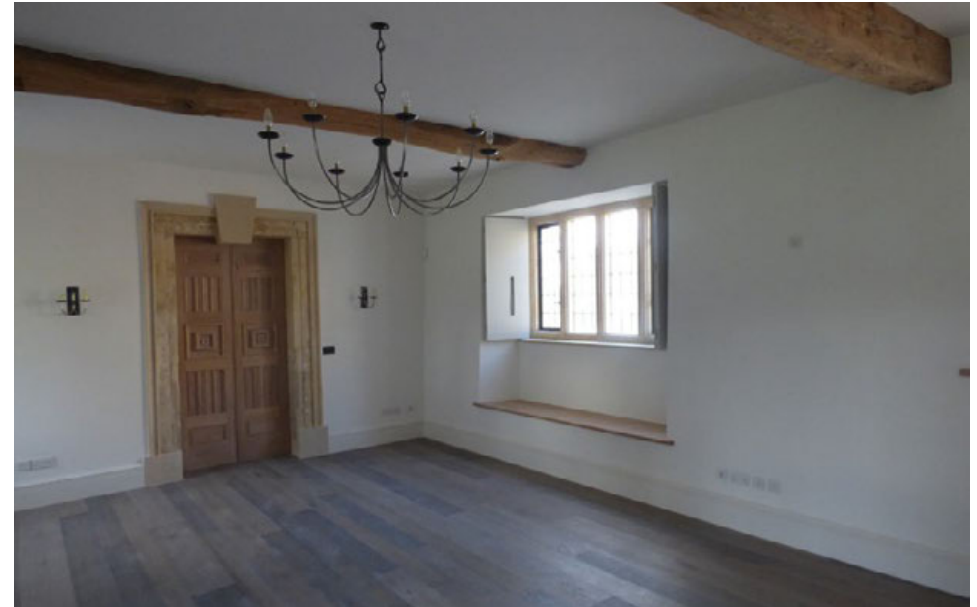
Image showing breathabe woodfibre internal wall insulation and lime render, as approved by Historic England in a Grade I listed building in Lincolnshire
