## Former Hambly's Garage, Pelynt, Looe, Cornwall

### Phase 1 Preliminary Risk Assessment Report

#### Report No. 21011-R1

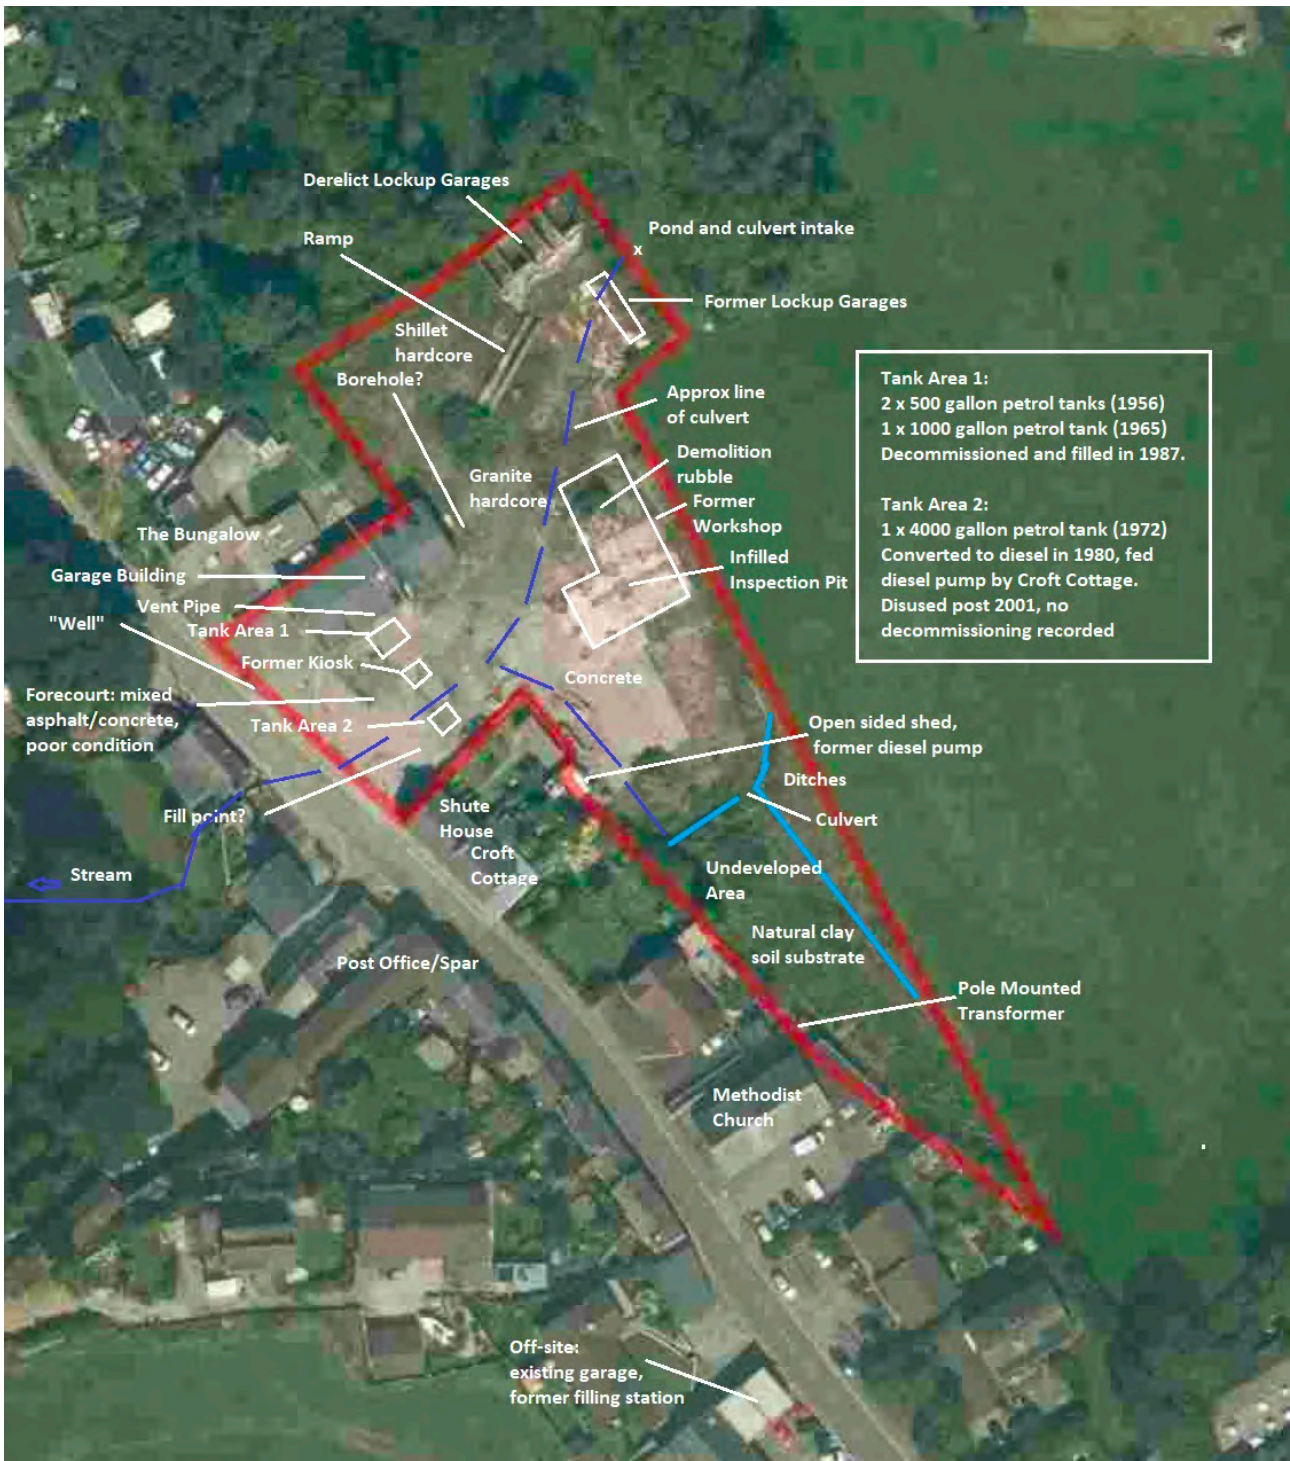
Figure 2: Aerial Photograph with Site Walkover Observations

The area formerly comprising the garage forecourt is located to the south of the extant garage building and north-east of the village street (Jubilee Hill). It comprises areas of potholed asphalt surfacing in poor condition and areas of concrete surfacing in varied condition. In the centre the base of a former kiosk is located. No evidence of pump islands is visible but they are believed to have been located south-west of the former kiosk.

Limited evidence is visible of the underground fuel tanks. A vent pipe is observed on the side of the garage building and a possible fill point is located on the south-east side of the forecourt area. There is no extant evidence of previous investigation boreholes/monitoring wells. A number of drainage channels including a culverted stream run beneath the forecourt area.

The former garage building is set back from the road frontage by a few metres, providing an asphalt surfaced access to the neighbouring property (The Bungalow). The garage building is a block walled and rendered two storey height building with timber roof trusses. The roof appears to be formed from felt and chipboard and is heavily degraded and the building is no longer weathertight. In the roof of the northern part of the garage, formerly occupied by a sign painting business, an unsupported length of ducting is present at roof height, assumed to be from a former extraction fan.

An inspection pit infilled with hardcore is visible in the concrete floor and a lowered area probably represents the location of a former hydraulic car lift. There is some discolouration on the floor but it is not clear if this resulted from former garage activities or from water ingress. No visible evidence of asbestos containing material was observed but its potential presence can not be excluded.

On the frontage of the area is a small enclosure in which a swan necked 75mm pipe discharges a continuous flow of water into a gully. This feature is mapped as a well on OS mapping. Although appearing to be artesian, it is understood to be a piped feed from a spring at higher elevation in the grounds of The Bungalow. It is separate from the culverted stream that crosses the yard and forecourt areas.

This area includes a large flat, concrete surfaced area to the rear of the forecourt currently forming part of the car park. A number of manhole covers are present indicating the culverted stream and drainage runs crossing the area. In the southern part of this area, on the Croft Cottage boundary, an open sided shed is present in a derelict state understood formerly to have housed a diesel pump for the coach depot. No evidence of the pump remains extant.

To the east of the area in use for car parking is the concrete floor of a former workshop building, now demolished. A large inspection pit is present that has been infilled with hardcore/demolition rubble. Further rubble, appearing to consist of inert materials from the demolition, is present to the

To the north-west of the garage building, a large yard area, partially overgrown, is present. It is surfaced in hardcore consisting of granite and slaty material (shillet). This material may have originated from the Caradon Hill area and may be derived from historical mining wastes. To the northeast of the garage building a vertical pipe in the ground may be a former borehole or may be a drainage-related feature.

In the north of the yard area two mass concrete walls formed an inspection ramp for large vehicles (assumed, coaches). No evidence of staining on the concrete between the ramps was evident. To the east of this ramp are remains from a former building, assumed to have been a terrace of lockup garages, including broken concrete panels and metal doors. A more modern set of block walled lockup garages are located to the north of the ramp; these are unroofed and derelict, but no evidence of staining of floors was visible from outside. On the north-east boundary of the area an intake from a pond feeds water into a culvert that runs beneath the yard area. There is also an open ditch running along the site boundary.

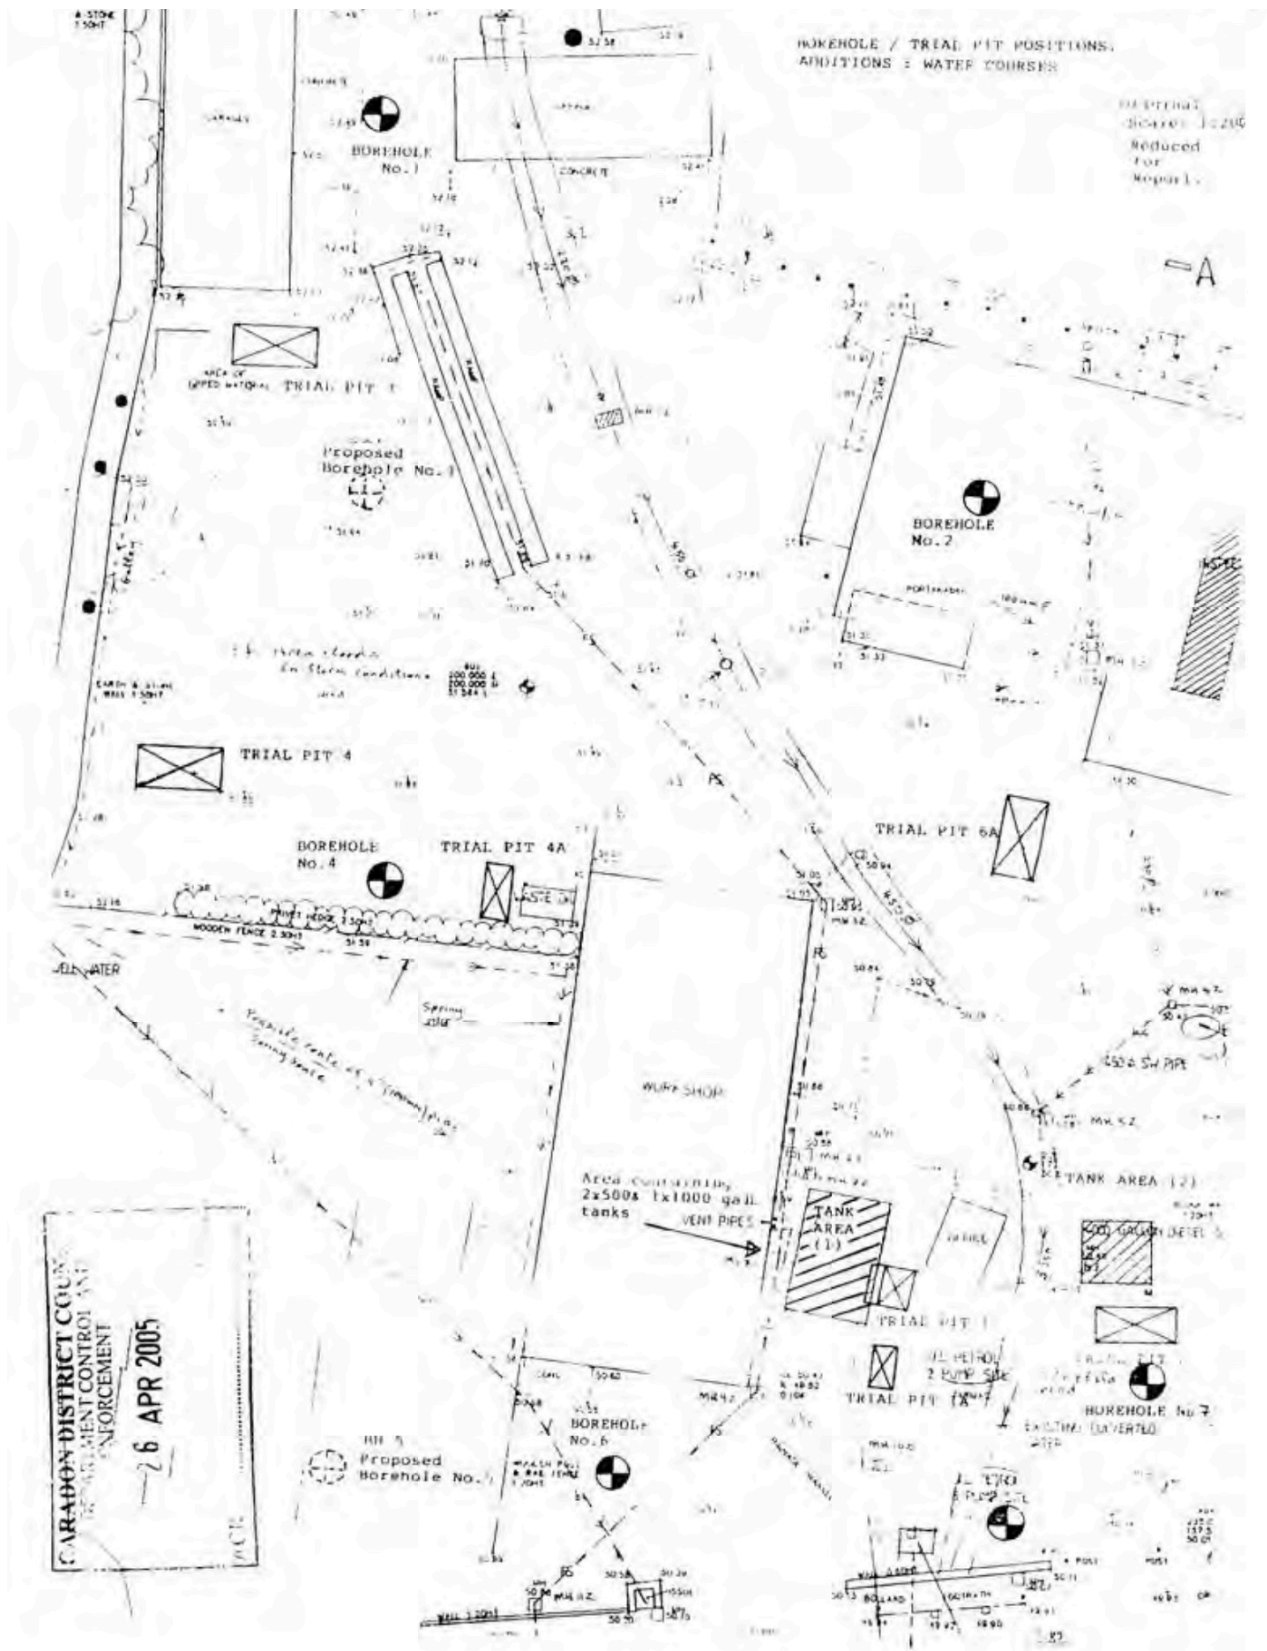
Figure 4: Plan of Forecourt and Tanks extracted from A. Robin Hood Report

The report recorded observations including that the highest concentrations of hydrocarbons were present in the packing sand around the tanks and that contamination levels in the surrounding clay formations were “minor”. No impact was observed near the diesel pump by the boundary with Croft House.
