Milltown House, Yeolmbridge, Launceston, Cornwall, PL15 8TL

Statement of Significance

SH Ref MILT0921

NHLE1142820 MILLTOWN HOUSE AND GARDEN WALLS TO FRONT. GII*

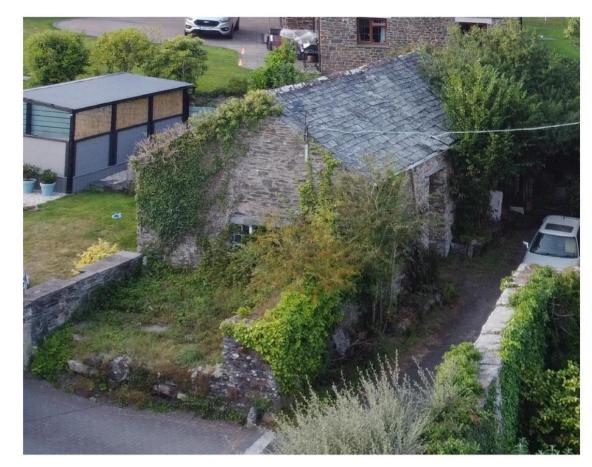
i) Outbuilding to the west of the house. Note rag slate roof and killas rubble construction

- 3.1.5 A **cowshed** to the west of the house (figure 5) survives with much of its vernacular character in-tact.
- It has a rag⁶ slate roof with the eaves detailed in scrips⁷, under aged, lichen covered red ceramic ridge tiles. There are numerous slipped slates, usually on rag roofs the result of the failure of iron nails through corrosion rather than the slate itself. Repair in good time is advised.

- Securing the viable use of the western outbuilding. This building should be put to viable use, sufficient to justify its repair and ongoing maintenance. The building fabric is currently becoming colonised by woody vegetation. It is recommended that this is cut back, roots poisoned and, once they have died back, masonry repointed. It is further recommended that

costs are sought for the conservation led restoration of the building, including the repair of its rag slate roof. These costs should be used to determine the optimal viable use of the building under the NPPF²³

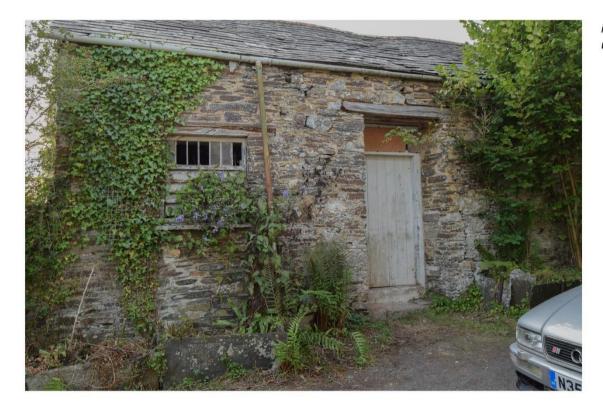
ii) southern door in east elevation, note blocking masonry underneath early 20th century window.

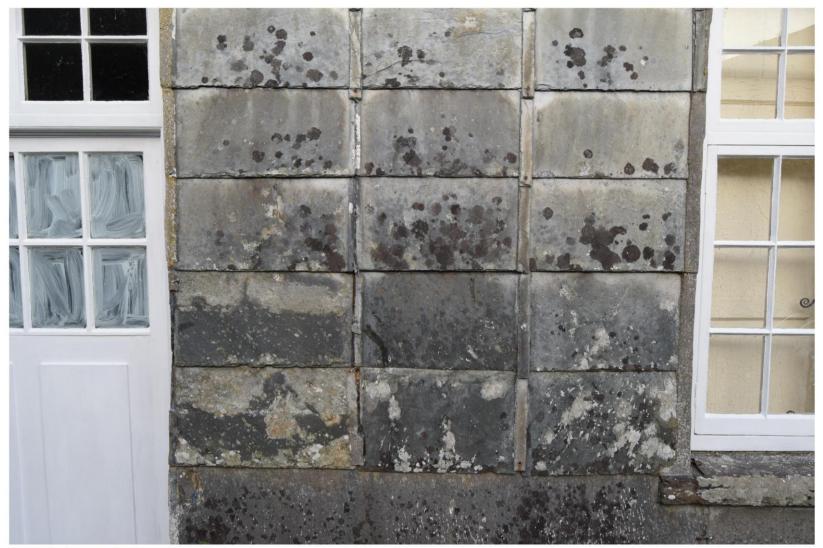
i) Detail of patent slating on the west elevation. Nove missing over sealing slates

- 3.1.10 South and west elevations of the building are clad in local, probably Delabole, slate using the **patent system as defined by** *Charles Rawlinson* of *Lostwithiel* in 1772 (figure 8) mostly in good condition. The system, patented for use on roofs but not known in Cornwall except as wall cladding, uses large format *rag* slates of regular size which are (in the original patent) screwed, single lapped (at their base) to battens, with the vertical butt joint between slates over-sealed by regular slate strips bedded in cement and then screw fixed.

- At *Milltown* over-sealing has been fixed by flat headed but regular and machine produced (post 1850) ferrous screws, the corrosion of the heads of which has led to some missing oversealing. Where over-sealing is missing this allows us to see that the main slates are fixed with galvanized flat headed wire nails (likely of 20th century date), with over sealing fixed with Portland cement-based cement. These characteristics suggest a 20th century date for the currently fitted system. Despite the failure of some over-sealing very few if any signs of internal damp were observed on the internal surfaces of clad walls although it is strongly recommended that like for like repairs are sought as necessary from a specialist in this technique⁸. Where failing it is recommended that screws are replaced with stainless equivalents.

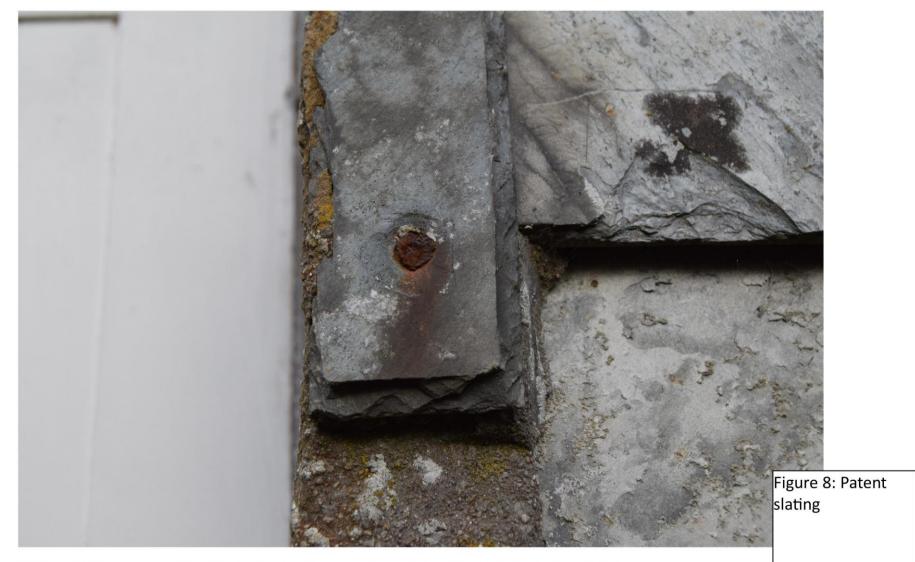
ii) Close detail of one oversealing strip showing heavily corroded screw fixing. The strip below has been failed.

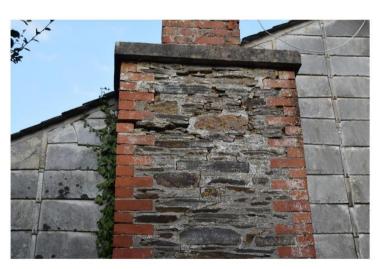
ii) Above, the western stack as attached to the rear outshut. Stone rubble in cement mortar with brick detailing.

- Above are two two-light 6 pane casements.
- The range stack against the outshut is pointed in Portland cement, there are cracks in the structure which should be addressed by a competent builder using lime-based mortar.

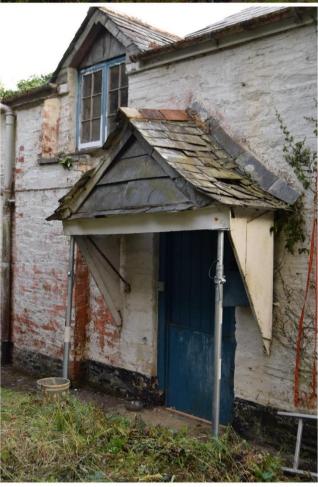
ii) Rear porch

- 3.1.13 The **north (rear) elevation (figure 10)** is more vernacular in character of limewashed slate rubble. with an off-centre pitched porch.
- The porch, which has a rag slate roof, was originally supported by failing slanting timber brackets clad in wide timber planks, with further iron-bar stanchions probably added during the twentieth century as additional support, but now further supported by screw-props introduced as emergency safe-guarding works by our client). The porch urgently requires a more permanent solution if it is to be conserved, or replacement informed by this record (this would require listed building consent). We do not recommend like-for-like repair or replacement due to the inherent historic shortcomings of the current design, and would suggest that the advice of a structural engineer or architect is sought.

- **Rear Porch.** This feature appears in a parlous state (currently supported by screw-props) and will clearly require structural repair, likely including renewal of some components, and reslating of its small roof. The feature is most likely of 19th century date.
