**Arboricultural Report  
and Tree Survey for the Proposed Development  
at  
Alvechurch Sports and Social Club,  
Radford Road,  
Alvechurch,  
Birmingham.  
B48 7LD**

**Prepared for Westbourne Leisure**

**Prepared by  
Peter Wilkins BA (Hons) MArborA MIEnvSc CEnv  
Our Ref 0422-10053  
February 2023**

## **Tree Condition Survey at Alvechurch Sports and Social Club, Radford Road, Alvechurch, Birmingham. B48 7LD**

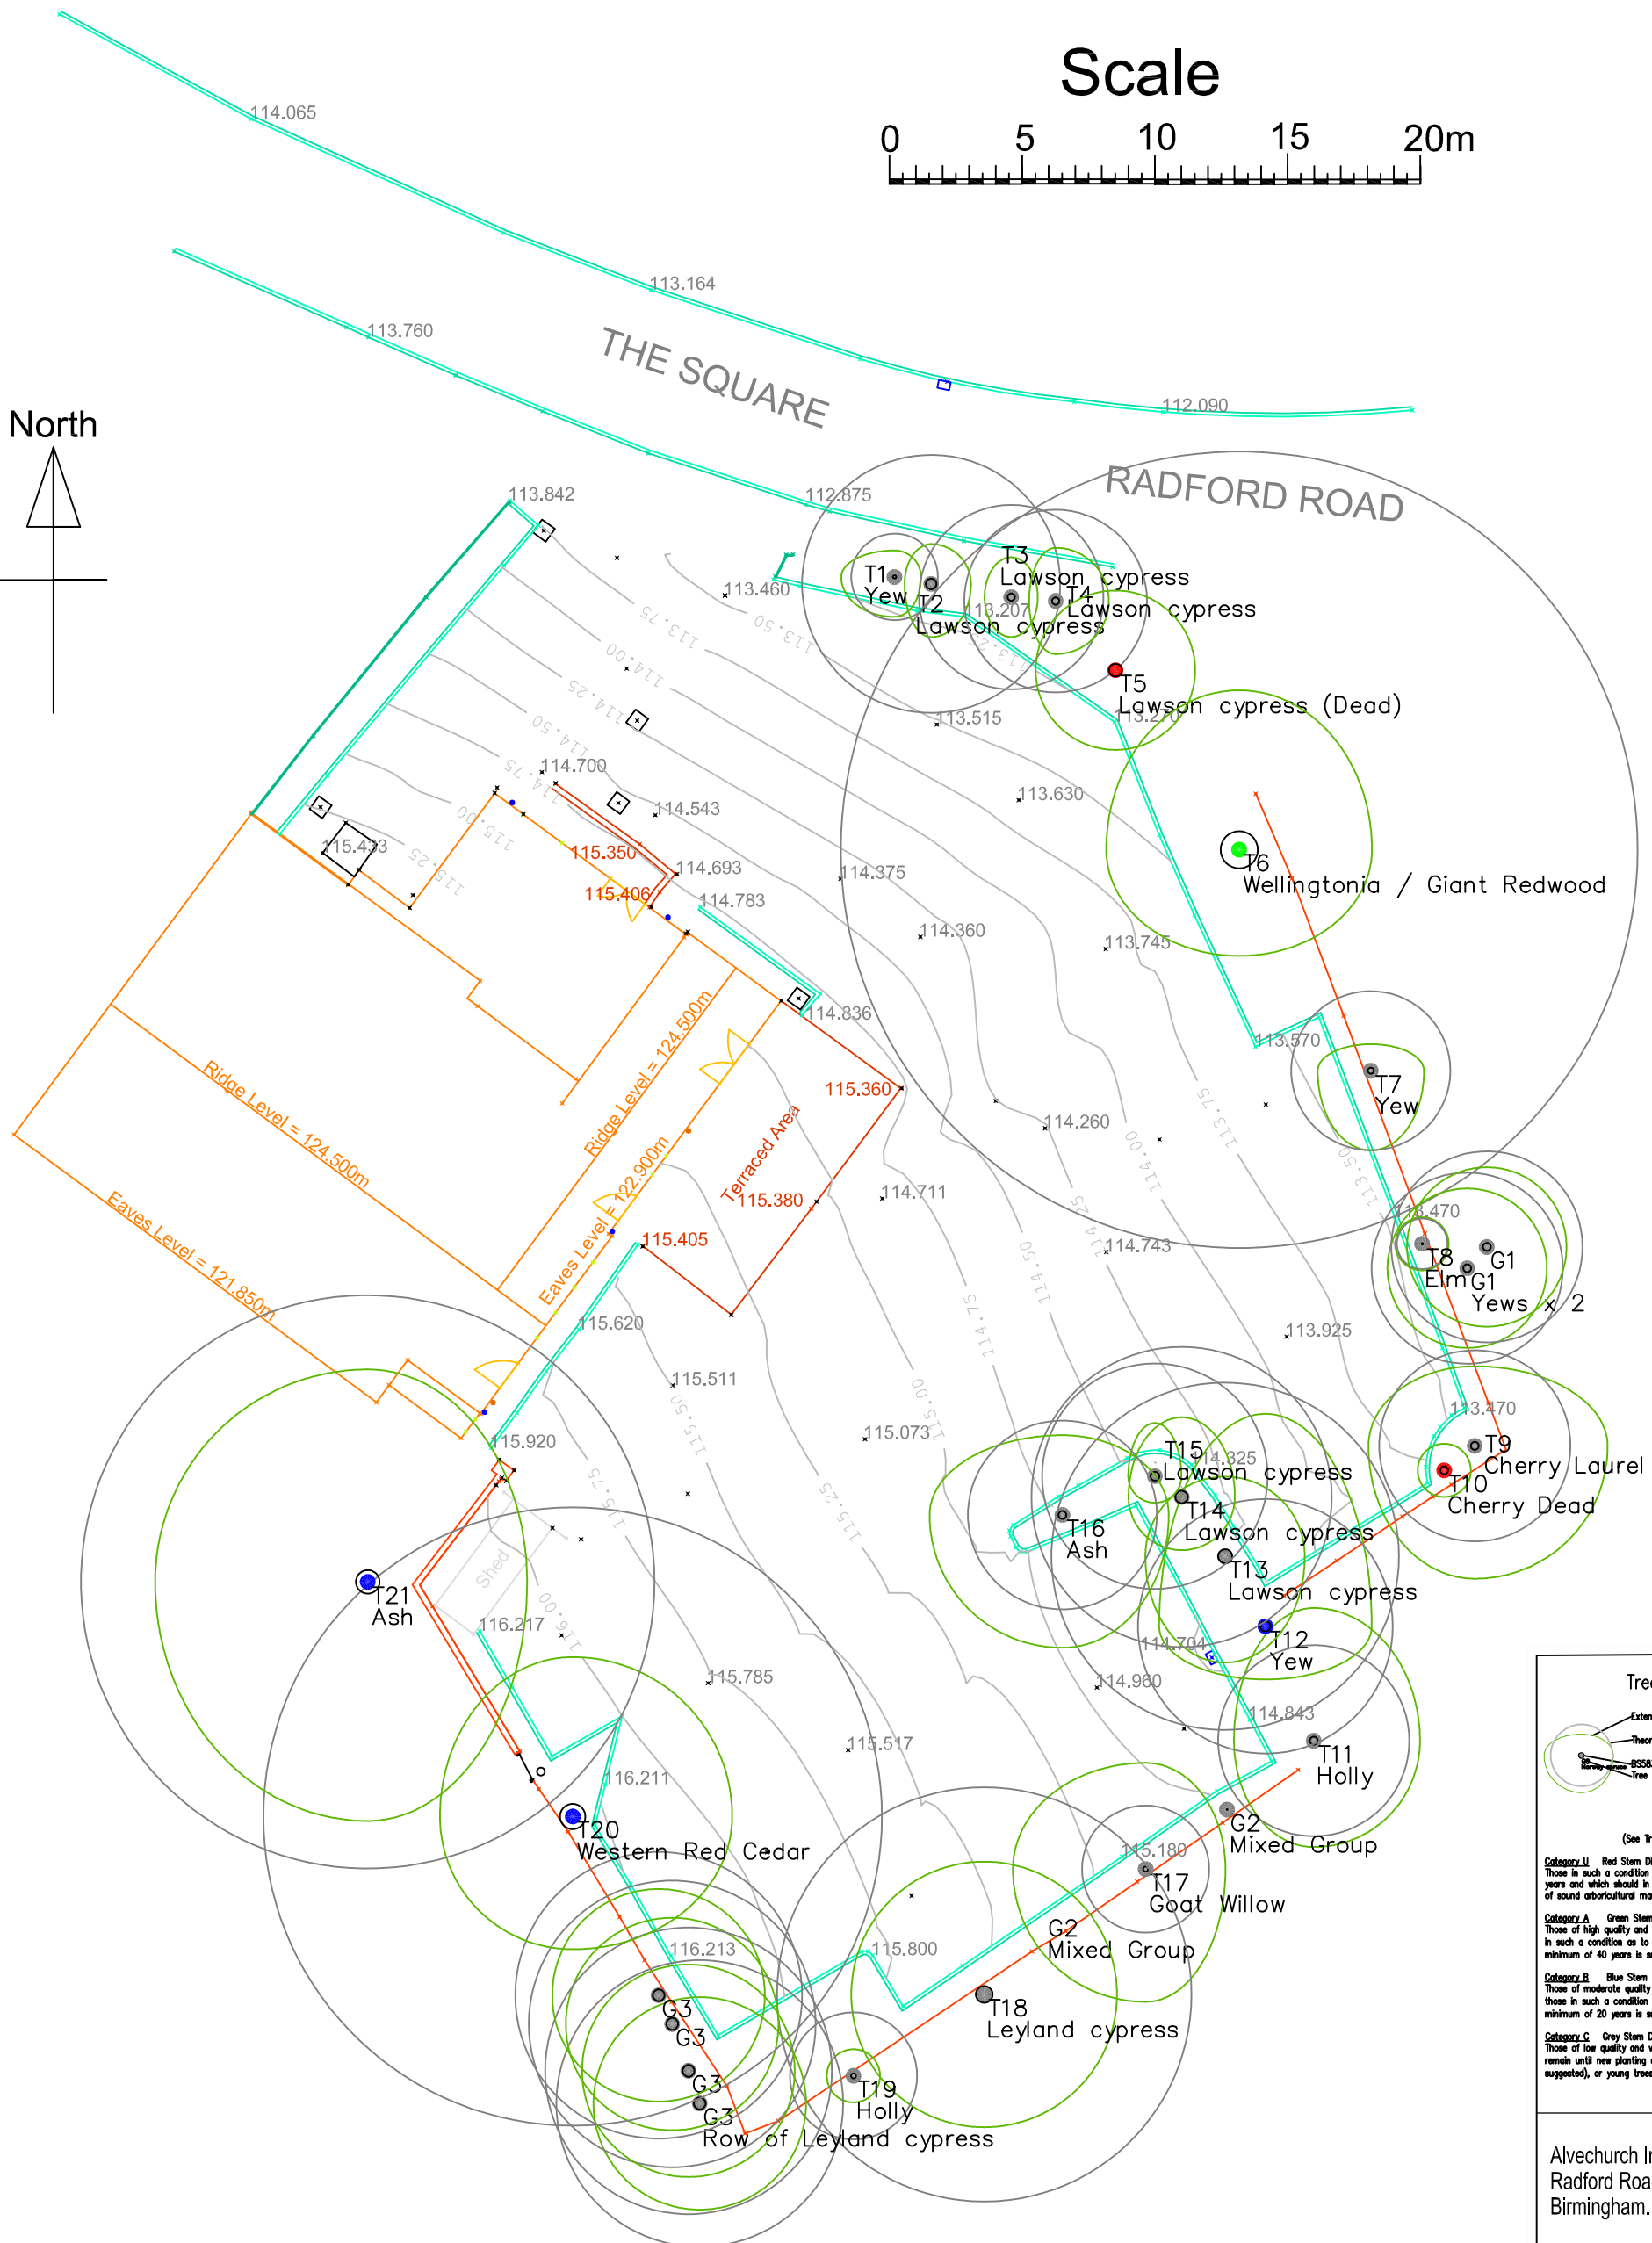
- 6.1 The site is previously developed with tarmac hardstanding covering the majority of the ground around the sports and social club. The tree resource is growing in narrow strips of open ground close to the boundary of the car parking area, within a narrow landscape strip which divides part of the car parking area and beyond the site boundary within the site is dominated by conifers including Lawson cypress, western red cedar, yews, Leyland cypress and Wellingtonia with some planted cherry laurel and a self-set ash and a mature off-site ash tree.

- 6.2 An ash tree T16 growing within a narrow strip of open ground within the car park is to be removed to ease constraints around the proposed extension. Two dead trees which are remote from the proposed works are to be removed, the remaining trees are to be retained.
