# **Additional historic building recording at Oakwood, Wylam, December 2020**

**Historic Environment Research and Interpretation  
On behalf of Peter McGirr**

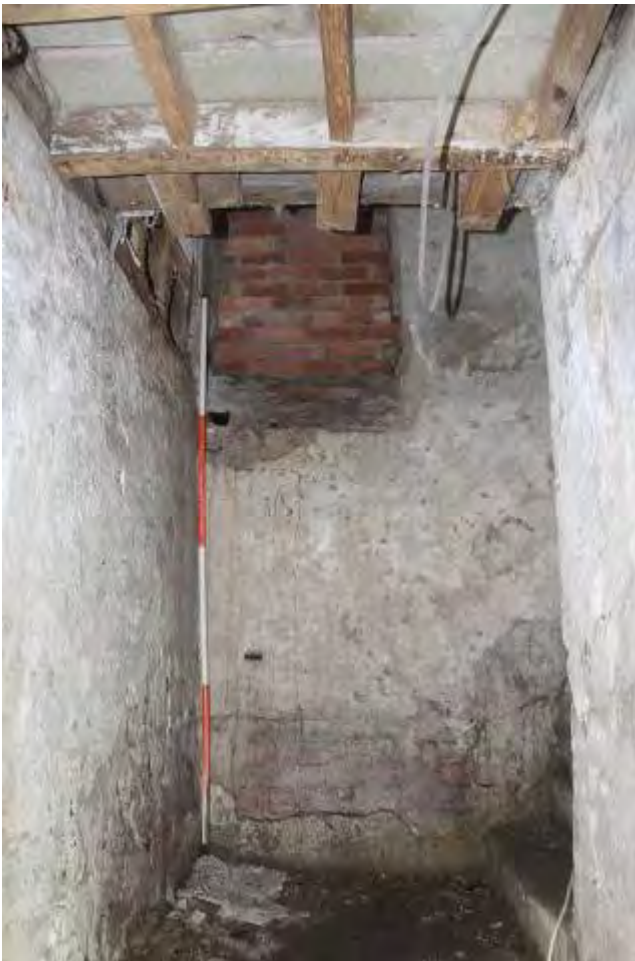
The cellar is accessed from the interior of the house via a flight of stone steps, descending beneath the main staircase, and a short lime rendered brick lined passage running south at right angles from their base. A brick blocked opening, high up in the north wall of the passage at the foot of the steps, gave access to the yard outside and may have provided access to bring goods directly into the cellar and perhaps some light or ventilation.

**Photo 1. Opening with modern blocking at N. end of passage. Base of steps to right**

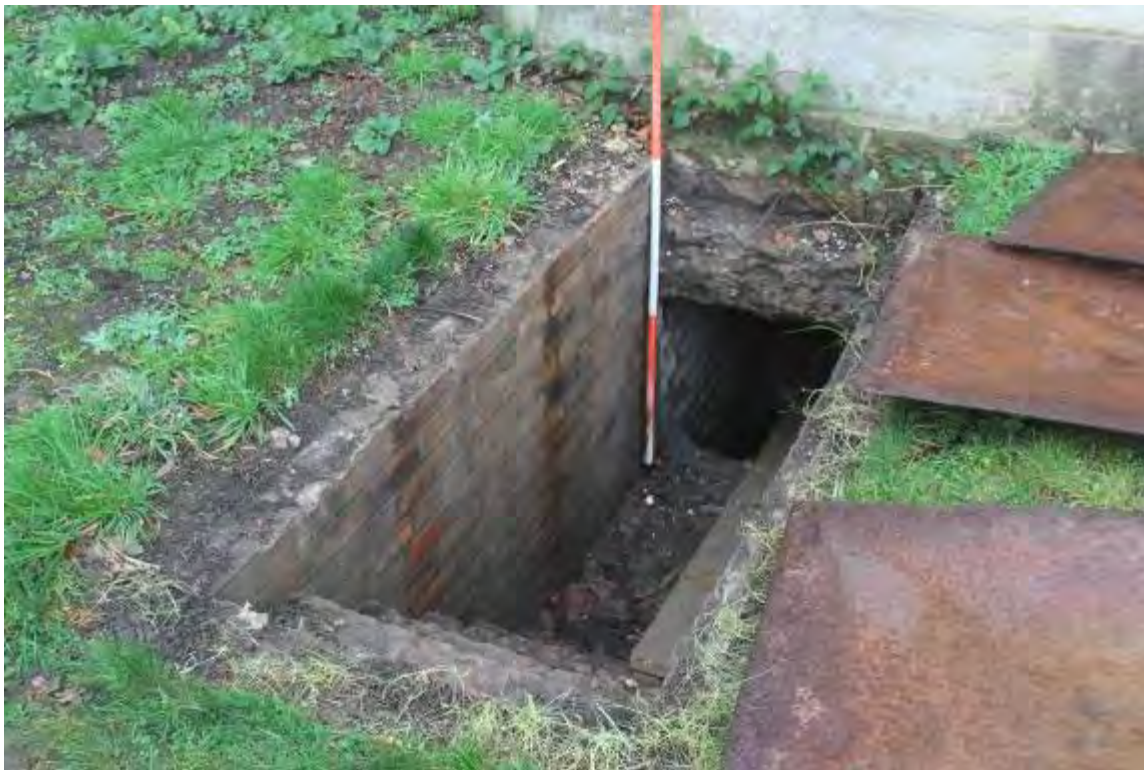
Additional access was subsequently provided from the garden front via brick steps and a brick lined passage leading into the cellar below the bay of the 1880's extension. This would have facilitated delivery of large items such as beer barrels to the cellar space below the 1880's extension to the house. This passage had been blocked in the modern period, presumably once the household no longer required regular delivery of barrels. The blocking was subsequently re-opened, perhaps

**Photo 2. Steps and brick lined passage below the bay on the S. front. Note mass concrete foundation to 1880's bay and modern blocking, subsequently re-opened, behind ranging rod**

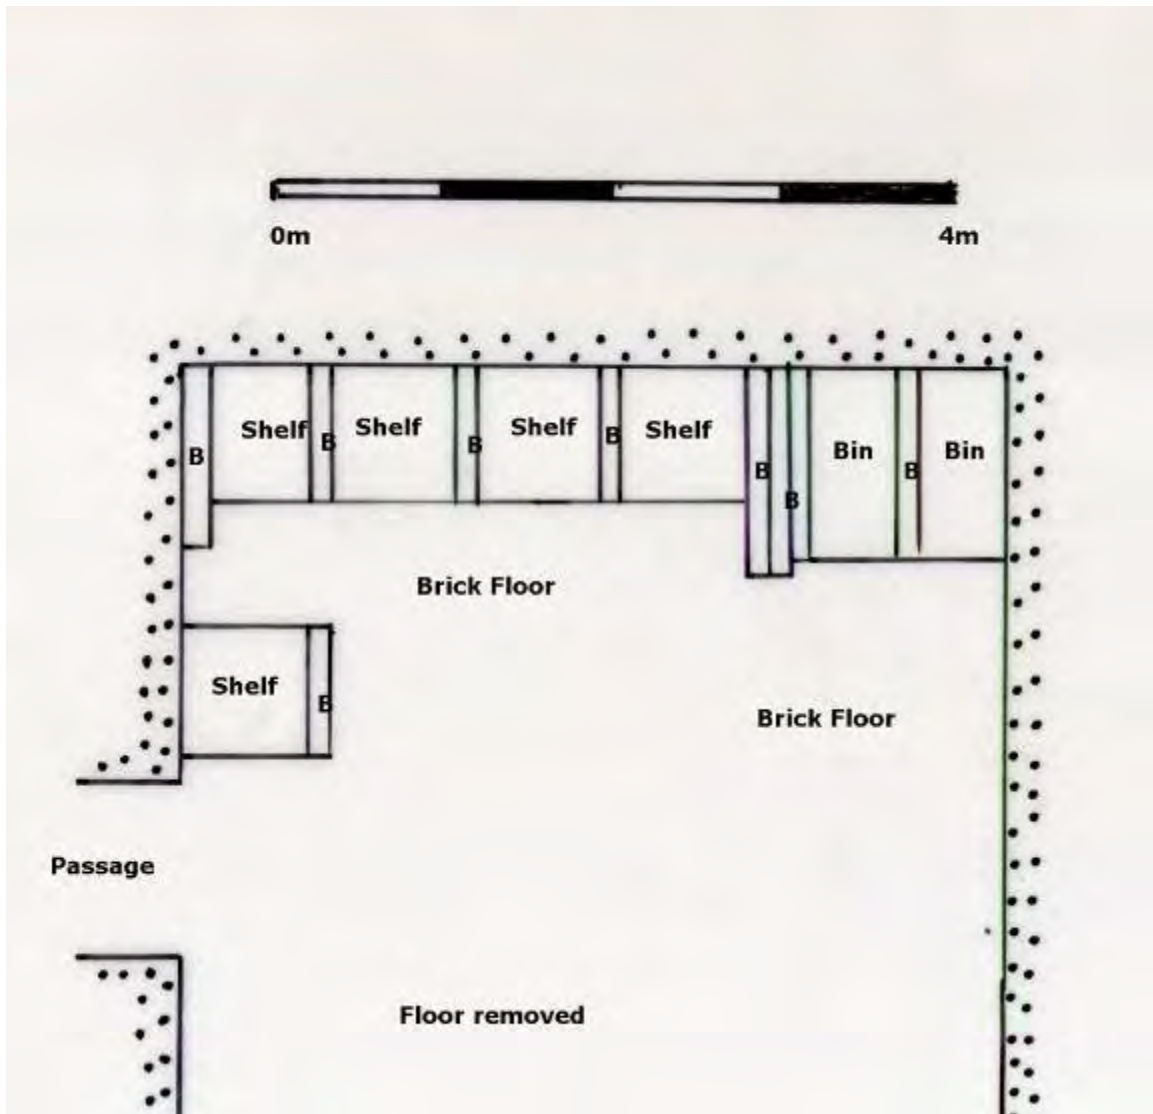
**Fig.2 Annotated plan of features at the eastern end of the cellar**

The principal features of interest within the eastern cellar are the brick and stone built wine bins built against the eastern wall of the cellar. These are secondary to the rubble built walls of the cellar but are presumably contemporary, providing storage for wine in bottles. A separate shelf built against the north wall just inside the doorway through a E/W partition across the cellar (removed in previous works) would have been convenient for gathering bottles from storage for use in the house above. The storage compartments are formed by slabs of sandstone set across brick built piers. The vertical divisions are carried up above the slabs and a surviving timber batten and “tide mark” on the rear wall indicate that an additional storage shelf ran across at least part of the space. At the southern end of the wine bins, arched bins, again in brick, provided additional storage [see Figs. 2 & 3 above].

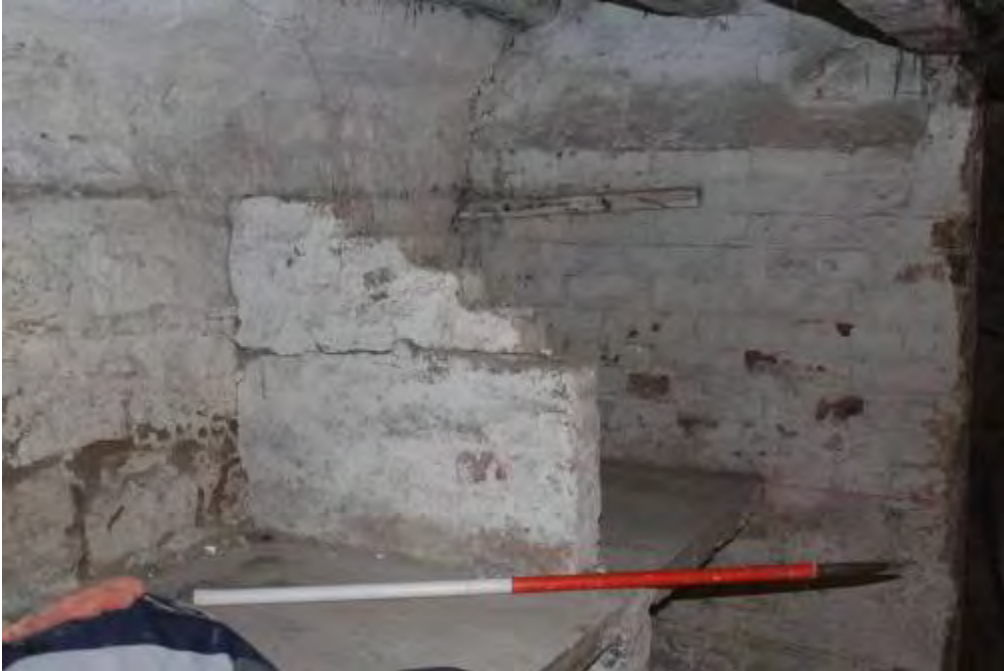
**Photo 5. Timber batten against far wall supporting former shelf across top of brick dividers. Note "tide mark" on back wall at level of former upper shelf**

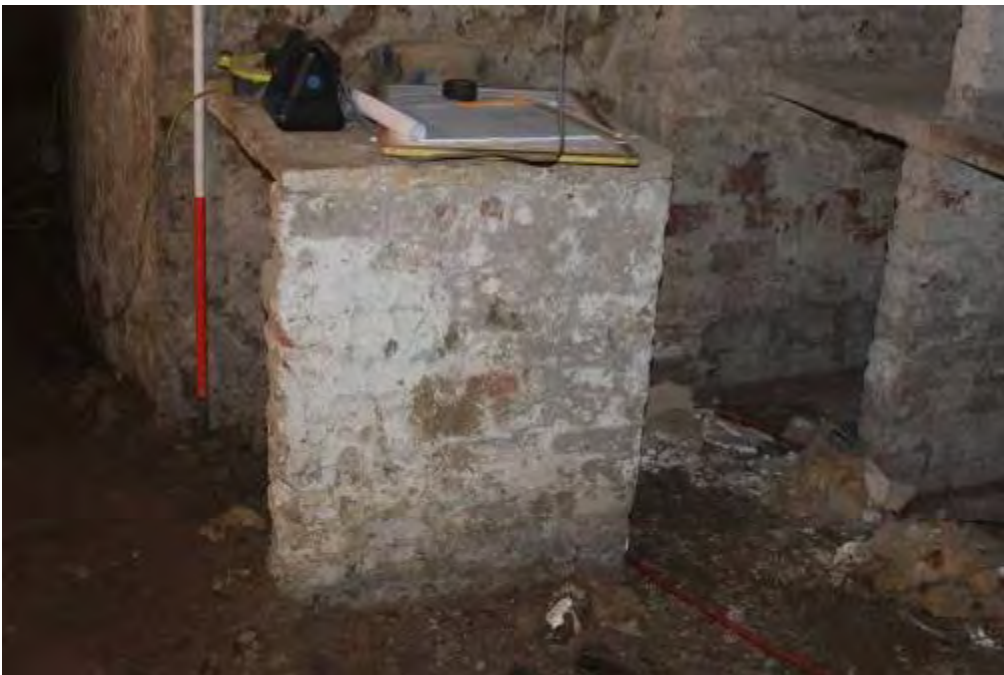
**Photo 6. Stone shelf on brick pier against north wall. This would have been inside a former N/S running partition (scar visible at position of ranging rod)**

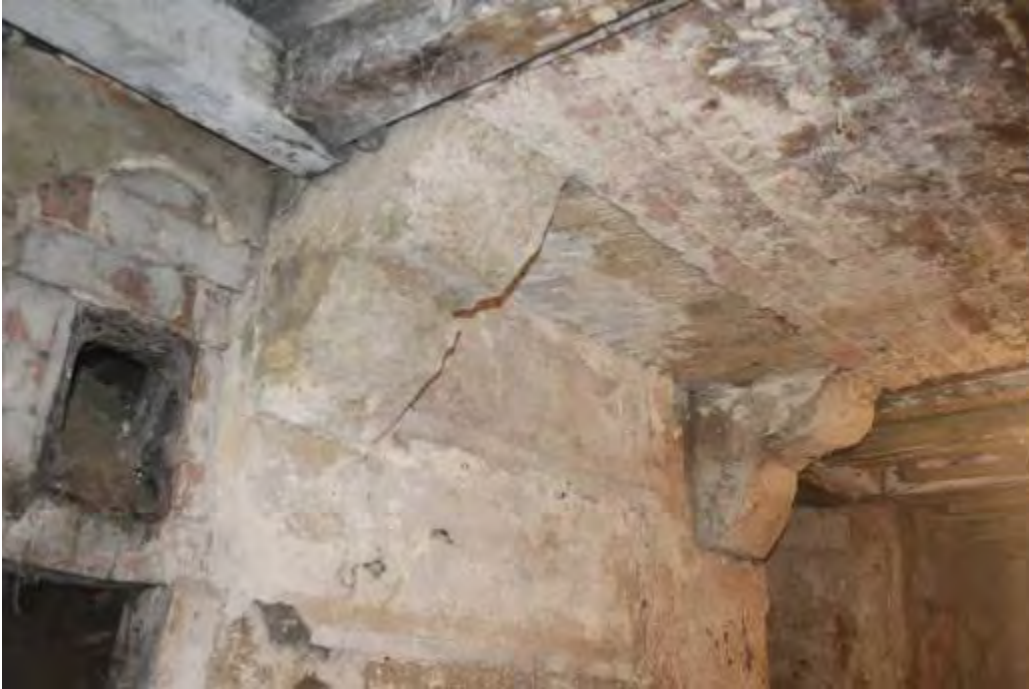
Other features include a pair of substantial stone corbels projecting from the north wall to the west of the passage entrance. These support the fireplace and hearth in the room above [see photos below]. Two inserted openings adjacent may have provided draught

**Photo 7. Corbels and brick hearth for ground floor fireplace against north wall**

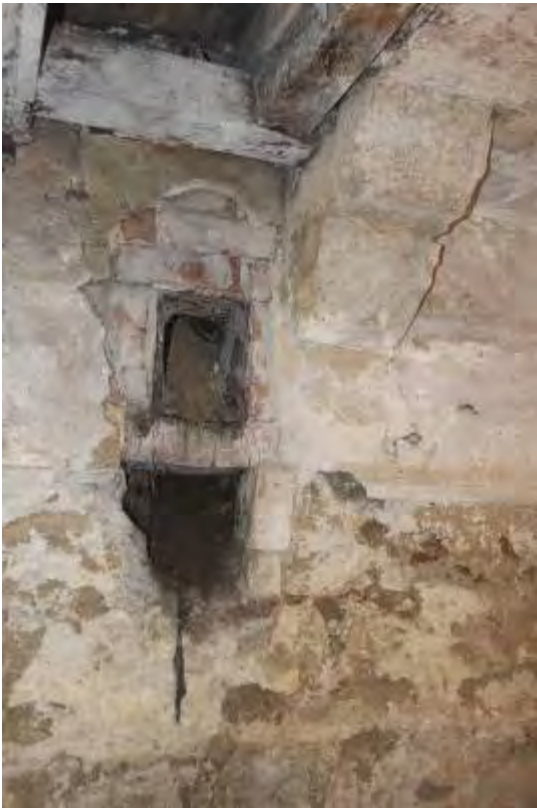
**Photo 8. Vent and shute cut into cellar wall to LHS of fireplace above**

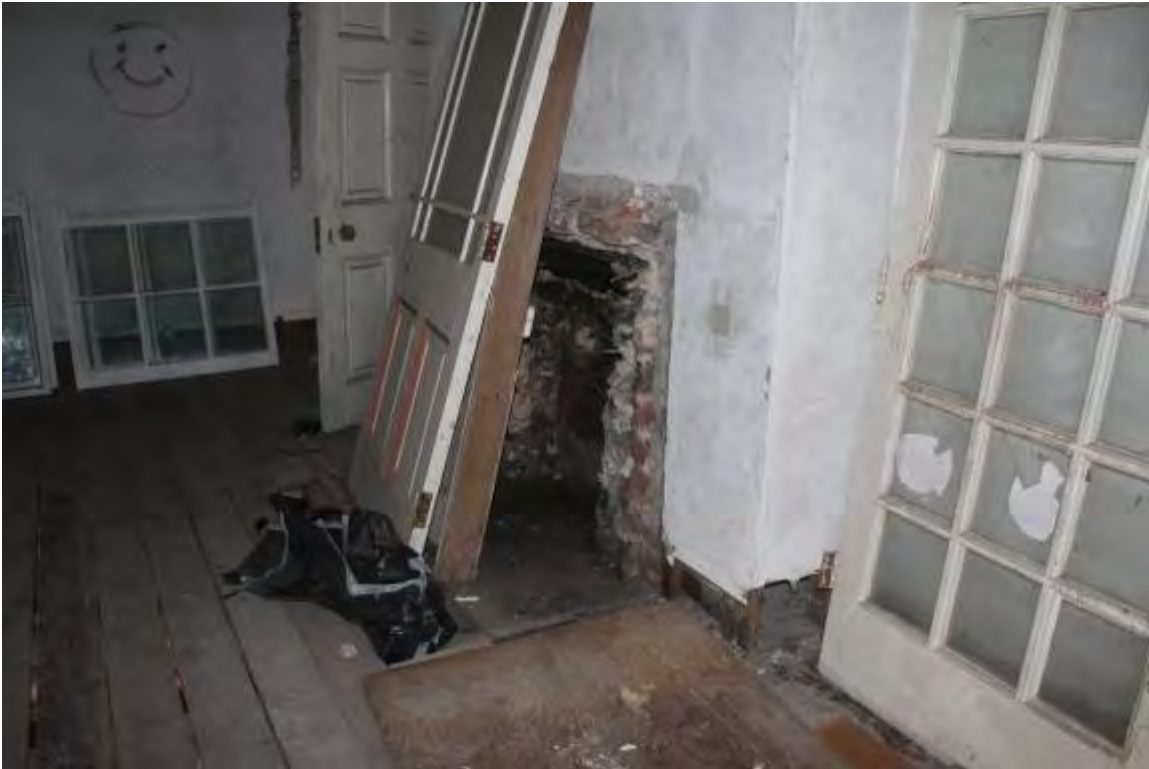
**Photo 9. Fireplace and hearth in the room above**

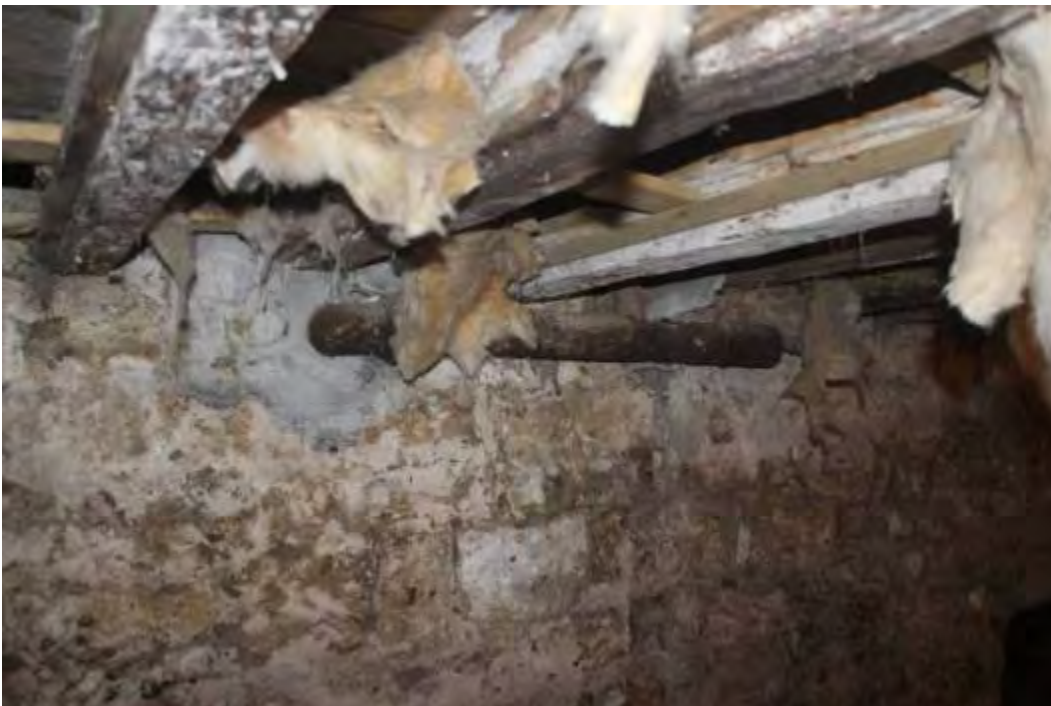
for the fireplace. A four inch diameter cast iron drain pipe has been inserted in the south wall but its function is not immediately obvious.

**Photo 10. Four inch cast iron drain pipe against south wall of cellar**

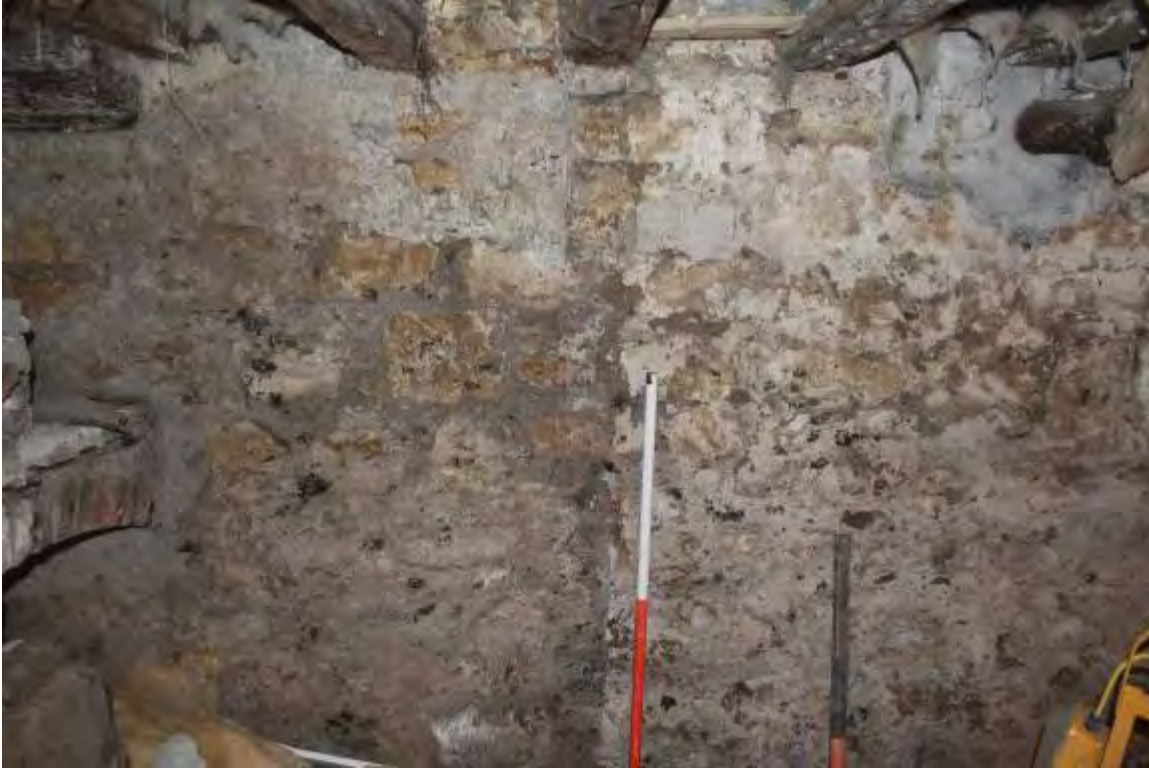
**Photo 11. Traces of former N/S partition against south wall**

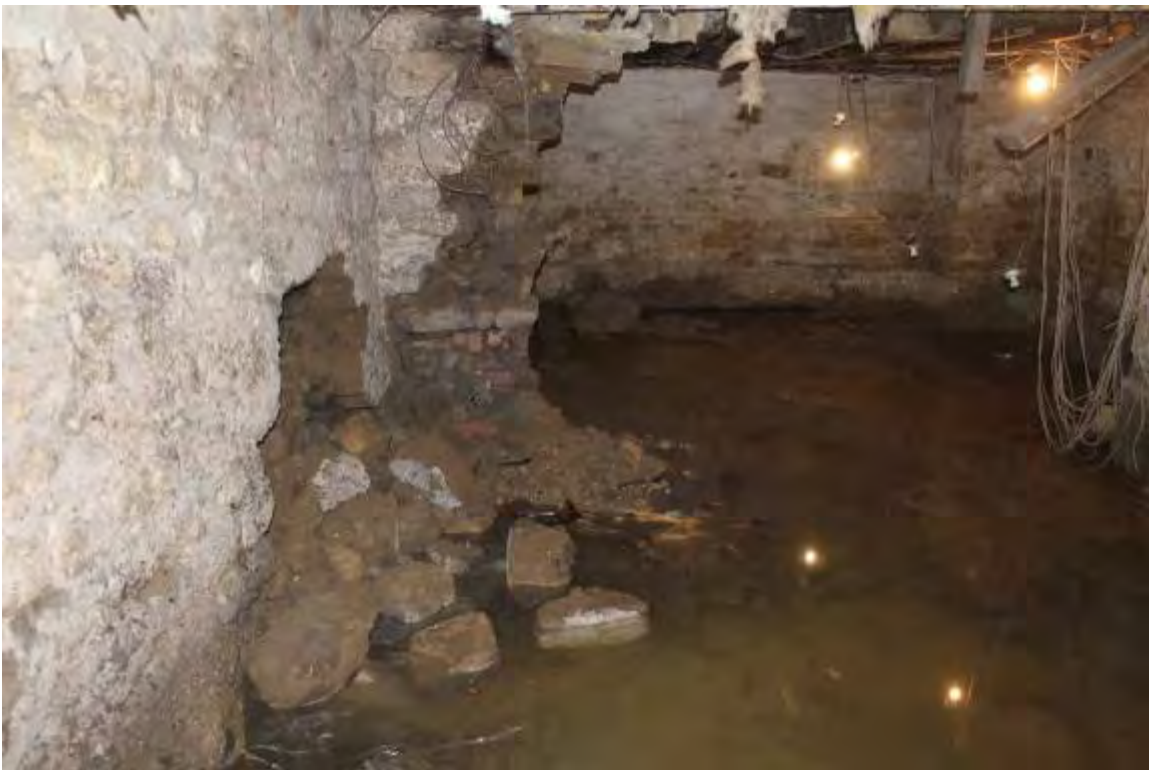
The revised Heritage Statement had identified surviving features in the basement. Clearing of previously excavated material and the provision of temporary lighting allowed an improved record of the features to be made. A review of earlier plans accompanying previous planning applications identified internal partitions within the cellar, removed by previous owners, who had also excavated the majority of the cellar floor to a depth of over 0.5m below the original level to gain additional headroom in the basement. Previous owner's works had also breached the structural wall between the two parts of the cellar, leaving the wall above and the floor joists of the Drawing Room unsupported.

**Photo 12. Stub of cross wall removed in previous works and recent collapse of unsupported south wall. 1880's cellar in background**

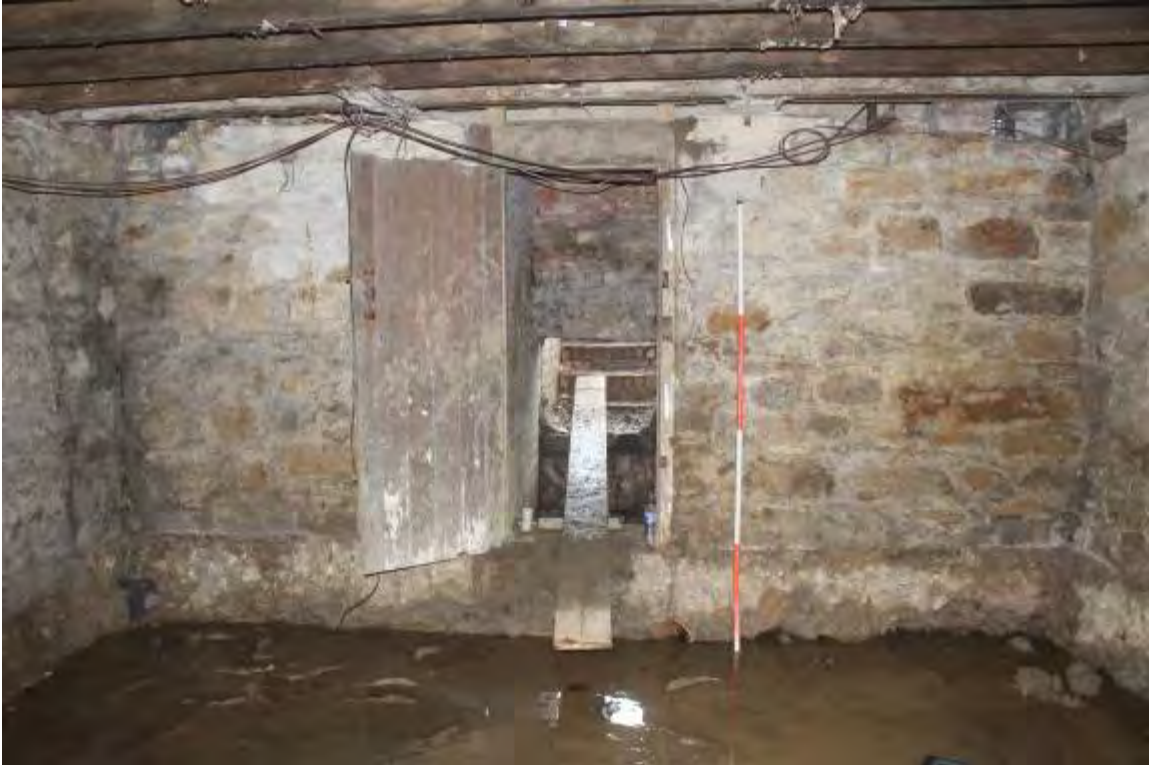
**Photo 13. Door in south wall. Note substantial Victorian foundations here and drain pipe to L. of ranging rod. High level ventilation slots, top L and R**

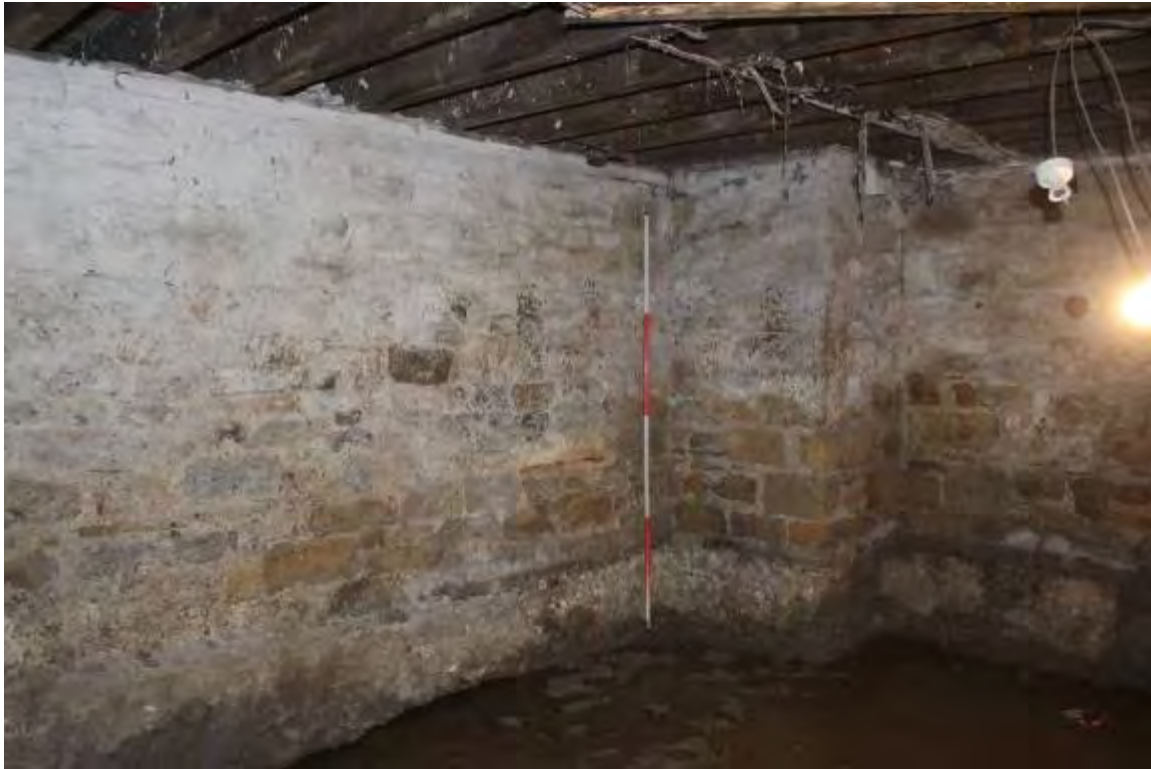
**Photo 14. Pier in NW corner of cellar (providing support for large Drawing Room fireplace and associated stack). Note depth of mass concrete foundation**

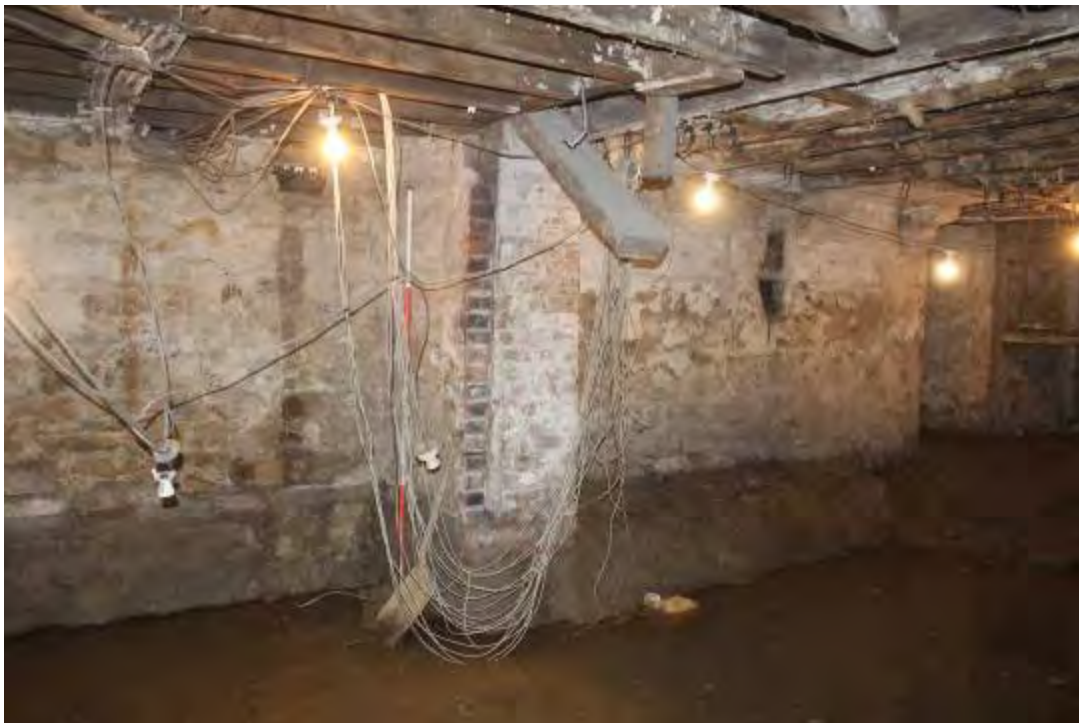
former dividing wall has been removed during previous works, resulting in a lack of structural support for the fabric above. Victorian building practice is reflected in the provision of good under floor ventilation, with vents at high level in the cellar and above ground level outside, to either side of the bay window. A broken ceramic drain pipe at low level, adjacent to the door in the south wall, shows that drainage from the cellar was considered and appears to still be regulating the flood water level in the now excavated cellar floor.

**Photo 15. Surviving jamb of doorway broken through earlier wall (now largely removed). Note ventilation slot at high level to L. and "tide mark" indicating original floor level in both cellars**

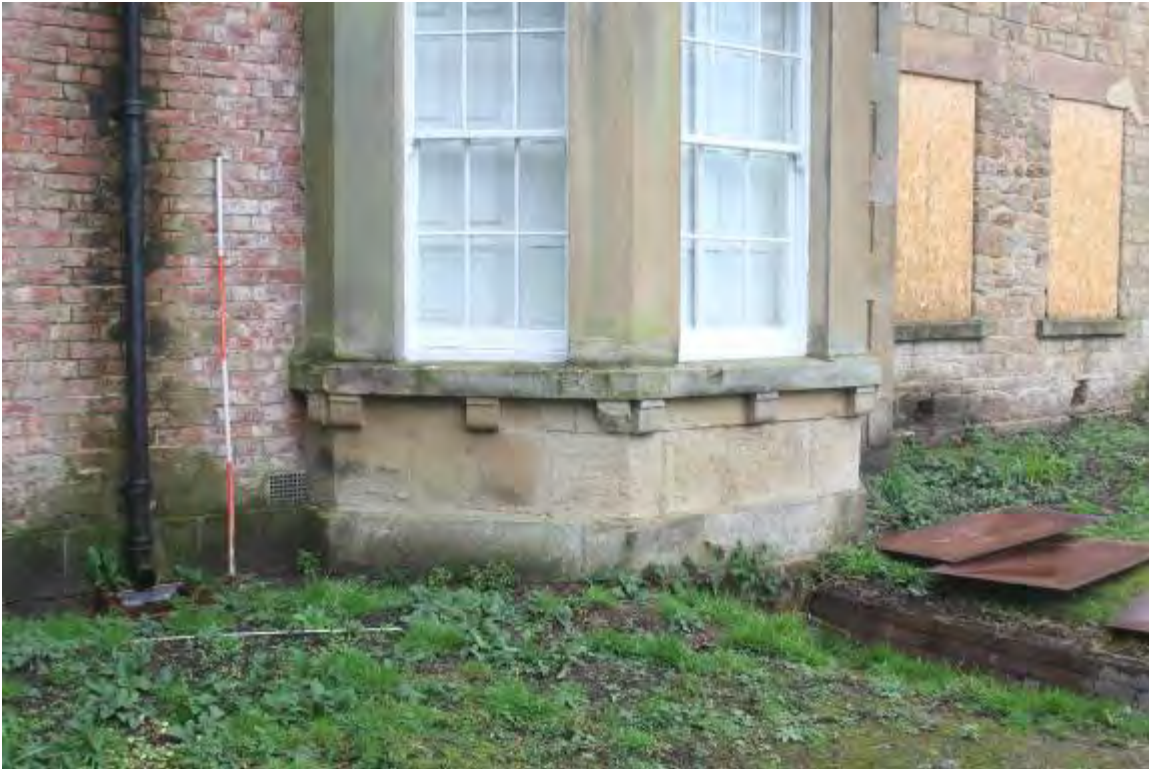
**Photo 16. Ventilation grille to LHS of bay (adjacent to ranging rod)**

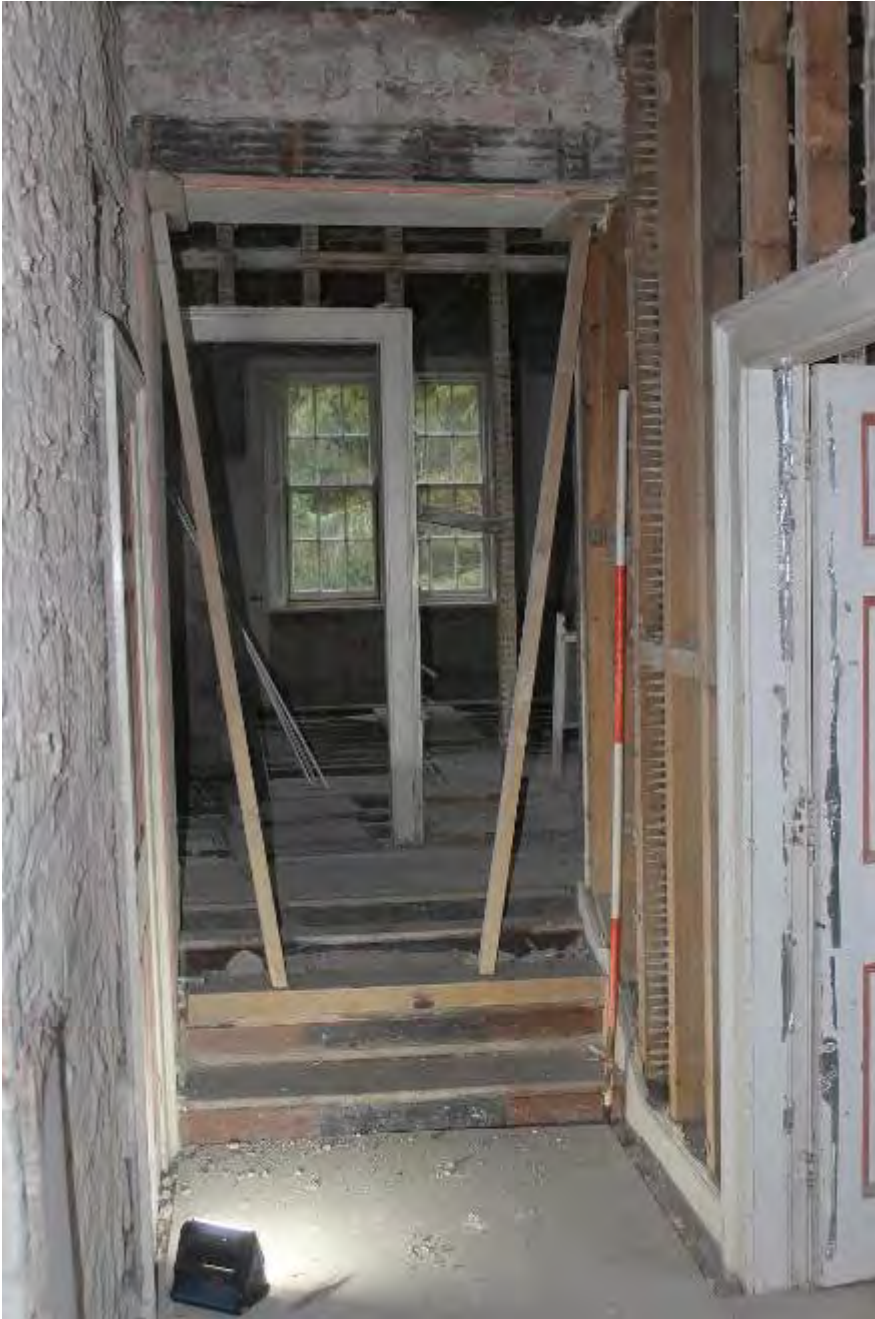
**Photo 19. View looking west along landing. Wallpaper surviving behind studwork partition adjacent to ranging rod. Note timber props resting on second step and brick relieving arch over timber lintel above 1880's opening through earlier gable wall**

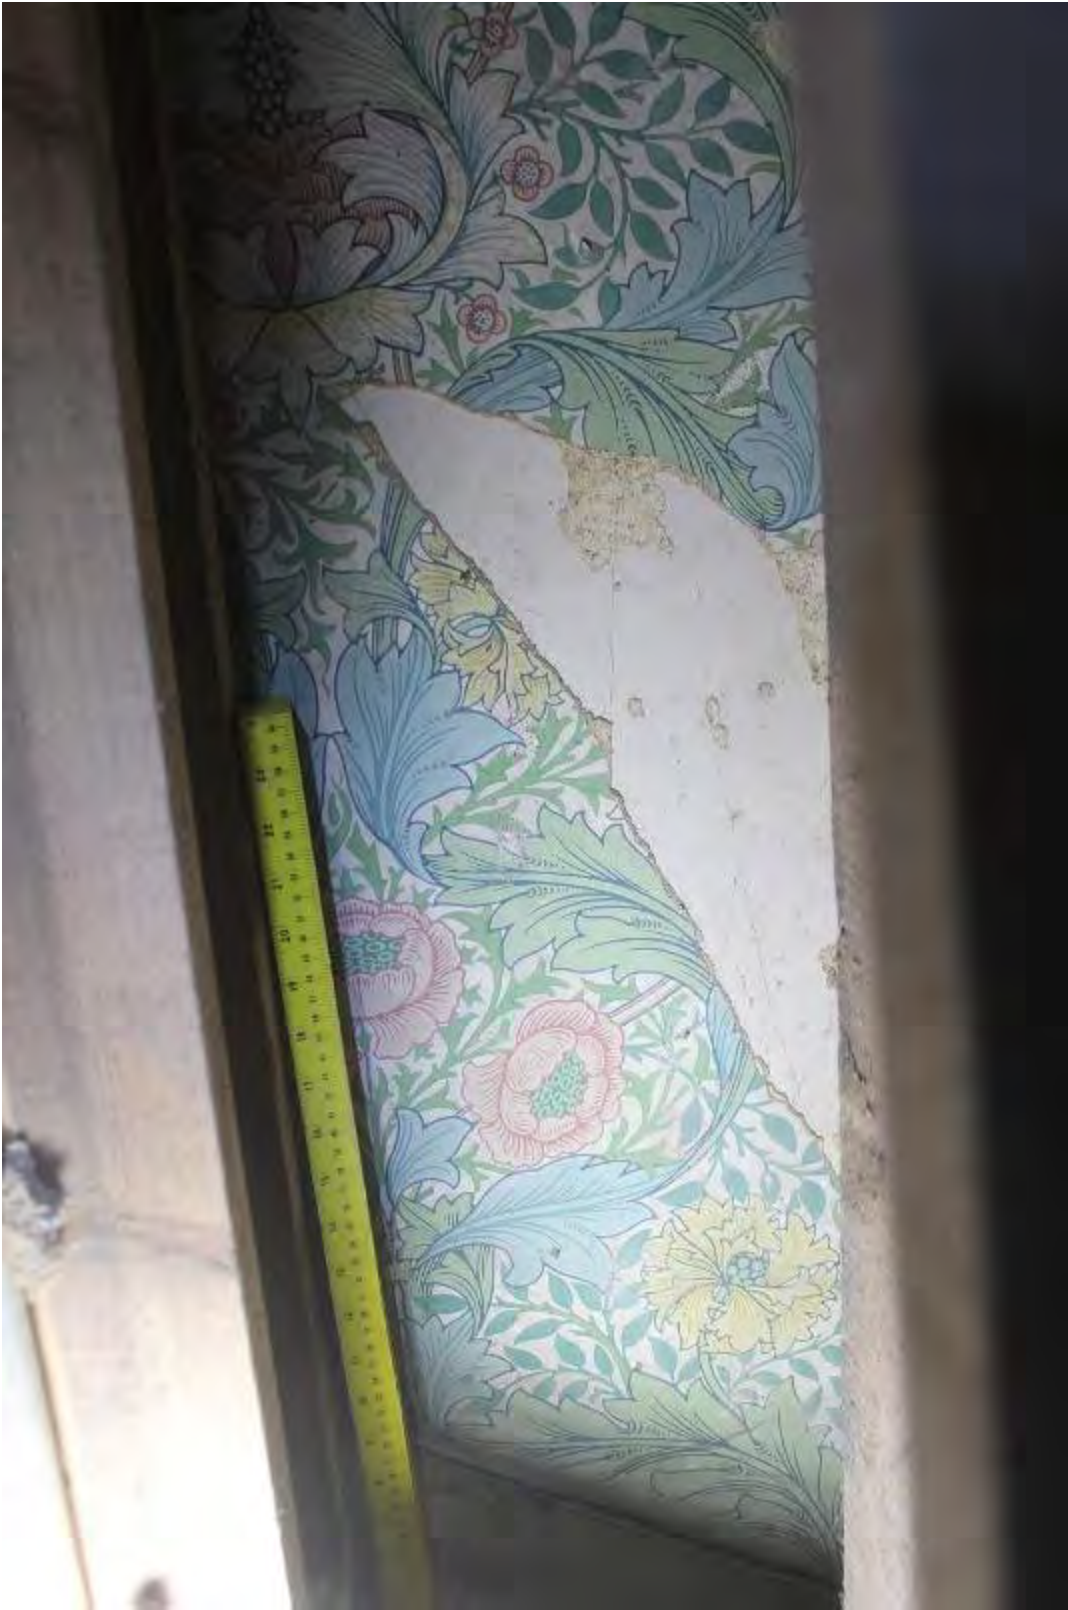
**Photo 20. Lower section of wallpaper**
