Additional historic building recording at Oakwood, Wylam, December 2020

**Historic Environment Research and Interpretation
On behalf of Peter McGirr**

A return visit was made to Oakwood on 16 December 2020 to undertake additional recording of the basement cellar and a wallpaper fragment surviving on the first floor landing. This supplements an earlier round of recording and assessment made for a revised Heritage Statement¹ in support of an LBC application for the building in July 2020.

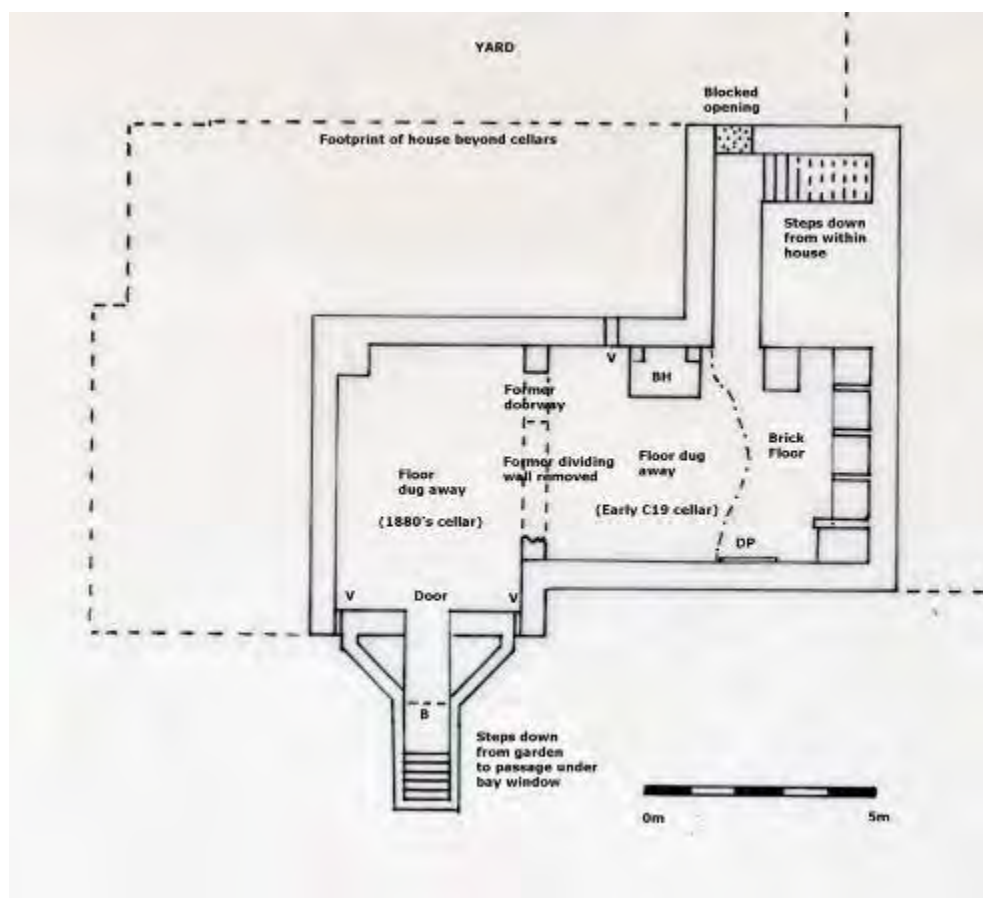
Fig. 1 Annotated basement outline showing location of cellars below house.

- B – modern blocking of passage below bay window
- BH – brick hearth and corbels supporting GF fireplace
- DP – Cast Iron drain pipe set against cellar wall
- V - vents

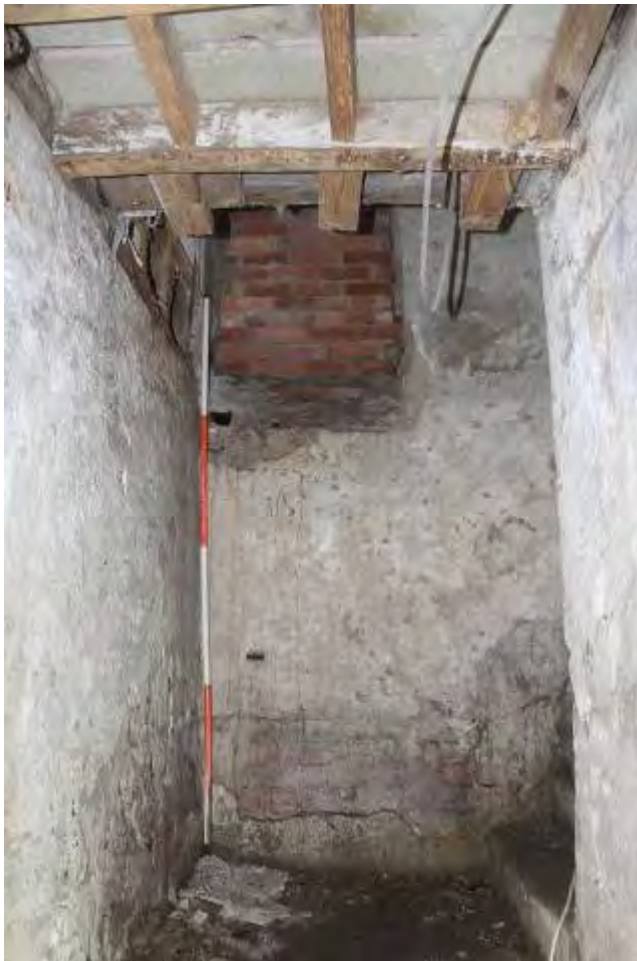
The cellar is accessed from the interior of the house via a flight of stone steps, descending beneath the main staircase, and a short lime rendered brick lined passage running south at right angles from their base. A brick blocked opening, high up in the north wall of the passage at the foot of the steps, gave access to the yard outside and may have provided access to bring goods directly into the cellar and perhaps some light or ventilation.

Photo 1. Opening with modern blocking at N. end of passage. Base of steps to right

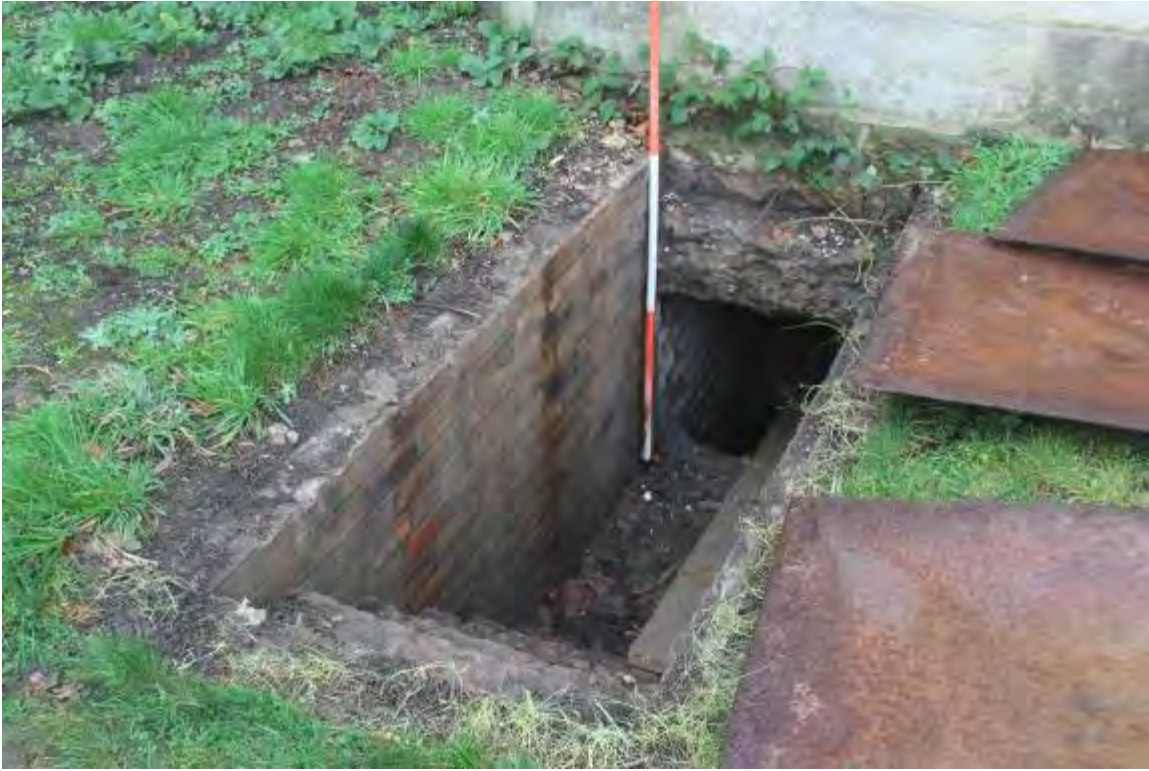
Additional access was subsequently provided from the garden front via brick steps and a brick lined passage leading into the cellar below the bay of the 1880's extension. This would have facilitated delivery of large items such as beer barrels to the cellar space below the 1880's extension to the house. This passage had been blocked in the modern period, presumably once the household no longer required regular delivery of barrels. The blocking was subsequently re-opened, perhaps

Photo 2. Steps and brick lined passage below the bay on the S. front. Note mass concrete foundation to 1880's bay and modern blocking, subsequently re-opened, behind ranging rod

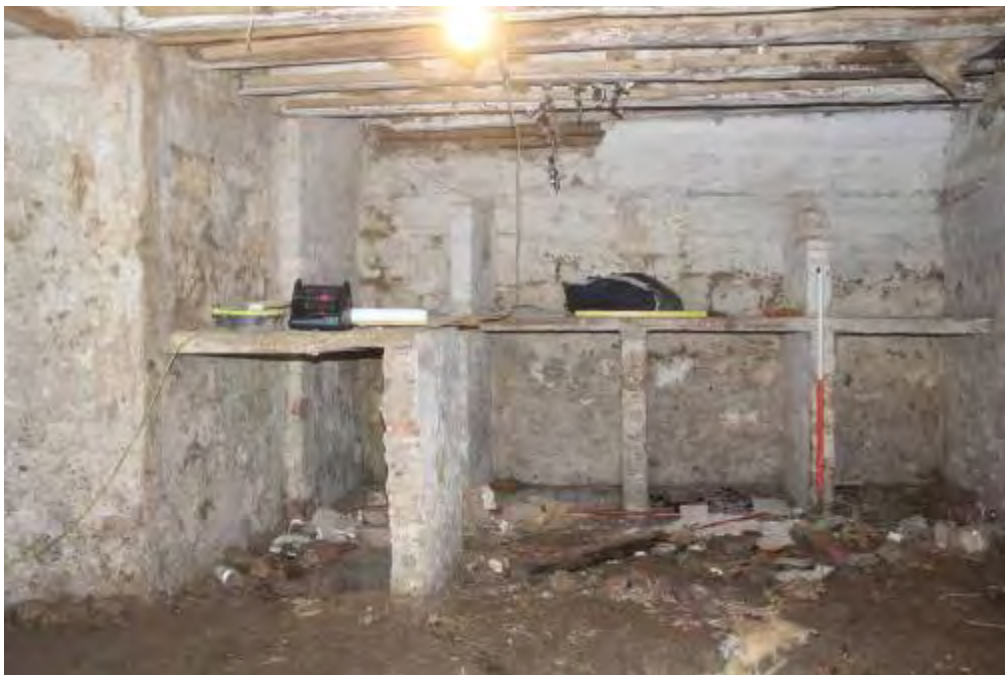
Photo 3. Brick and stone wine bins built against east wall of cellar. Stone shelf in front of bins left middleground

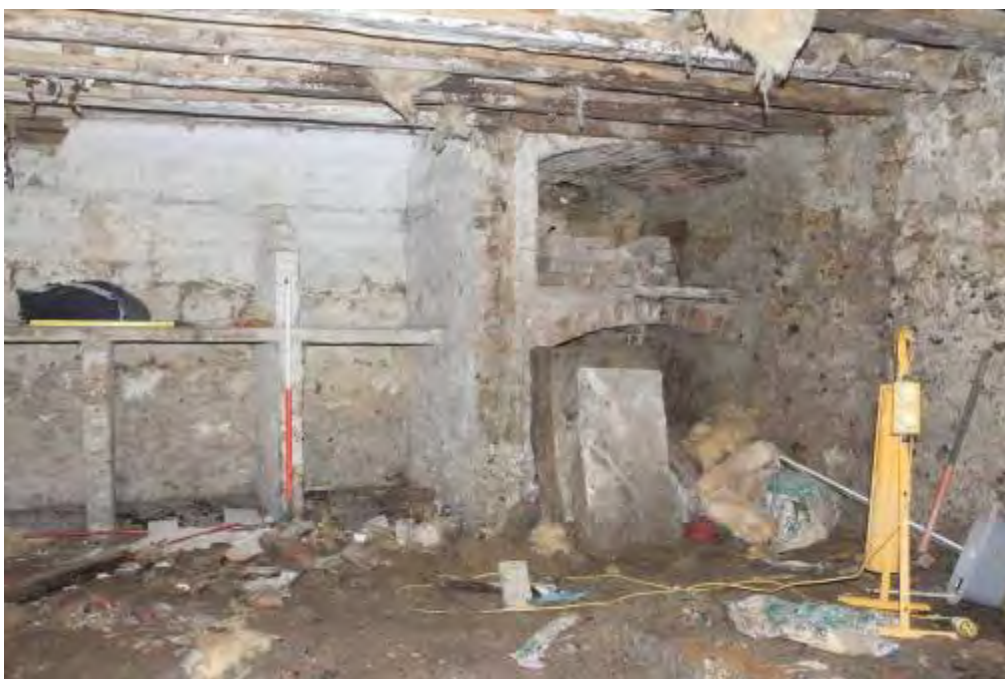
Photo 4. Arched wine bins built in brick against southern wall. Note floor joists running N/S across cellar

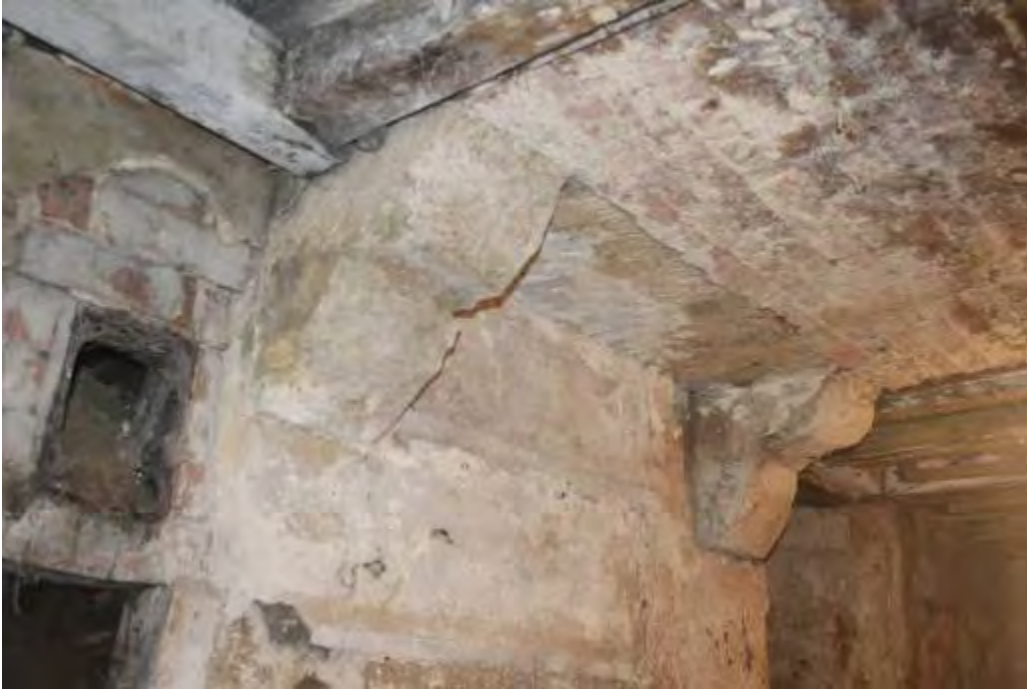
Other features include a pair of substantial stone corbels projecting from the north wall to the west of the passage entrance. These support the fireplace and hearth in the room above [see photos below]. Two inserted openings adjacent may have provided draught

Photo 7. Corbels and brick hearth for ground floor fireplace against north wall

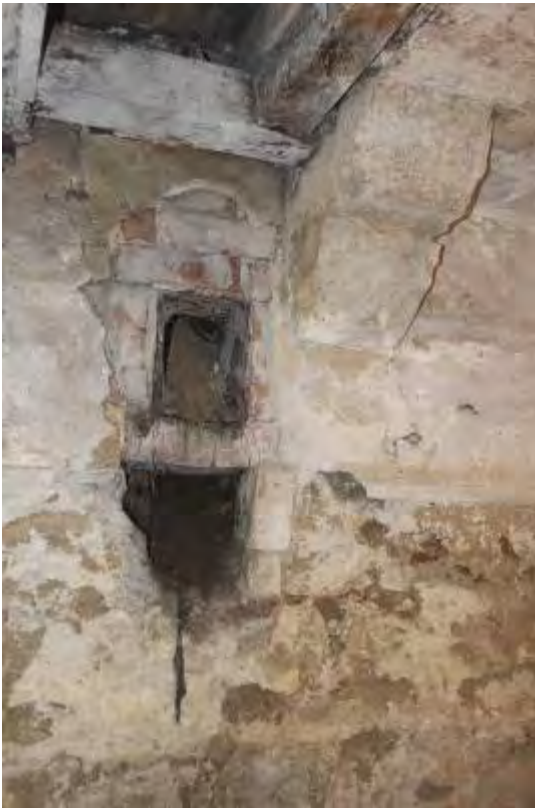
Photo 8. Vent and shute cut into cellar wall to LHS of fireplace above

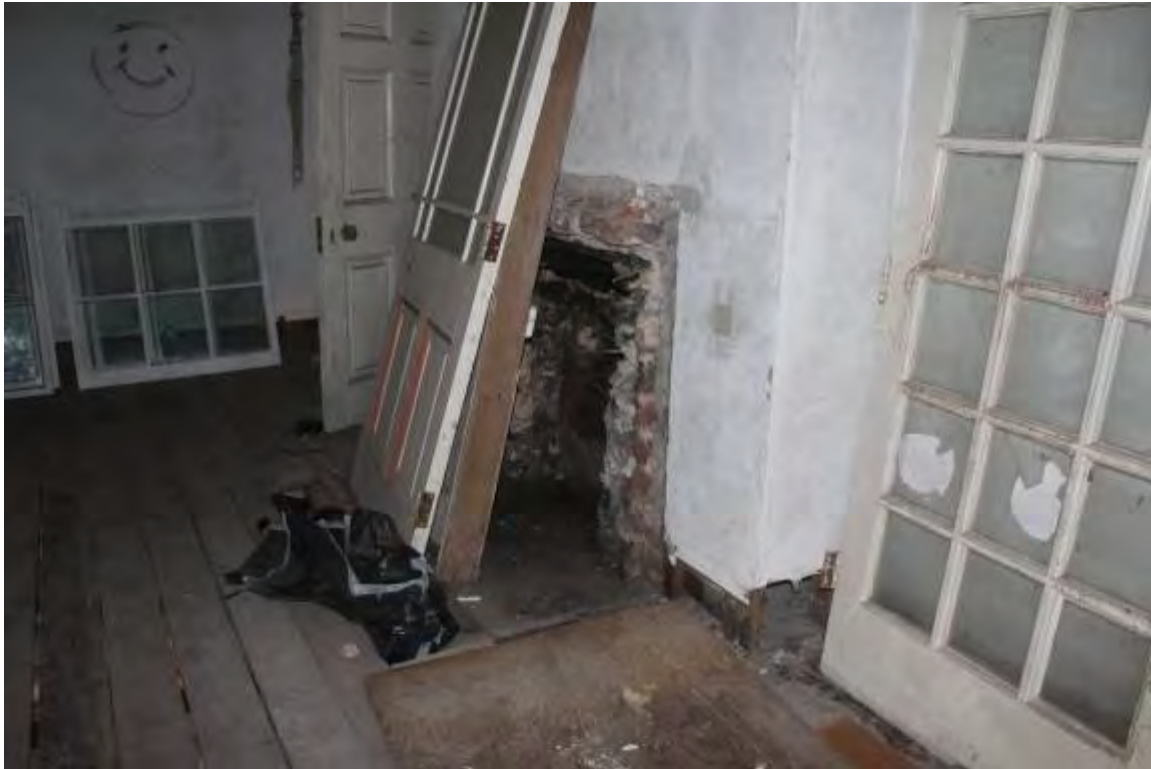
Photo 9. Fireplace and hearth in the room above

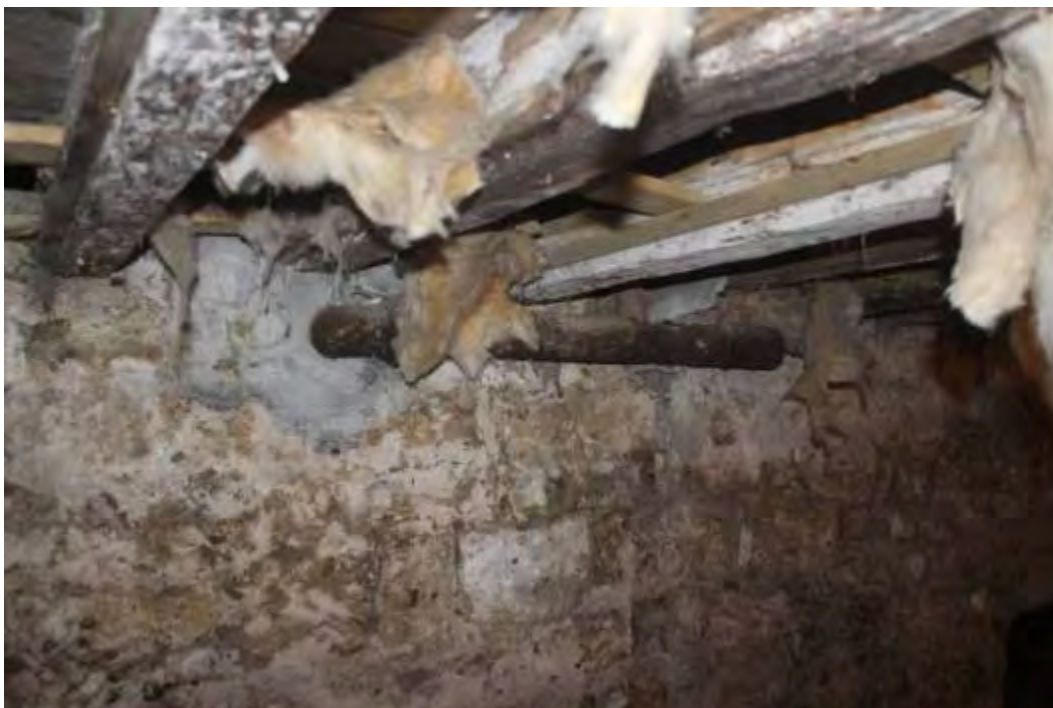
for the fireplace. A four inch diameter cast iron drain pipe has been inserted in the south wall but its function is not immediately obvious.

Photo 10. Four inch cast iron drain pipe against south wall of cellar

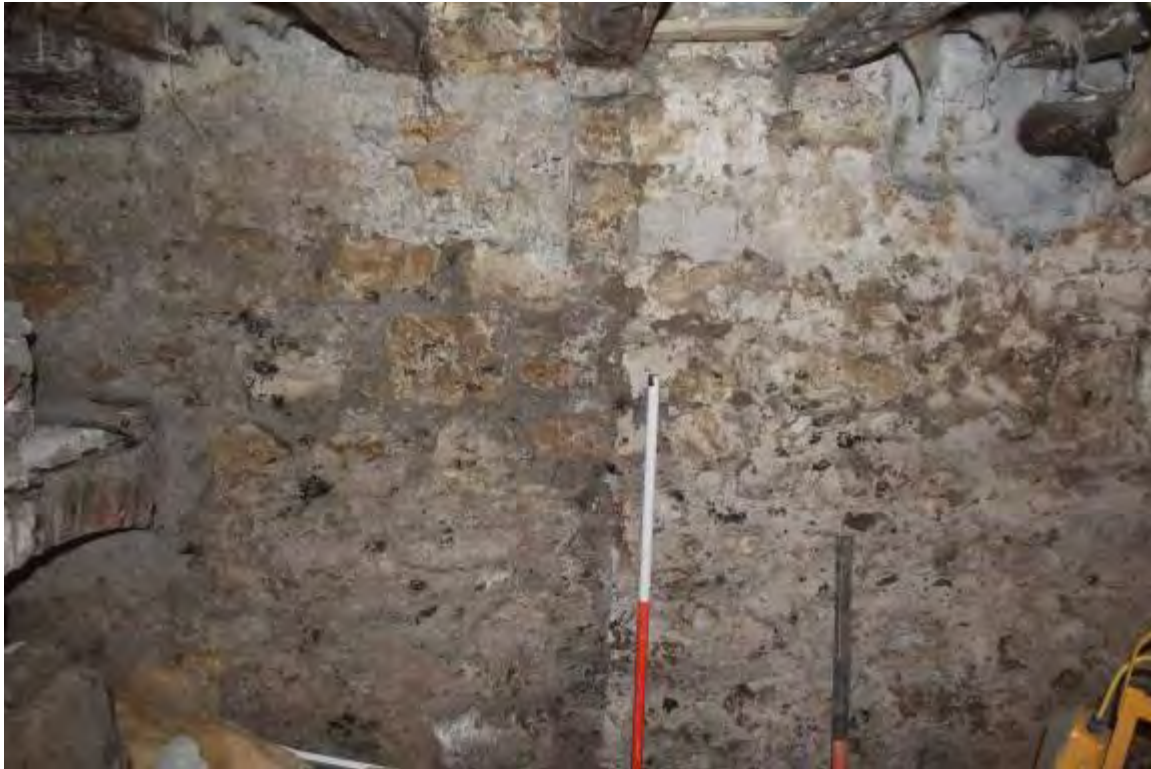
Photo 11. Traces of former N/S partition against south wall

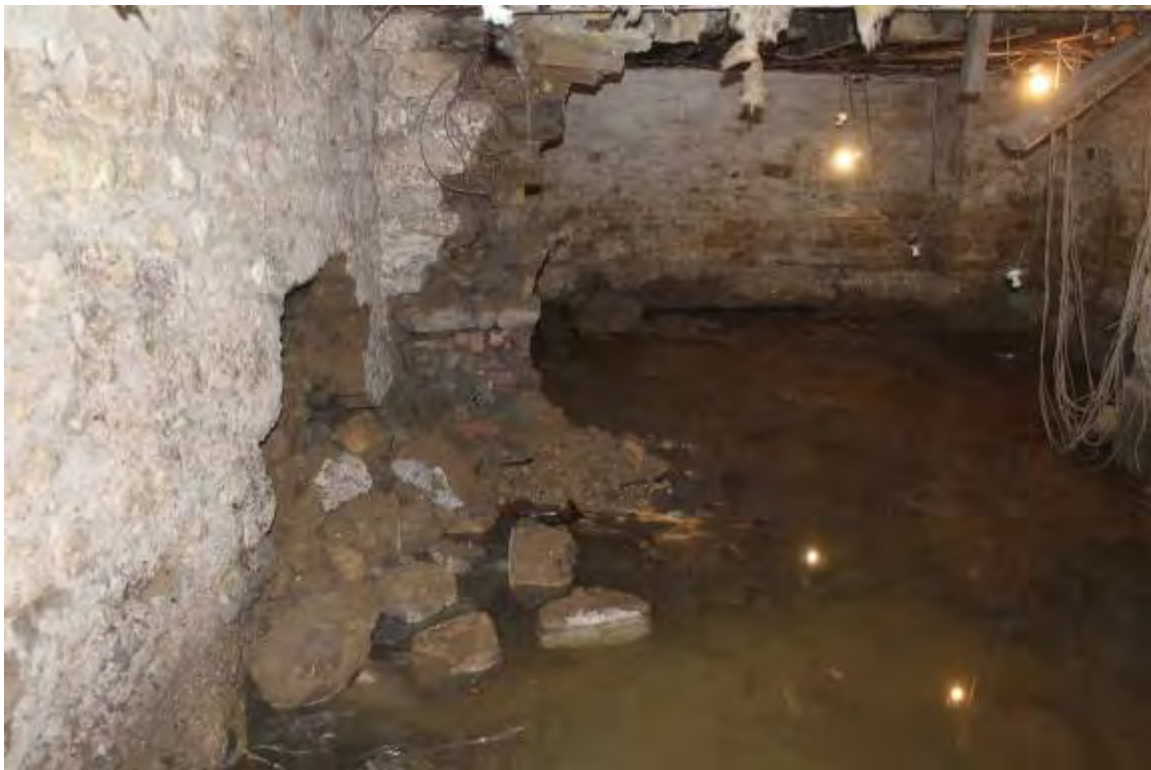
The revised Heritage Statement had identified surviving features in the basement. Clearing of previously excavated material and the provision of temporary lighting allowed an improved record of the features to be made. A review of earlier plans accompanying previous planning applications identified internal partitions within the cellar, removed by previous owners, who had also excavated the majority of the cellar floor to a depth of over 0.5m below the original level to gain additional headroom in the basement. Previous owner's works had also breached the structural wall between the two parts of the cellar, leaving the wall above and the floor joists of the Drawing Room unsupported.

Photo 12. Stub of cross wall removed in previous works and recent collapse of unsupported south wall. 1880's cellar in background

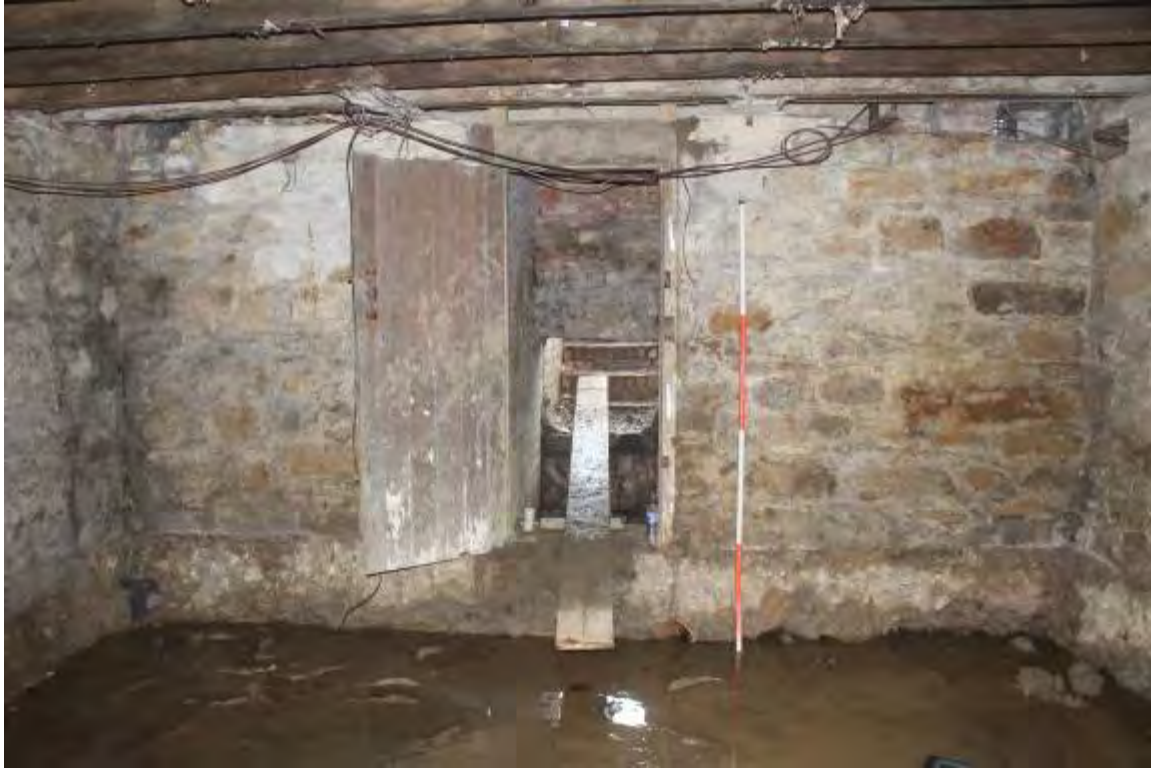
Photo 13. Door in south wall. Note substantial Victorian foundations here and drain pipe to L. of ranging rod. High level ventilation slots, top L and R

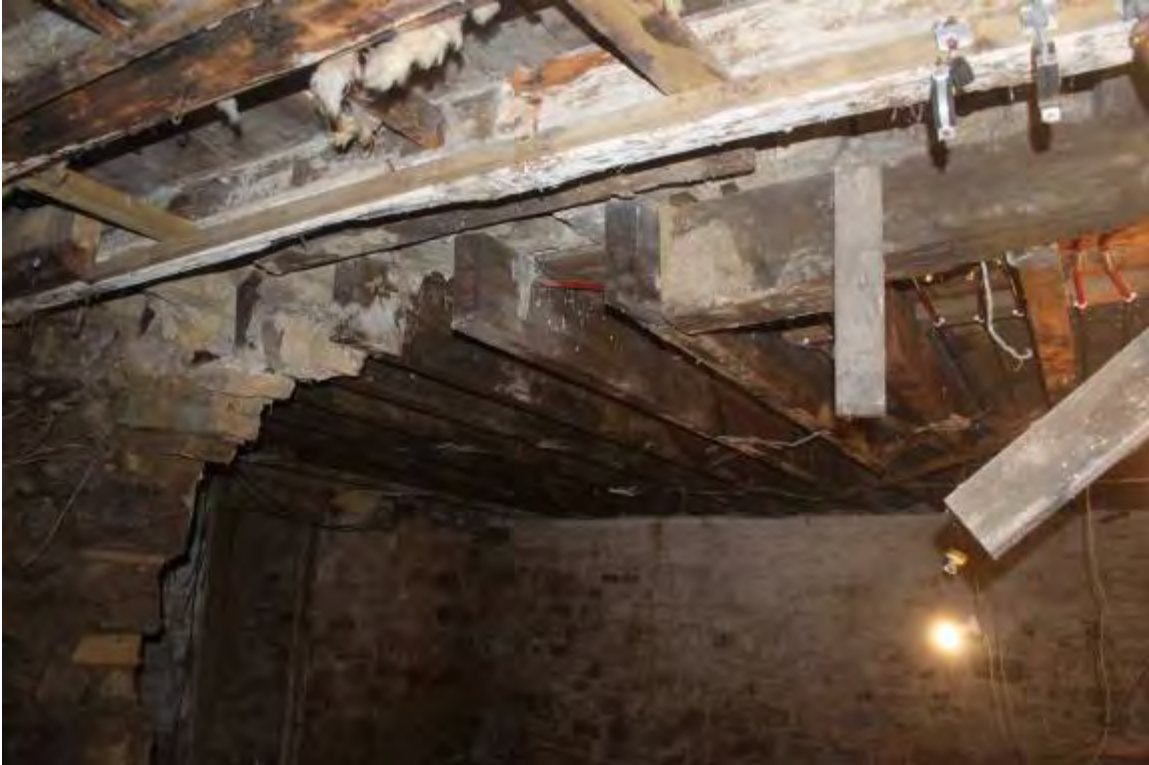
former dividing wall has been removed during previous works, resulting in a lack of structural support for the fabric above. Victorian building practice is reflected in the provision of good under floor ventilation, with vents at high level in the cellar and above ground level outside, to either side of the bay window. A broken ceramic drain pipe at low level, adjacent to the door in the south wall, shows that drainage from the cellar was considered and appears to still be regulating the flood water level in the now excavated cellar floor.

Photo 17. E/W running floor joists above 1880's cellar, left unsupported by removal of supporting cross wall

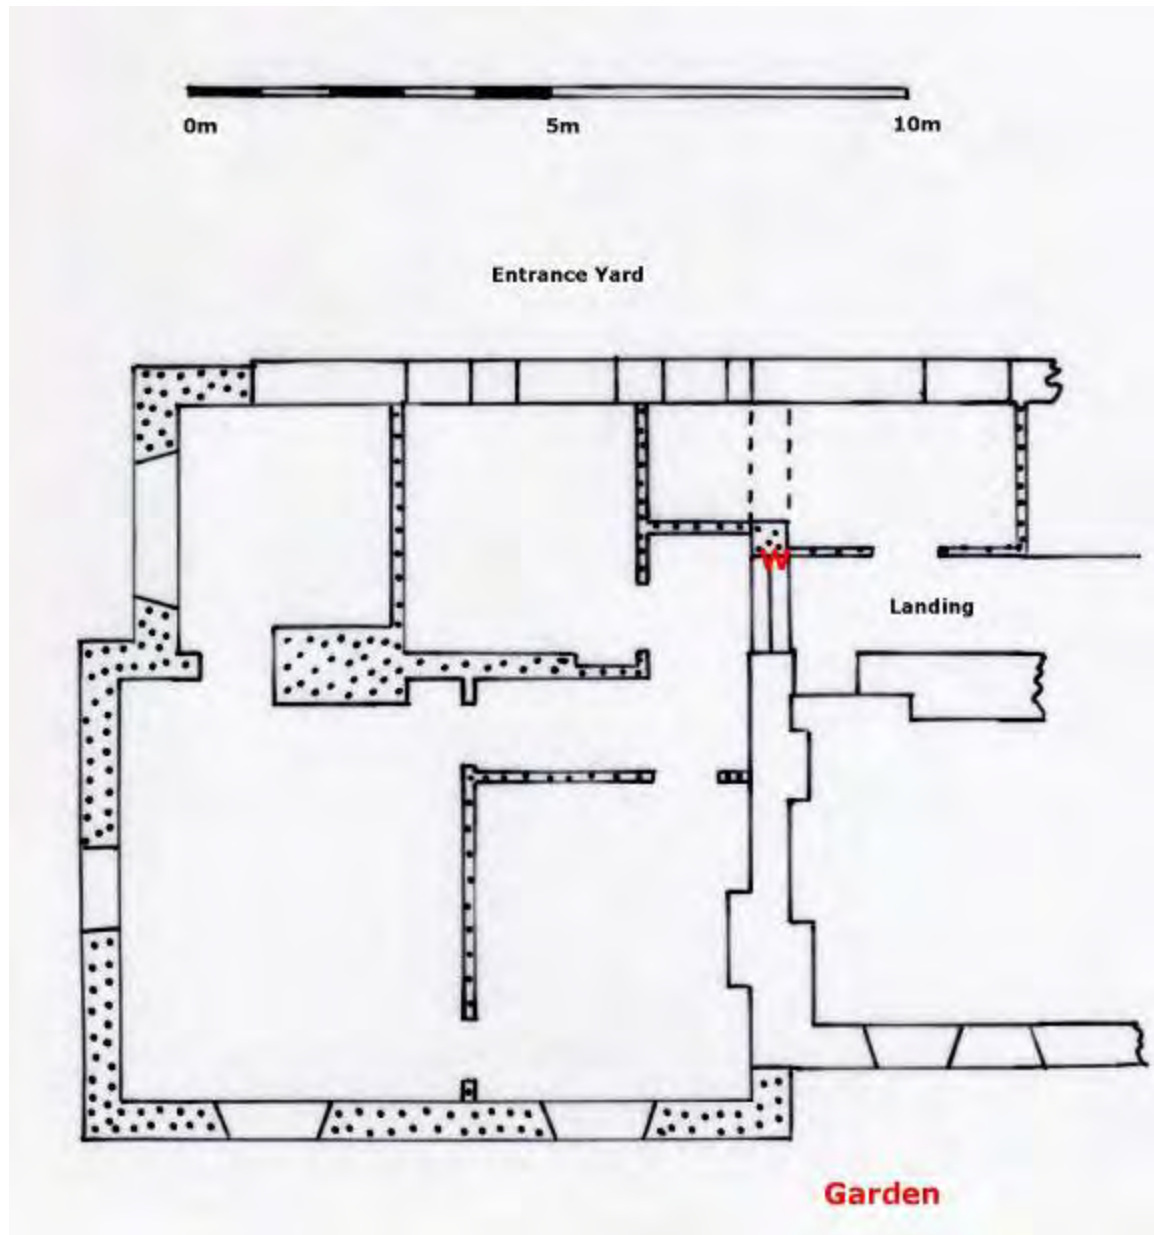
Fig.5 Annotated plan of western end of First Floor showing wallpaper location

Red "W" marks location of surviving wallpaper.

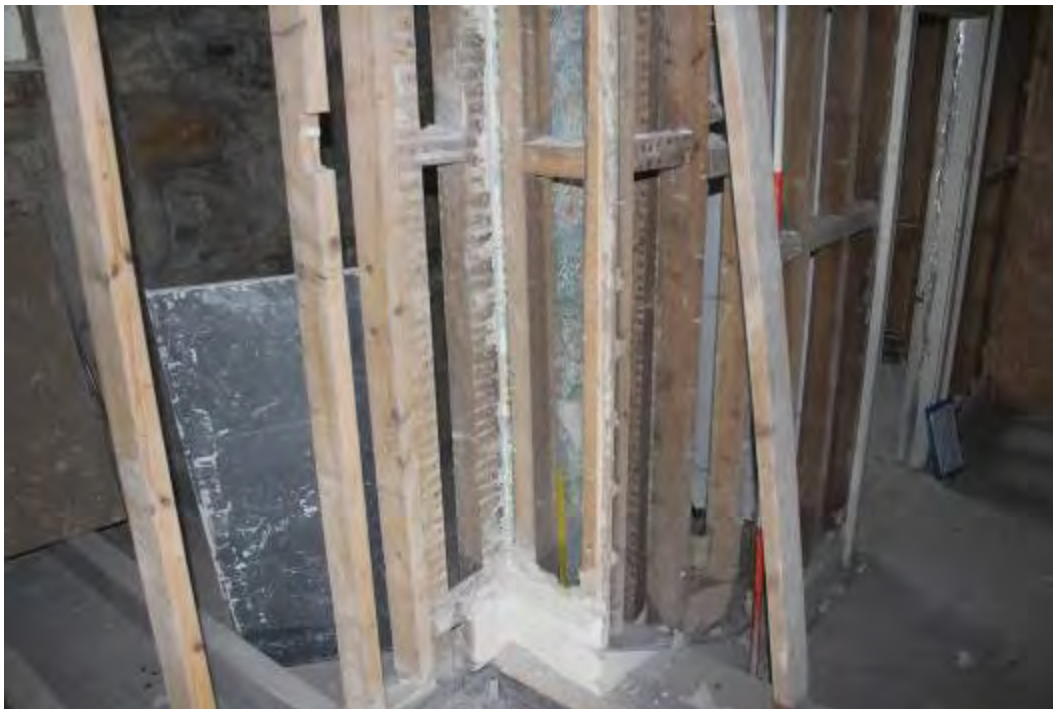
Photo 18. General context of wallpaper survival behind later studwork and plasterboard, looking NE.

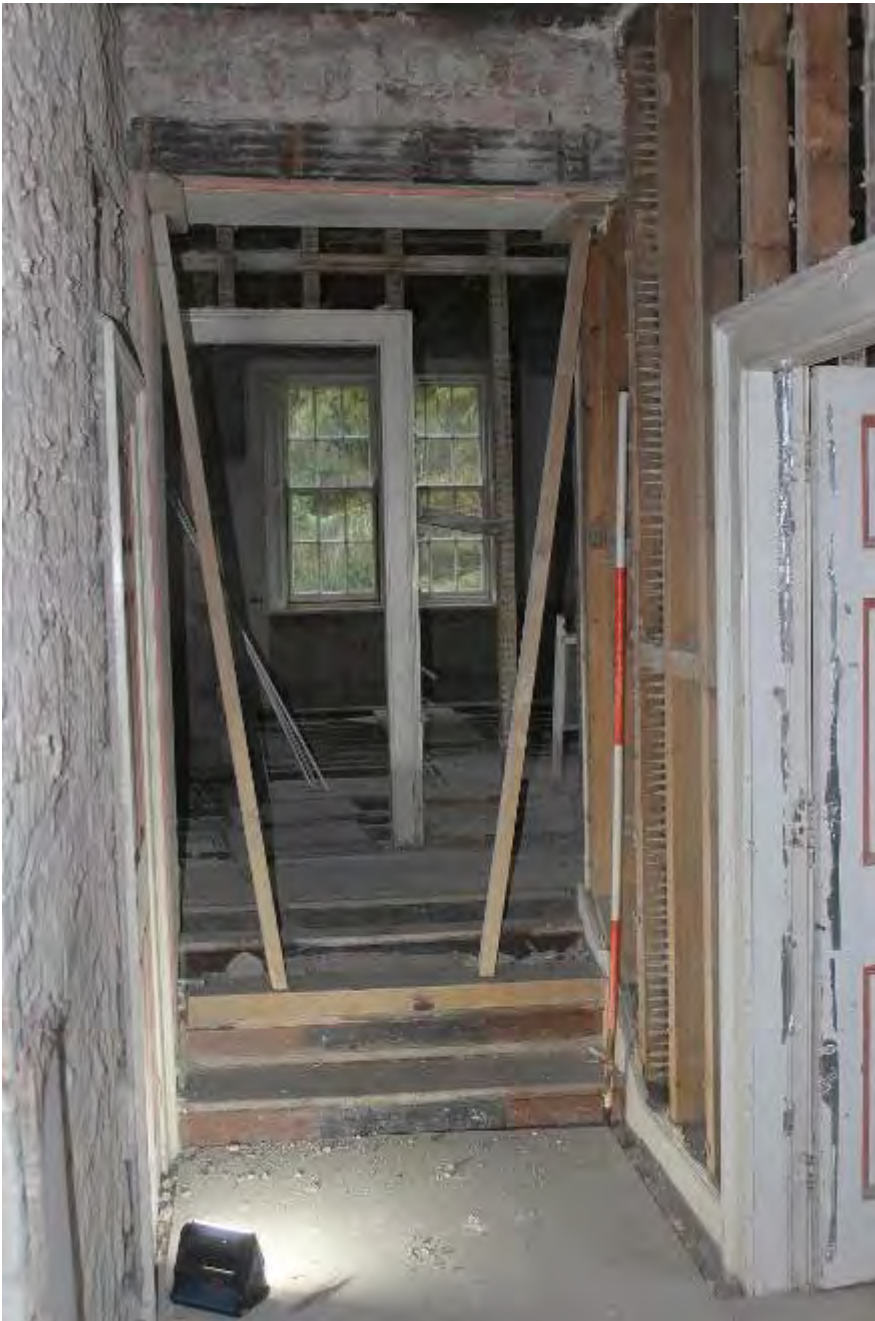
Photo 19. View looking west along landing. Wallpaper surviving behind studwork partition adjacent to ranging rod. Note timber props resting on second step and brick relieving arch over timber lintel above 1880's opening through earlier gable wall

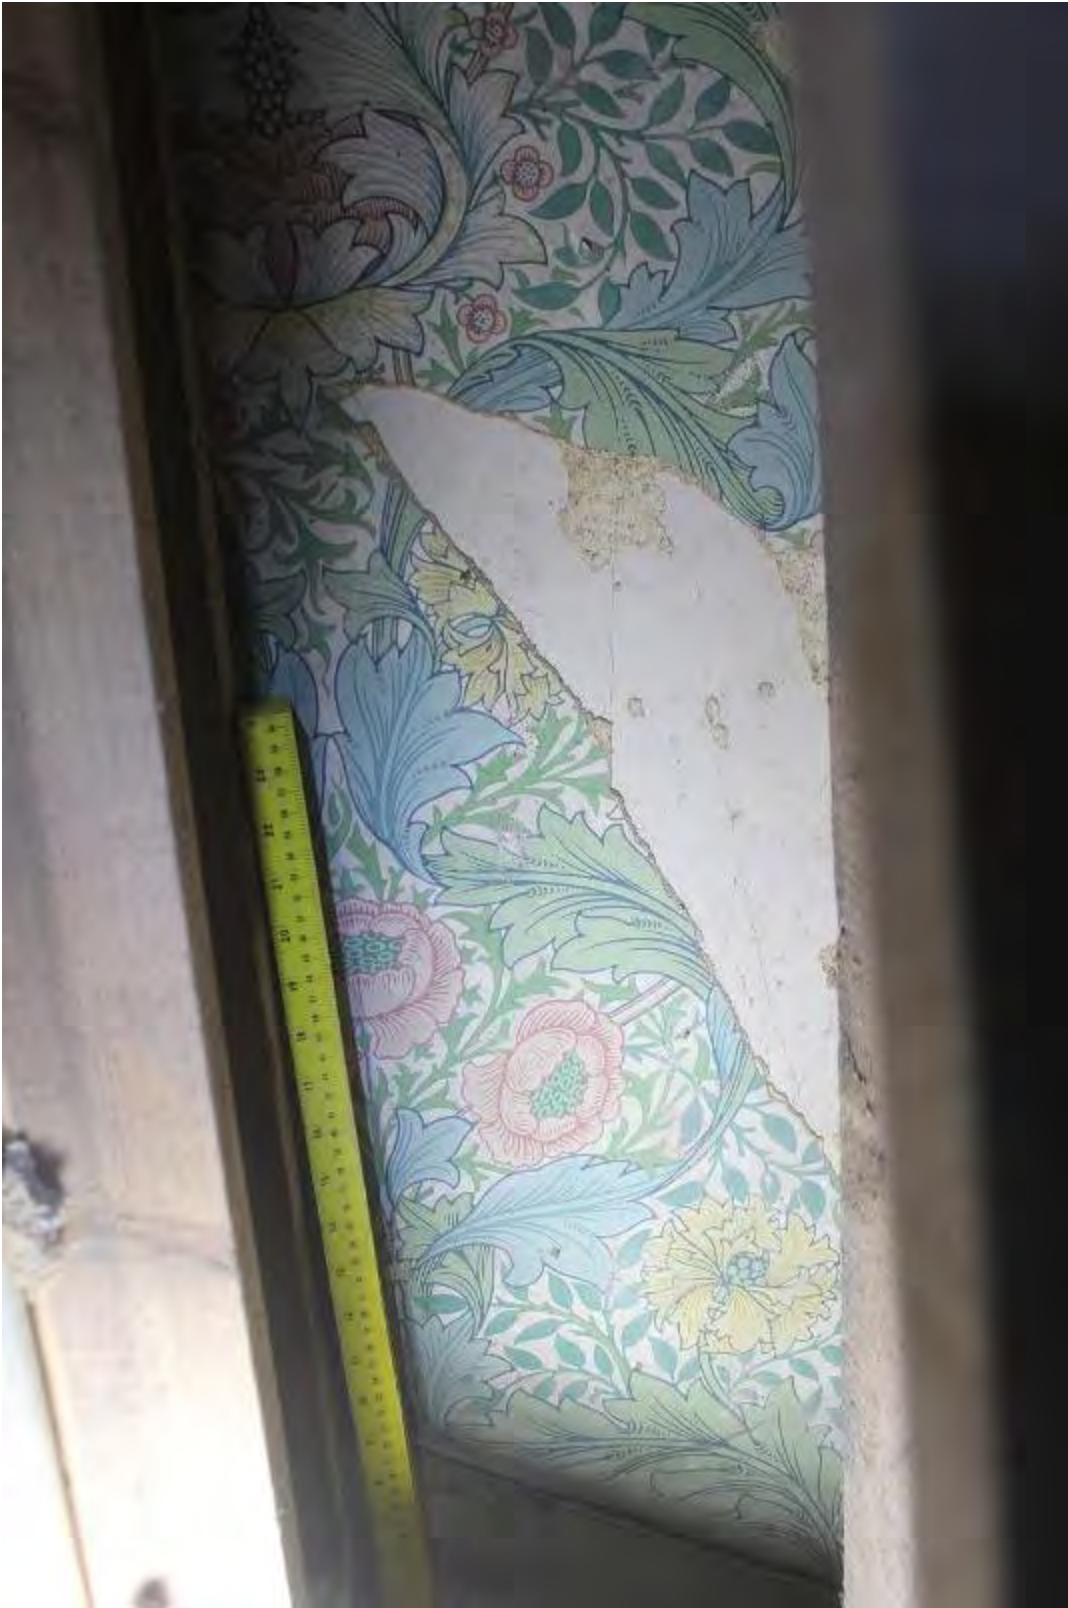
Photo 20. Lower section of wallpaper

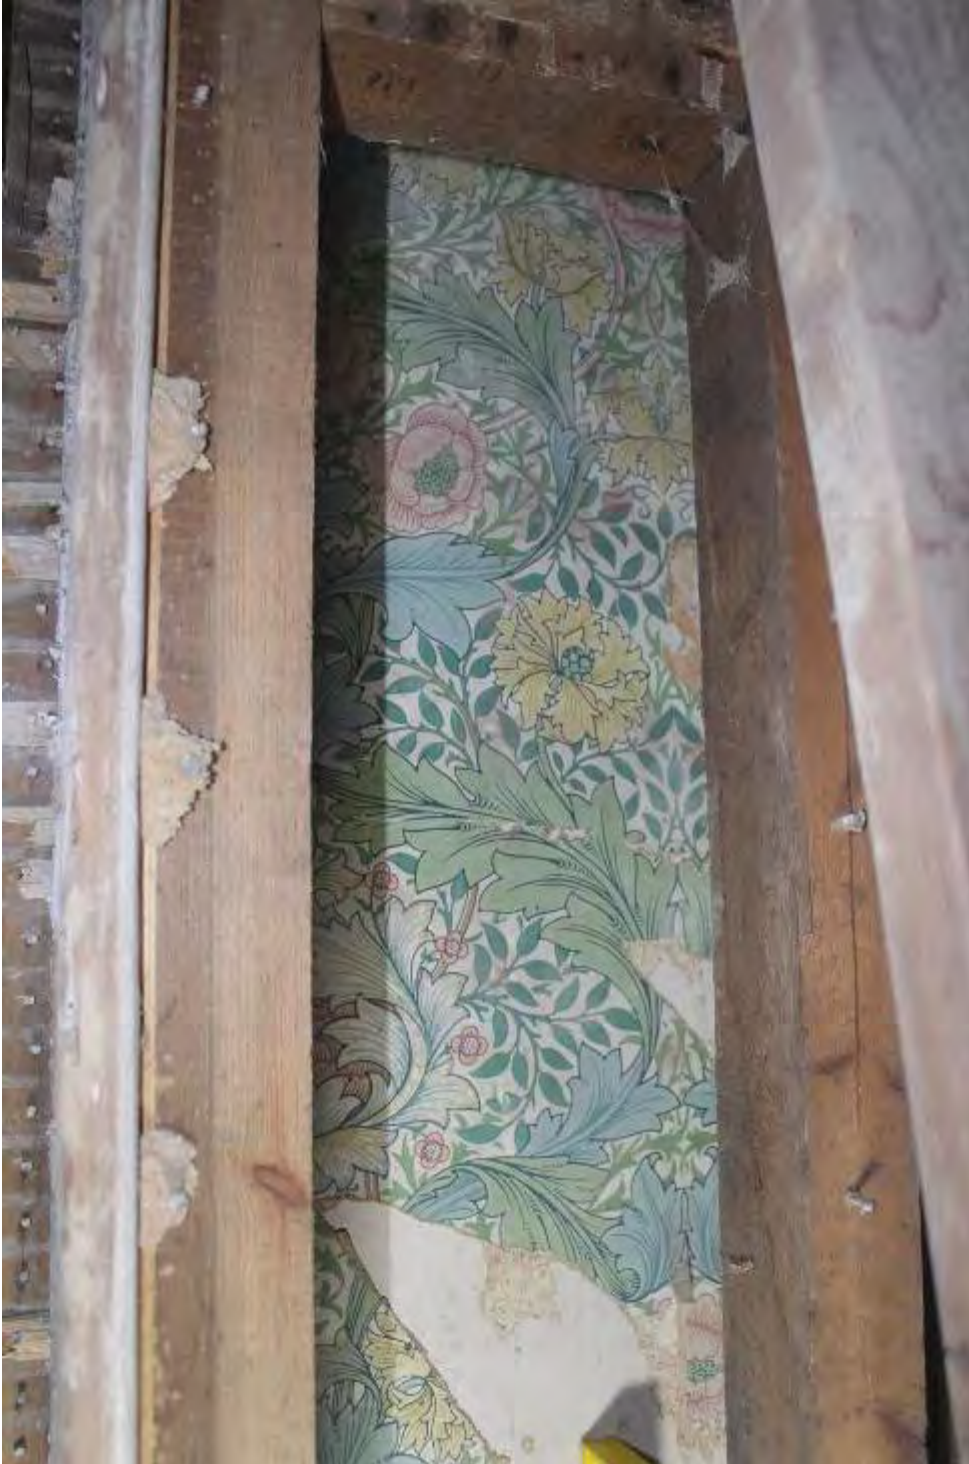
Photo 21. Upper section of wallpaper. Note remains of 1930's plasterboard adhering to later studwork overlying the wallpapered wall. Earlier studwork partitions (left of view) are traditional lath and plaster
