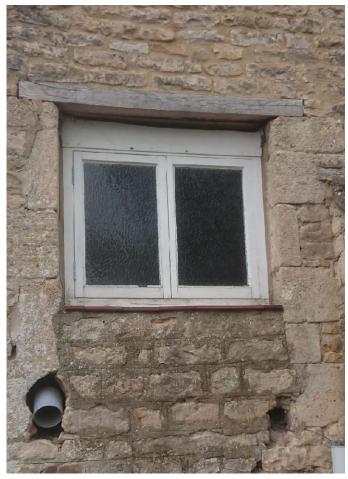
Photo II: Bathroom Window and In-fill Below

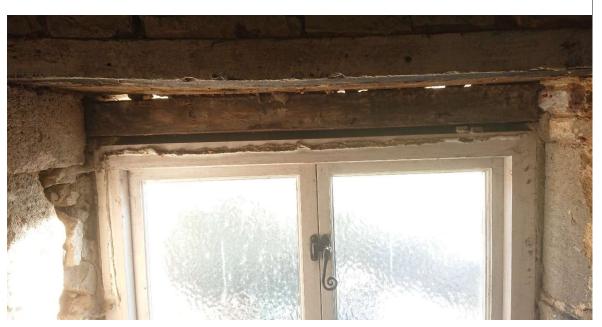
Photo 12: Old Doorframe Head in Bathroom Window Opening (showing poor window fitting)
