Project No. 22215/P01

We have surveyed the property on Wednesday the 25th of January and we found the property to be in poor condition, as you may already be aware of.

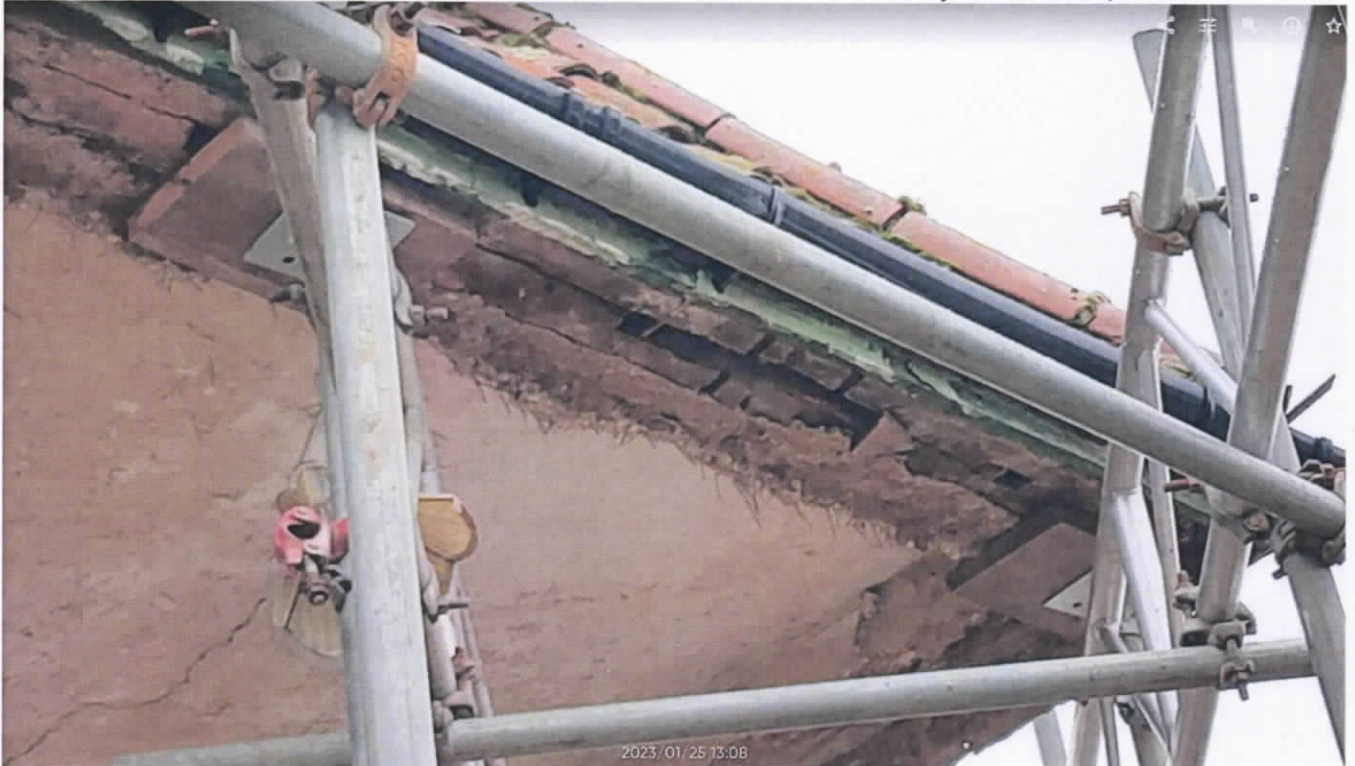
The external wall panels of the property are clay bricks (clay lump structure). Although the existing wall plates have slots, which could indicate the existence of former timber stud structure, it is most likely that this is re-used material from other structure. This is more evident near the north-east corner where the slot in the timber plate is too large for an anticipated corner bracing element, showing that this formed part of the frame of a larger scale structure.

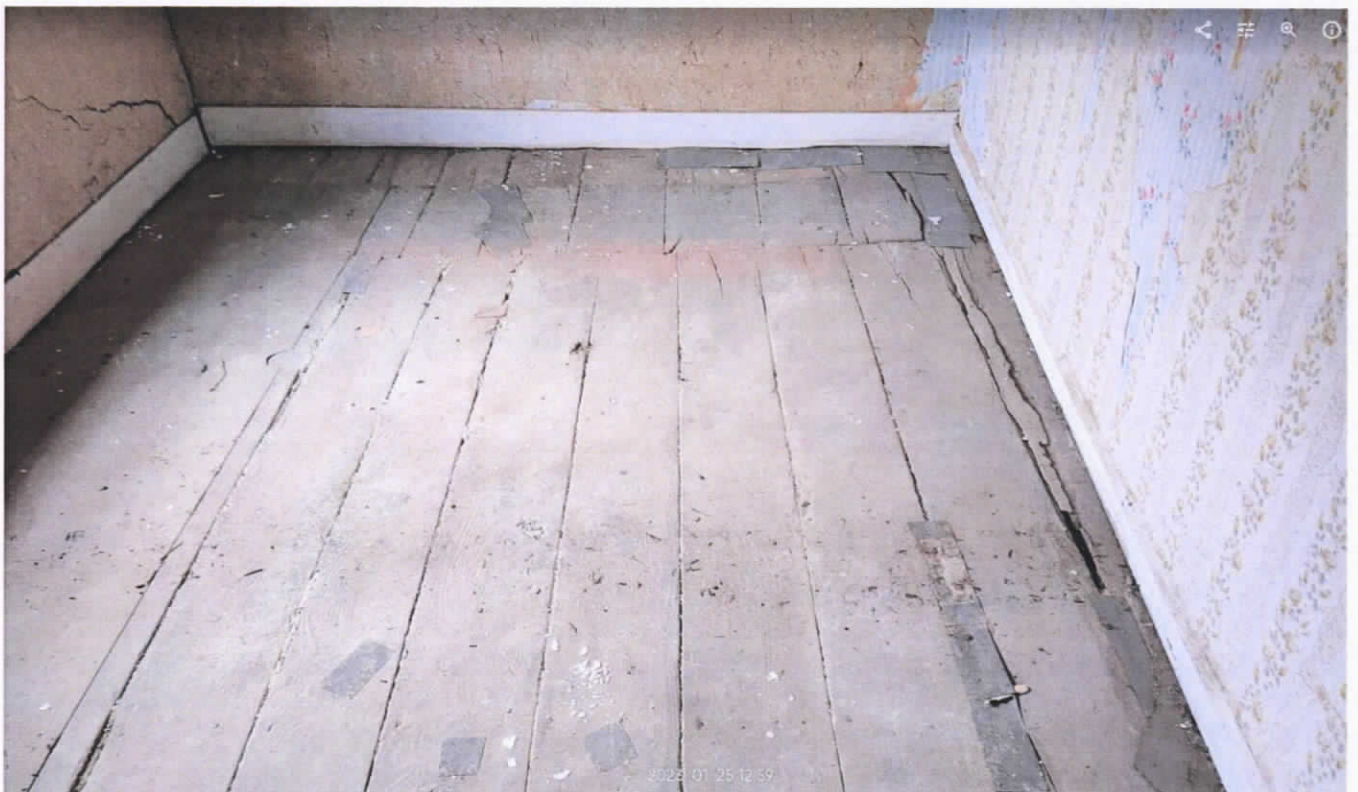
The internal floor comprises of the main floor beams and secondary timber beams, all boarded with what seems to be the original fabric.

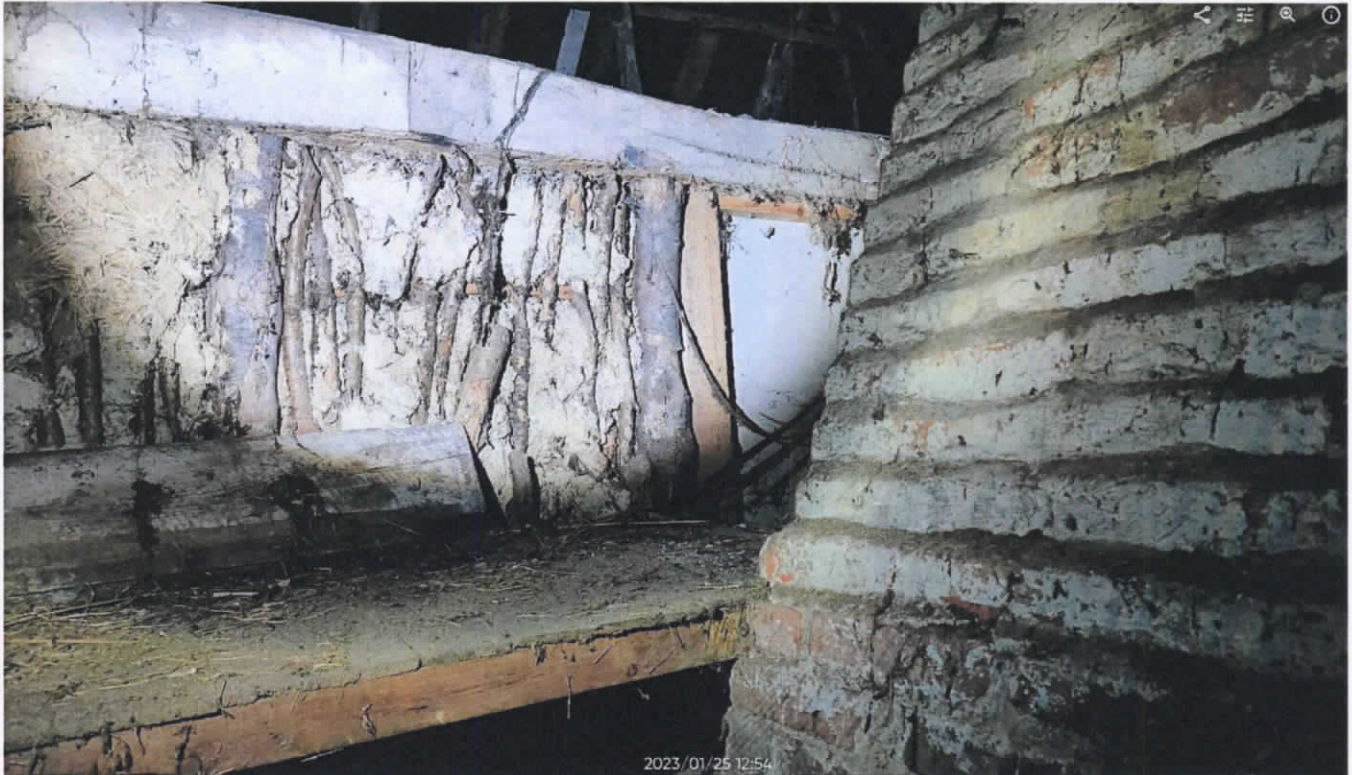
Internal partitions (where they could be identified) are either masonry (as part of the chimney structure in the middle) or wattle and daub. Some of these walls appear to have been repaired in the recent past (softwood studs pairs with original fabric below).

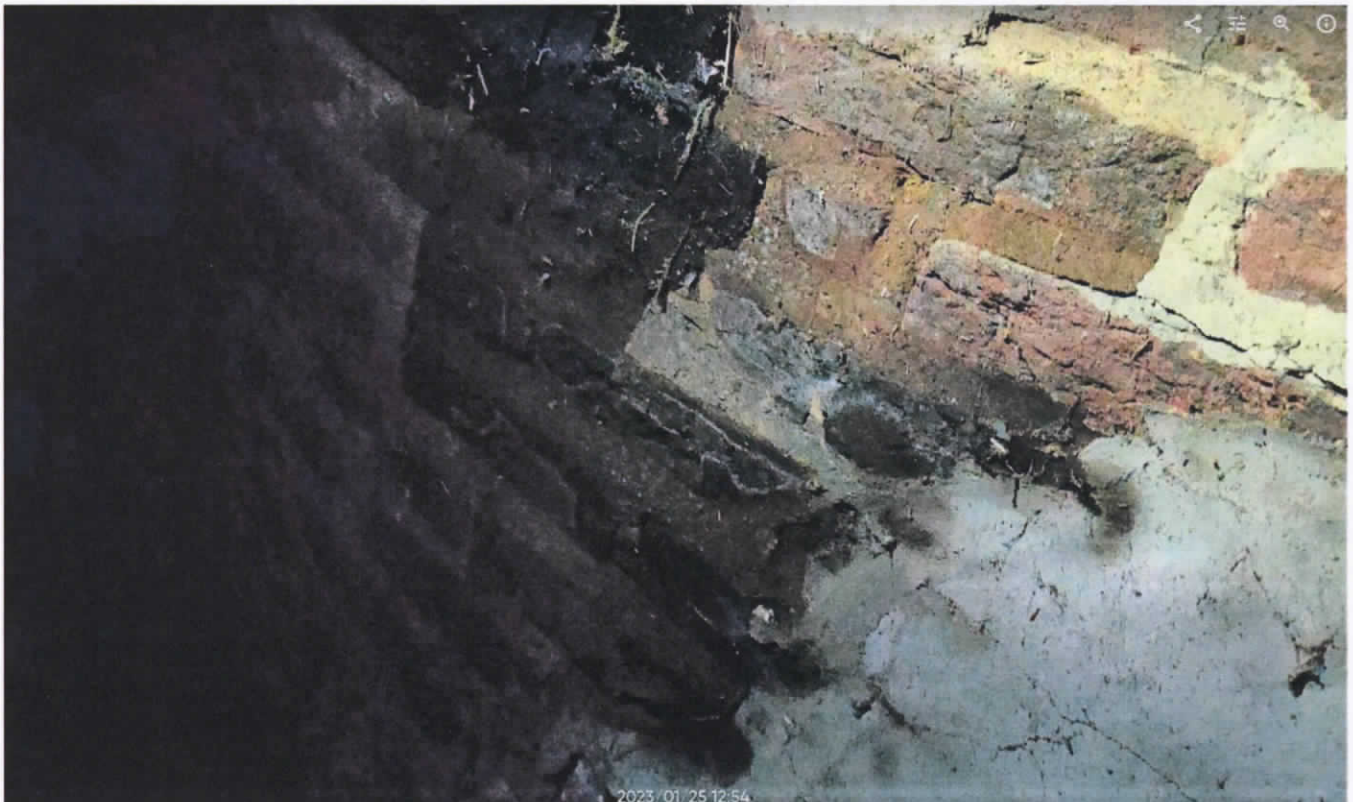
The chimney structure is made out of clay bricks. Random patches of past repairs indicate are evident at 1st floor level between west and east partition). Some of these repairs are carried out with cementitious agents.

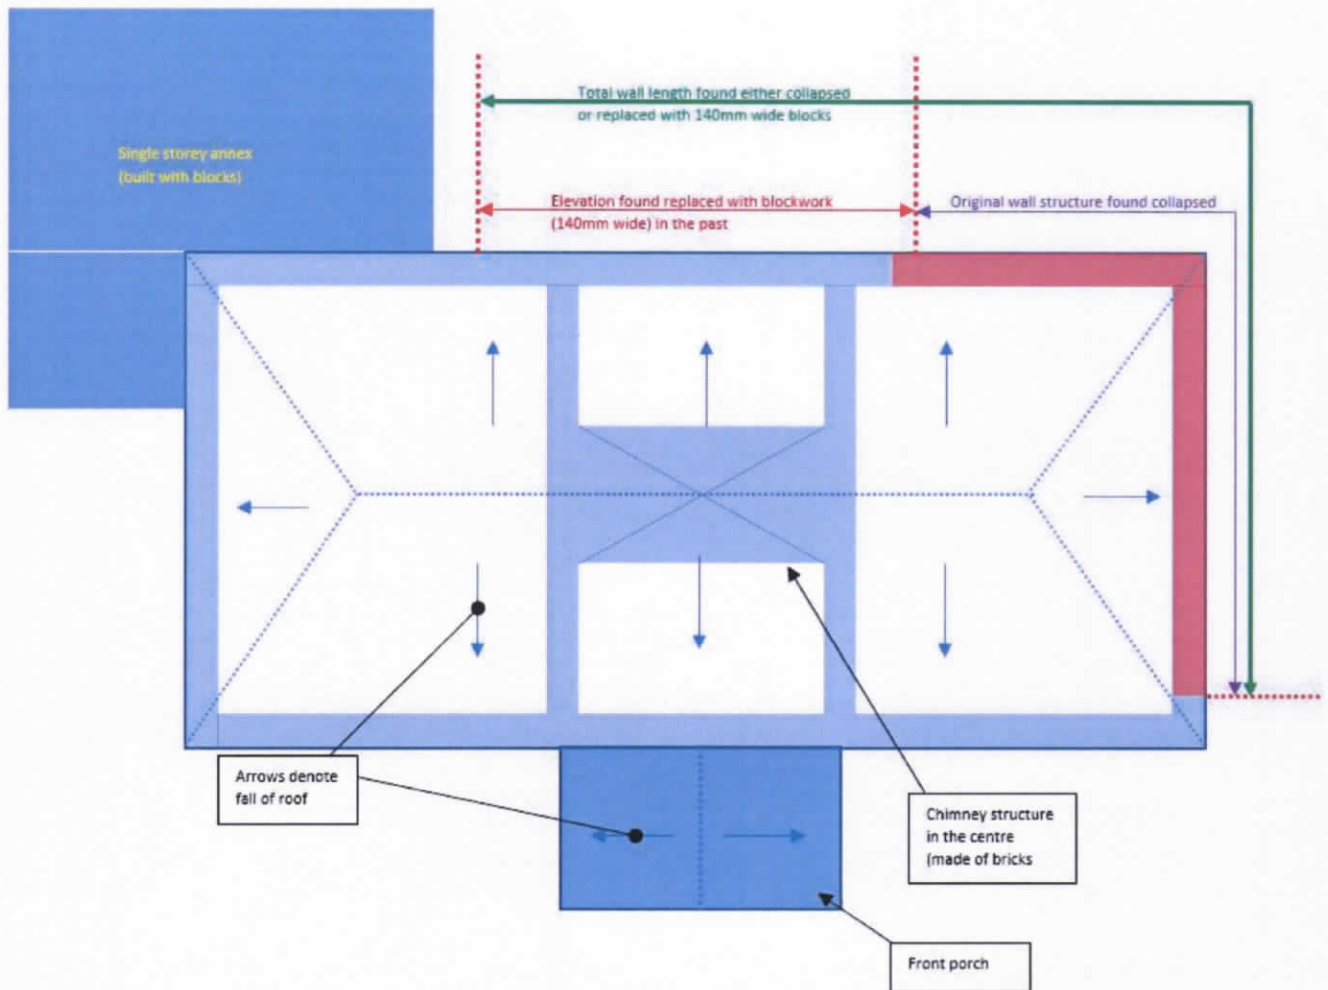
The sketch below, although not in scale, should help identify the extent of the failure, as it retains the analogies of the failed elevations in relation to the total elevations.

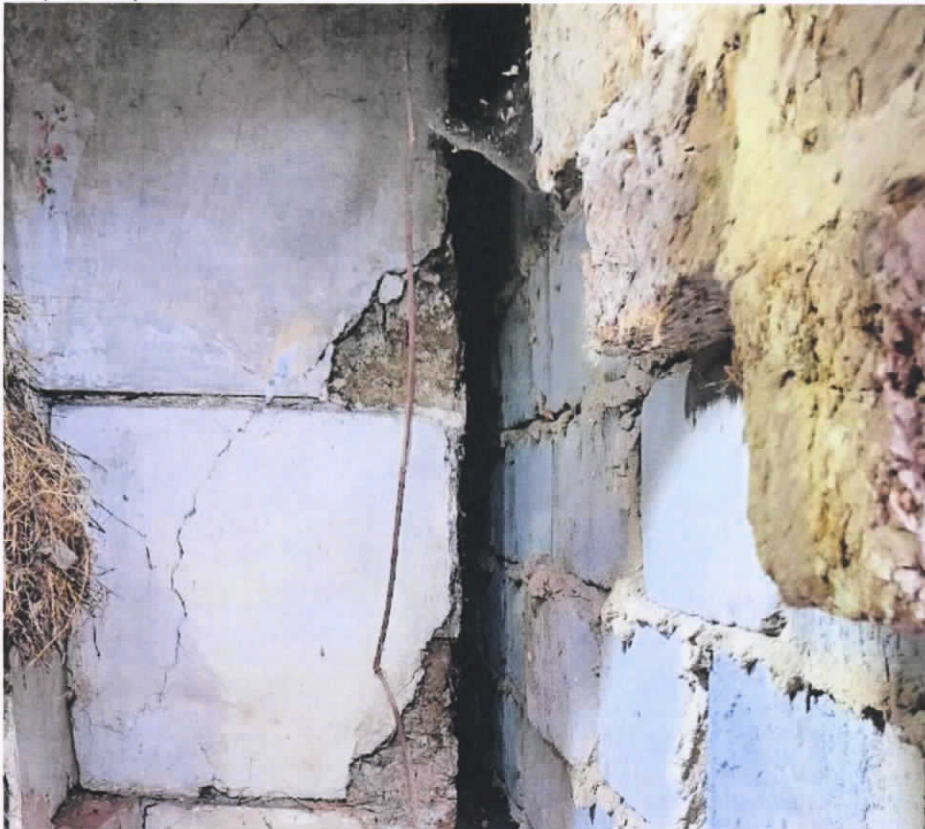
Where the wall is denoted with red arrow, the majority of the clay bricks have been replaced with slenderer structure (140mm wide blockwork). There are parts where clay bricks are keyed in the blockwork, but the interface generates eccentricity and should be rebuilt as explained in this report.

One of the major interventions for this, to restore the structure to its original structural order, it would be to rebuild the walls, maintaining the original thickness. Of course the 140mm blockwork would have to be removed and rebuilt as 200mm wide structure as this is too slender for this type of application (a 140mm wide wall unrestrained at 1st floor level is not structurally sound). The operation can be carried out in two ways. The first way is to rebuild as clay lump and the other is the less sympathetic to the original fabric which is to rebuild using blocks of 215mm width (blocks laid to side). While the latter is the less preferable in terms of conservation, it has some advantages which should be considered in this process.

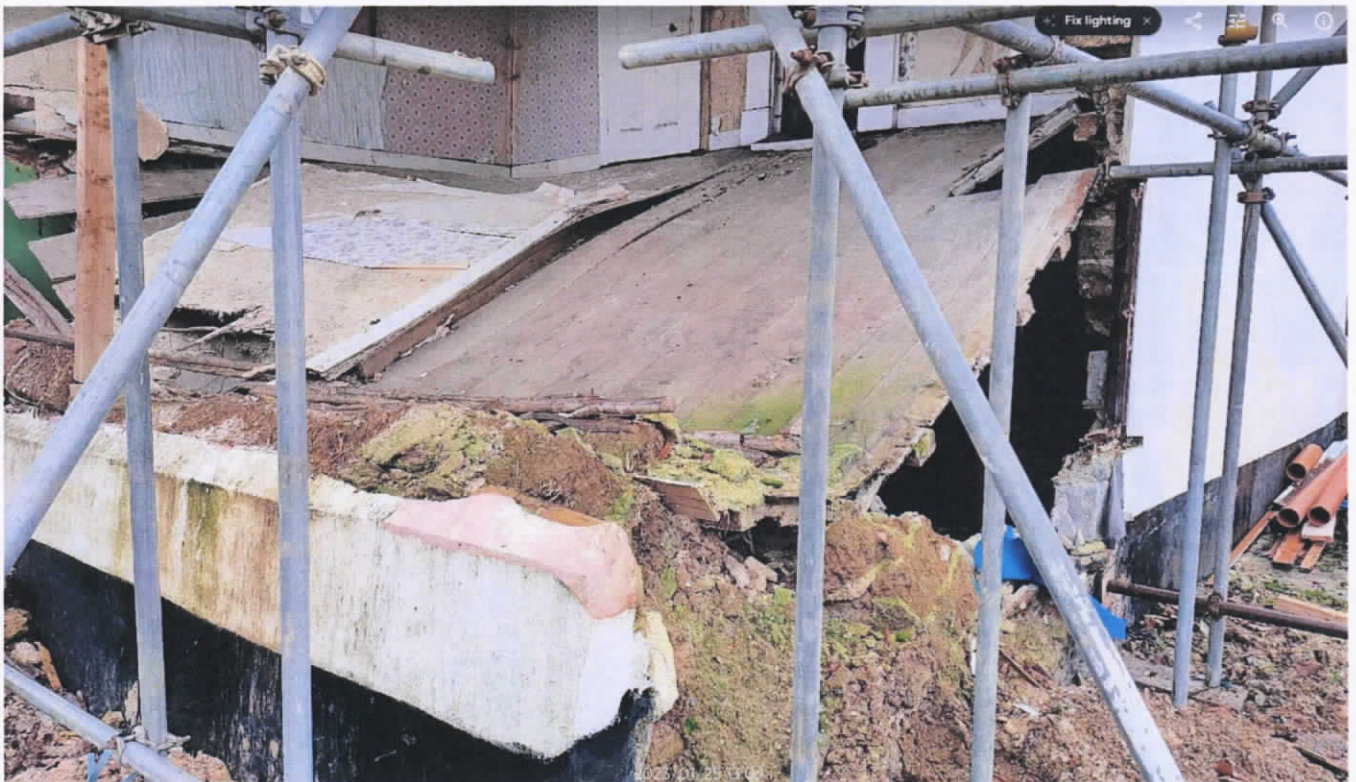
The collapsed wall (purple arrow) leaves either some or all the brick plinth in place. The east elevation brick plinth is wider than the west elevation. That could indicate past works to protect erosion of the wall.

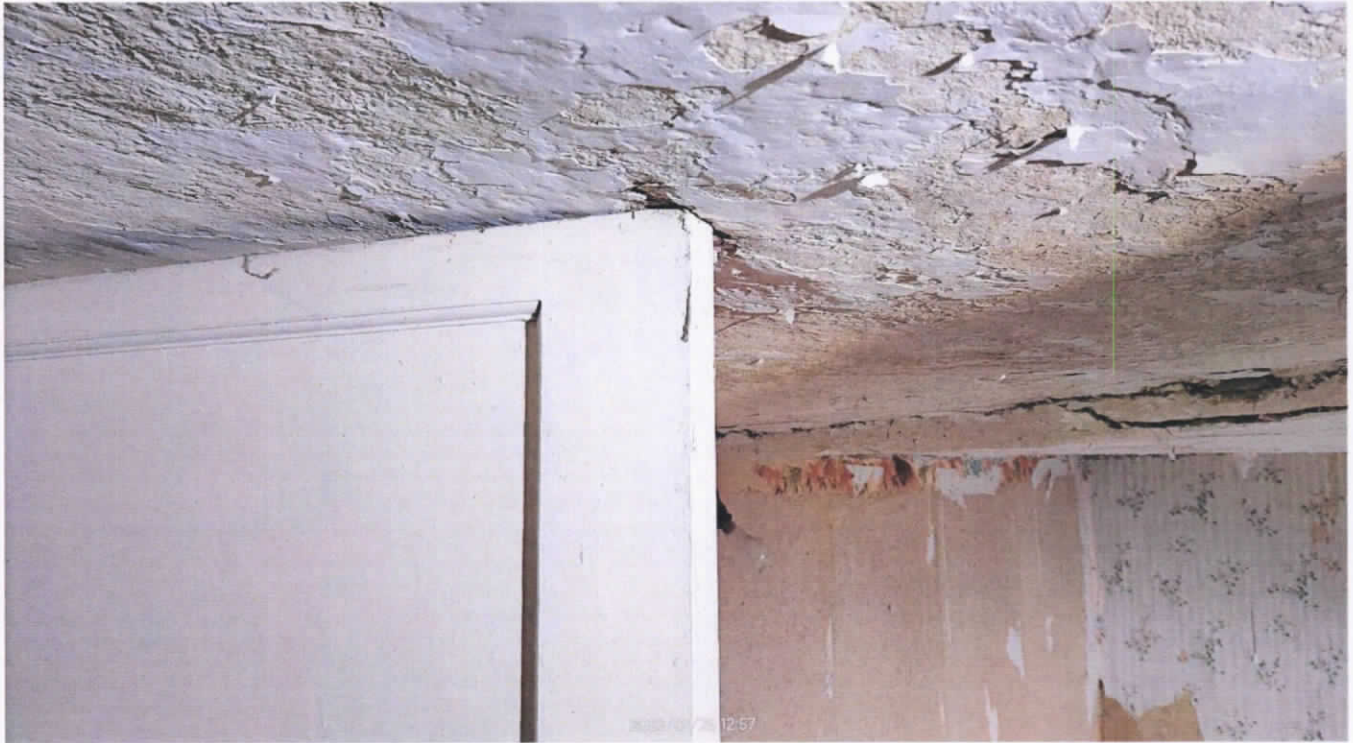
The ceilings over first floor appear to suffer from excessive deflection. To rectify this additional timber could be introduced over the existing pole ceiling joists. The ceiling finishes should be replaced with finishes of same type, which is a clay mixture with straw. The photo below shows the 1st floor ceiling of the west partition resting on the door.
