Tree Inspection 2023 (Ver 1)

**22 Shipton Road
York
YO30 5RF**

2nd December 2023

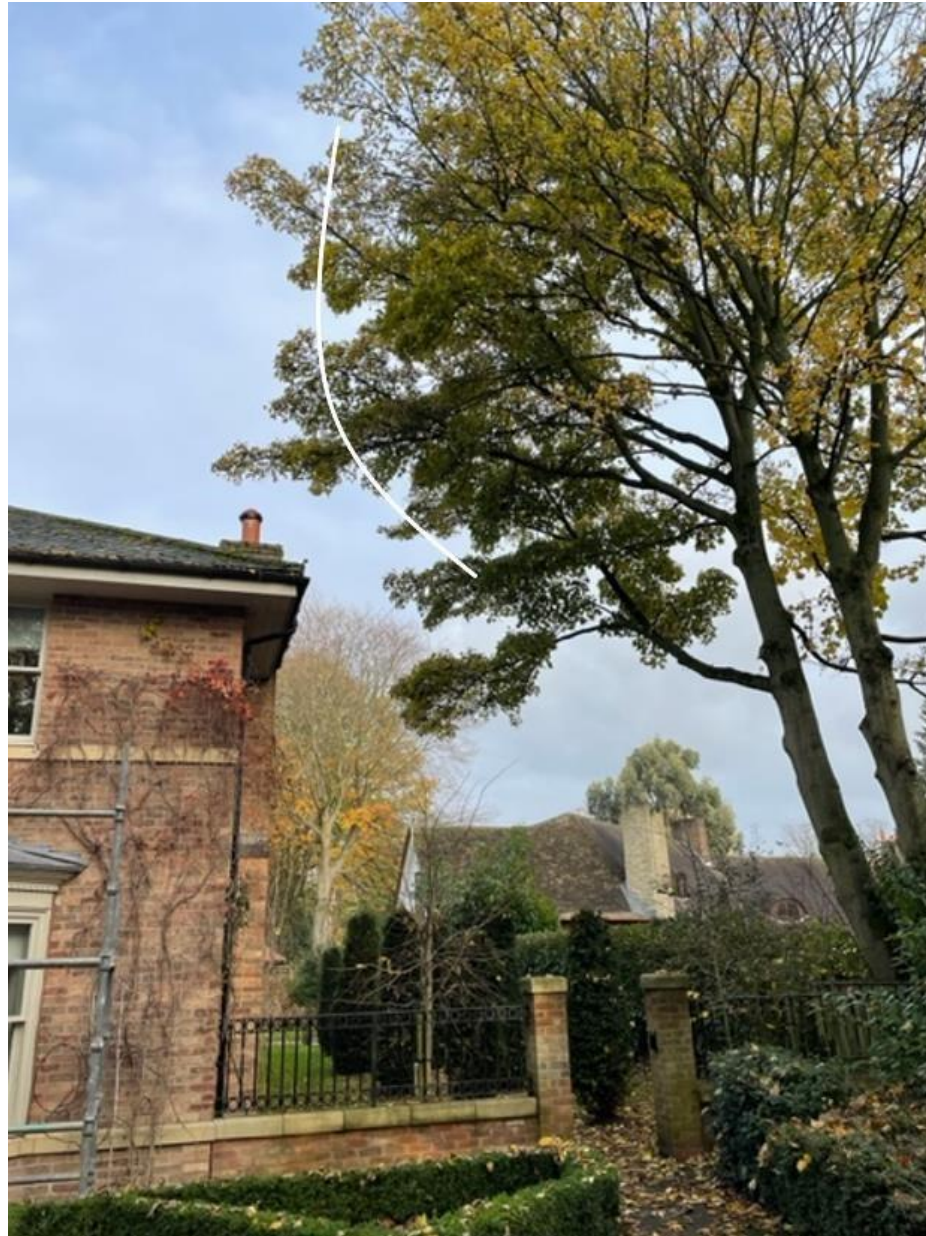
5.1 – Sycamore T1

Tree no	Species	Height Trunk Dia Crown Spread	Management Recommendations	Work Completed
T1	Sycamore	25m 600mm 8m	Minor crown reduction over the roof to provide 2m clearance. Note the tree is on adjacent land so this work should be discussed with the owner.	
T2	Lime	28m 600m 5m	No action - tree on adjacent land	
T3	Lime	20m 400mm 4m	No action – Tree on adjacent land	
T4	Lime	25m 600mm 5m	No action	
G5	Hollies (5 bushes / trees)	25m	Remove to facilitate new landscape planting The bushes located on the southern side of the drive	
T6	Sycamore	25m 800mm 9m	<ol style="list-style-type: none"> 1) Remove large dead limb 6m / 100mm). The limb is over the highway at approximately 12m above ground level. 2) Remove second dead limb (8m / 200mm) at 18m over the highway. Note - crown appears as though it might be slightly thin so review in summer when in leaf

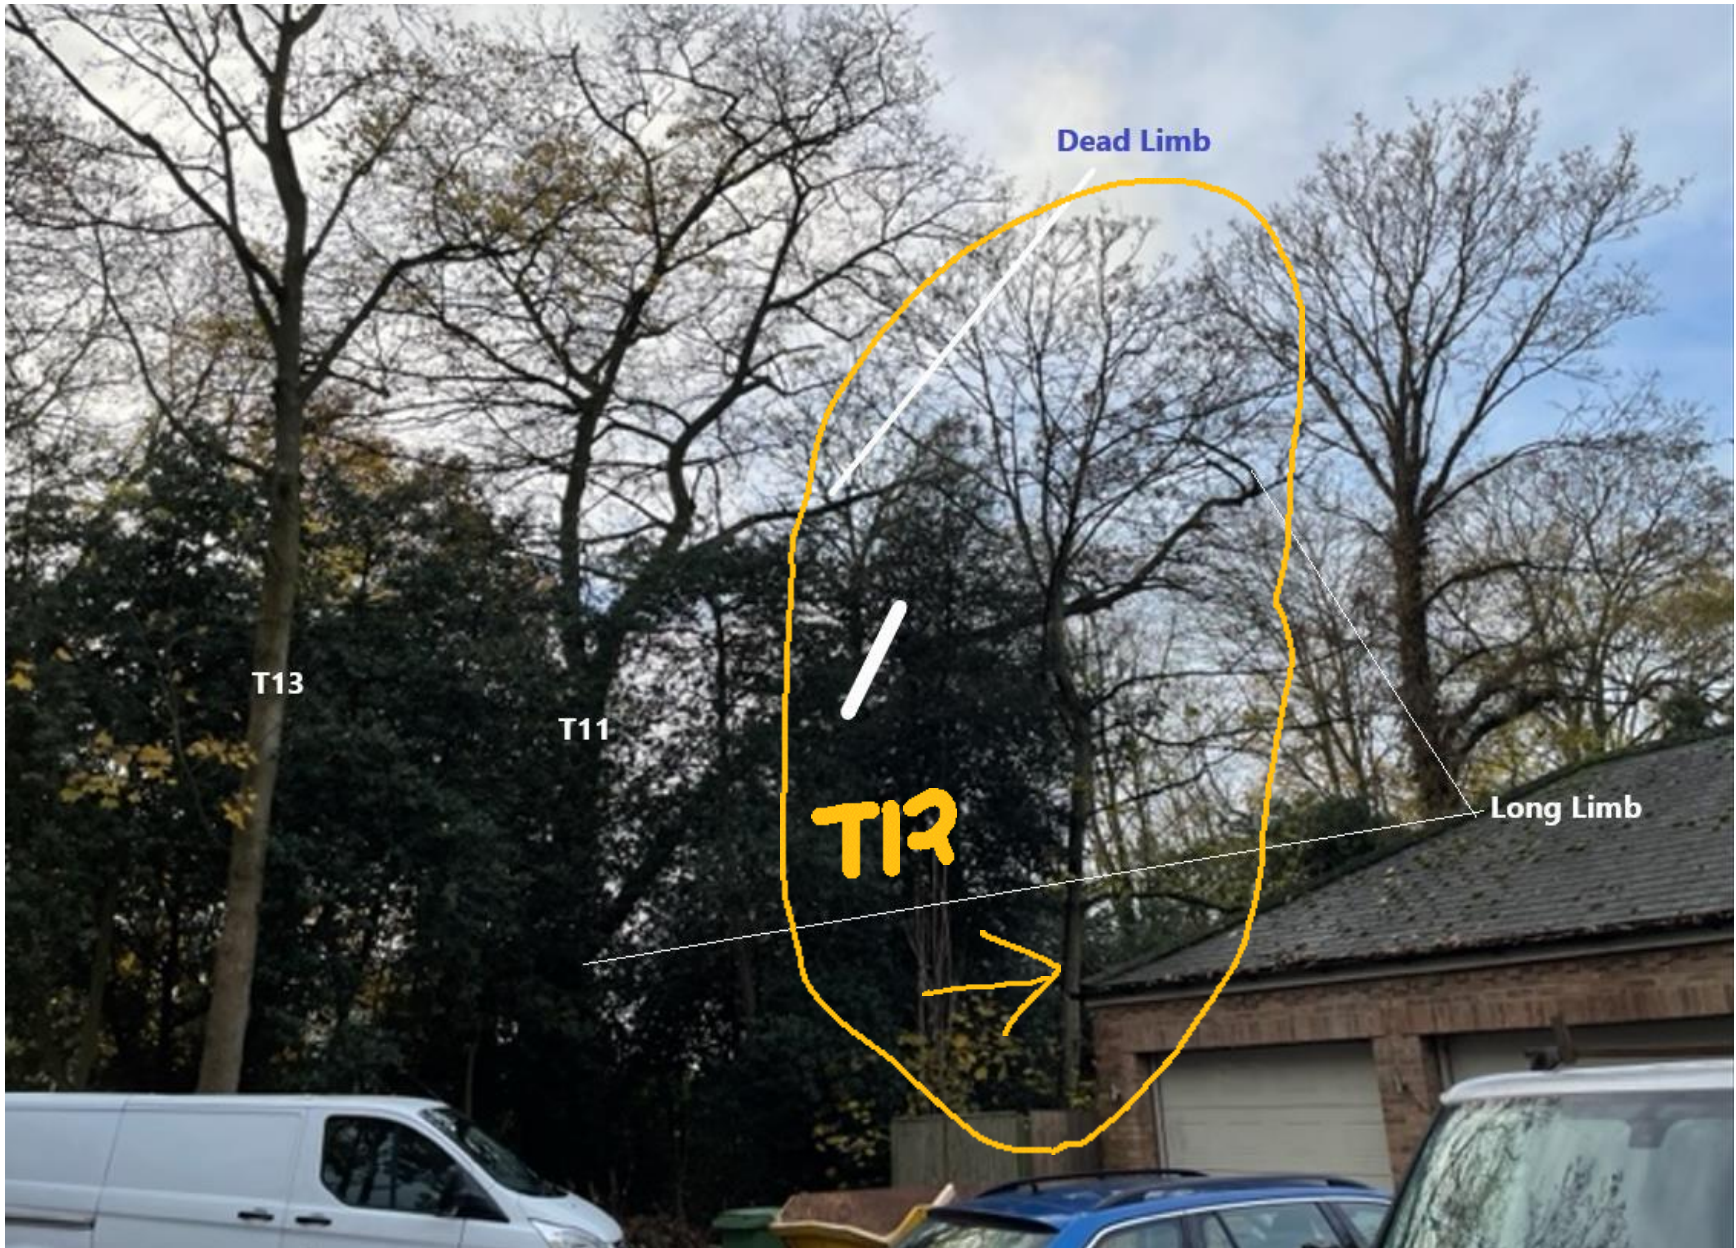
5.2 Turkey Oak T11

T7	Lime	25m 400mm 4m	No action	
Tree no	Species	Height Trunk Dia Crown Spread	Management Recommendations	Work Completed
T8	Oak	20m 800mm 6m	No action	
T9	Horse Chestnut	20m 800mm 5m	Remove Dead tree (Contractors viewed in October 2022 when no leaves were present)	
T10	Turkey Oak	30m 700mm 10m	Reduce one long limb A long limb (20m / 400mm dia) extends northwards at 5m on stem . Reduce by approximately 10m to where two smaller branches extend from the limb. Remove dead limb Remove one long dead limb (10m x 200mm) located at approximately 15m above ground level.	
T11	Evergreen Oak	16m 300mm 2m	Remove due to cavity at the base and general poor form	
T12	Holly	8m 300mm 3m	No action	
T13	Sycamore	20m 300mm 3m	No action
