**ARBORICULTURAL SURVEY &  
IMPACT ASSESSMENT**

**10a WILLOUGHBY ROAD  
MORCOTT  
RUTLAND  
LE15 9DY**

**9<sup>th</sup> May 2023**

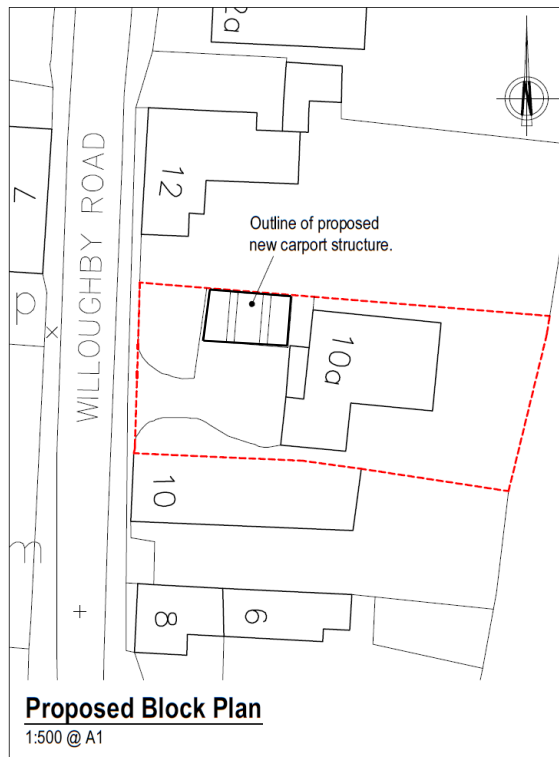
- 2.1 For the purposes of the survey and assessment of the proposals, I was provided with the Planning Drawing (Project Ref 2023/05 Drawing no. 02 Revision A) prepared for the client by Runcorn Architects. The block plan from this drawing is reproduced below, showing the location of the proposed car port.

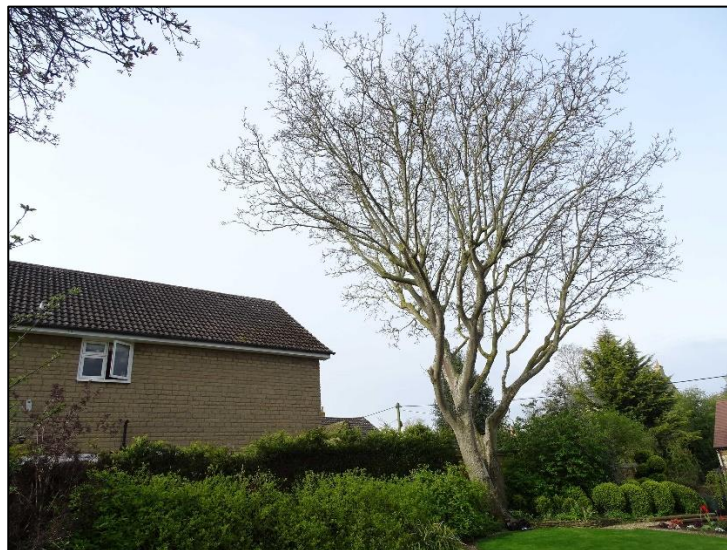
- 3.2.1** The walnut is twin-stemmed from a major fork at a height of a metre. It is growing within the garden of the neighbouring property, approximately 1.3 metres from the fence forming the northern boundary of the front garden of number 10a.
- 3.2.2** I found the tree to be in good overall condition, with healthy buds throughout the crown. Whilst the tree's canopy encroaches over the boundary, it has previously been lifted to give a clearance of around 3 metres.

**Photograph 1: Walnut viewed from the neighbouring garden to the north-east**

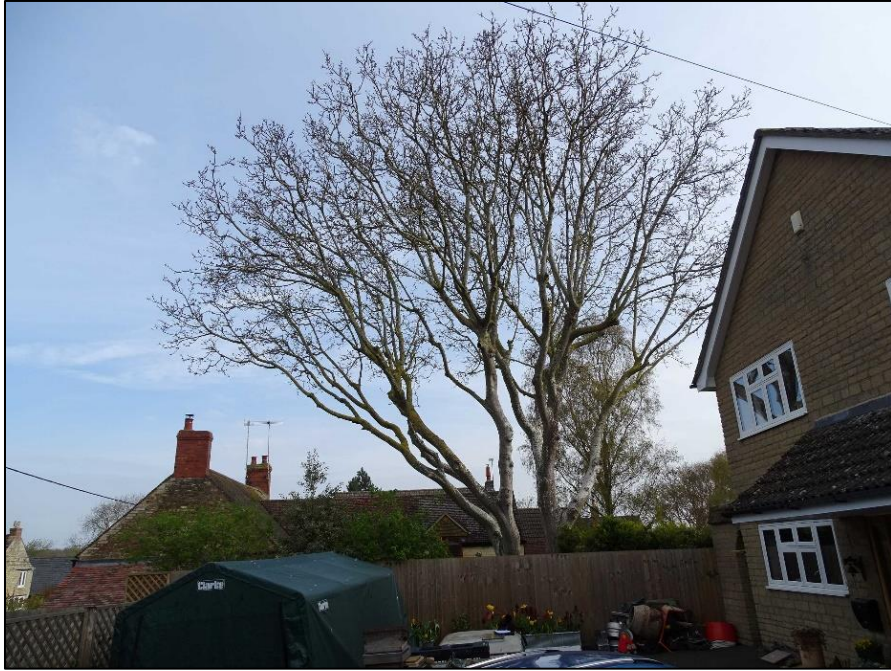
**Photograph 2: Walnut tree viewed from the south**

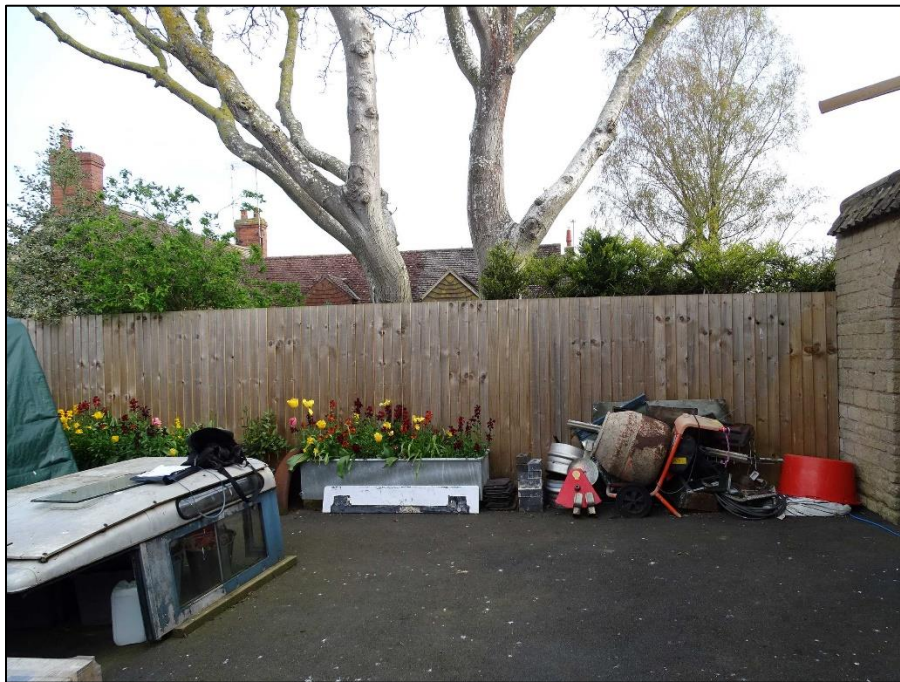
**Photograph 3: Section of drive where the car port is to be located,  
with the walnut tree beyond the boundary fence**

- 5.3** The current tarmac surfacing protects the underlying encroaching roots from the walnut tree, and this will be utilised for the floor of the car port, minimising the need for potentially damaging works within the tree's root protection area. Intrusive works will be limited to the digging of the holes for the foundations of the four corner posts, which will support the roof. These will be excavated with a 45 centimetre diameter auger to minimise their size, following the initial manual excavation of a trial pit to ensure any significant underlying structural roots are avoided. The holes will be sleeved to prevent the concrete leachate contaminating the surrounding soil.

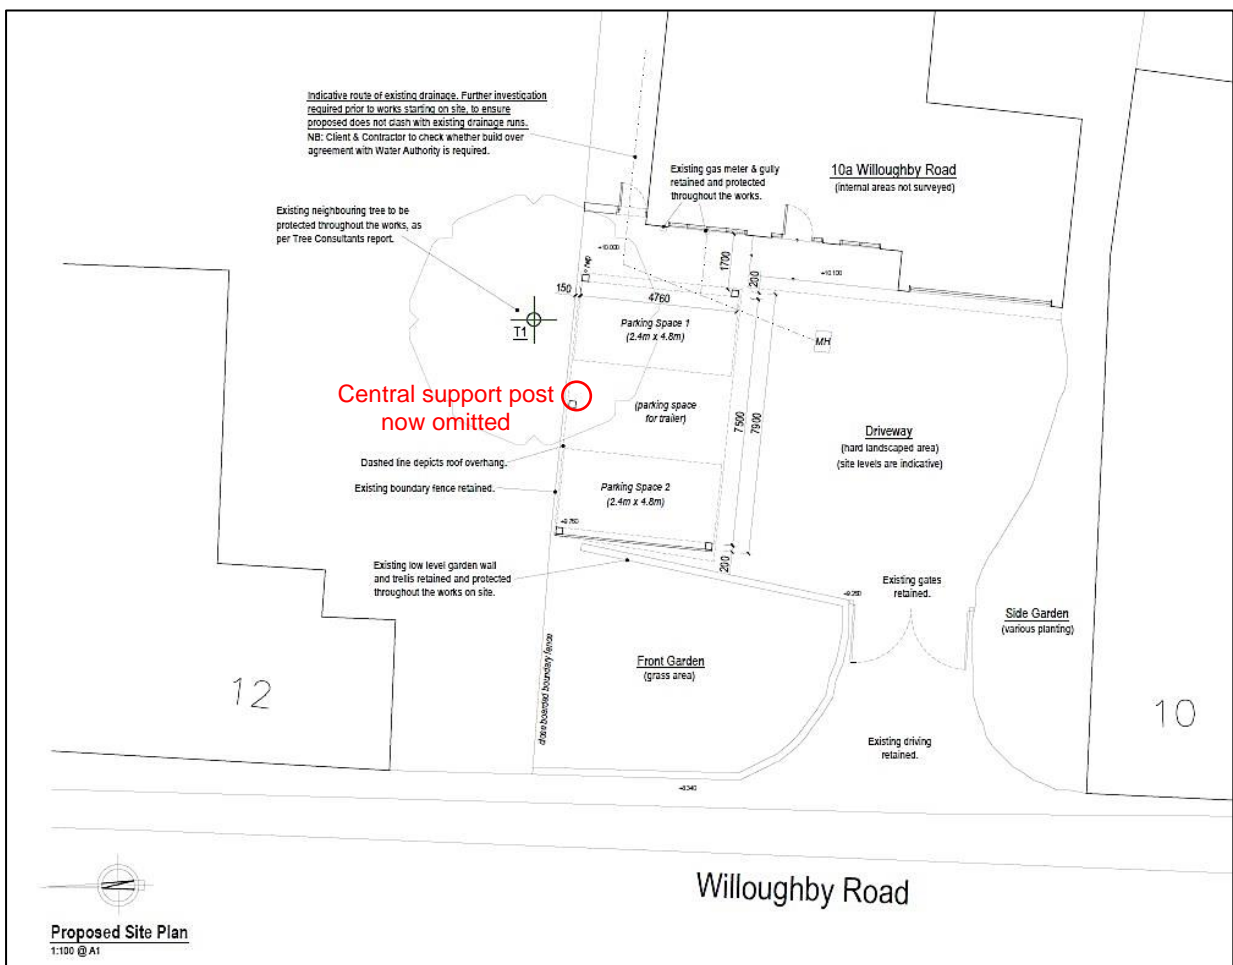
- 5.2 The proposals drawing showing the dimensions and precise position of the car port is reproduced below and this shows a fifth supporting post midway along the rear (northern) elevation. A trial hole excavated in the proposed position of this central post revealed a substantial root from the walnut tree just below the surface. In view of this, the design has been revisited and the need for the central post eliminated.
