Roof Condition Report

Project:
Burnside Primary School

Project ID: SP123301-Rev2
Date of issue: 26/01/2023

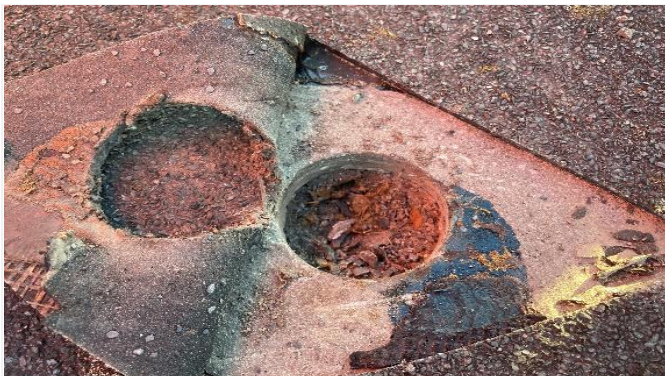
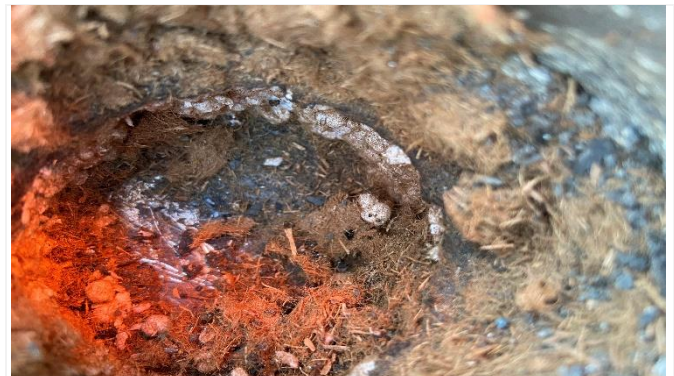
Core 1 - Location:	South side of Roof 1a (High Point)		
Core 1 - Condition:	Wet	Core 1 - Probe reading:

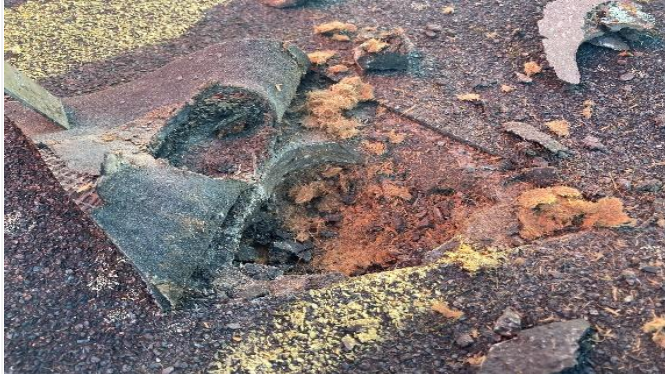
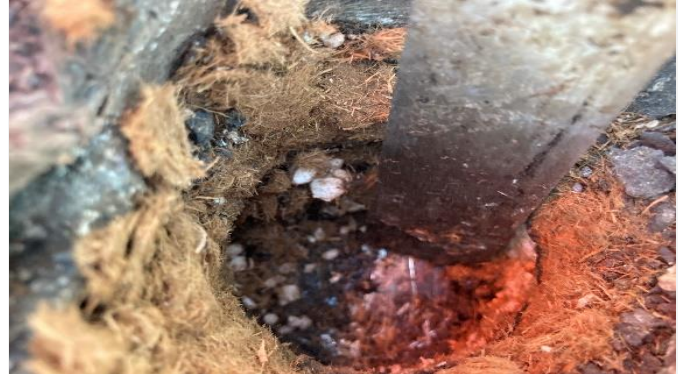
Core 2 - Location:	North side of Roof 1a (Low Point)		
Core 2 - Condition:	Wet	Core 2 - Probe reading:

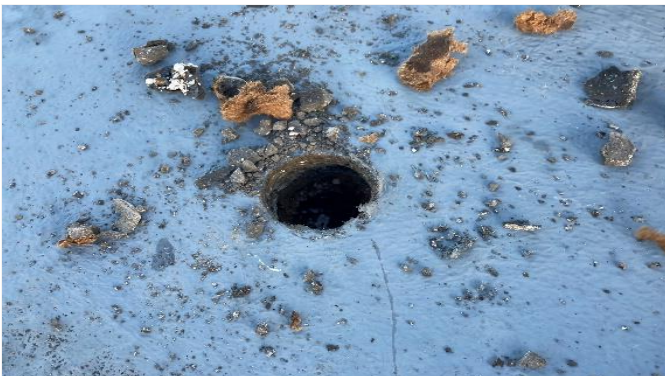
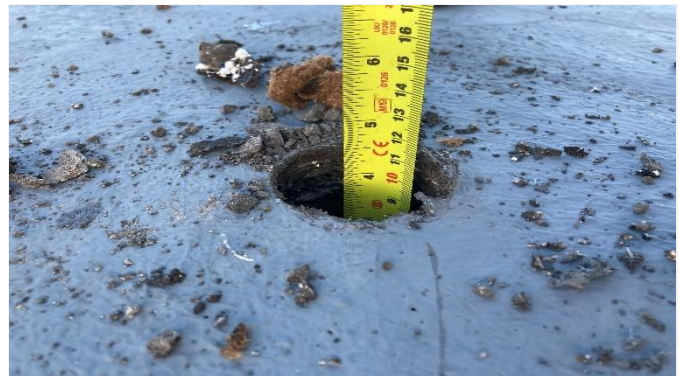
Core 3 - Location:	Roof 1b		
Core 3 - Condition:	Wet	Core 3 - Probe reading:

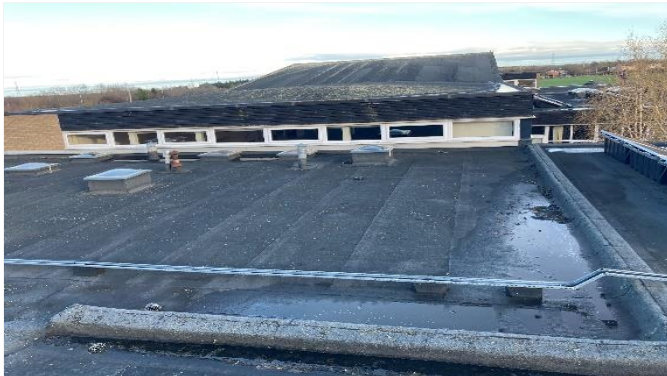
Overview of part of Roof1a – as shown areas of ponding water and moss/vegetation are evident.

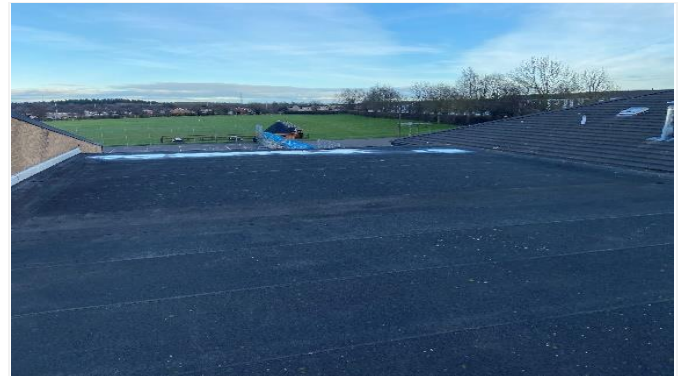
A second overview of Roof1a – Ponding water evident

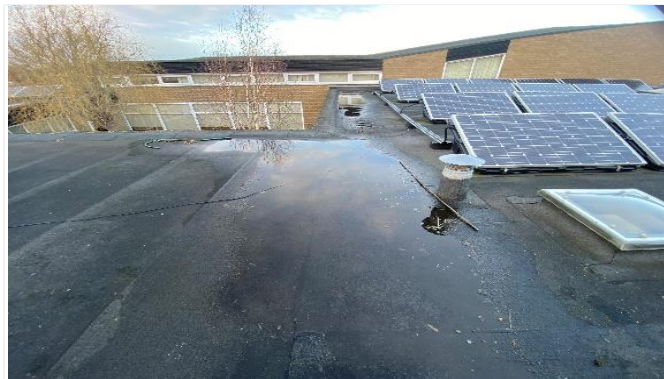
Close-up on Roof1a of ponding water surrounding the existing penetrations and plant.

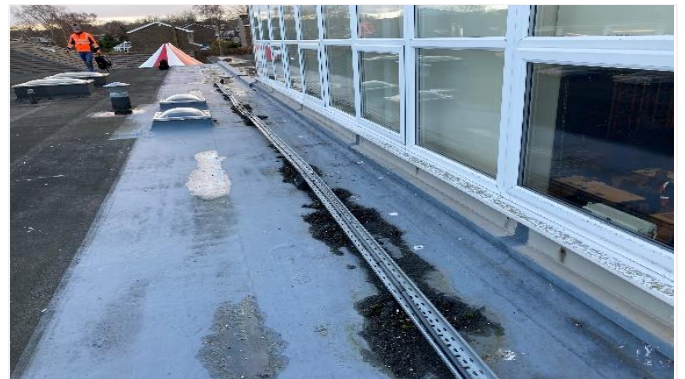
Part of Roof1b shows repair work evident along with ponding water and moss/vegetation

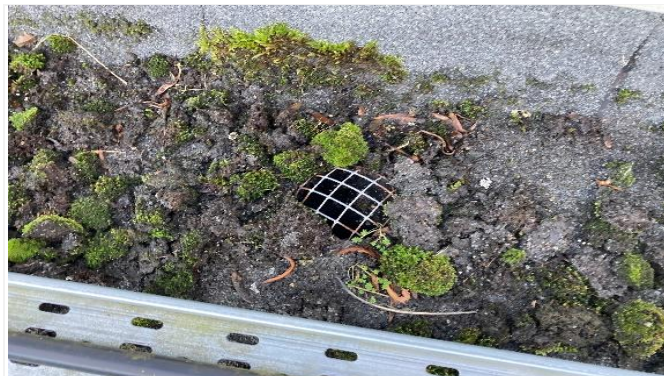
Existing outlets are blocked due to moss/vegetation

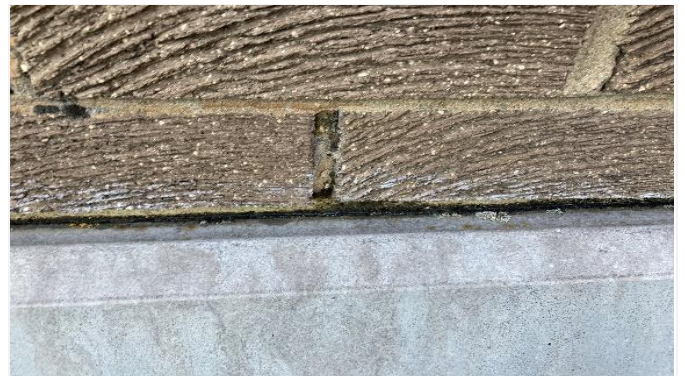
Existing Lead flashing is splitting away from the brickwork causing exposure to the building

- Existing lead flashings, which we assume were part of the original installation, have been removed from the perimeter detail thus leaving the detail exposed. To prevent a similar recurrence, we would advise that an alternative flashing to lead is utilised going forward.

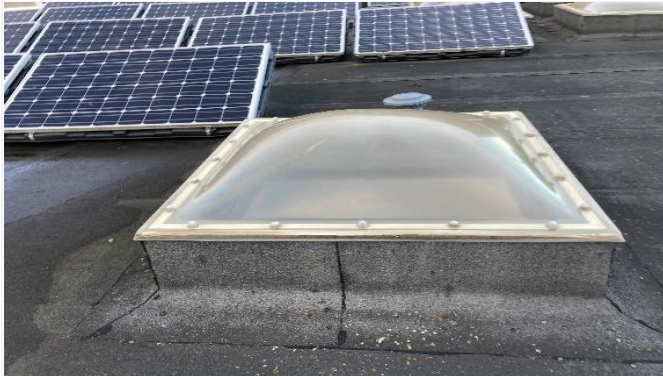
Existing rooflights are not in accordance with current regulations and will require replacement.

- Existing rooflights are in poor condition and are also non-compliant with current thermal and light transmittance standards. Our recommendation is to replace all units to meet current standards thus improving performance, light transmission into the premises and providing a service life that is aligned with the new roof covering.
- Detailing around the existing rooflights is in poor condition with deterioration of the waterproofing evident.
- Various rooflights are now deemed redundant. It is advised that these items are removed and that the existing openings are to be boarded over to achieve a flush finish to the adjacent construction build-up. Allowances for internal adaptations and redecoration works should be made where applicable.

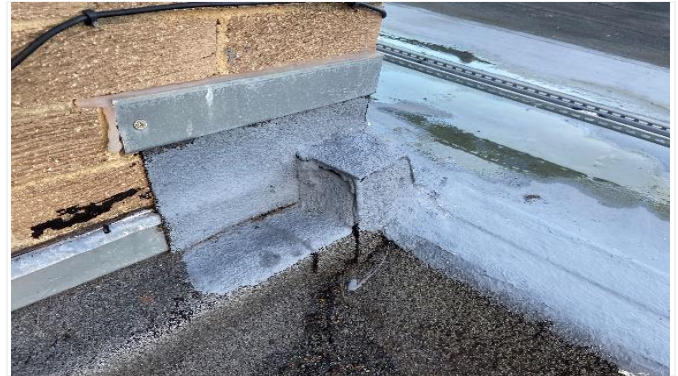
Repairs on Roof 1b upstand detail are evident and not sufficient

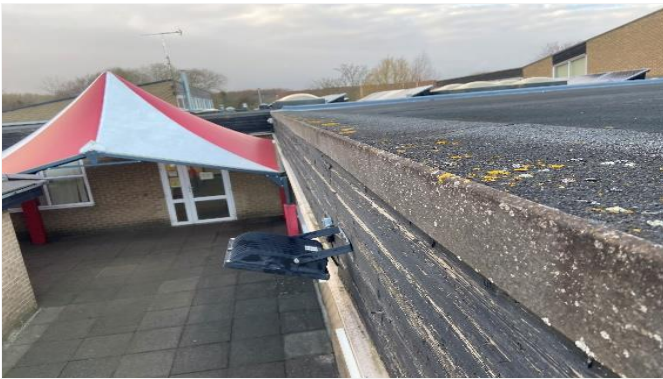
Existing fascias are also in poor condition and will require work

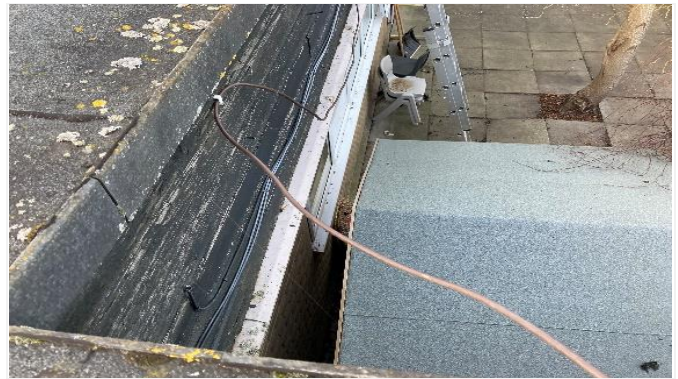
Check kerb detail shows signs of cracking and exposure. Poor condition of fascias also evident here

- Cracks and splits in the existing roof covering are visible bridging the edge trim profile. This is a common occurrence caused by differential movement across this type of interface using traditional membranes.
- Movement in the existing aluminium trim has resulted in the breakdown of the waterproofing at the joints. It is recommended that the trim is removed and replaced with an alternative.

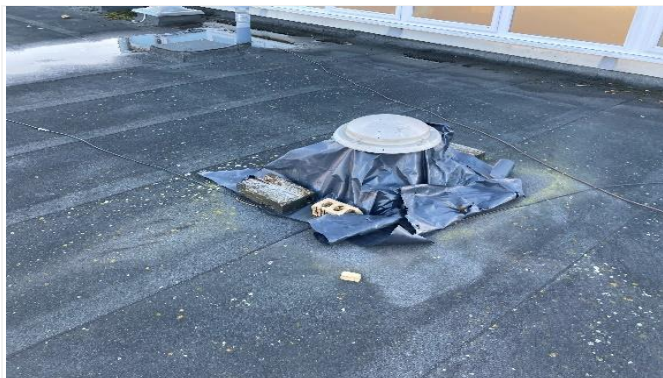
Existing penetration has been exposed and temporary coverings have been placed over and require immediate attention

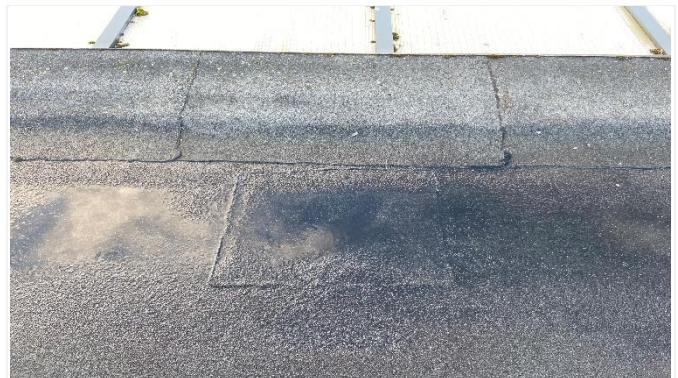
Some outlets have been discarded, this has created ponding water in areas. These details need reinstated.
