TREE HAZARD RISK ASSESSMENT and TREE DECAY DETECTION REPORT

Mature Beech tree and Ancient Oak tree at
Park House

30 March 2023

21 April 2023

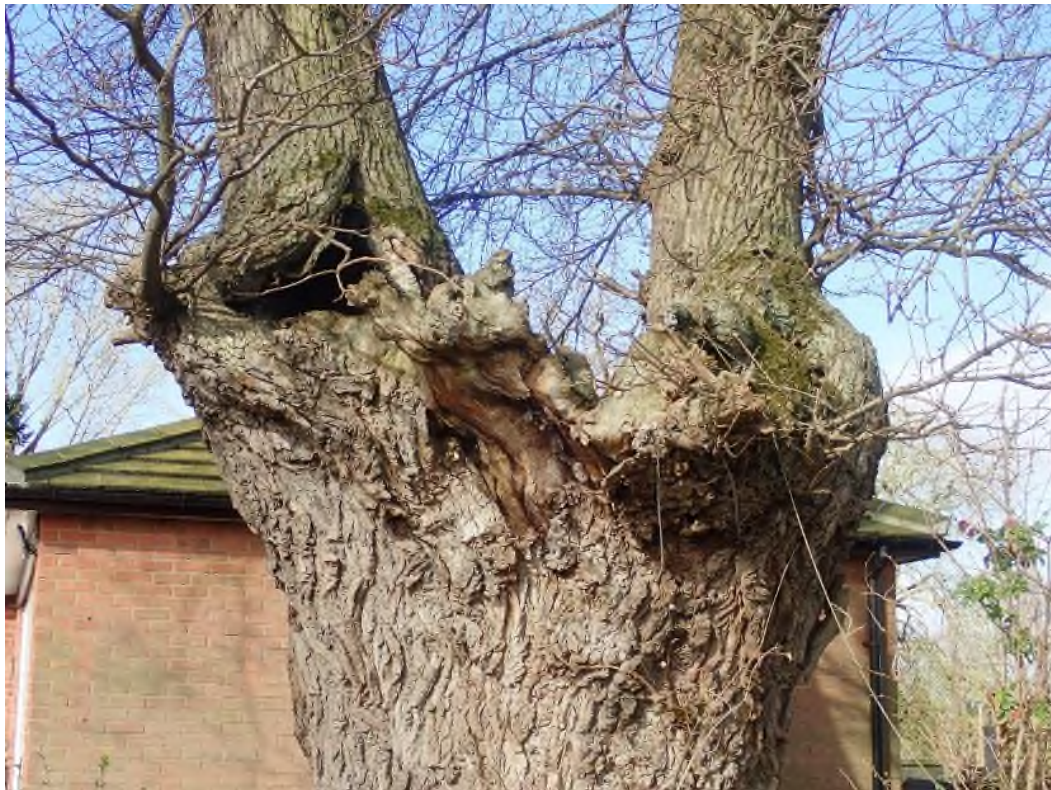
The tree has a short stem of very large girth, typical of an outgrown, lapsed pollard. There is accentuated root buttress flare at the base. The inner stem is hollow and the lower section filled with detritus to approximately 1.5m from ground level. There is a swelling to the west of the upper stem where the tree has laid down adaptive growth to strengthen the outer cylinder of wood. There is also a swelling at the attachment point of the two vertical stems to the north and south. These swellings are remnants of the old pollard 'head' and reaction growth, as these stems are also hollow. There is evidence of fire scorching of the decayed wood at the base of the southern stem. To the east of the upper stem there is a section of fractured deadwood which was once part of the lost, third stem. There are 'rolls' of robust wound-wood growth around the open cavities of the remaining two stems acting as strengthening arches to the structures.

Detail of upper stem. Original pollard 'head' and fracture wound where third stem has previously failed.

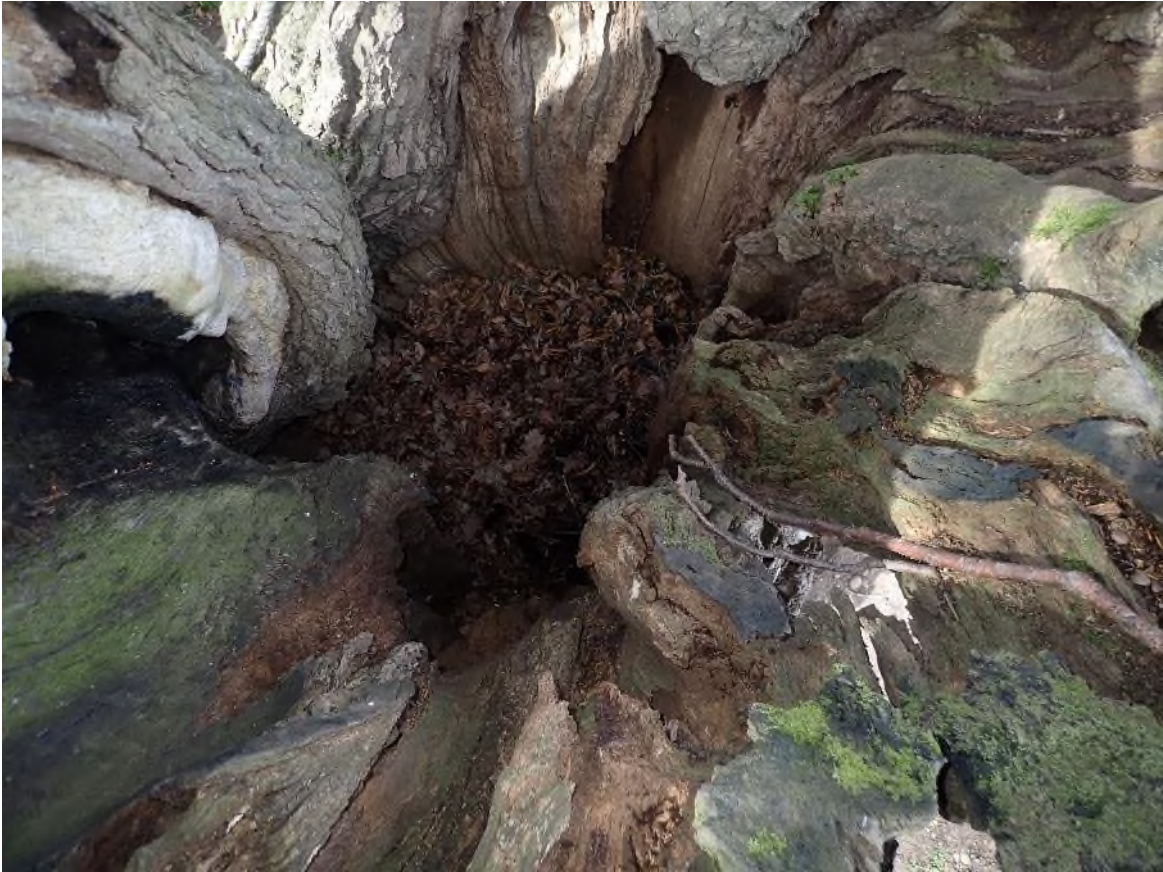
Looking down into the hollow upper stem

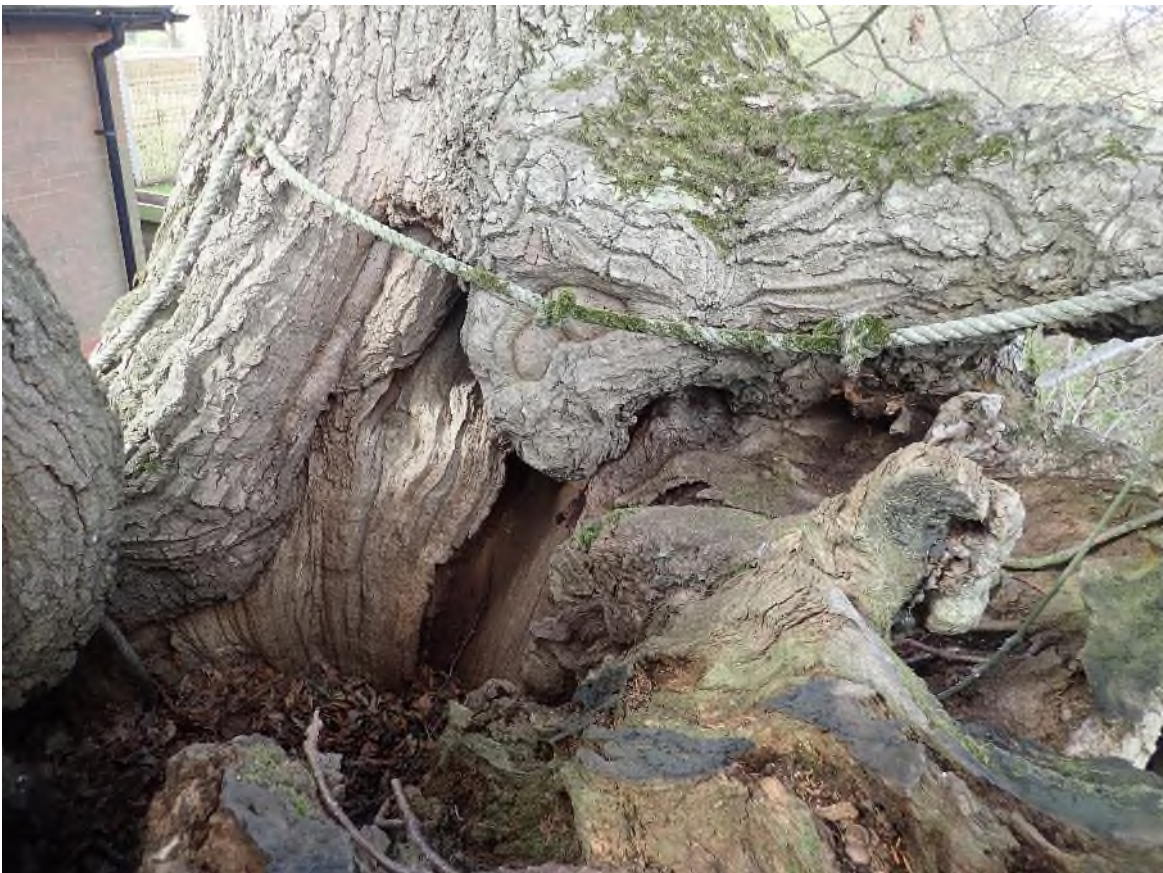
Decay at the base of the northern stem. Fire scorch marks in the foreground.

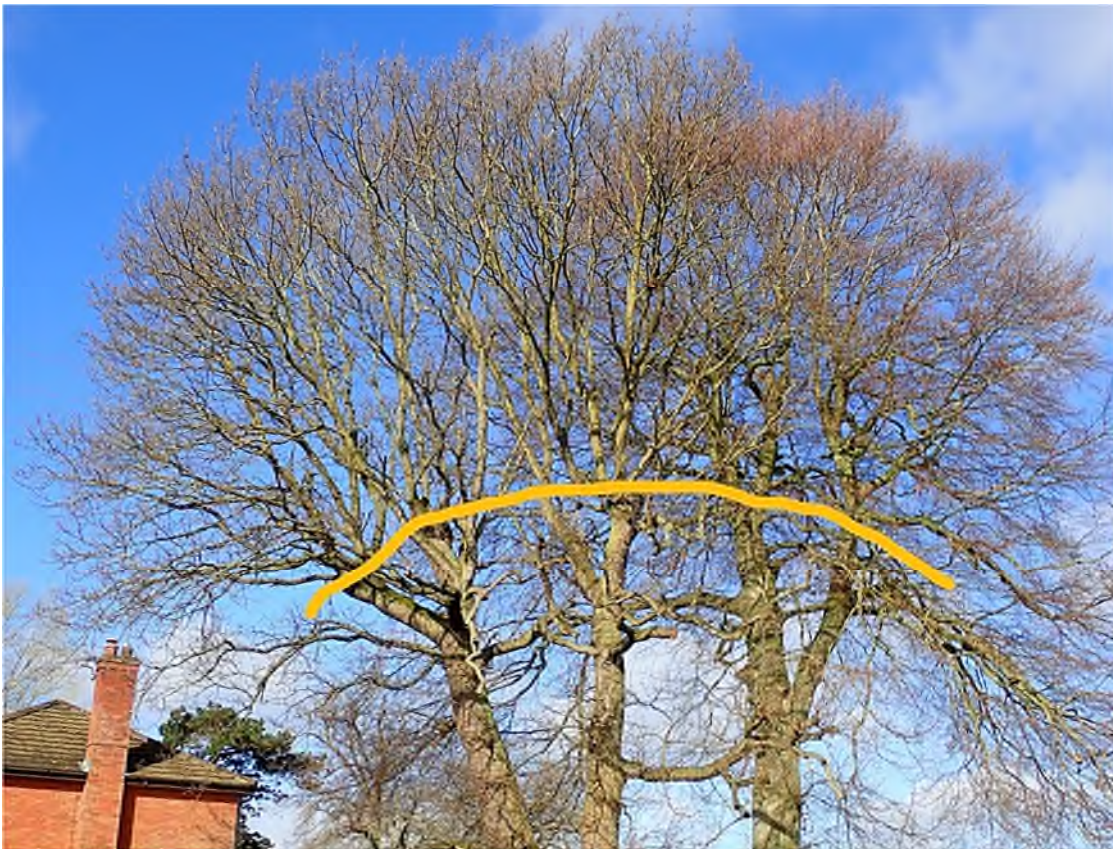
The two remaining, vertical stems have short scaffold branches. The stems have previously been severed at 12m from ground level and the side limbs cut back to a few meters. This work may have been carried out when the house was constructed in the 1980s prior to the TPO being applied. The severing of these large limbs will have caused localised decay. The branches that have re-grown, since this event, have only established in the outer annual rings. Subsequently, they do not have a deep attachment to the parent branch. These re-grown branches are long and narrow, as they have grown in close competition with each other. The length can increase the lever arm loading on the attachment point. A combination of decay, poor attachment and lever arm loading makes the old topping points potential locations of failure.

Position of topping (Orange line). Everything above this point has re-grown since the topping event.

Detail of topping points with localised decay and multiple branch re-growth.

Reduce and shape the crown to lessen the loading on the old 'topping' points. See annotated photograph in section 3.3.

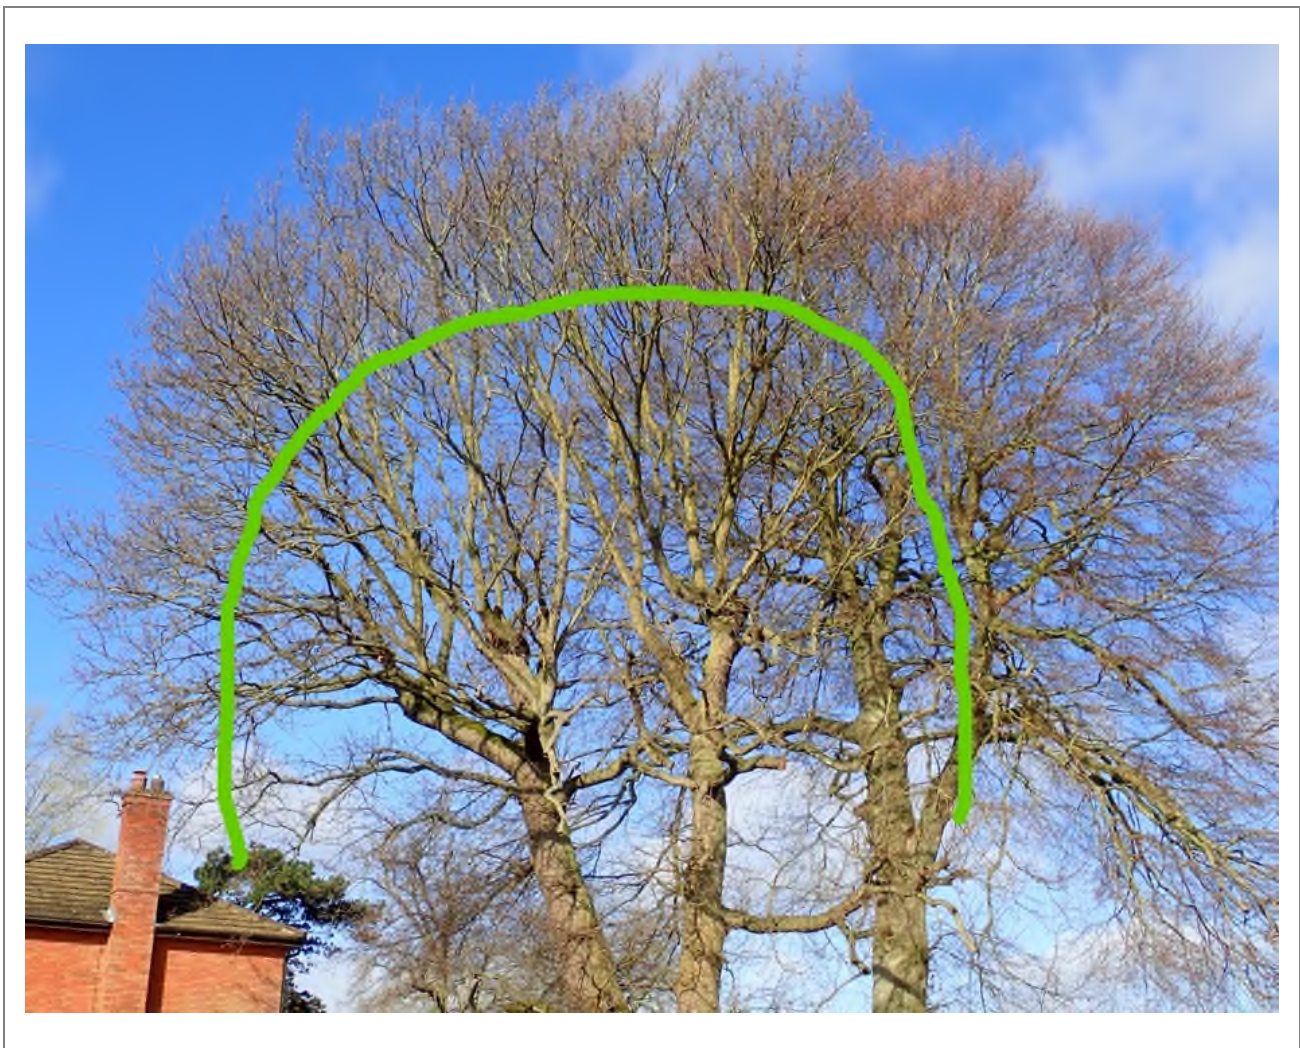
The Oak tree is an old, outgrown pollard and of cultural, historical and ecological importance. The main stem is hollow with the decay extending into the base of the two remaining, vertical limbs. A third large limb has previously failed leaving a fracture wound. Hollowing is a natural aging process and expected in a tree of this age. There is evidence of fire damage within the hollow to the south. The most likely point of failure is the old ‘topping’ points in the crown where the tree was heavily reduced in the past. I recommend that a reduction is undertaken to lessen the loading on the old topping points and the hollow stem. It is important that the load reduction is undertaken in the upper crown where the wood is younger and more likely to respond well to pruning. This will also keep wound sizes to a minimum. Please see annotated photograph below for reduction guide.

Proposed crown reduction			
Crown	Present Dimensions	Proposed Dimensions	Proposed Reduction
Height	25m	20.5m	4.5m
North Radius	3m	3m	0m
South Radius	10m	6.5m	3.5m
West Radius	5m	4m	1m
East Radius	8m	5m	3m

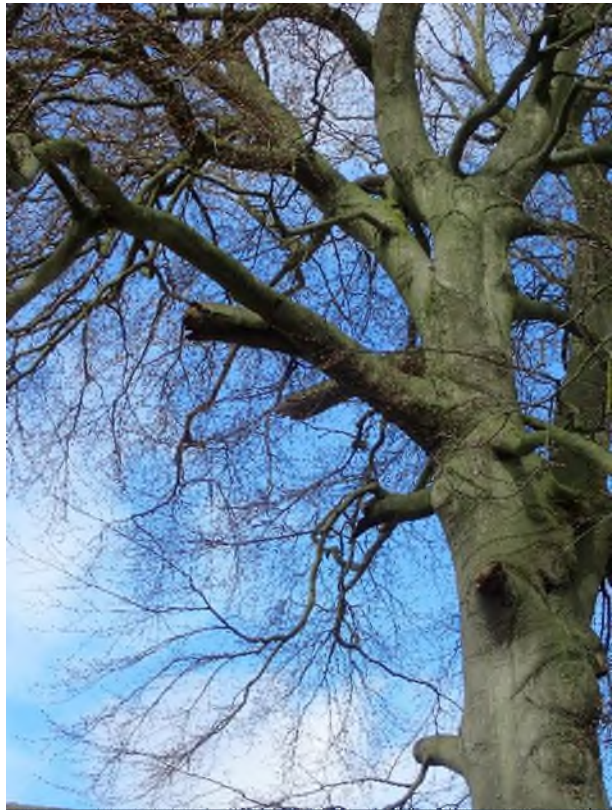
<u>Stem</u>							
<p>The tree has a single, main stem with accentuated root buttress flare and gradual taper typical for a mature, open grown Beech. There are several occluded pruning wounds (closed by wound-wood growth) to a height of 9.5m where side branches have been removed in the past. There may be some localised decay behind these scars but there are no external signs of significant structural decay. As previously stated, there is localised sapwood decay in the valley between root buttresses to the east and southwest of the stem base. This sapwood decay is a wet, white stringy rot associated with Armillaria infection. A previous tree survey found Honey Fungus fruiting bodies at these locations. I undertook a Picus soundwave scan through the stem base near ground level. See section 4.3 below. There are some stem shoots present and branch stubs in the lower crown where principal limbs have been removed.</p>

Old pruning stubs and natural fracture stubs

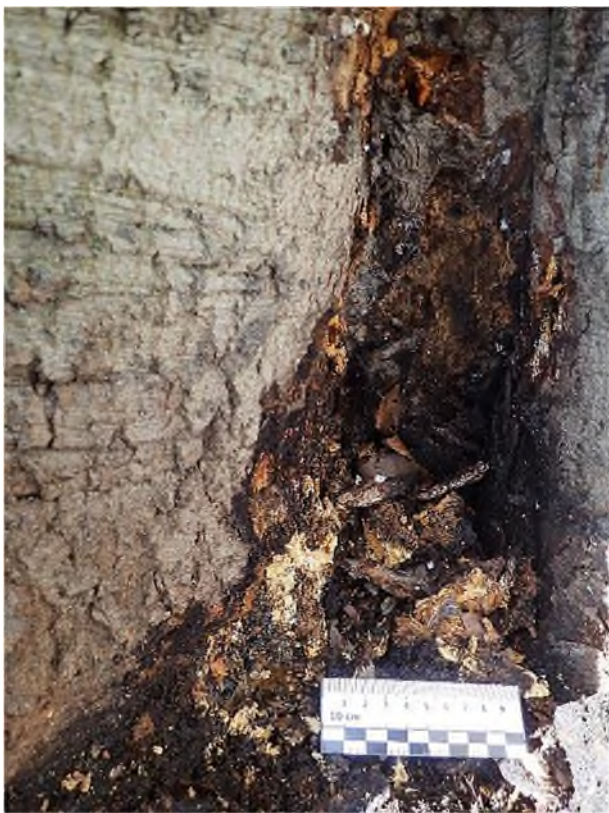
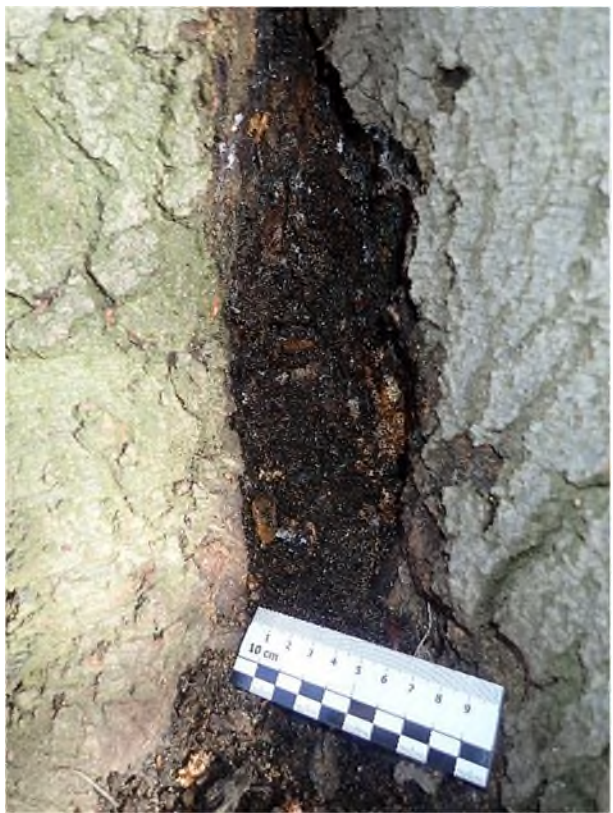
Detail of Honey Fungus decay

The tree has two areas of decay due to Honey Fungus between root buttresses. The Picus sound wave scan detected associated soundwave impedance to the southwest which penetrated approximately 35cm into the stem. At present the radiating root buttresses associated with structural roots appear intact and stability is unlikely to be impacted at this stage. Nonetheless, it will be important to monitor the progression of this decay.

I recommend that the crown is reduced to lessen the wind force on the crown structure. This will lessen the loading on individual limbs, lowering the risk of further branch failure. It will also reduce the loading on the root system. See annotated photograph below and specifications. The damaged branch at 15m to the north should be removed and the crown cleared of deadwood.

It would be prudent to have an annual visit in autumn to monitor for external signs of decay progression at the stem base and a follow up Picus scan should be undertaken in two and a half years to monitor the decay internally. If there are external changes in the meantime this scan should be brought forward.

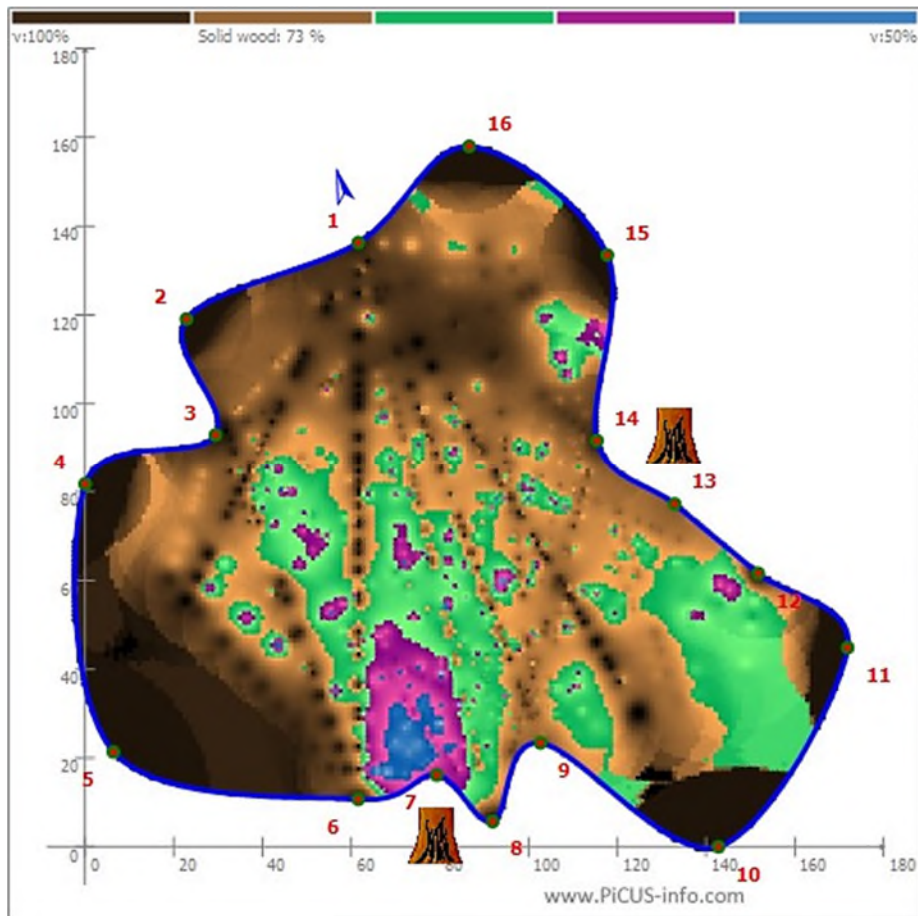
Soundwave tomogram through the stem base.

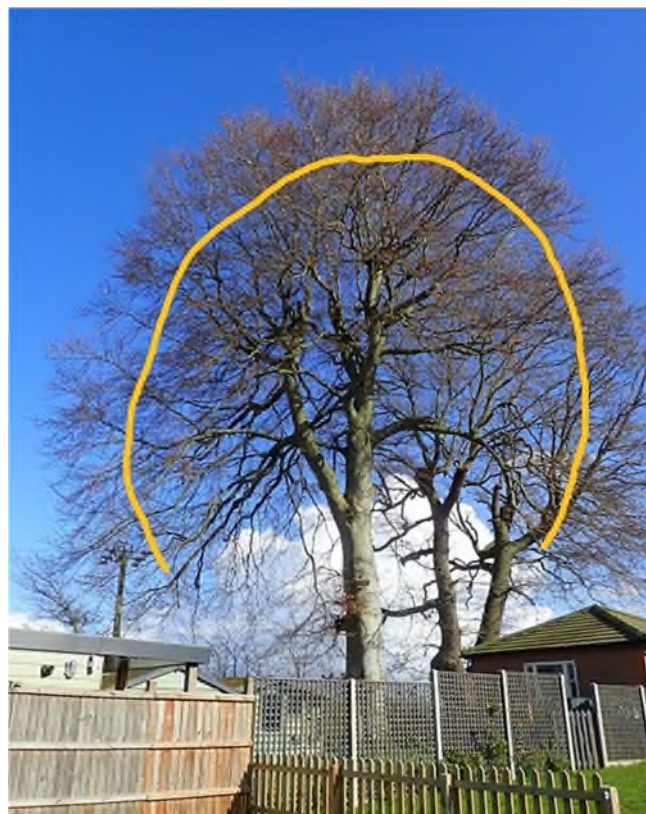
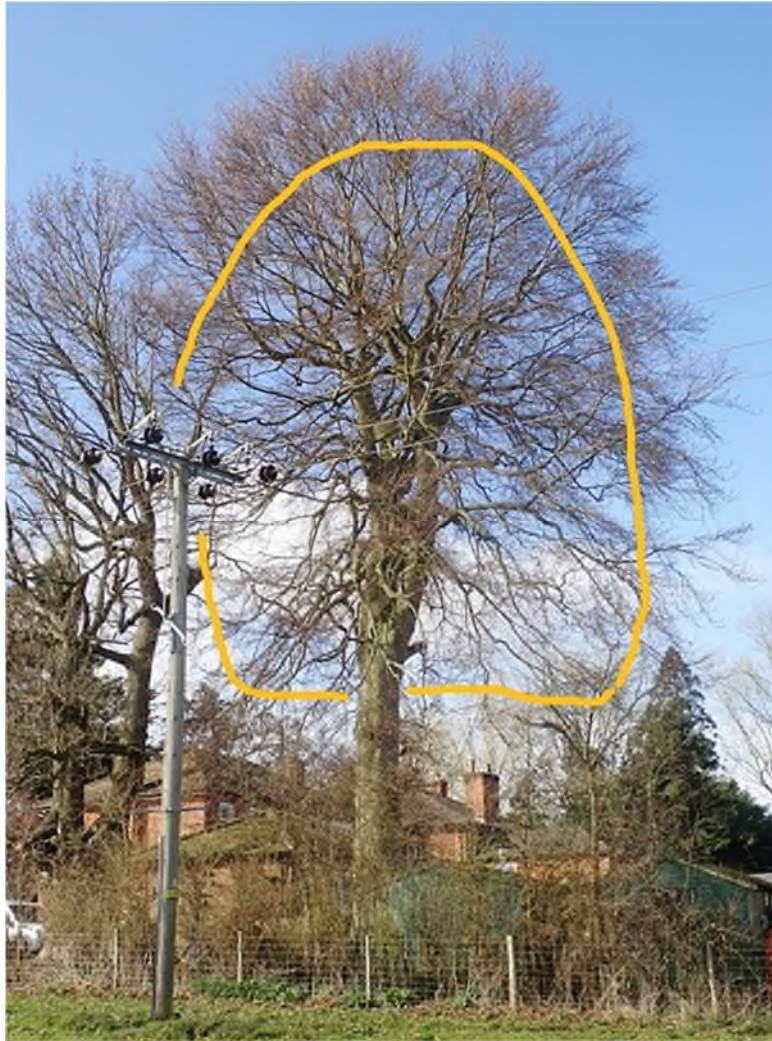
Proposed crown reduction from northwest

Proposed crown reduction from east.

Proposed crown reduction			
Crown	Present Dimensions	Proposed Dimensions	Proposed Reduction
Height	28m	24m	4m
North Radius	8.5m	6m	2.5m
South Radius	7.5m	5m	1.5m
West Radius	7m	5m	2m
East Radius	8m	6m	2m
