**Victoria's, Ashford Road, Harrietsham,
Maidstone, Kent**

Road Safety Audit Stage 1

on behalf of Swift Roofing Contracts

TMS reference no: 15875

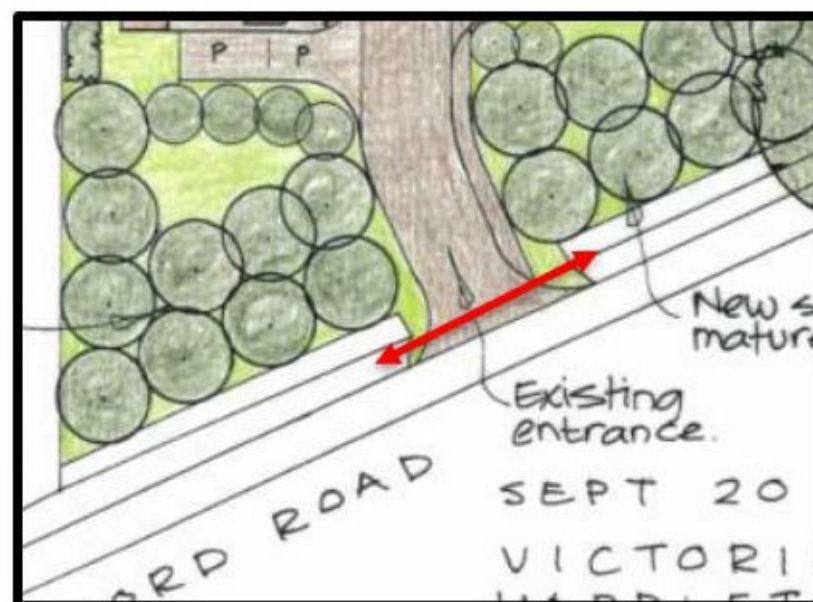
Location – Development access

Summary: Risk of tripping or injury for pedestrians

The footway leading into the development has no dropped kerb crossing point provided. The kerb upstands may present difficulty for visually or mobility impaired pedestrians when crossing to the opposite footway. Pedestrians may become injured if they trip or fall when attempting to cross, in particular for users of manual wheelchairs or pushchairs.

RECOMMENDATION

A dropped kerb crossing point with tactile paving should be provided and the footway resurfaced

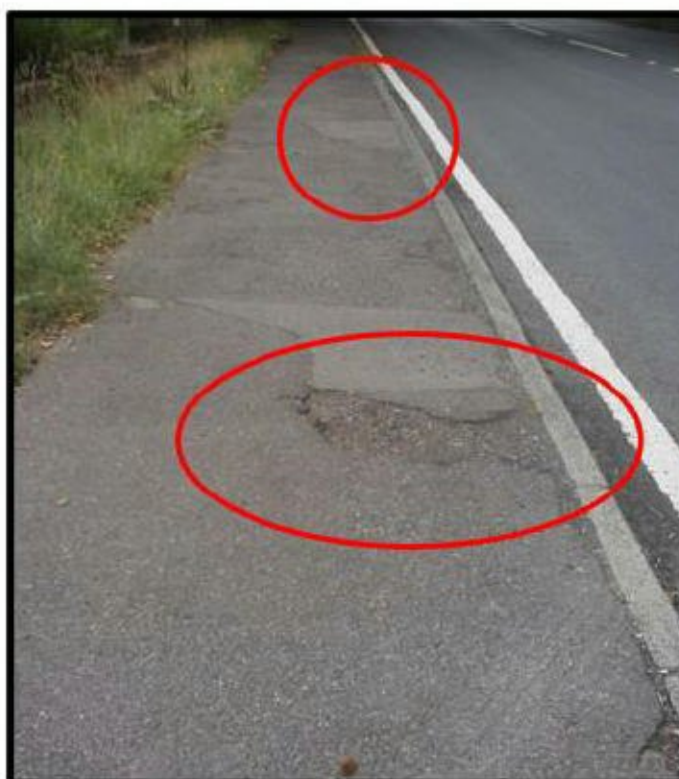
Location – Footway along Ashford Road

Summary: Potential trip / slip / fall type injuries to pedestrians

The footway is currently uneven on Ashford Road near the vicinity of the development, with evidence of patching and uneven surfaces. These could potentially cause trip / slip / fall type injuries to pedestrians, particularly to those with mobility and visual impairments.

RECOMMENDATION

The levels of the existing footway should be checked, and improvements carried out where necessary.

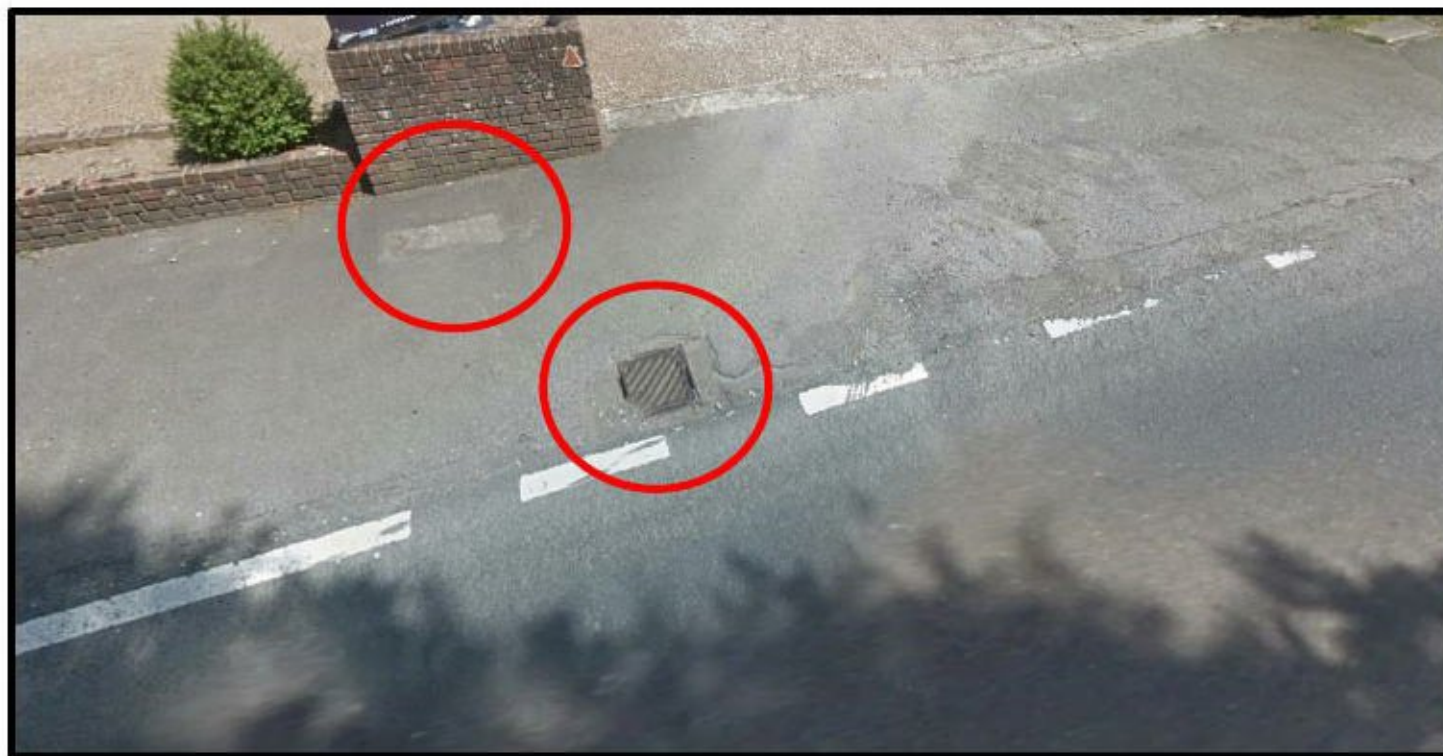
Location – Development access

Summary: Loss of control type collisions / potential slip / skid hazards to all road users

Details have not been provided for new locations of utility and service covers. Existing service / utility covers located in junction turning areas may present skid hazards to turning vehicles, particularly to two wheeled vehicles. In addition, metal service covers, and drainage gullies may present a slip hazard to pedestrians. Both issues will be exacerbated during wet or icy conditions.

RECOMMENDATION

Surface infill type covers should be provided, or the service / manhole covers should be treated with a non-slip surface with similar skid resistance to the surrounding carriageway

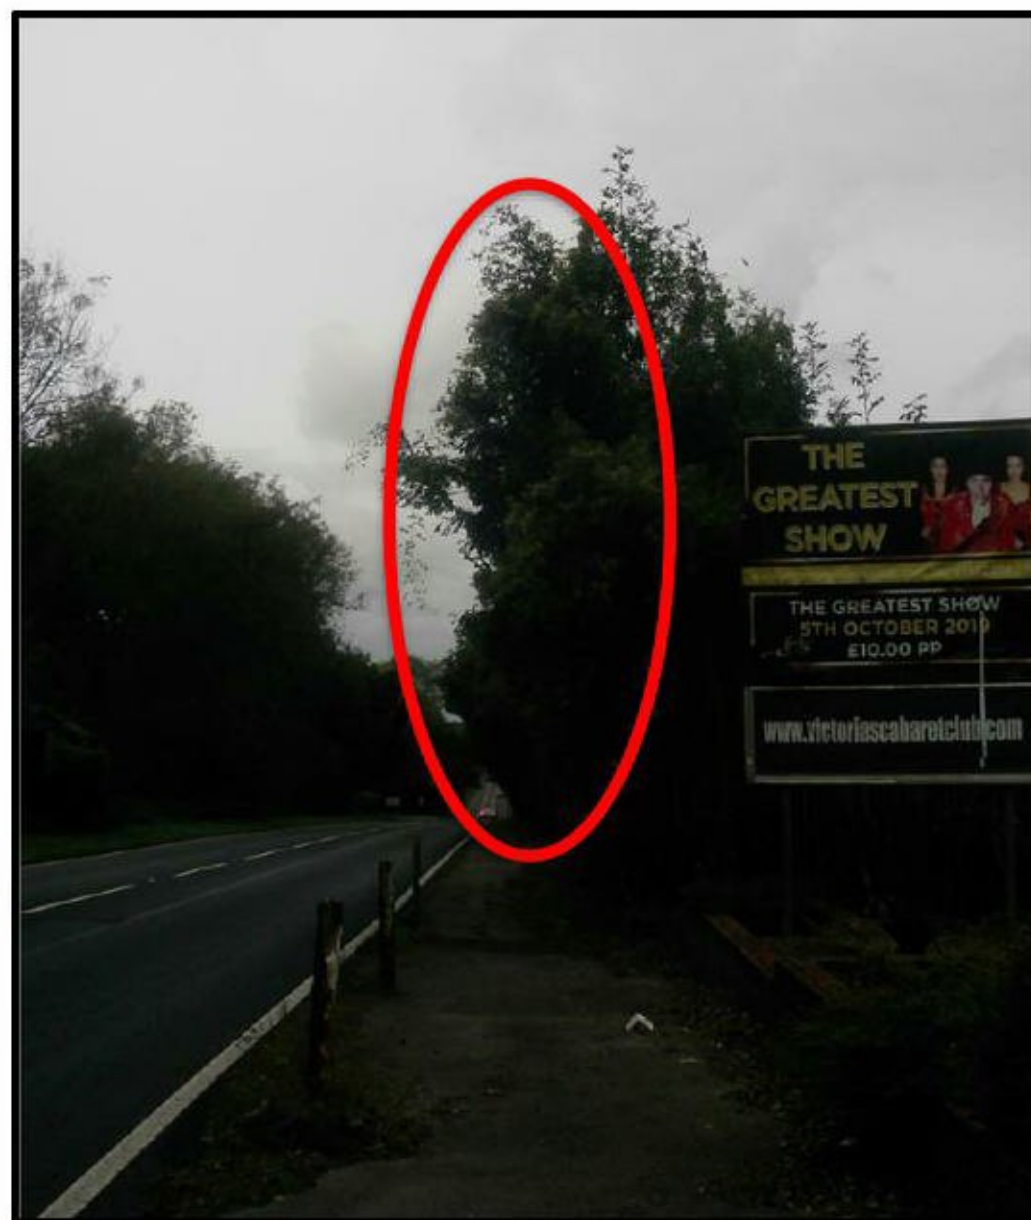
Location – Right hand visibility splay at proposed junction

Summary: Risk of pull-out type accidents.

The right-hand visibility splay at the junction for drivers waiting at the give-way line is likely to be obstructed by existing vegetation, this could result in pull-out type collisions if drivers fail to see approaching vehicles in time.

RECOMMENDATION

Vegetation within the visibility envelope should be cut back and maintained on a routine basis.

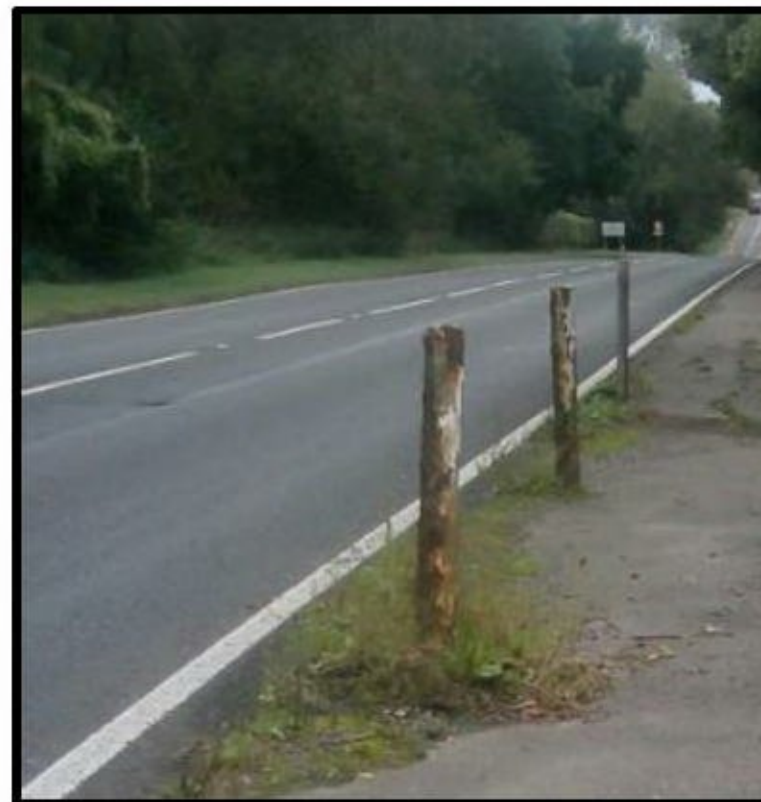
Location – Northern Footway

Summary: Potential vehicle strike type collisions

There are currently several old metal verge markers on the northern footway which could be a hazard to any errant vehicle attempting to turn too early into the development. This could increase the risk of injury to vehicle occupants.

RECOMMENDATION

The posts should be removed and replaced with a sufficient kerbed edge to the footway to safeguard users.
