Report on a Structural Inspection

Project: Proposed change of use of existing agricultural building to 2No. dwelling houses (C3) under Class Q of the GPDO

**High Walks Barn,
Stone Lane, Haddington**

Project No: 22-288

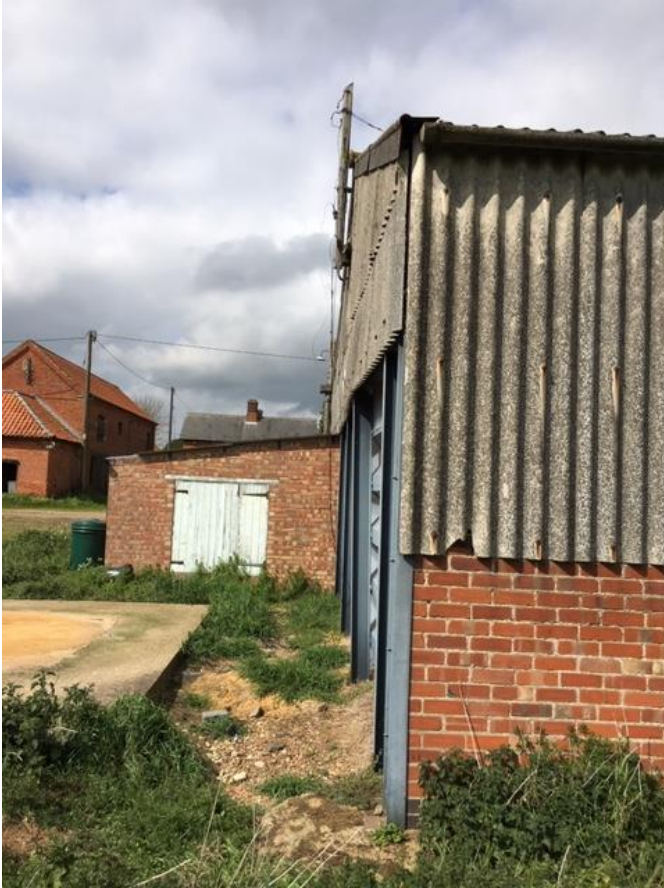
- 2.1.9 One of the steel columns to the rear of Barn A appears to have a minor outward lean and we would suggest that this column is re-aligned during the conversion works.

6.5 Outward Leaning Rear Columns (Barn A)

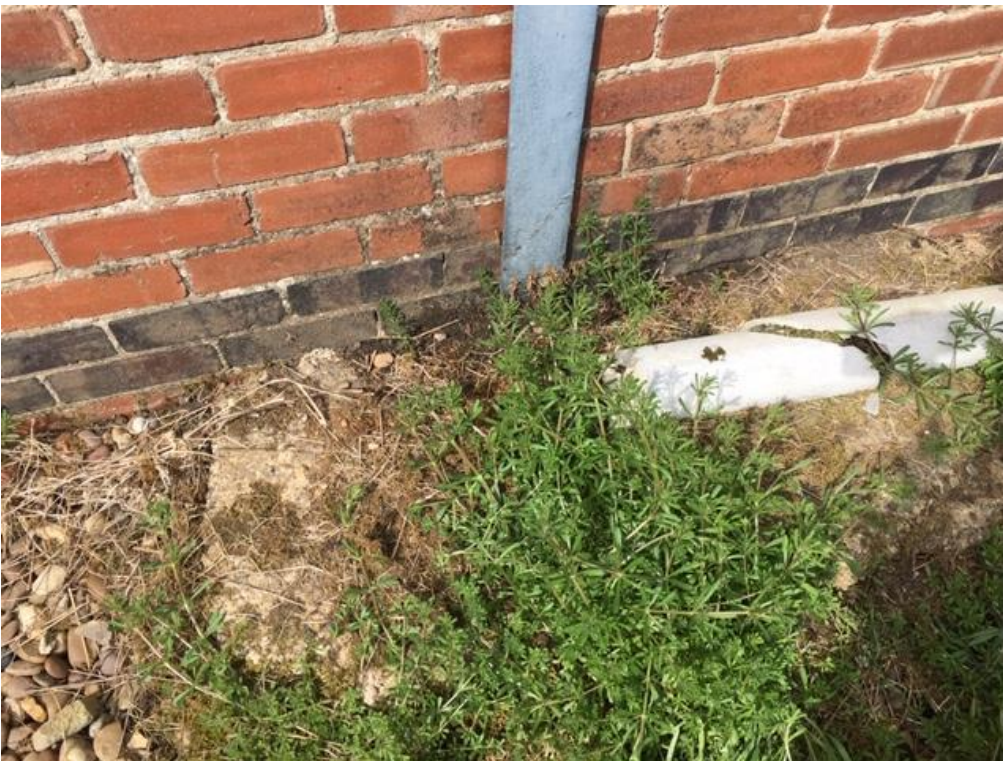
- 2.1.10 To the long elevation of Barn A, some of the external column pad foundations were exposed to view above the ground surface. These pad foundations appear to be of an adequate size for the building, being in the order of 1.2metres wide.

6.6 Exposed Column Pad Foundation (Barn A)

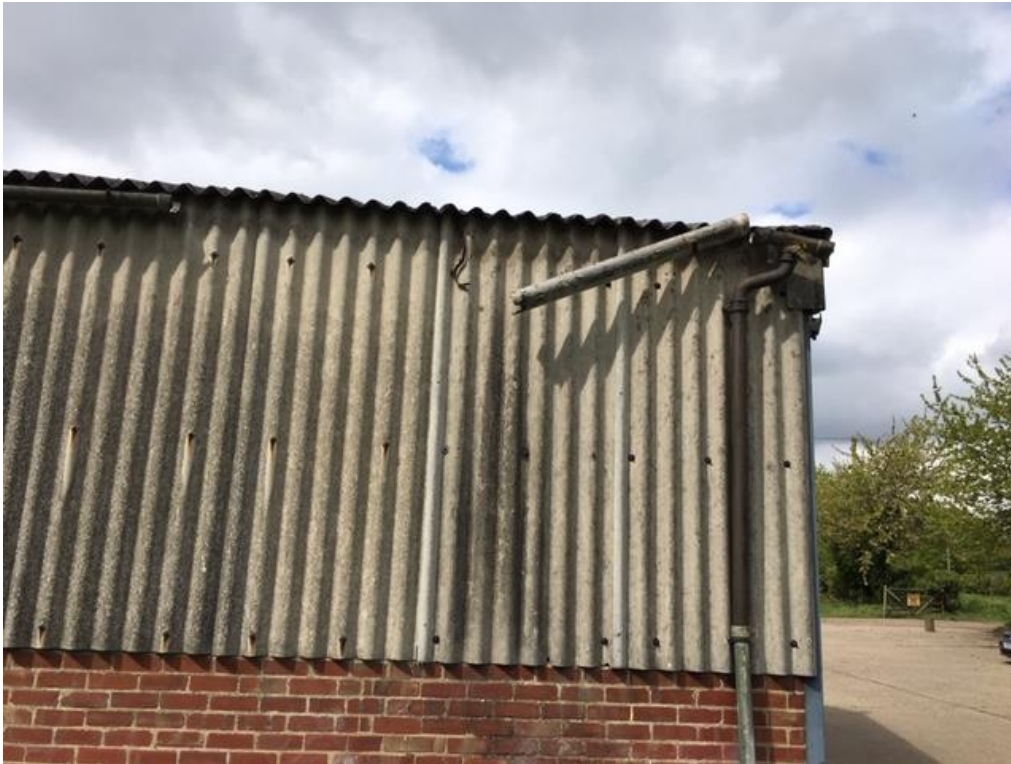
- 2.2.1 The roof is covered in shallow profile corrugated concrete asbestos cladding sheets.
- 2.2.2 Roof guttering is present to both low sides of the roof with rainwater down-pipes located at the end of each gutter with one at the overflow for the valley gutter. Some of the guttering is broken and all guttering will require renewal.
- 2.2.3 The roof sheets appear to be generally intact as viewed from inside the buildings. However, it is not known whether the roof is fully watertight.
- 2.2.4 As part of the Class Q conversion it is expected that the roof sheeting and rainwater collection systems would be replaced with a new lightweight insulated roofing system.

6.7 Front Corner Broken Gutter (Barn A)

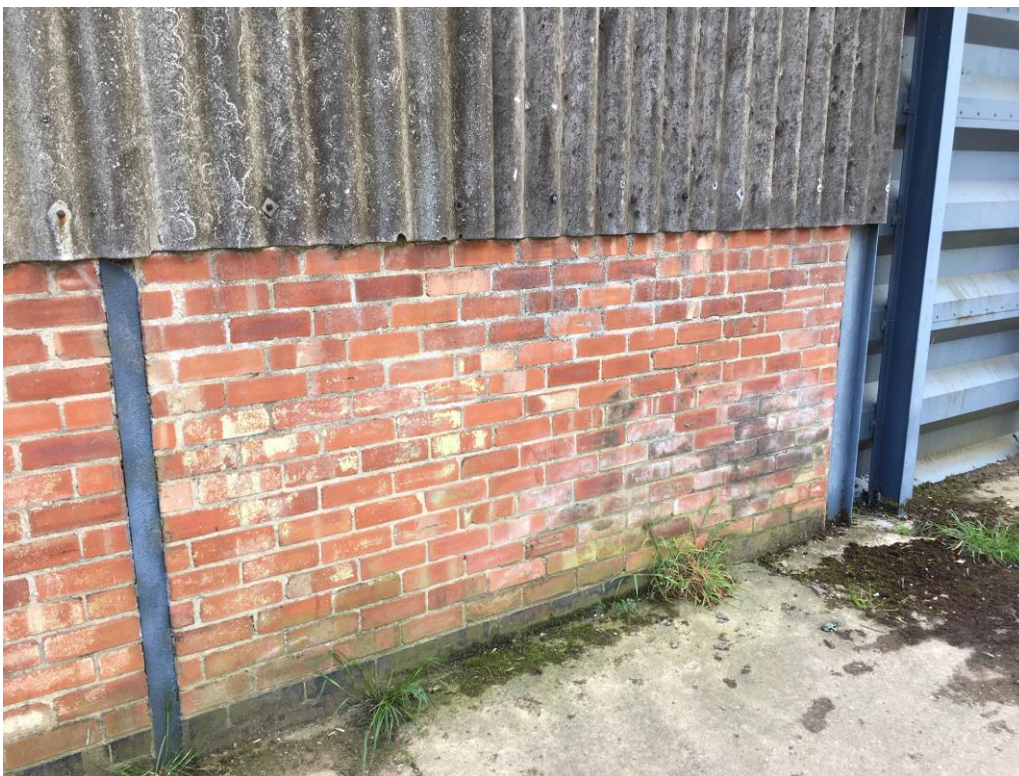
- 2.1.4 The front elevation to Barn A comprises a large roller shutter door, with dado brickwork cladding and-high level concrete asbestos corrugated cladding sheets. The faces of the steel column flanges are visible externally through the brickwork wall. The exposed brickwork is in a good state of repair.

6.8 Front Elevation Brick Wall (Barn A)

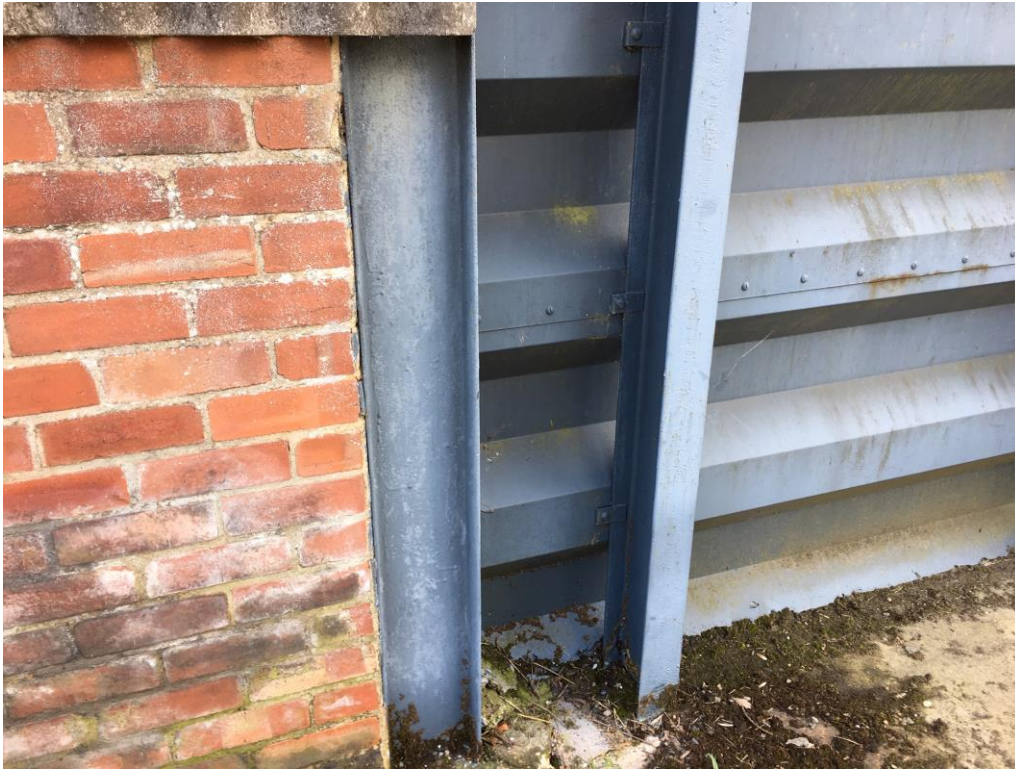
- 2.1.11 To all elevations, several of the externally exposed steel column flanges have experienced minor surface rusting and we advise that these are cleaned and re-protected with steel primer paint during the conversion works.

6.9 Low-level Minor Steelwork Surface Rusting (Barn A)

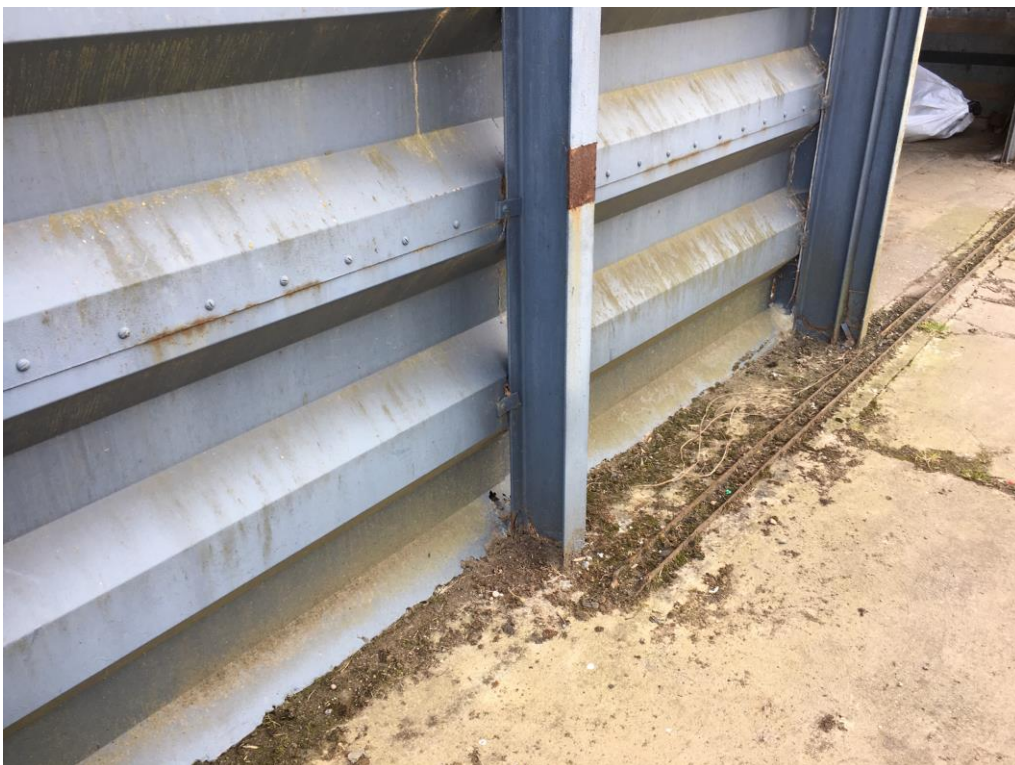
6.10 Low-level Minor Steelwork Surface Rusting (Barn B)

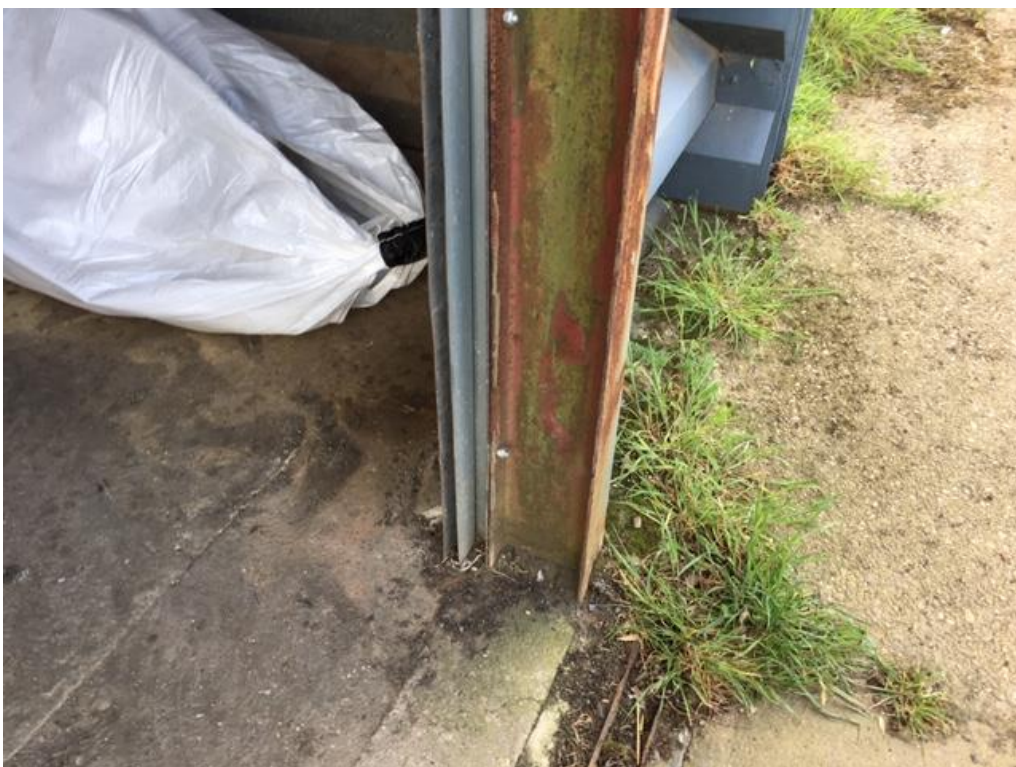
6.12 Surface Rusting to Front Door Post (Barn B)

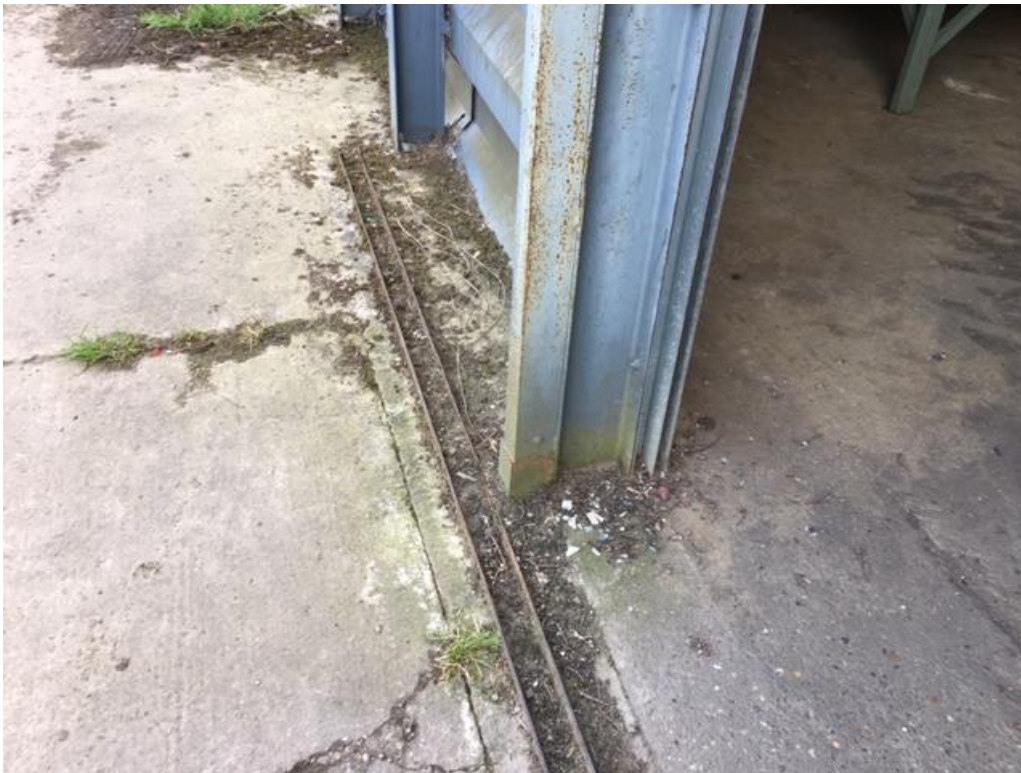
6.13 Minor Surface Rusting to Steel Door Post (Barn B)

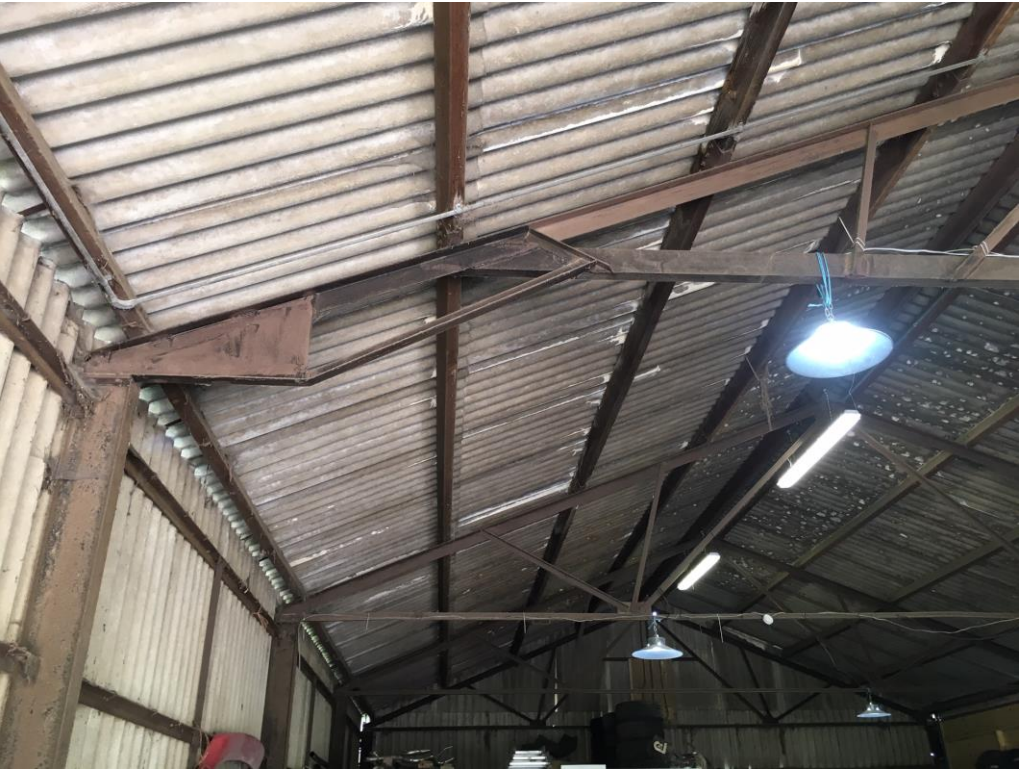
- 3.2.3 The trusses are formed in triangulated angle steelwork.
- 3.2.4 The two trusses closest to the roller shutter door have been partially modified. We suspect that this may have been undertaken in order to improve the working headroom at the front of the building.

6.16 Steel Roof Truss Amendments (Barn A)

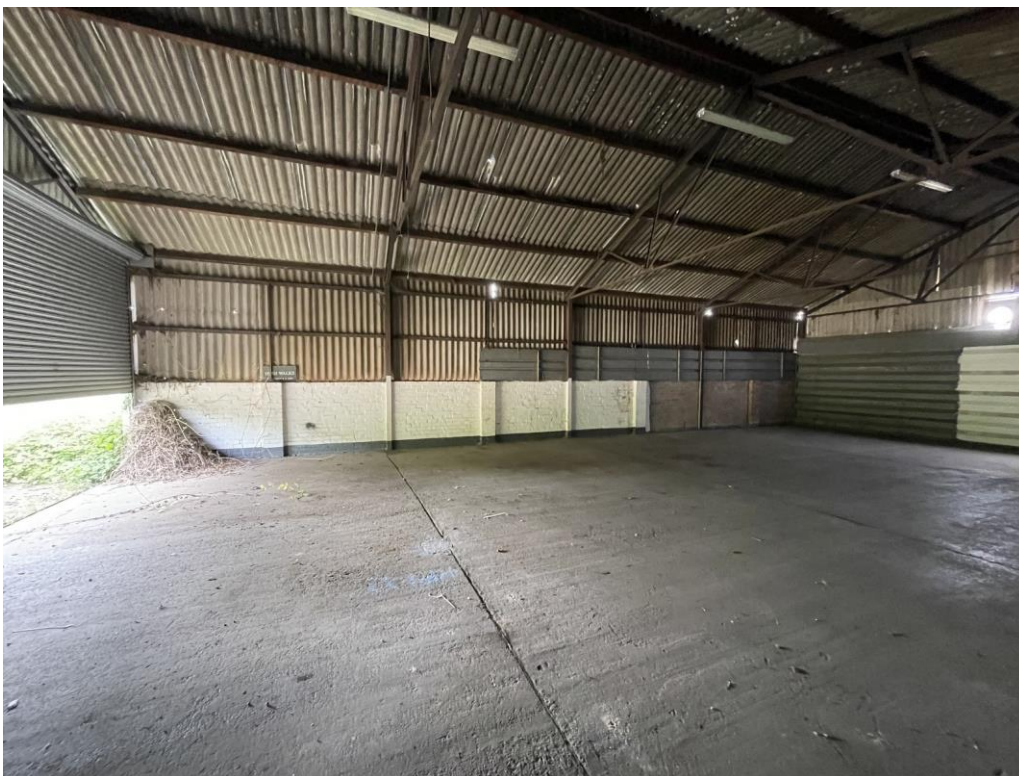
- 3.1.1 The floors to both Barn A are laid with jointed concrete floor slabs.
- 3.1.2 The slabs have some minor cracking and surface wear to the front of each building, but these are not significant enough to warrant removal and replacement of the concrete slabs.
- 3.1.3 We would expect that that floors will be overlaid with insulation and screed finishes in order to meet with current Building Regulations requirements.

6.18 Concrete Floor Slab Joint (Barn A)

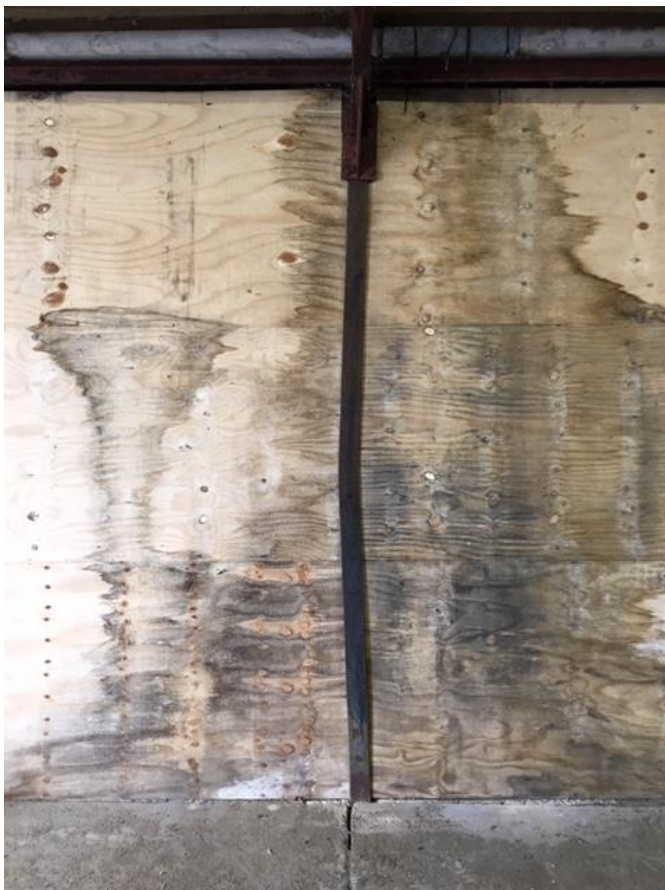
- 3.2.11 We identified a distorted/ buckled steel column along the internal valley line (mid-way along the building).
- 3.2.12 This column will need to be replaced with a new vertical column. The roof structure can be propped and then the column removed and replaced from within the building.

- 3.3.8 No roof bracing is present.
- 3.3.9 We identified a distorted/ buckled steel column along the internal valley line (mid-way along the building).

6.22 Distorted Steel Valley Column (Viewed from Barn B)

- 3.3.10 This column is shared with Barn A and will need to be replaced with a new vertical column.
- 3.3.11 A cast concrete kerb has been used to restrain the bottom of the steel cladding above the slab.

- 4.04 The existing steel frame should be cleaned and then paint protected to preserve its condition.
- 4.05 A single buckled column along the valley line will need to be replaced with a new column.

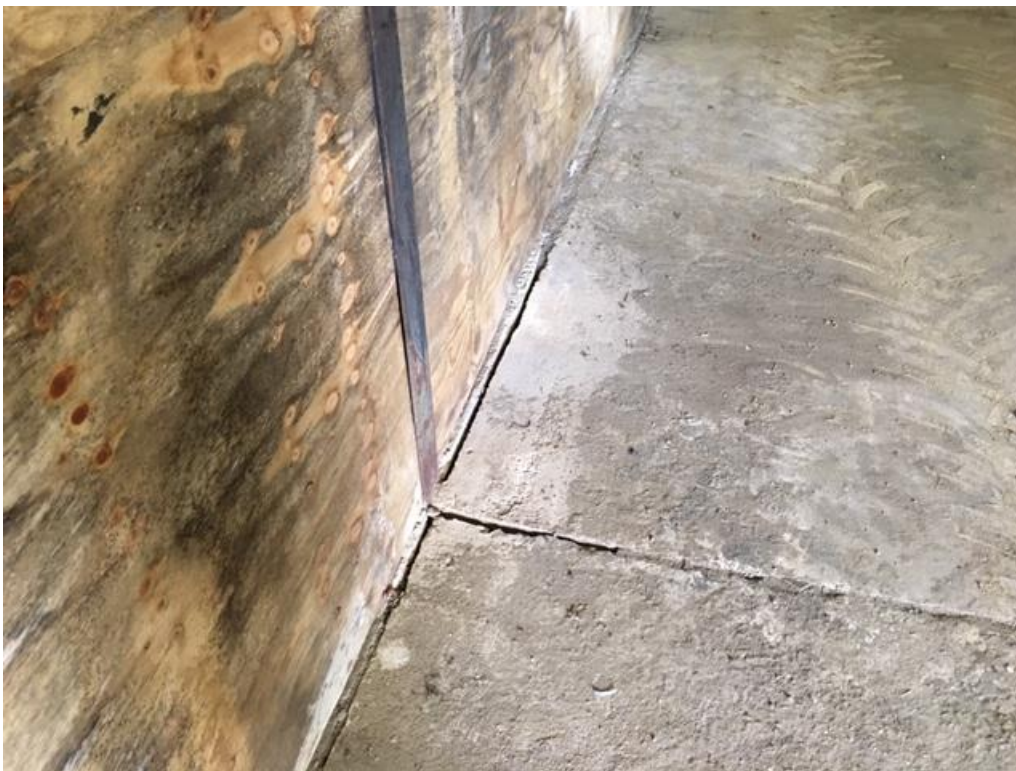
6.24 Concrete Floor Slab Joint (Barn B)
