**Part Discharge of Condition 3 of
Listed Building Consent, DC/22/02688**

Roof Timber Repairs

**Woodlands Farm
Bildeston Road
Ringshall
IP14 2LY**

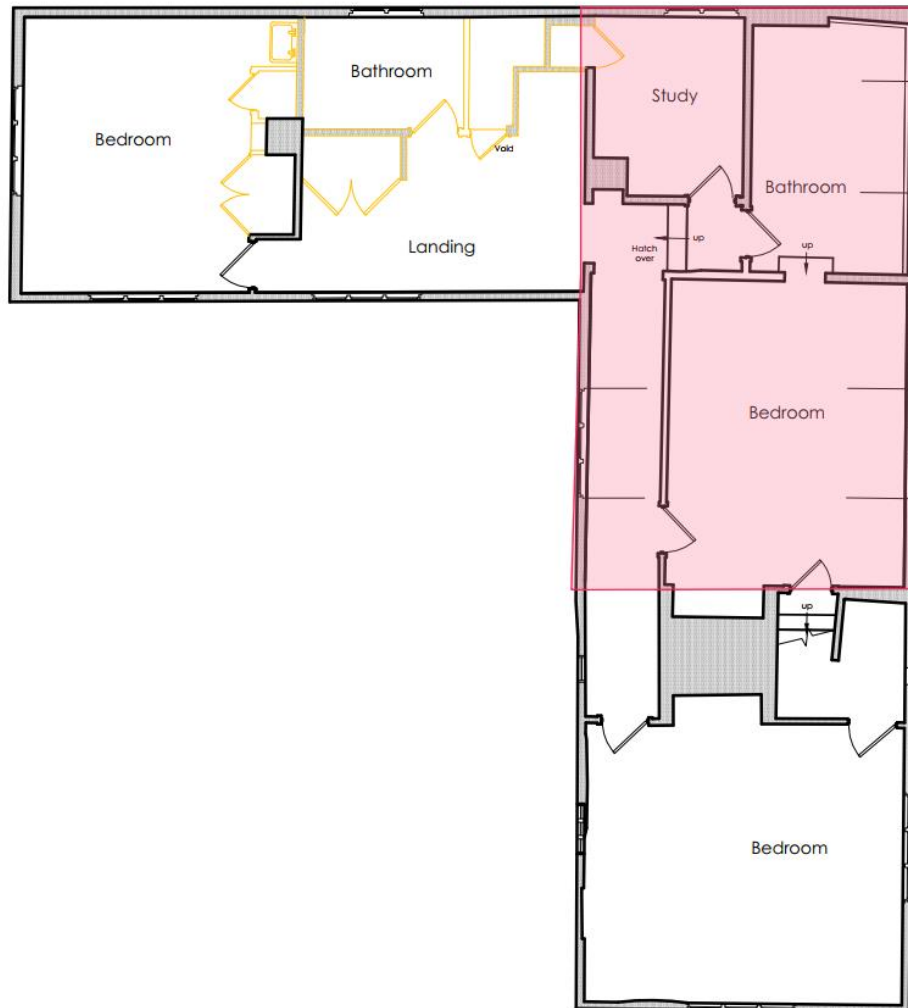
Following removal of the existing clay pantiles to the lower roof section the structure was found to be in poor condition. The affected area is shaded pink below:

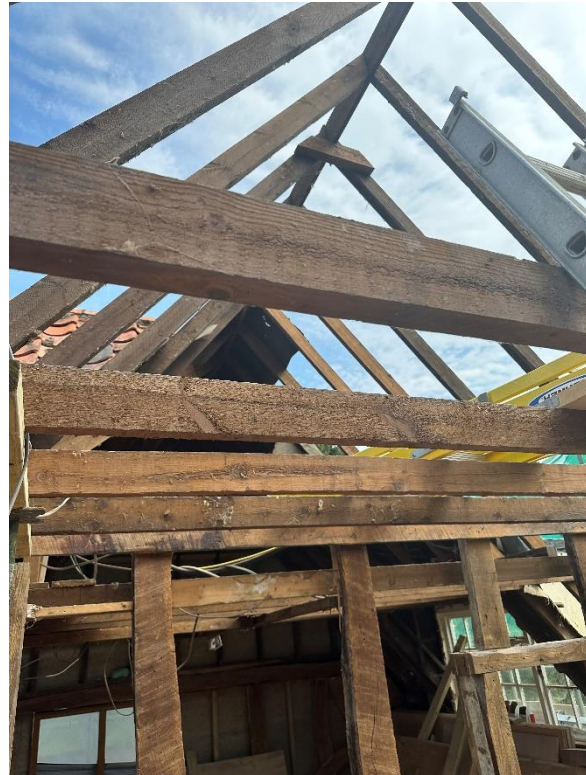
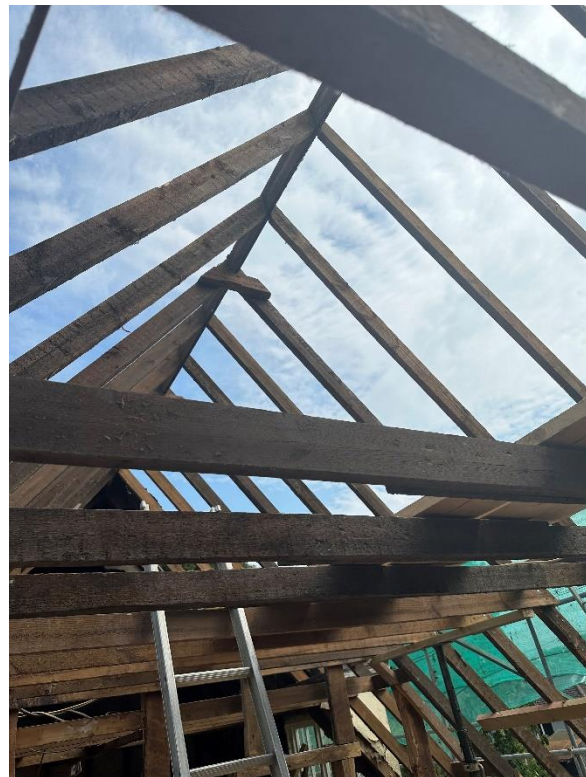
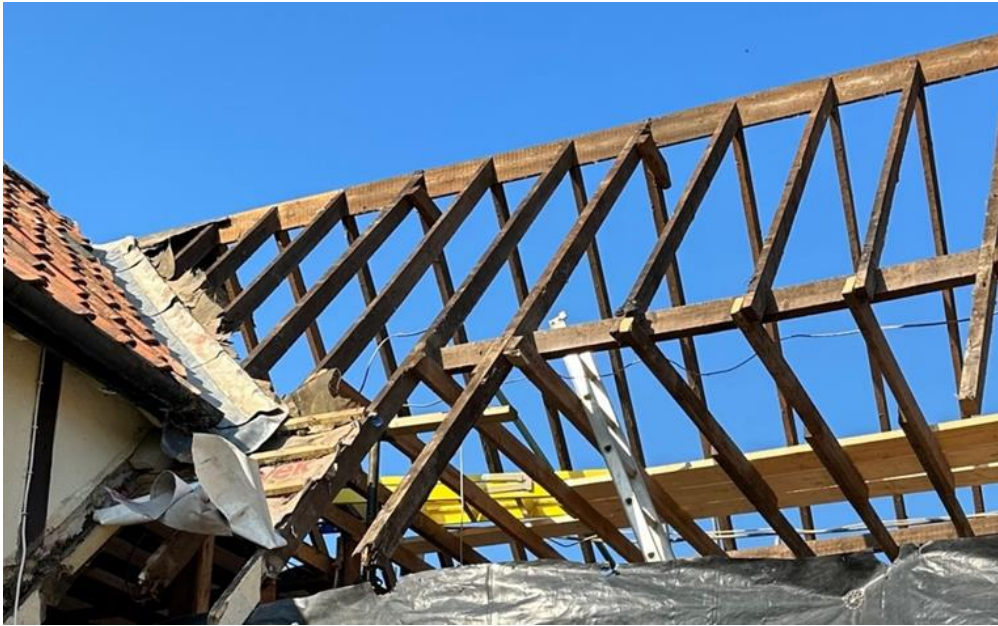
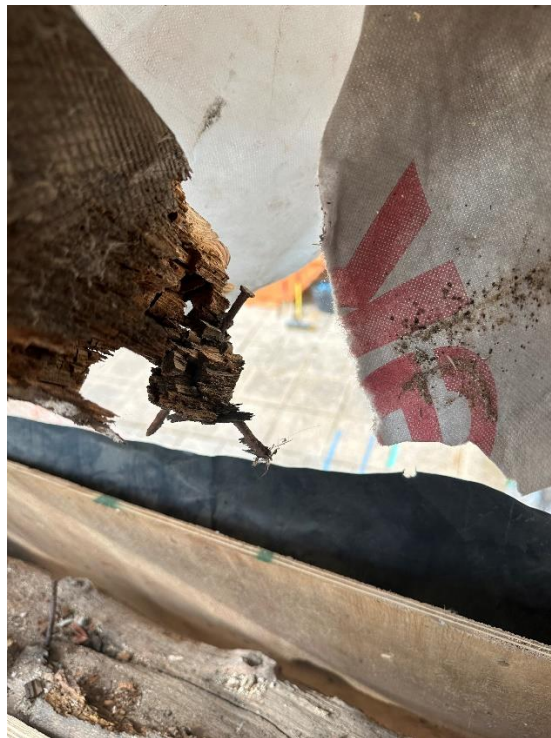
Following removal of the roof tiles the roof slopes were found to be covered with bitumen underlay felt with evidence suggesting the roof was re built in 1969.

The roof structure to this part is 'modern' C20 sawn softwood, all 50x100mm and significantly under designed for its arrangement being a raised tie roof.

There is significant wet roof decay to rafter feet, many decayed to the plate further destabilizing the roof framework.

Advice from the structural engineers is that the existing roof framework is structurally inadequate. Given the entire roof is C20 modern softwood framing with no historic fabric remaining, the proposal is for a complete new roof structure to this part of the roof. This will replicate the 'A' frame raised tie roof that currently exists, both pitch and ridge height.

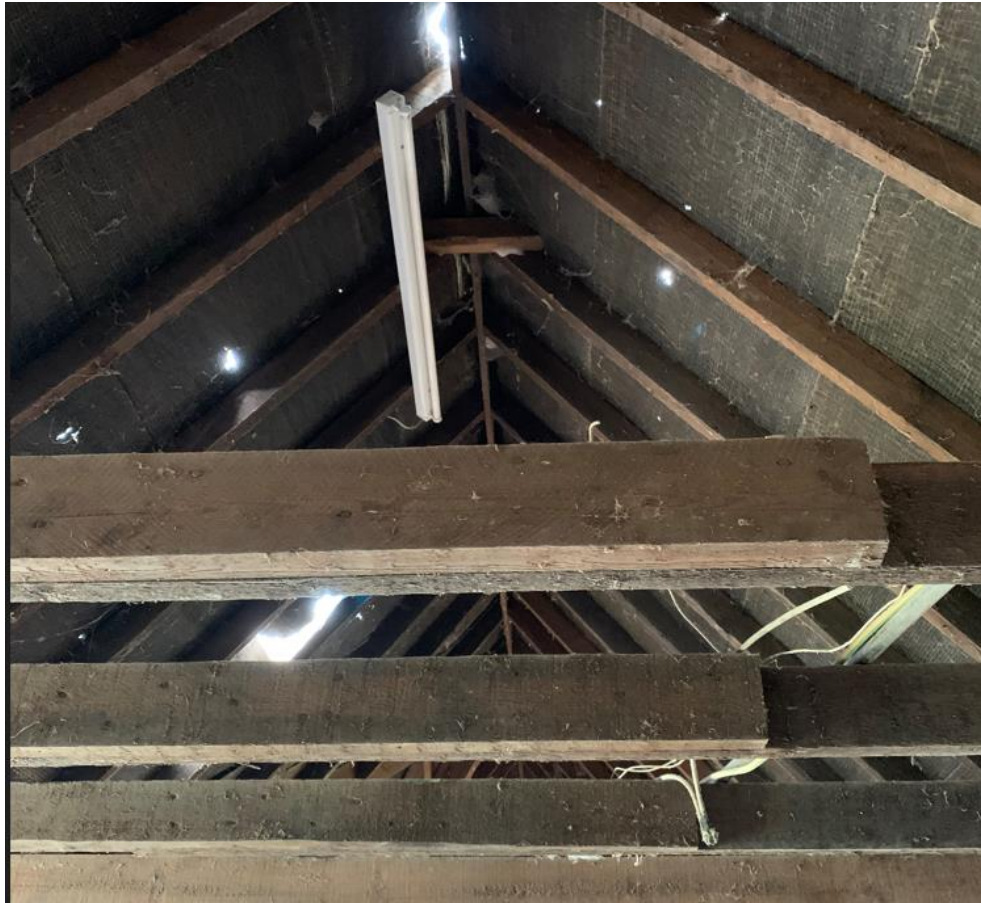
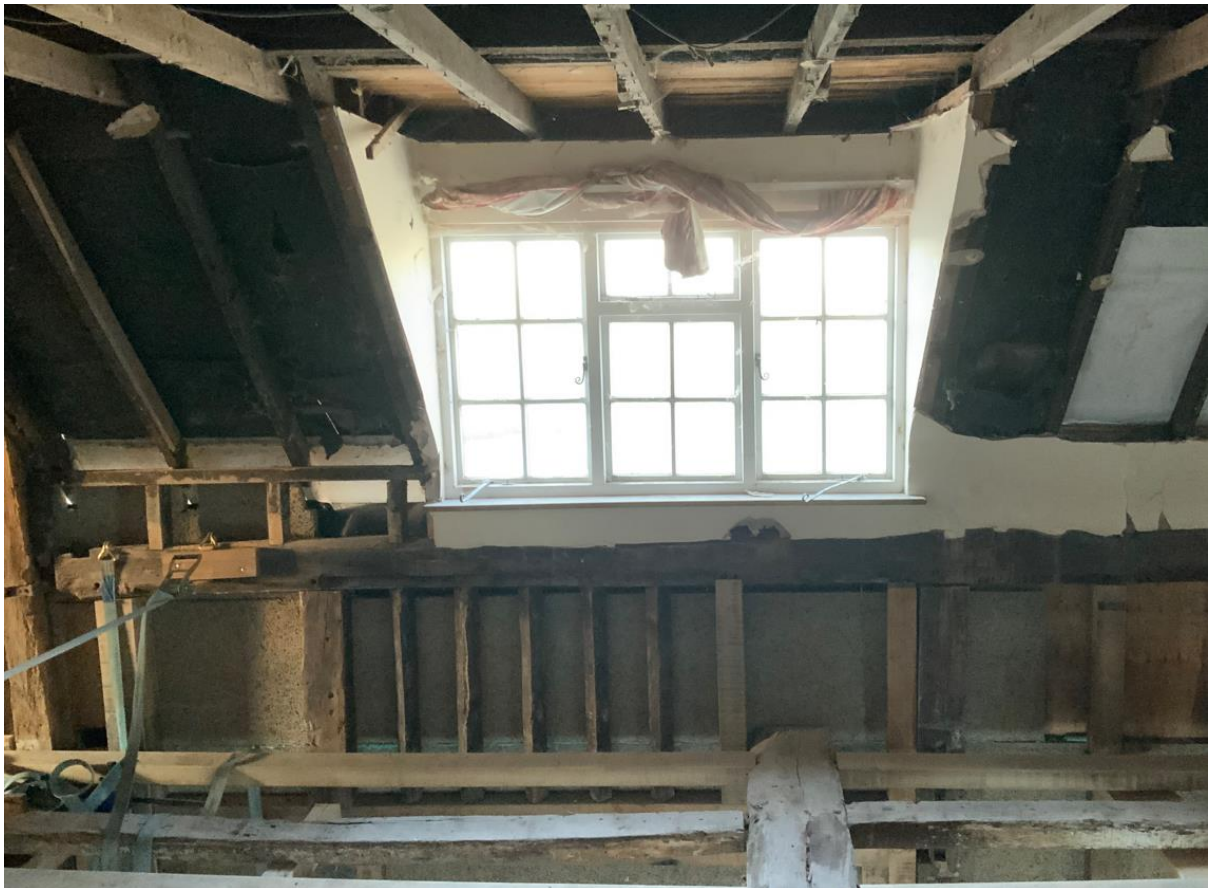
Rear elevation, showing roof make up and original mullioned window
