Barn at Gibbons Farm, Battisford, Suffolk

(Suffolk HER BAT 051)

Historic Building Record

October 2022

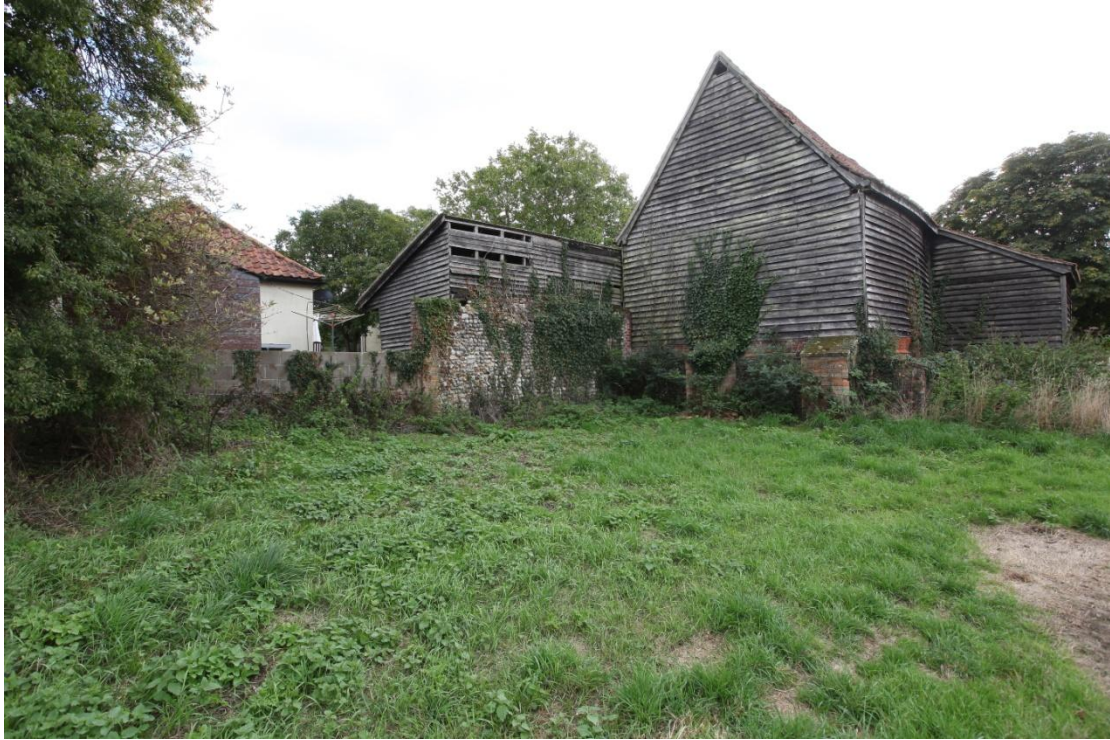
Illus. 9. The 20th century weatherboarding of the barn's northern gable (1) showing the 20th century brick buttresses added to the original flint-rubble plinth. The modern lean-to stable (2) adjoining to the left incorporates the flint-rubble western wall of the shelter-shed shown on the historic Ordnance Surveys but structure 3 in figure 9 to the extreme left has been demolished and replaced by a modern cement-block wall and a small boarded shed. The hipped roof of the modern bungalow is visible beyond.

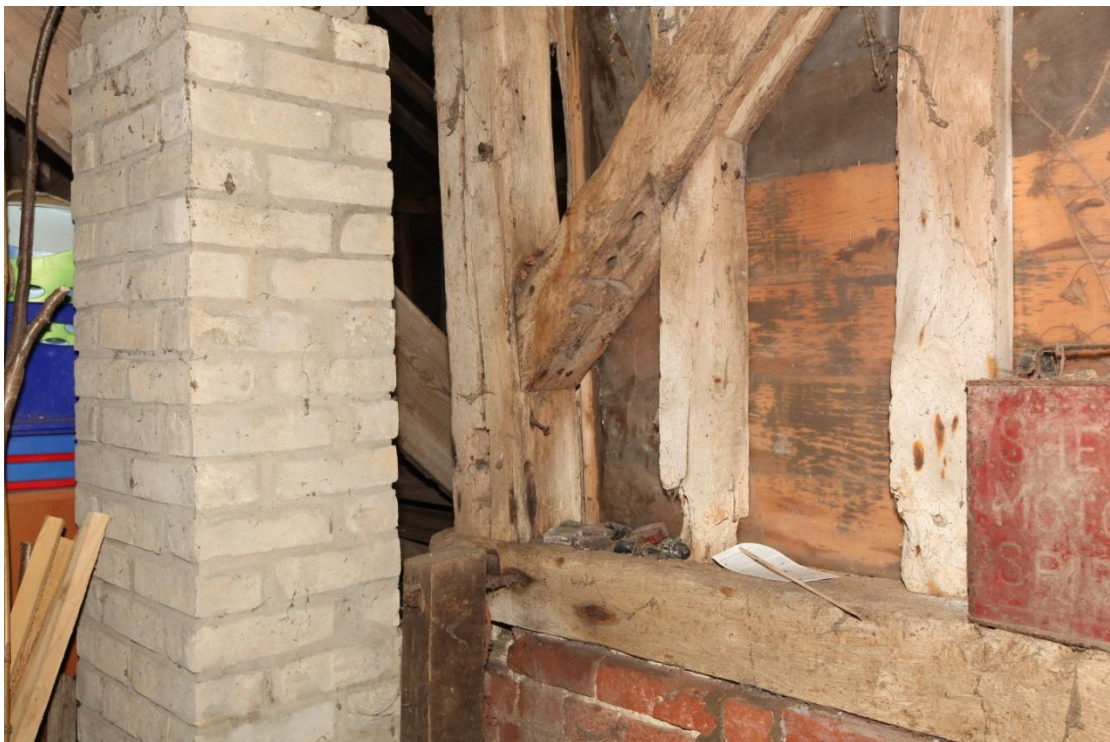
Illus. 12. A detail of the barn's rear (western) wall to the right in illustration 11 showing a modern brick pier supporting the loft and the empty mortices in both the storey post and the diagonal primary wall brace to the north of the porch which identify them as re-used timbers. The braces interrupt the studs and are nailed rather than tenoned at both ends.

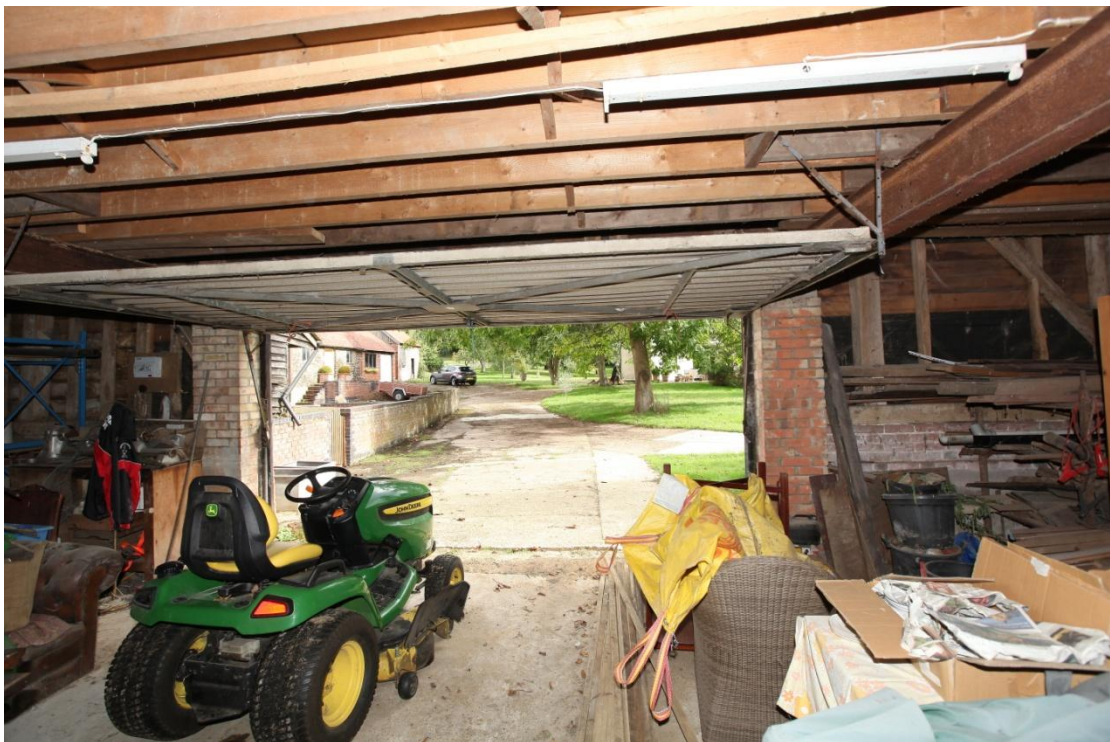
Illus. 14. The eastern interior of the barn (1) showing the modern 'up-and-over' garage-type door which replaced the original entrance in the central bay and extends into the adjoining bay to the right, cutting the storey post and door jamb in illustration 29.

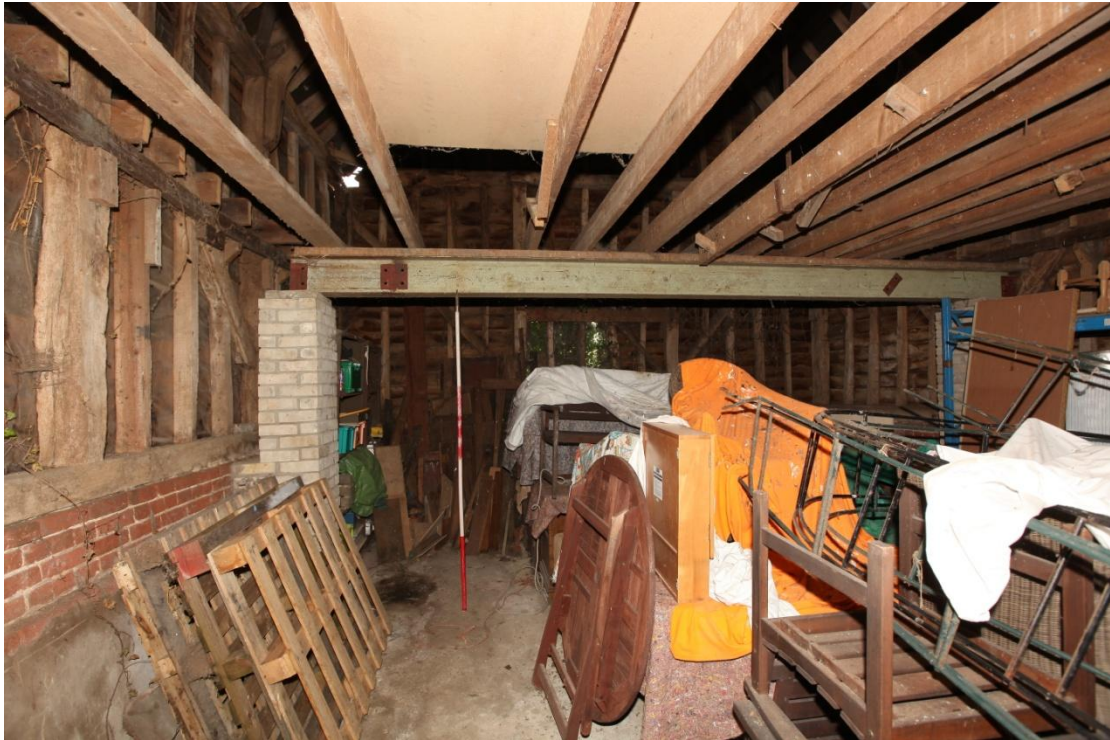
Illus. 15. The interior from the south of the northern bays of the barn (1) showing the late-20th century loft from which a number of joists have been removed. The truncated joists and wooden supporting rail of an earlier 20th century loft which the present structure replaced are visible on the western wall to the left.

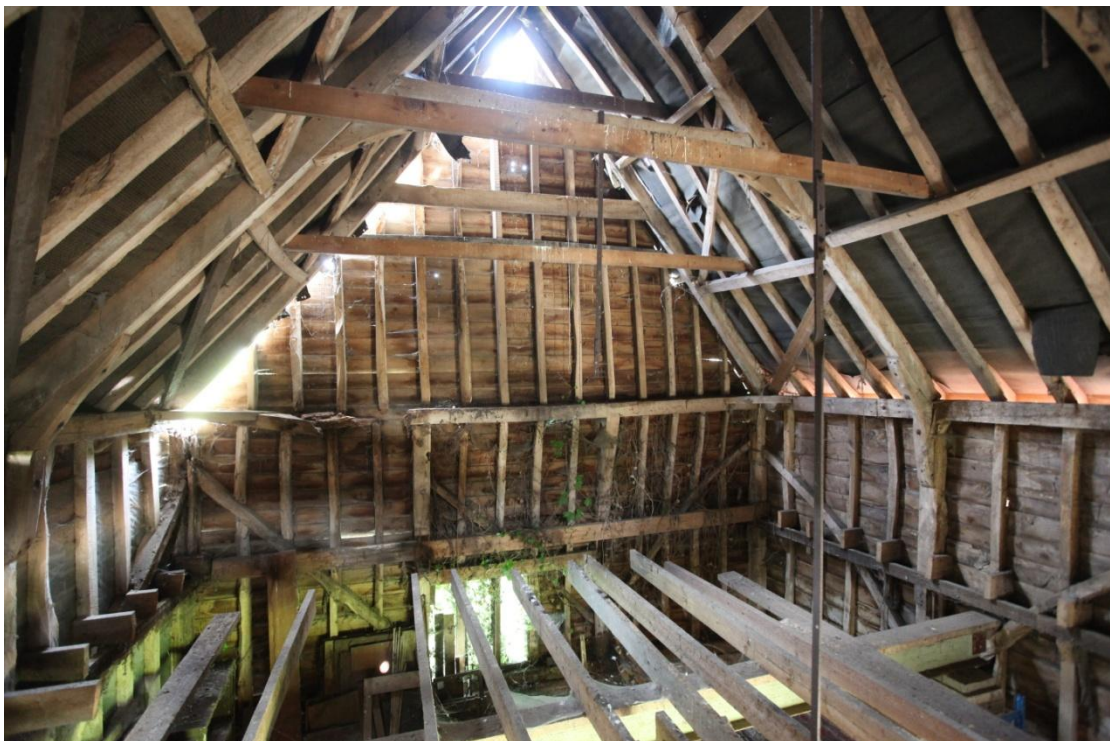
Figure 24. The northern internal gable of the barn (1) from the loft showing the original bolted knee-braces securing the two storey posts of the northern bays directly to the principal rafters in the absence of tie-beams (thereby increasing headroom). The steeply pitched roof structure consists of two tiers of staggered butt-purlins with knee-braces to the pegged collars and survives largely intact with evidence of some re-used material. Note the old break in the gable tie-beam to the left, apparently caused by water ingress.

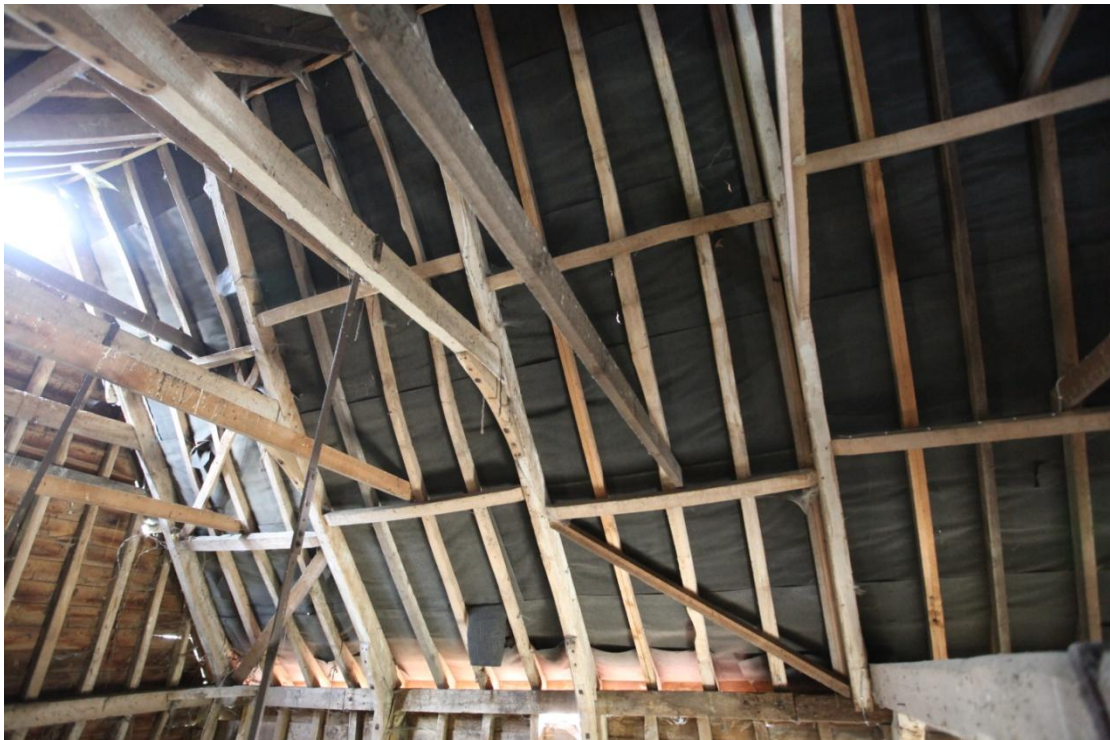
Figure 26. A detail of the largely original roof structure to the east of the northern bays (1). A small number of rafters have been renewed in light-coloured softwood and additional softwood collars inserted in the centres of each bay (lodged on the lower purlins and secured by vertical iron straps).

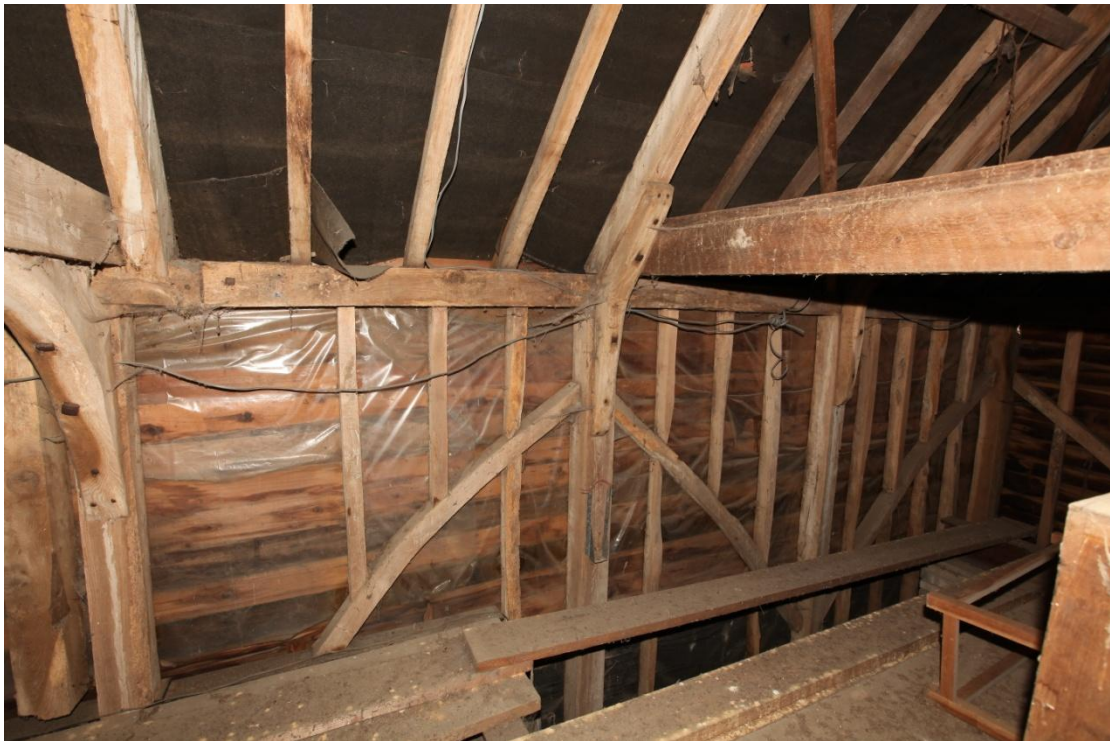
Illus. 28. The eastern interior of the barn's southern bays (1) showing the original knee-braces linking the principal rafters and storey posts with curved nailed primary braces in a style more usually associated with 18th century pegged examples. The softwood tie-beam to the right is a 20th century insertion and an original face-halved and bladed scarf joint is visible in the roof-plate to the left.

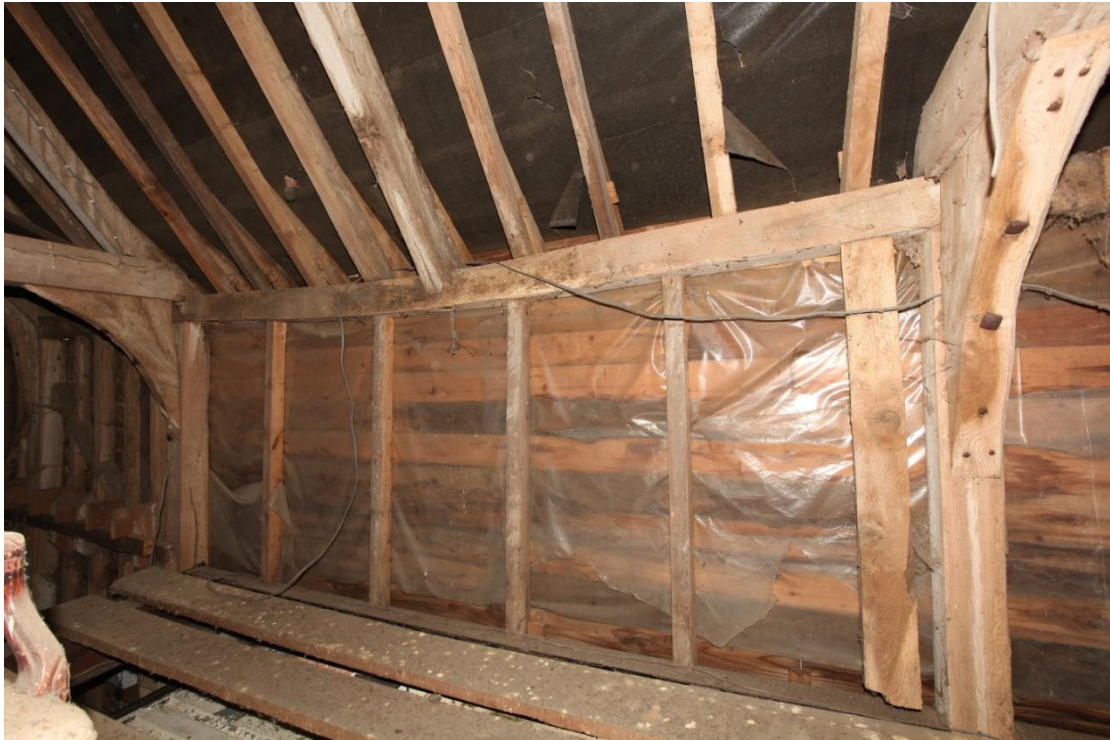
Illus. 29. The eastern roof-plate of the barn's central bay showing an original door jamb adjacent to the storey post on the right, pegged and tenoned to the plate. An empty pegged mortice for an identical jamb is visible to the left of the plate with an unpegged mortice for the locking post in the centre. The present wall studs are modern and lie above the garage door that cuts the post to the right and has caused the plate to bend beneath the central roof truss.
